Investigation of a Tower Crane Collapse in San Francisco, California-November 28, 1989

U.S. Department of Labor Occupational Safety and Health Administration

May 1990

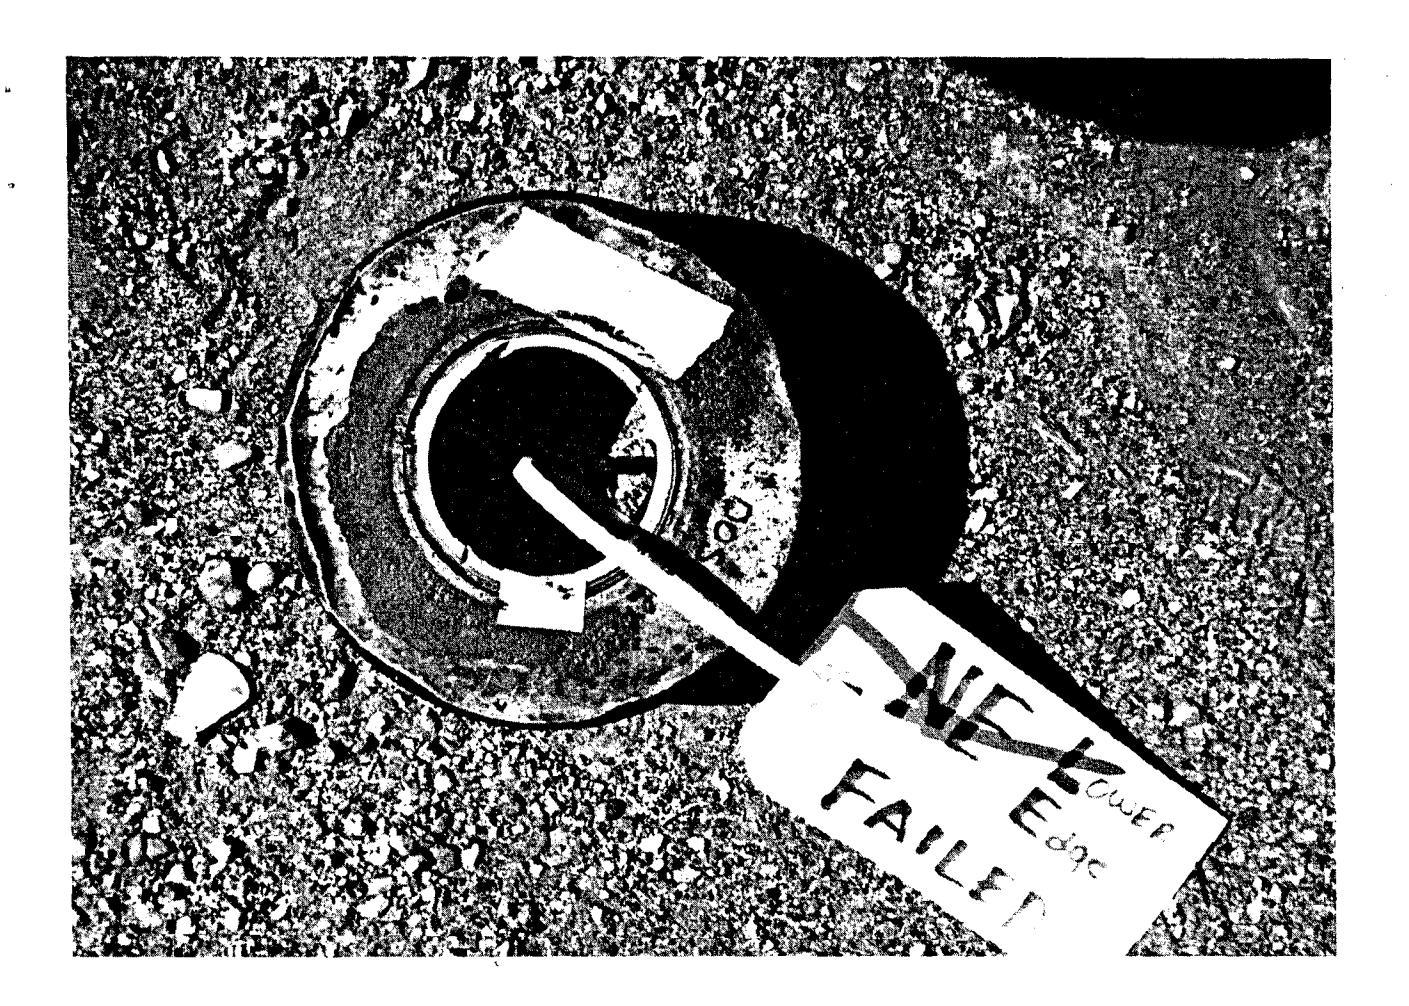
Figure 4.3.23

Missing NE lower edge roller.

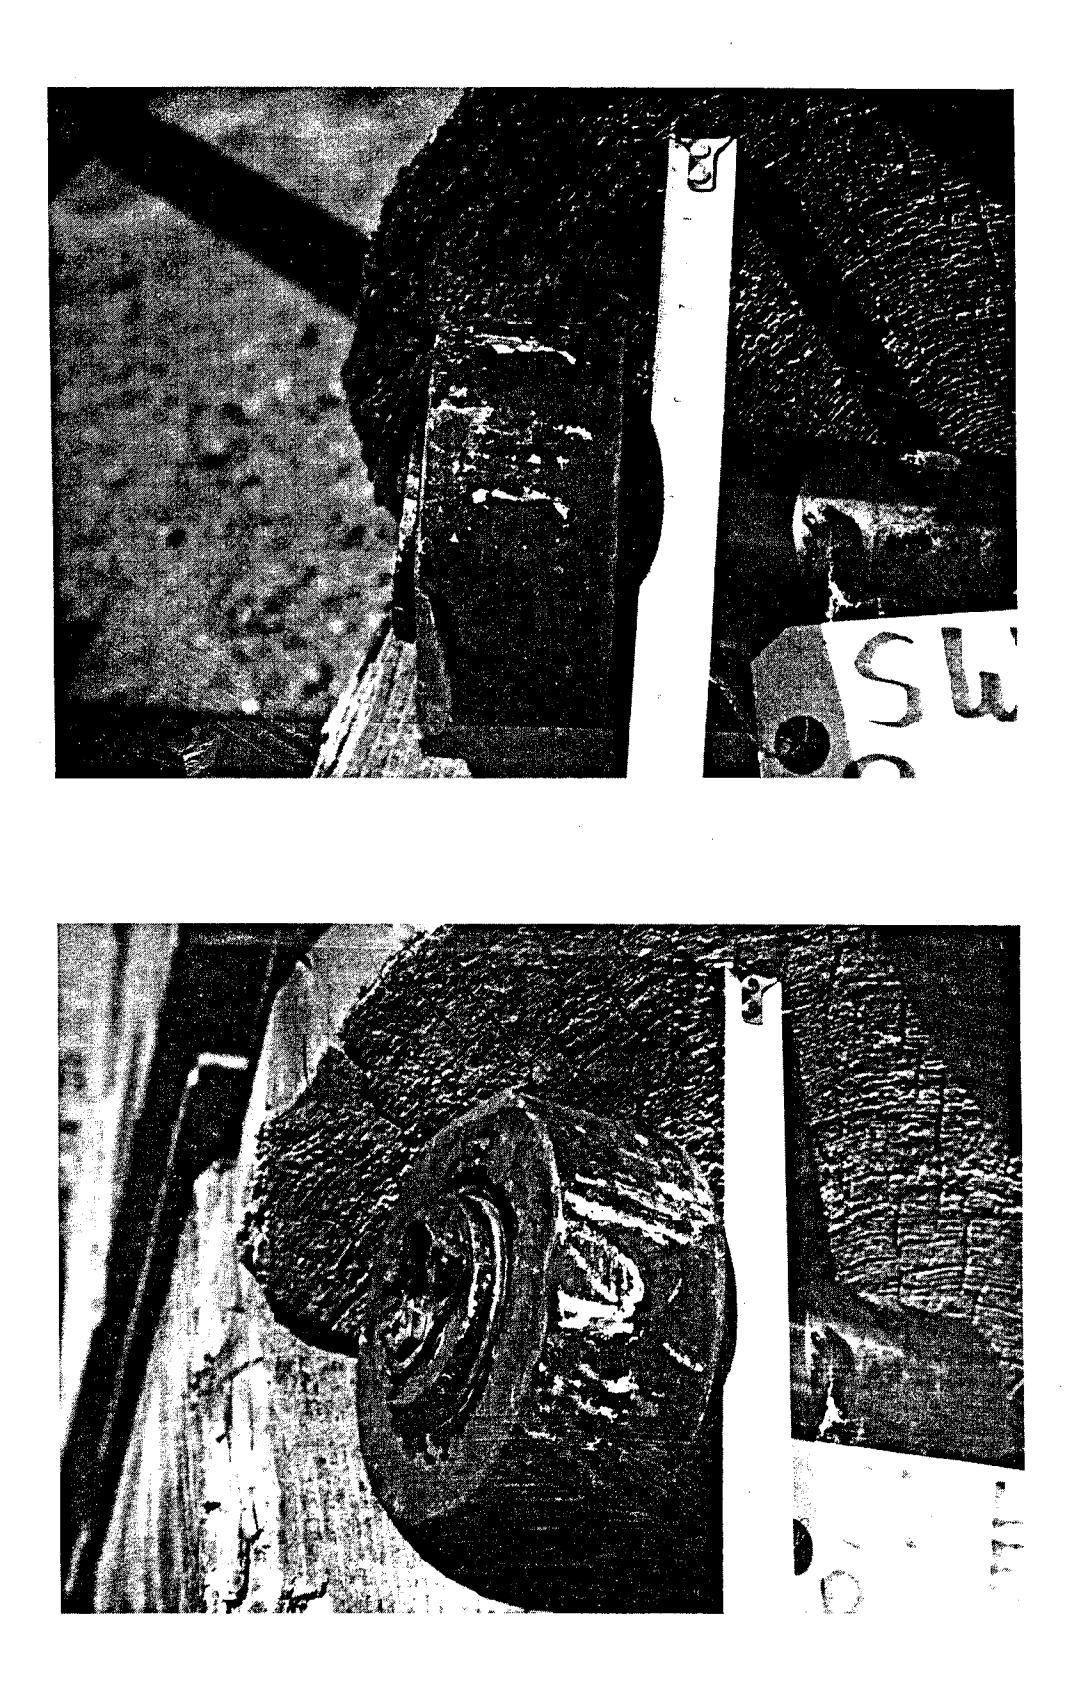
Damaged lower SW flange roller.

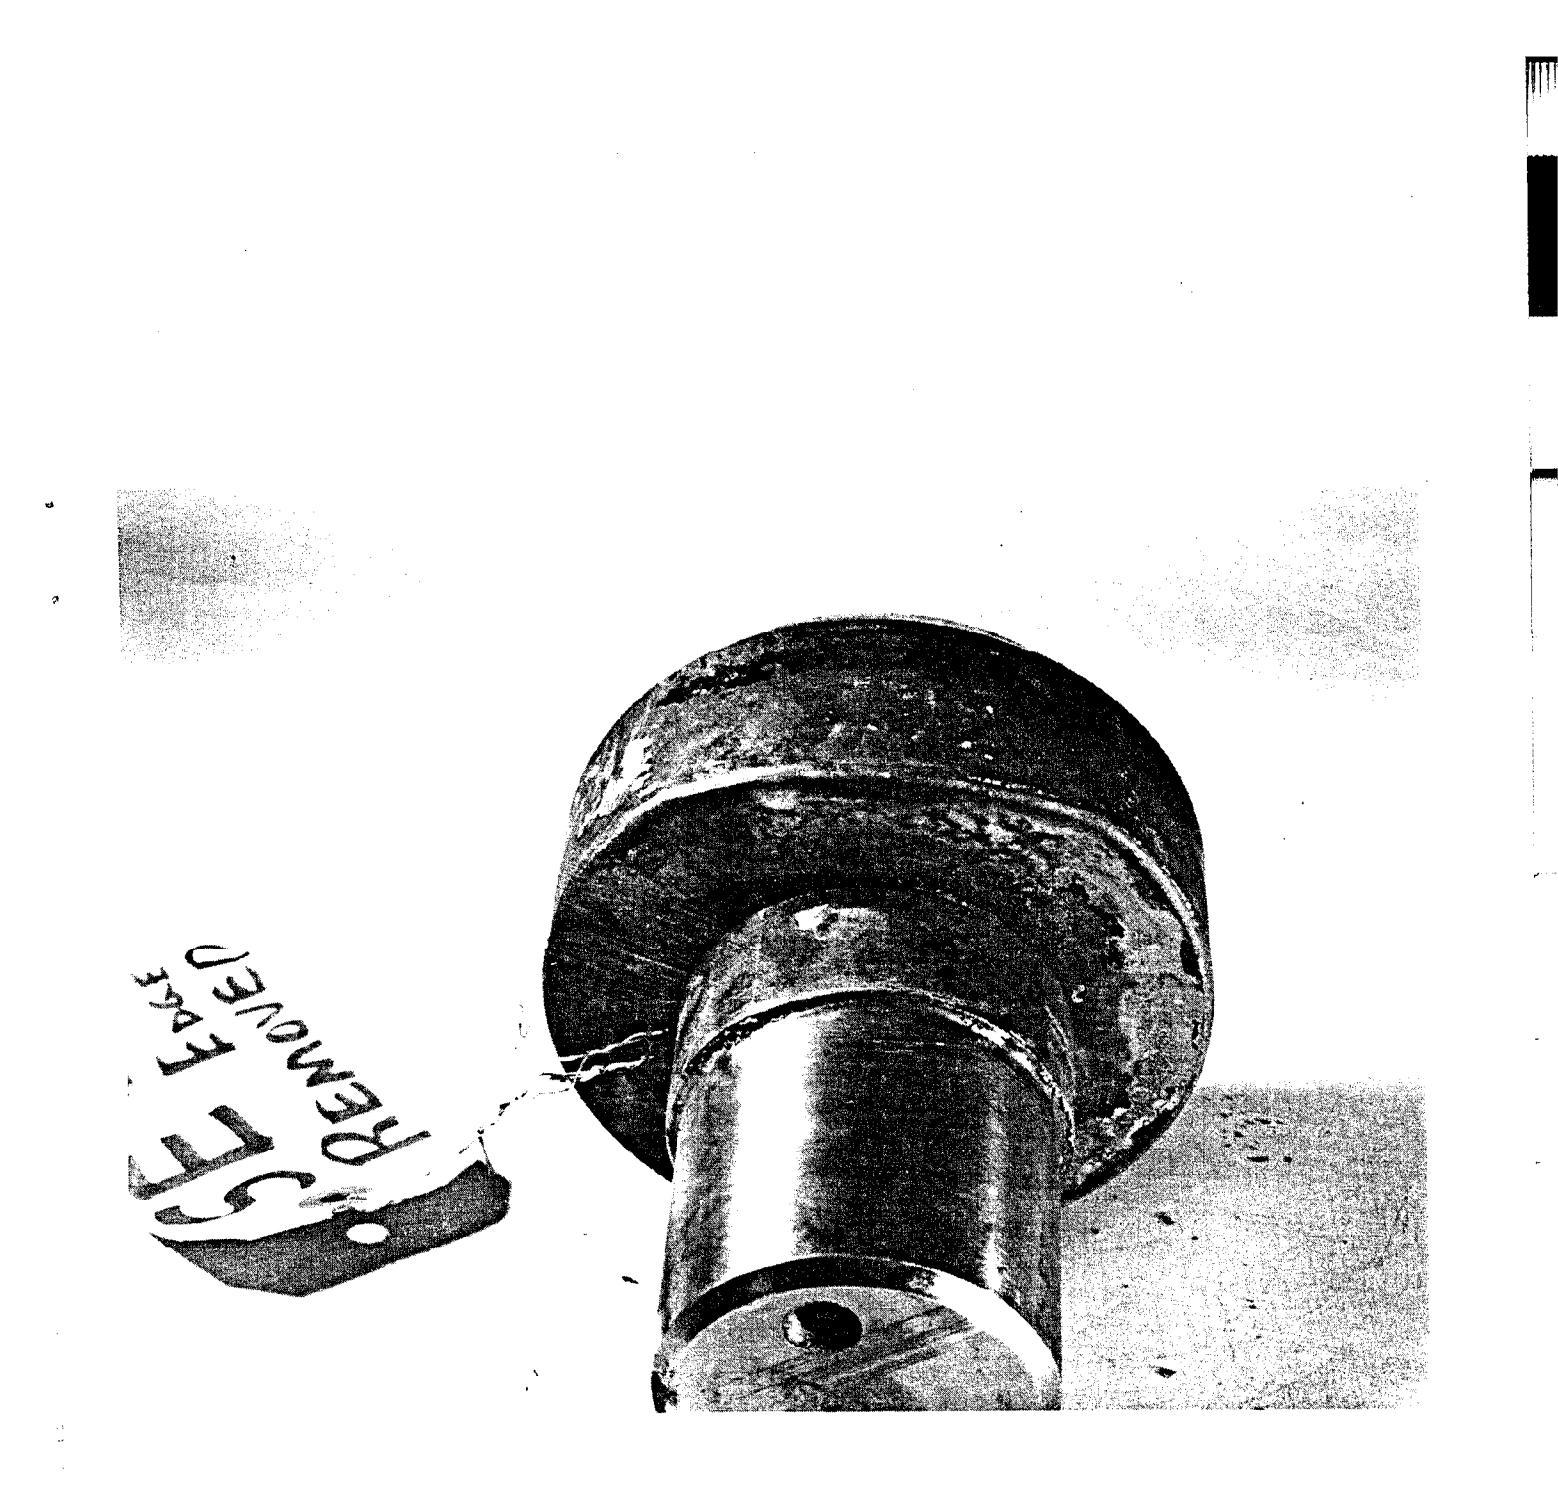
Deformation of upper SE edge roller.

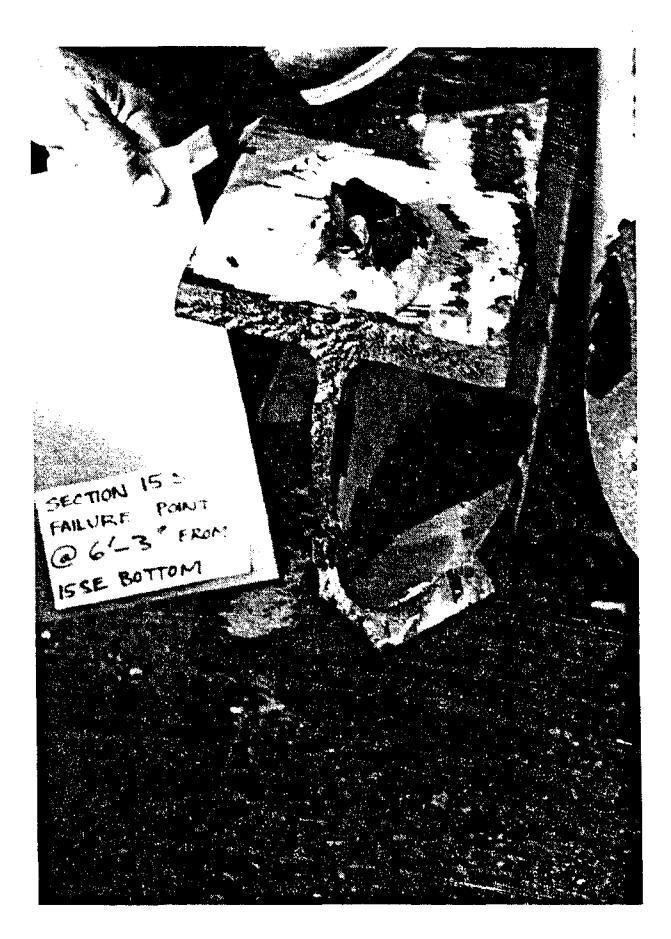
Figure **4.3.28**

Failure of Section 15 SE leg at 6'-3'' from top of section.

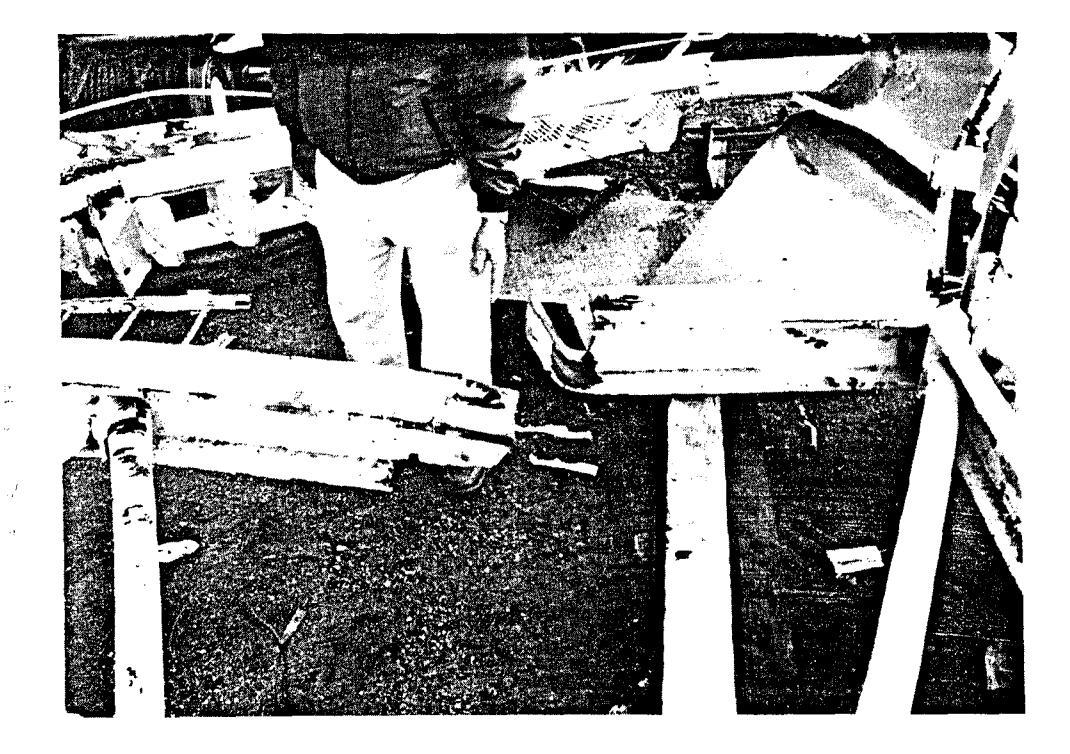
Figure 4.3.29

Failure of Section 15 SW leg — at 3'-4'' from bottom of member.

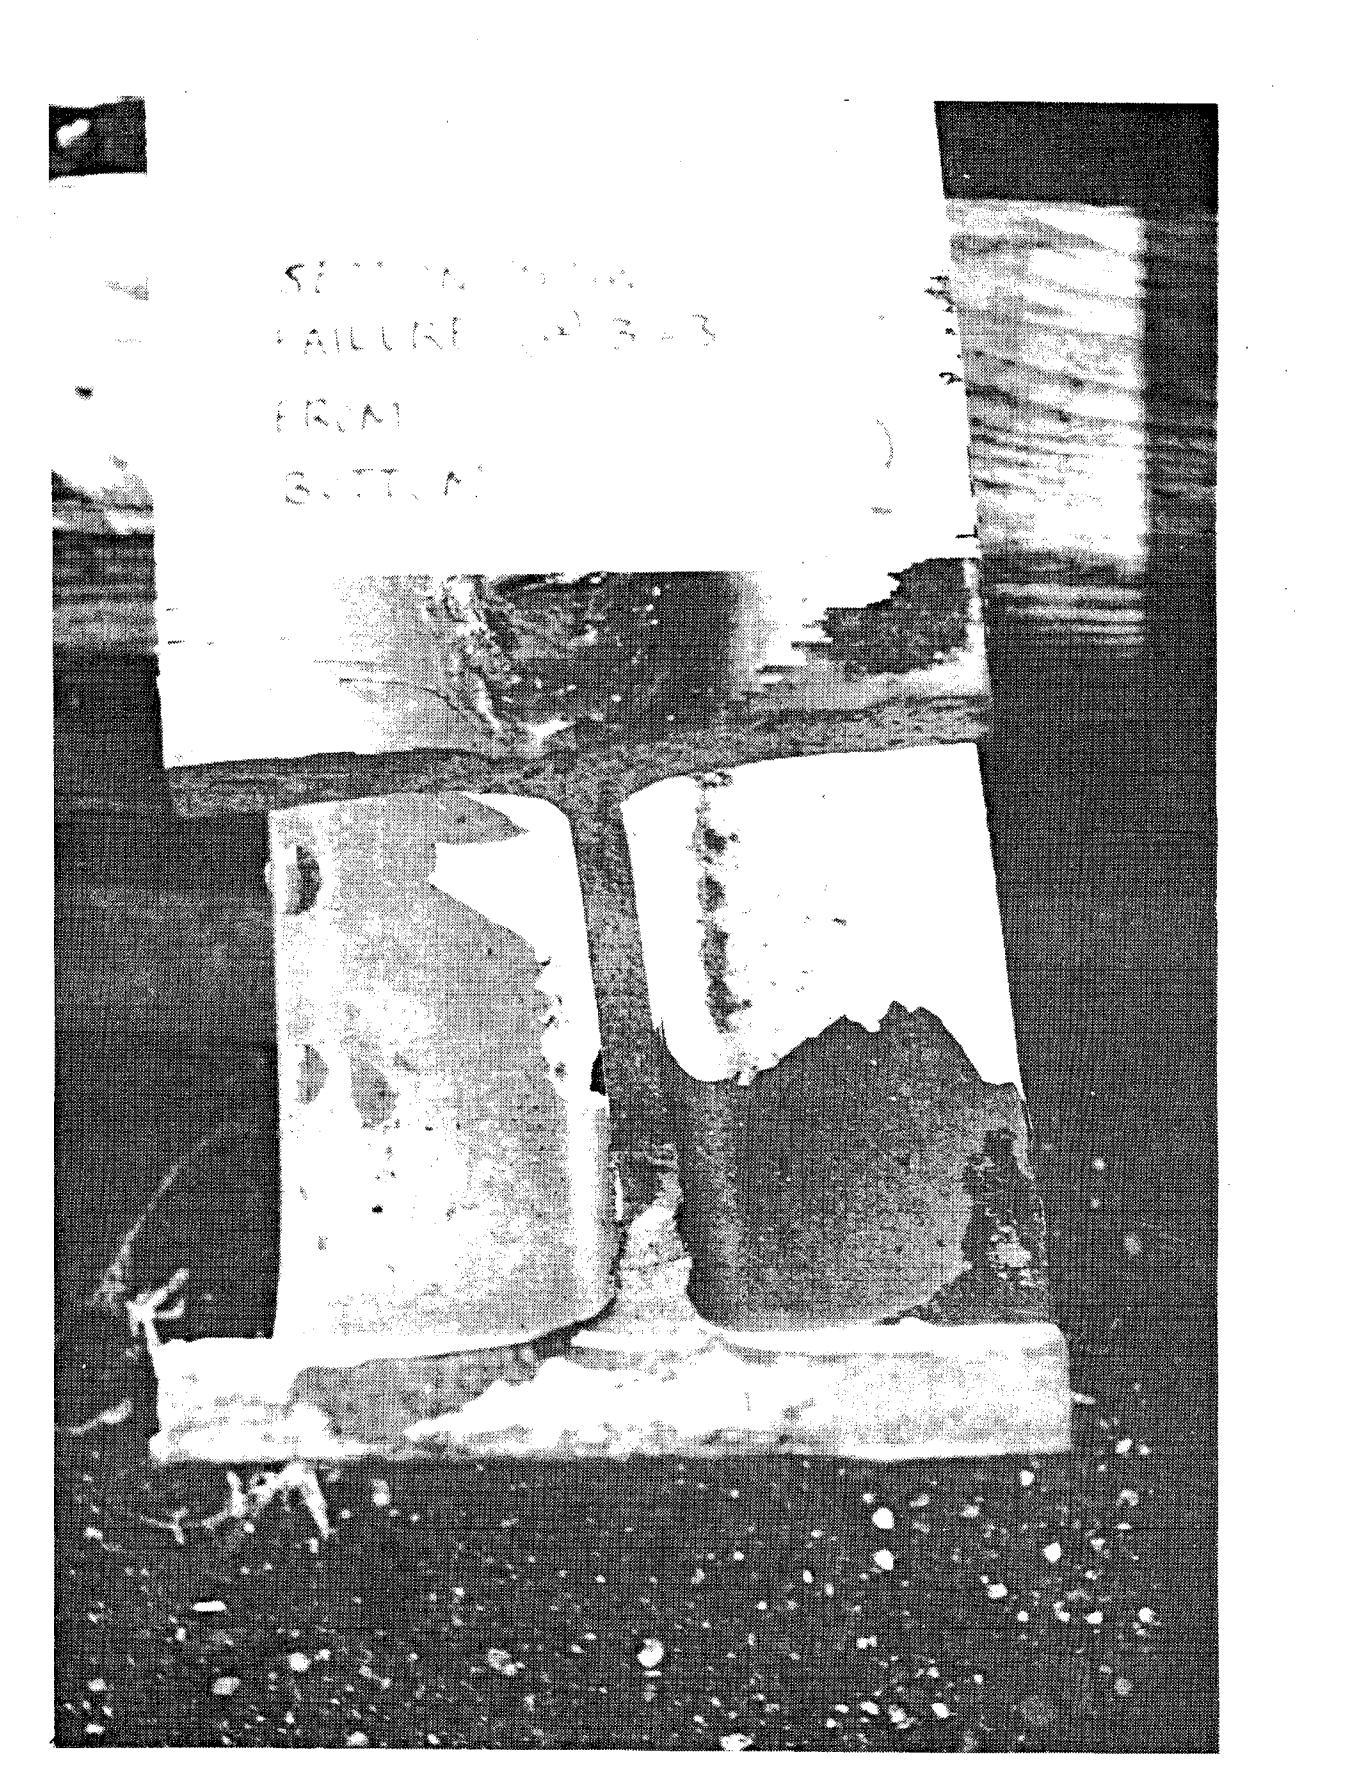
Failure of Section 15 SW leg at 3'-4'' from the bottom of member — viewed toward the bottom of member. Figure 4.3.30 107

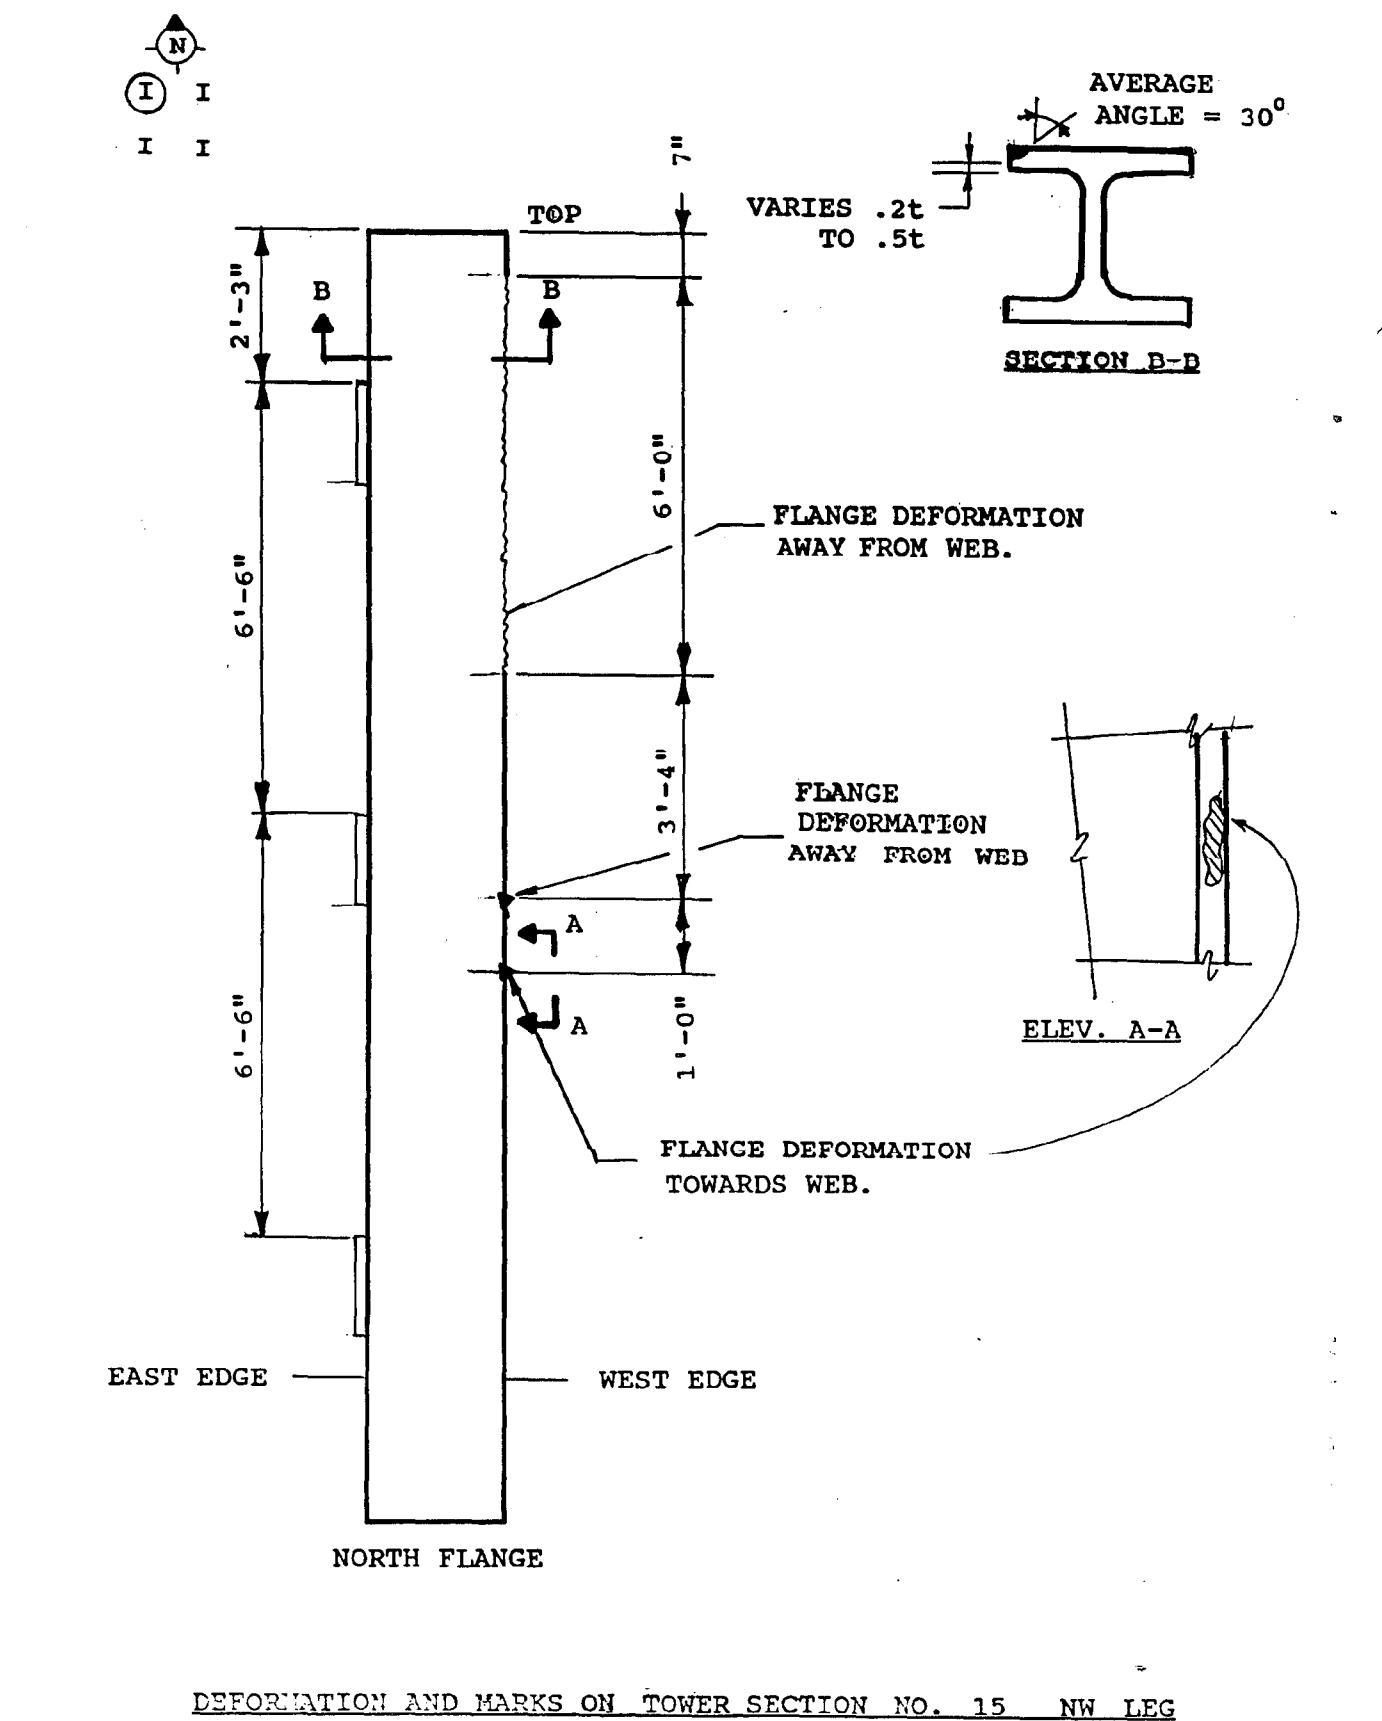
FIGURE 4.3.36

Figure 4.3.36 shows the deformation of the northwest leg of section 15. The north flange of the northwest leg also sustained damage indicative of a bearing type failure at the west edge.

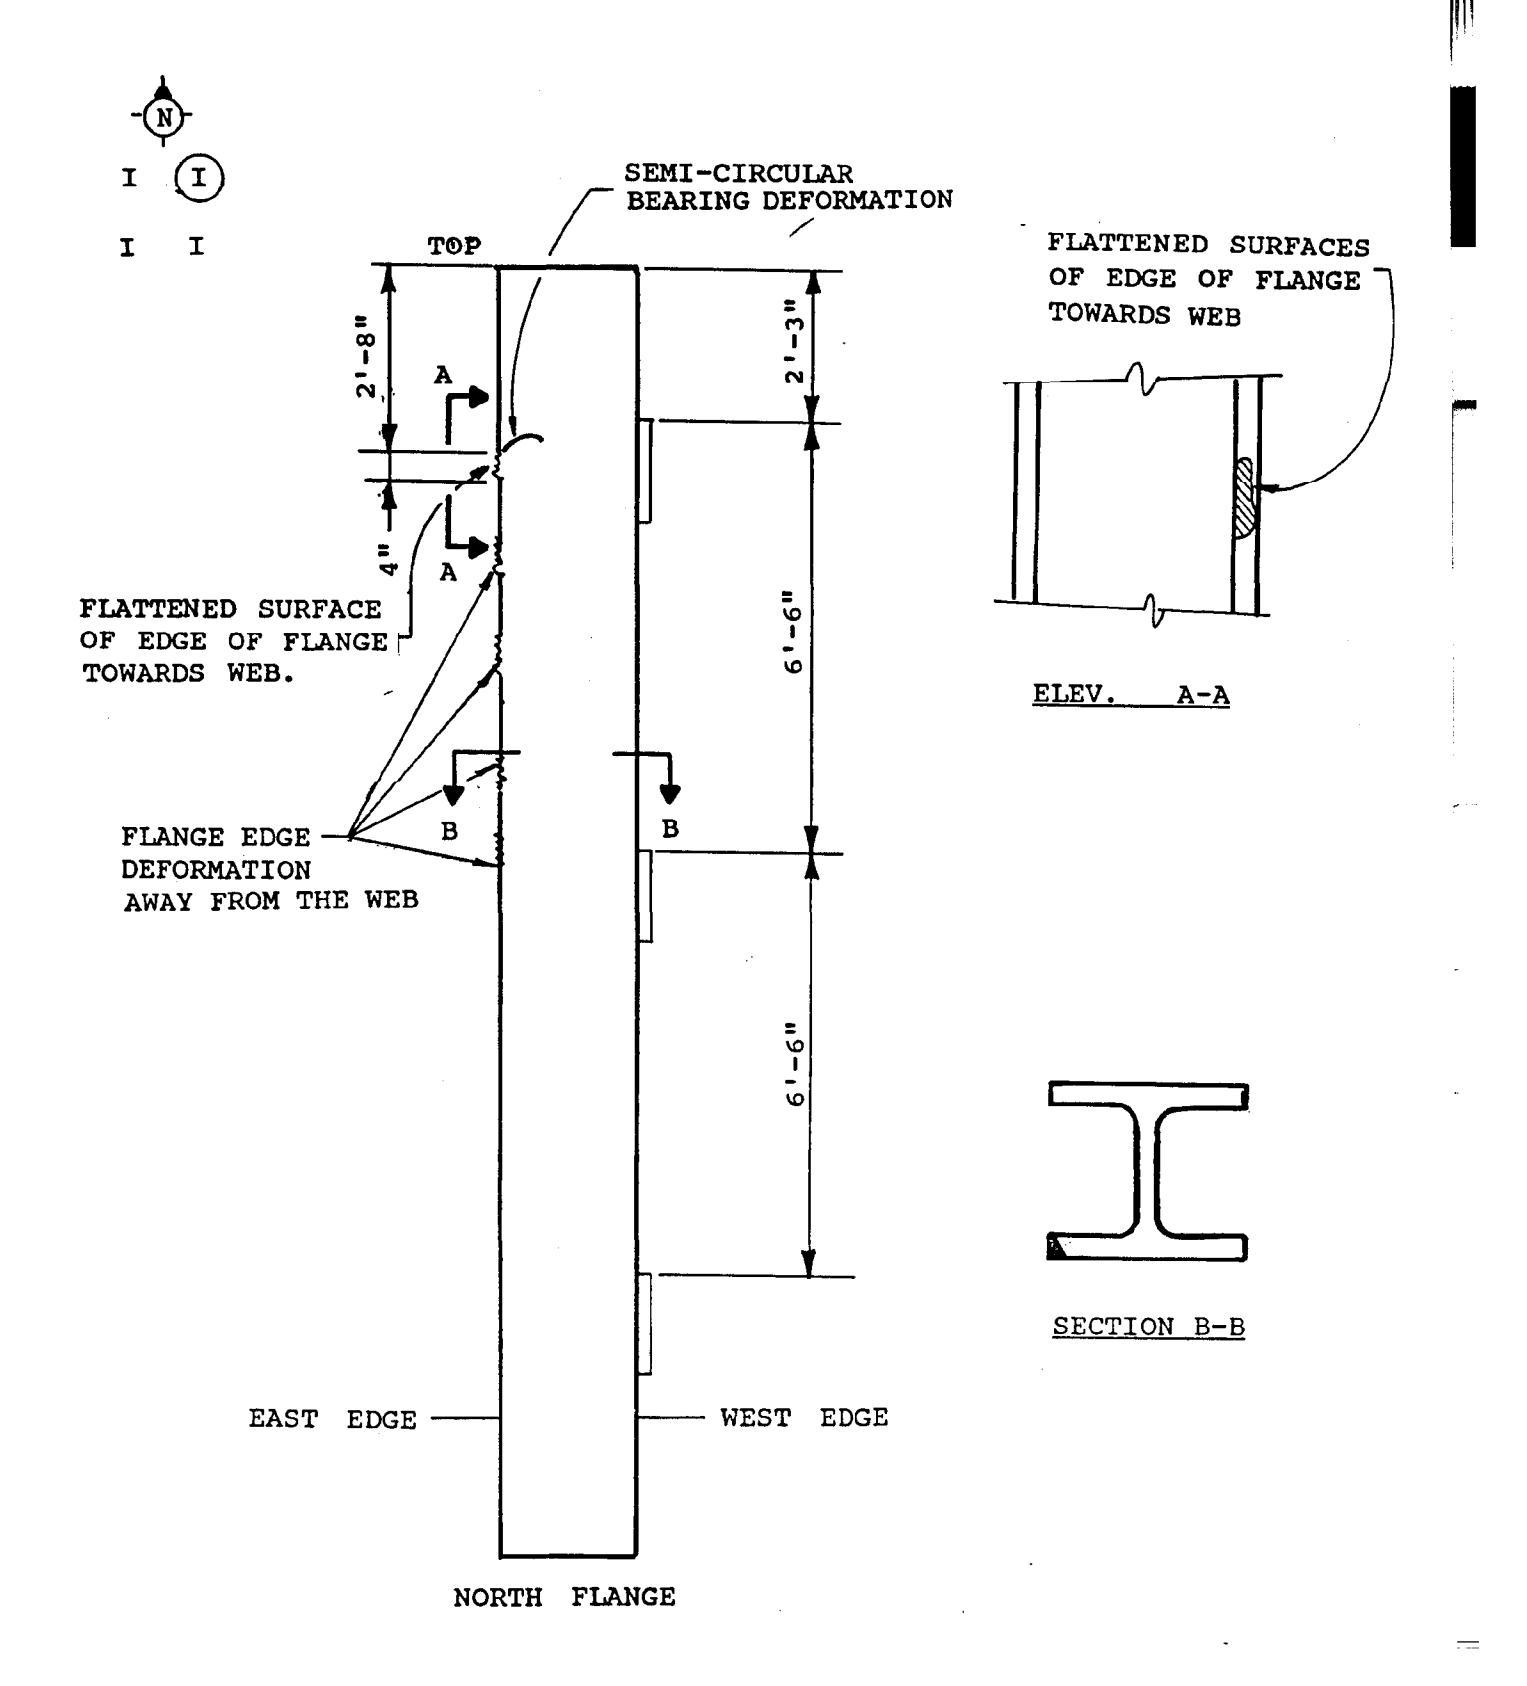
A number of deformed areas were found on the east edge of the north flange of the northeast leg of tower section 15. Figure 4.3.37 shows these deformations. About 2 feet-8 inches from the top, a flattened surface toward the web occurred on the flange edge extending for about four inches (see figure 4.3.50). The greatest deformation occurred slightly below the top and the severity appeared to decrease toward the bottom. Markings on the upper northeast edge roller conformed to the configuration of the flange edge deformation and could be positively identified as the source of the extreme load applied to the flange edge. Further, this was the only detached roller without a brass bushing. The brass bushing remained on the shaft. A few inches above this location, a semicircular bearing type impression occurred on the north flange. There were other smooth deformations on the flange in a direction away from the web, indicative of counterclockwise movement. There are no indications on the flanges that show either of the two rollers were displaced.

DEFORMATION AND MARKS ON TOWER SECTION NO. 15 NE LEG. FIGURE 4.3.37

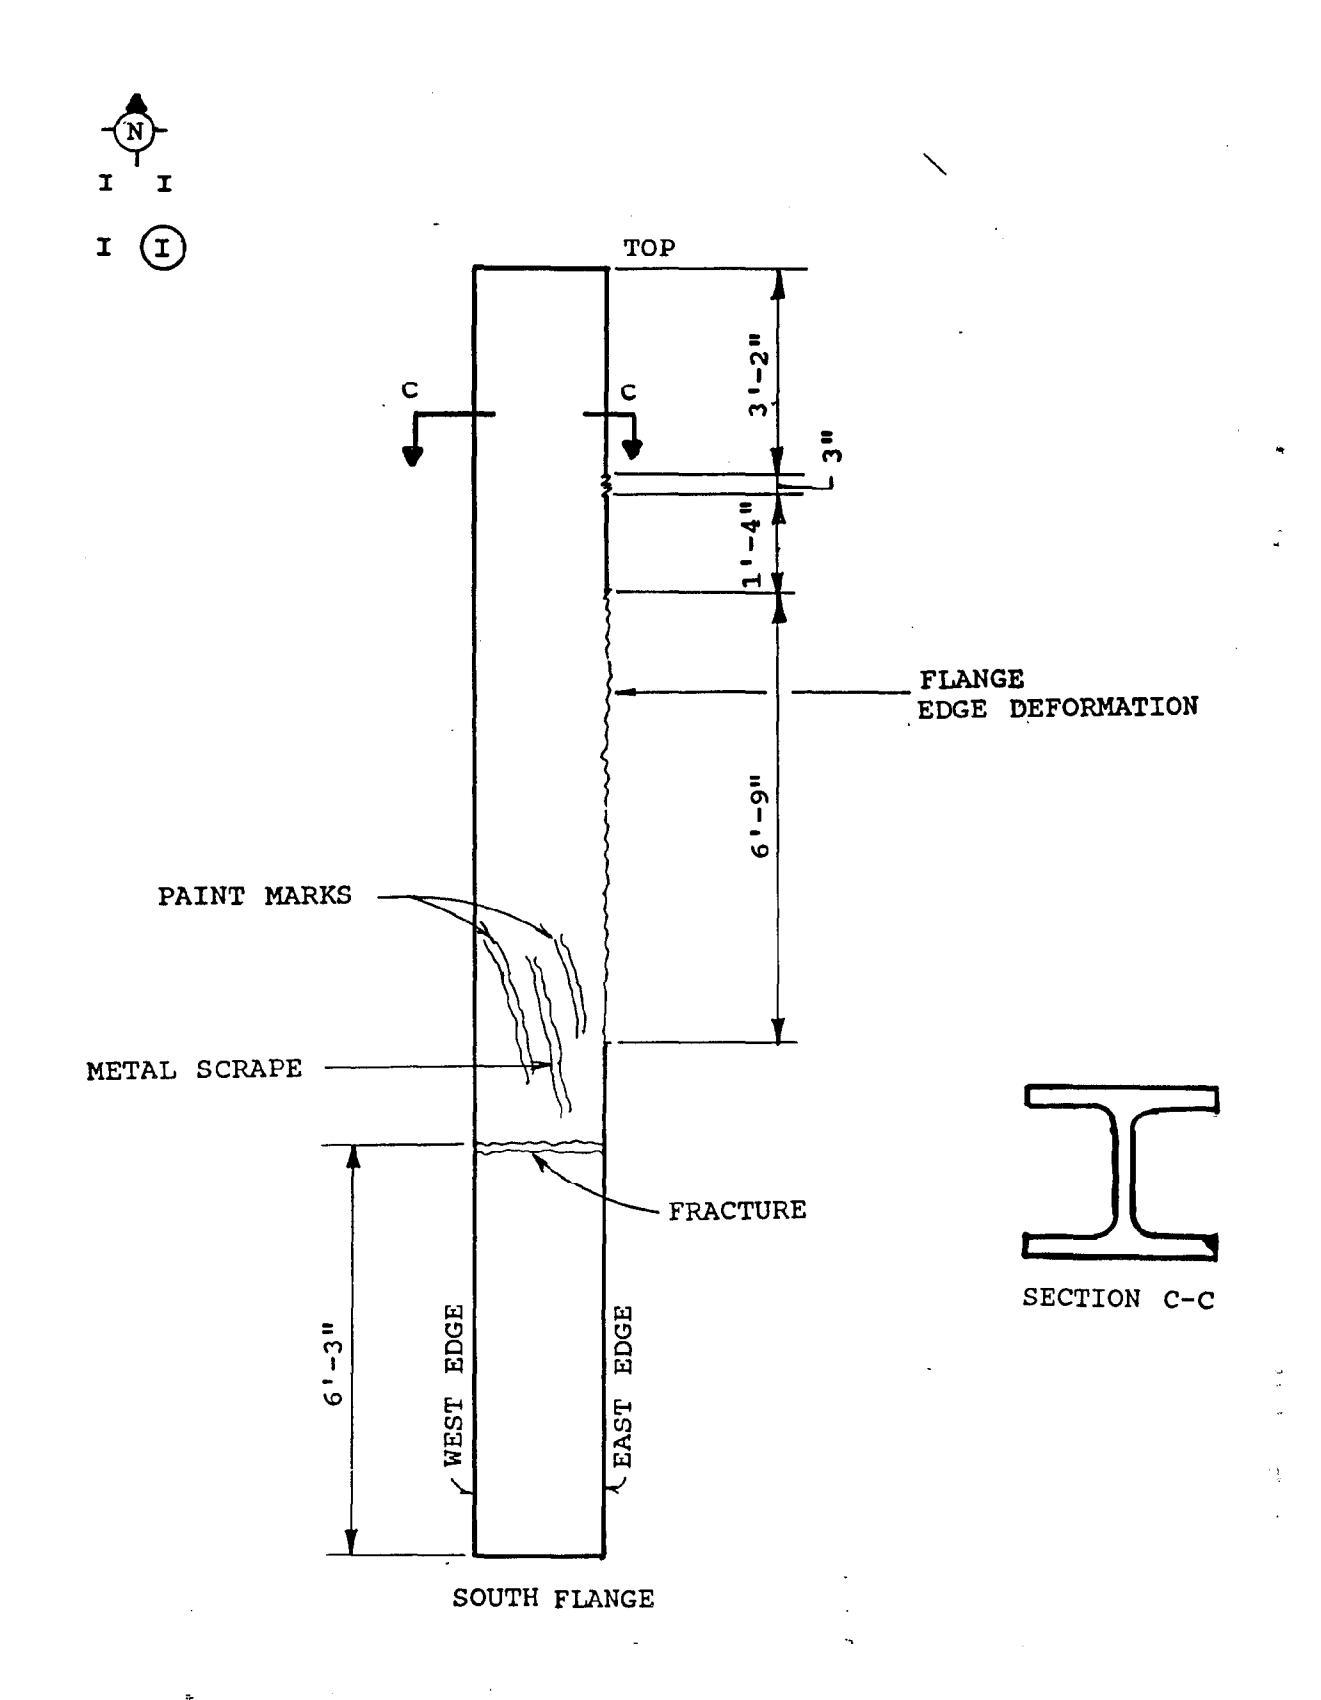
DEFORMATION AND MARKS ON TOWER SECTION NO. 15 SE LEG. FIGURE 4.3.38

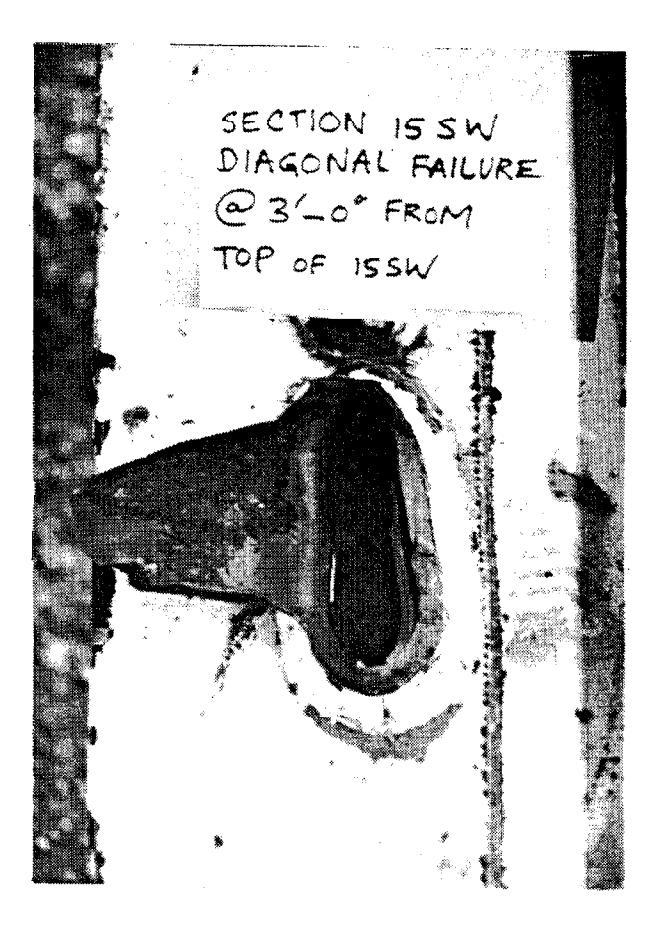
Failure of Section 15 SW diagonal at 3'-0'' from top of section.

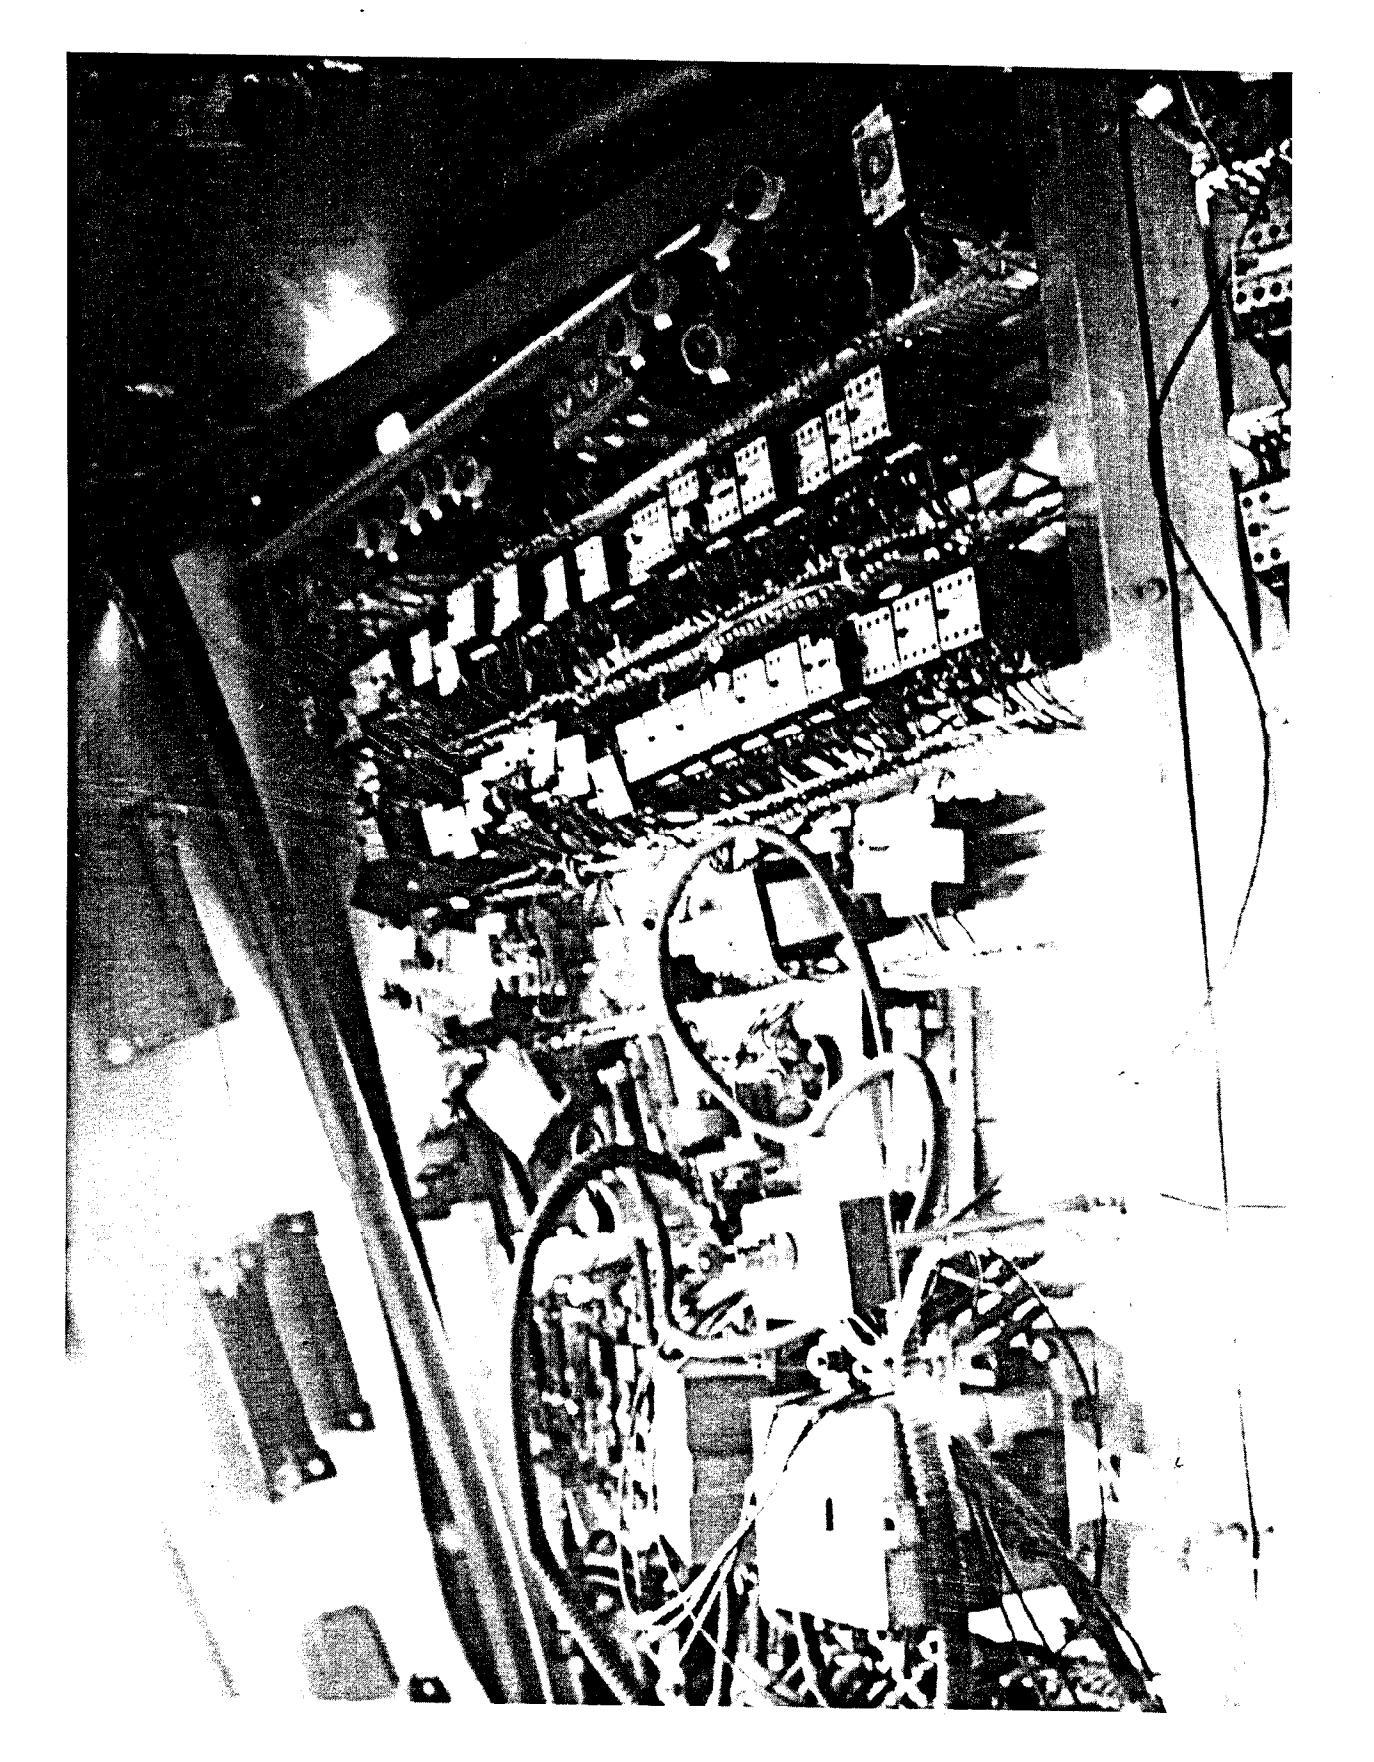
View of damaged electrical control room.

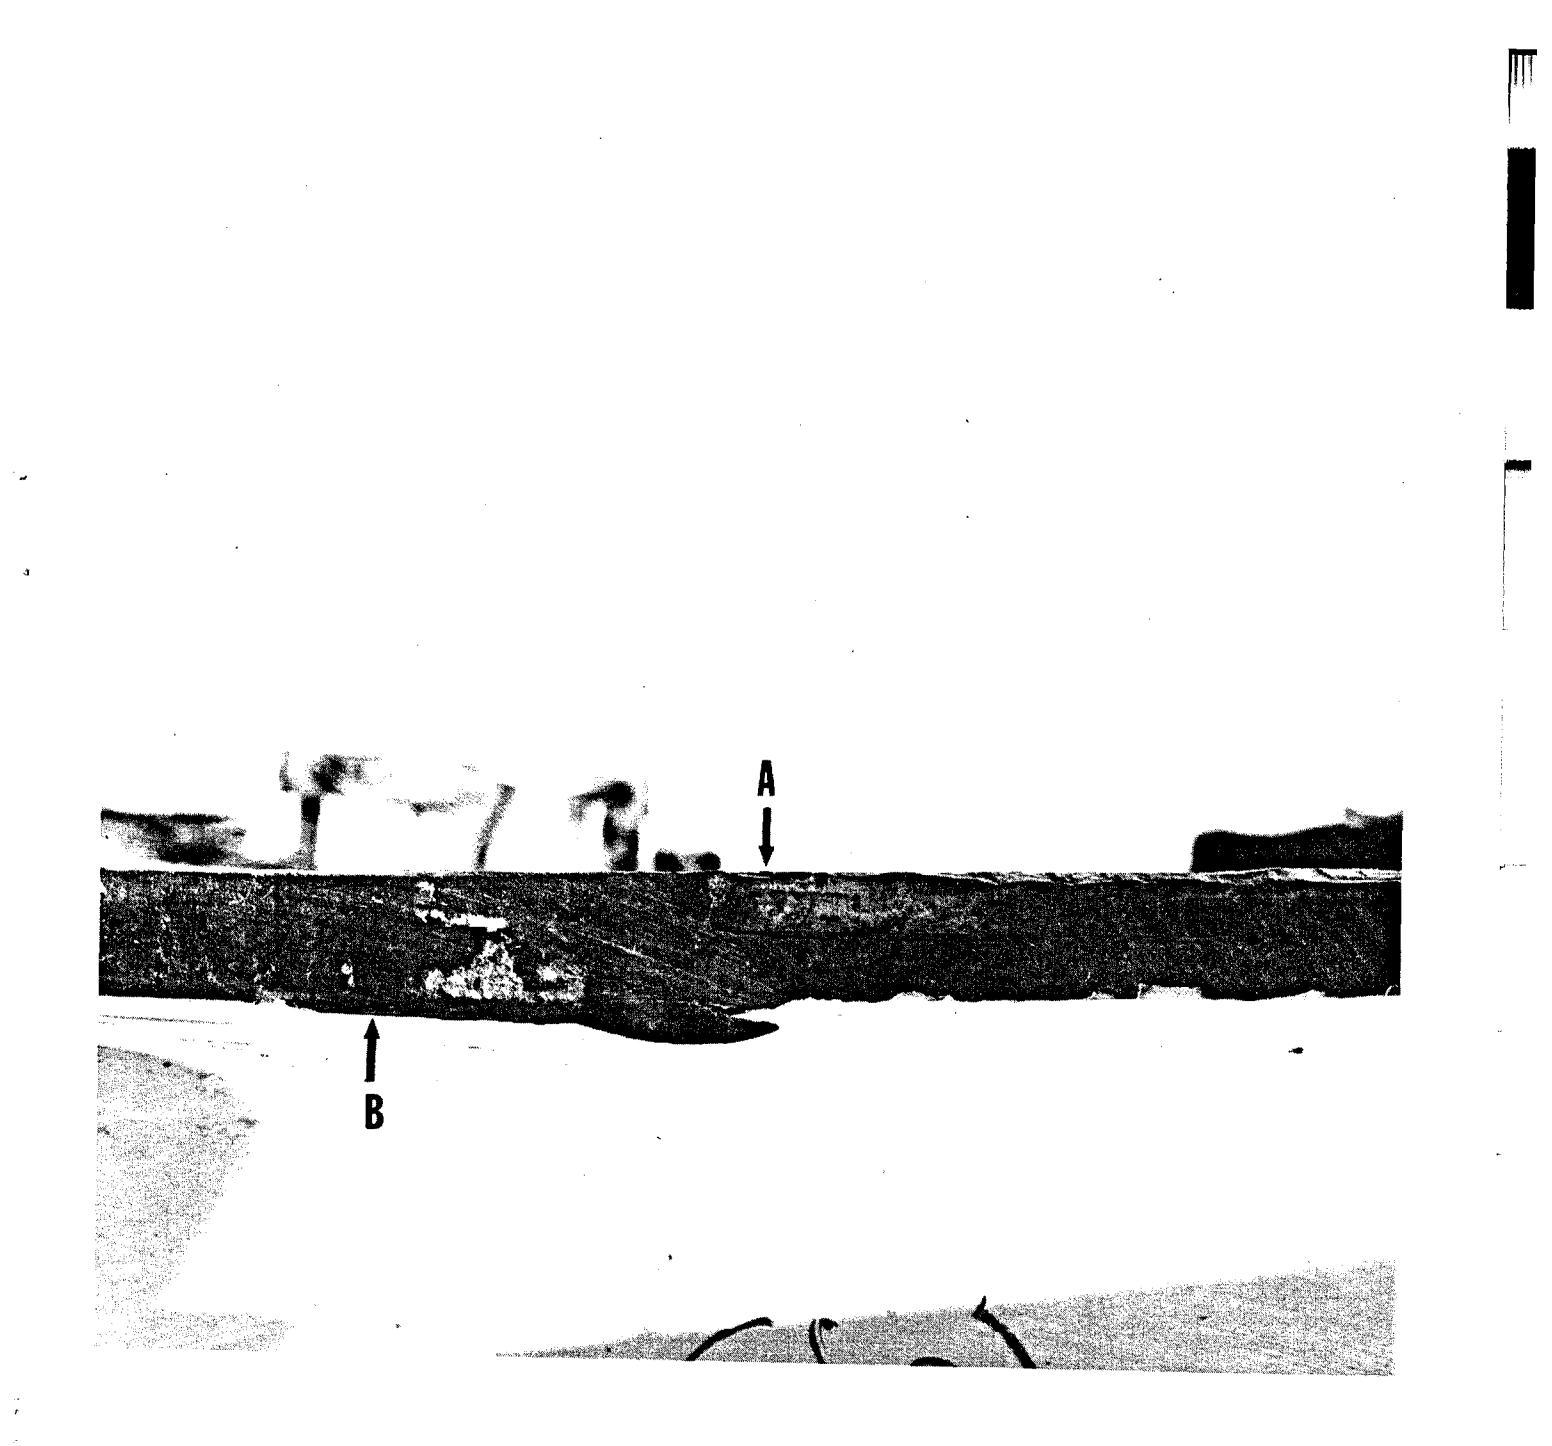
Flange deformations - marked as 1 and 2 - on the West edge of South flange of tower Section 15 SW leg.
