Investigation of a Tower Crane Collapse in San Francisco, California-November 28, 1989

U.S. Department of Labor Occupational Safety and Health Administration

May 1990

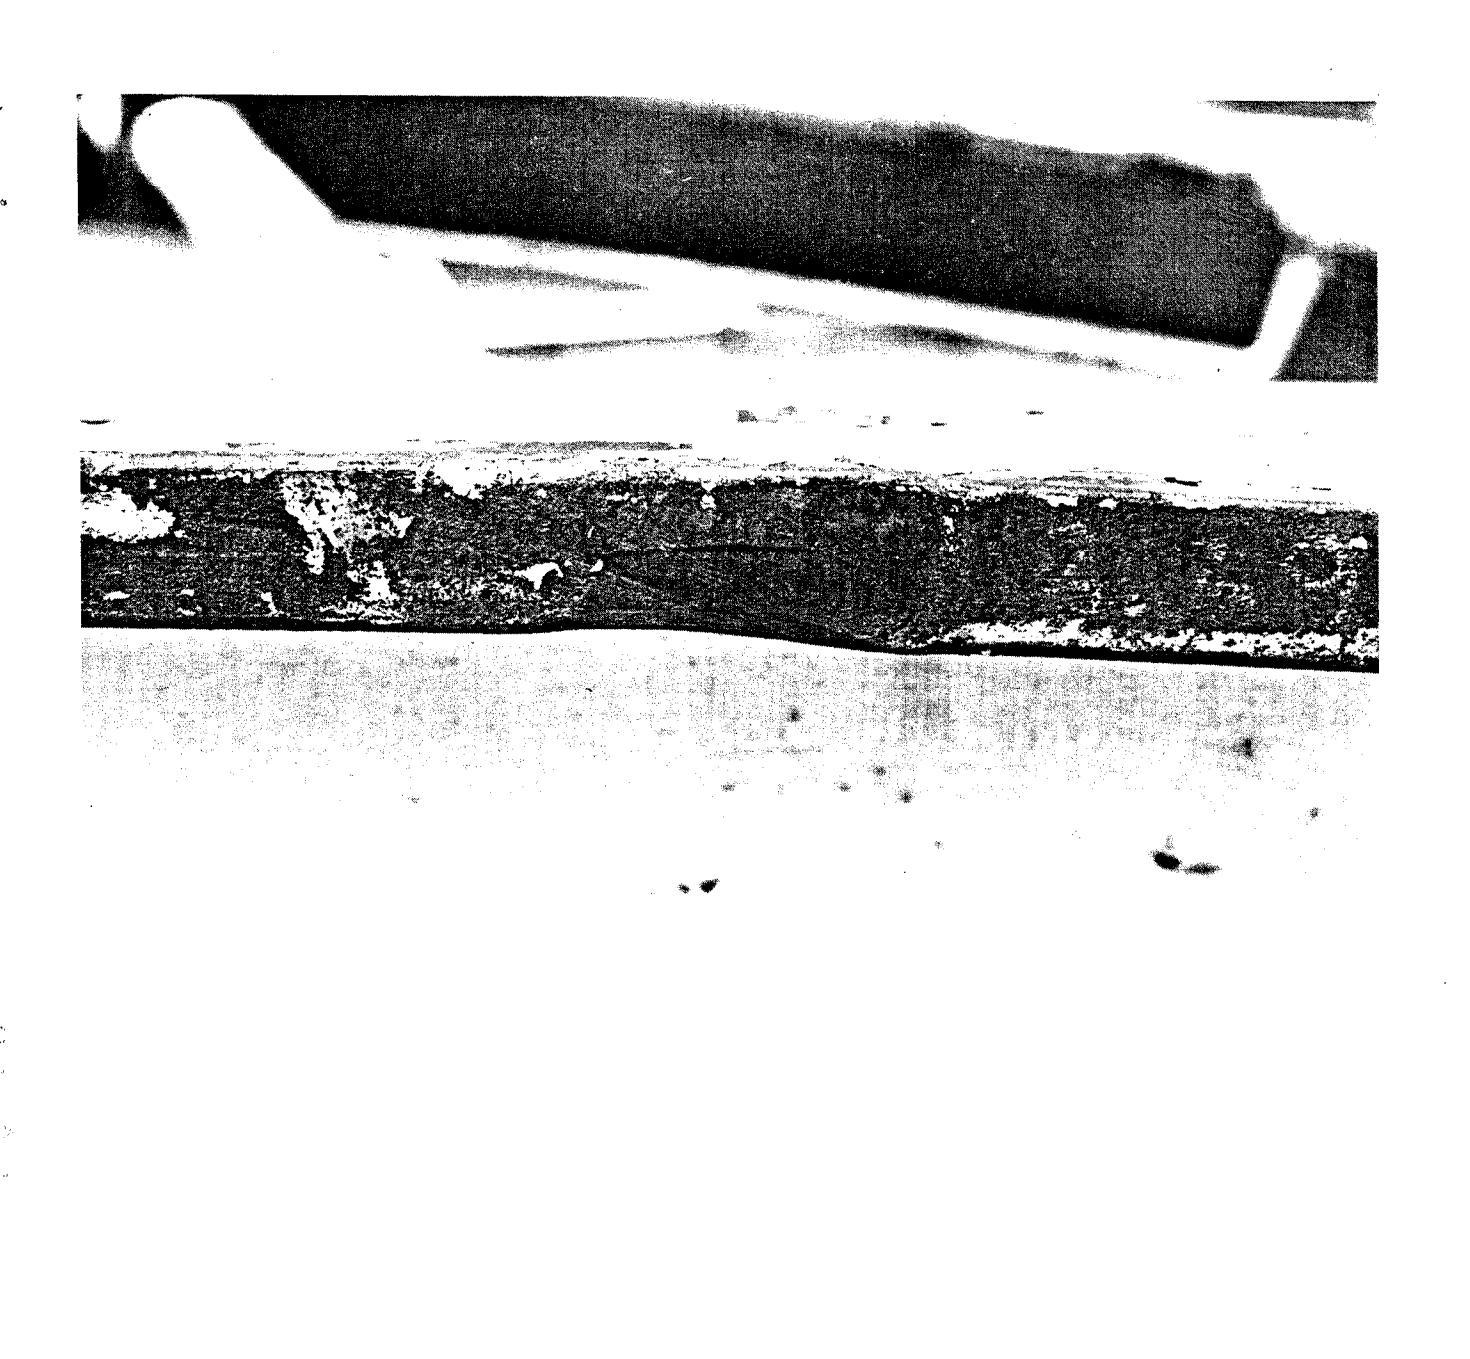
At eleven feet from the top, on the deformation on the west edge of the flange towards the web occurred. A bearing type depression and indentations was noticed on the underside of the flange, see figure 4.3.48. The form of this deformation corresponded to the configuration of markings on one of the detached rollers. Consequently, the lower northwest edge roller was positively identified. Further, the bushing inside the roller was noticed to have shearing and galling marks in the longitudinal direction indicating that damage was due to axial movement and not rotation of the roller. The marks on the bushing suggested that load was applied to the roller along its shaft resulting in failure of the bolts securing the retaining plate of the roller. This deformation on the flange edge is indicative of the location where the lower southwest edge roller came off the shaft. This deformation toward indicative of counterclockwise movement of the the web is Another deformation of the flange at about ten feet turntable. from the top of the section (see figure 4.3.49) occurred. This deformation indicated that the lower northwest edge roller was applying a high intensity force at an elevation of 10 feet from the top before being displaced at a point 12 inches below following a downward motion.

Deformation at 11'-0" from top on the West edge of North flange of tower Section 15 NW leg.
