Investigation of August 14, 1990 Collapse of Precast Concrete Beams At Airside Building, Midfield Terminal Project, Greater Pittsburgh International Airport, Allegheny County, Pennsylvania

U.S. Department of Labor Occupational Safety and Health Administration

December 1990

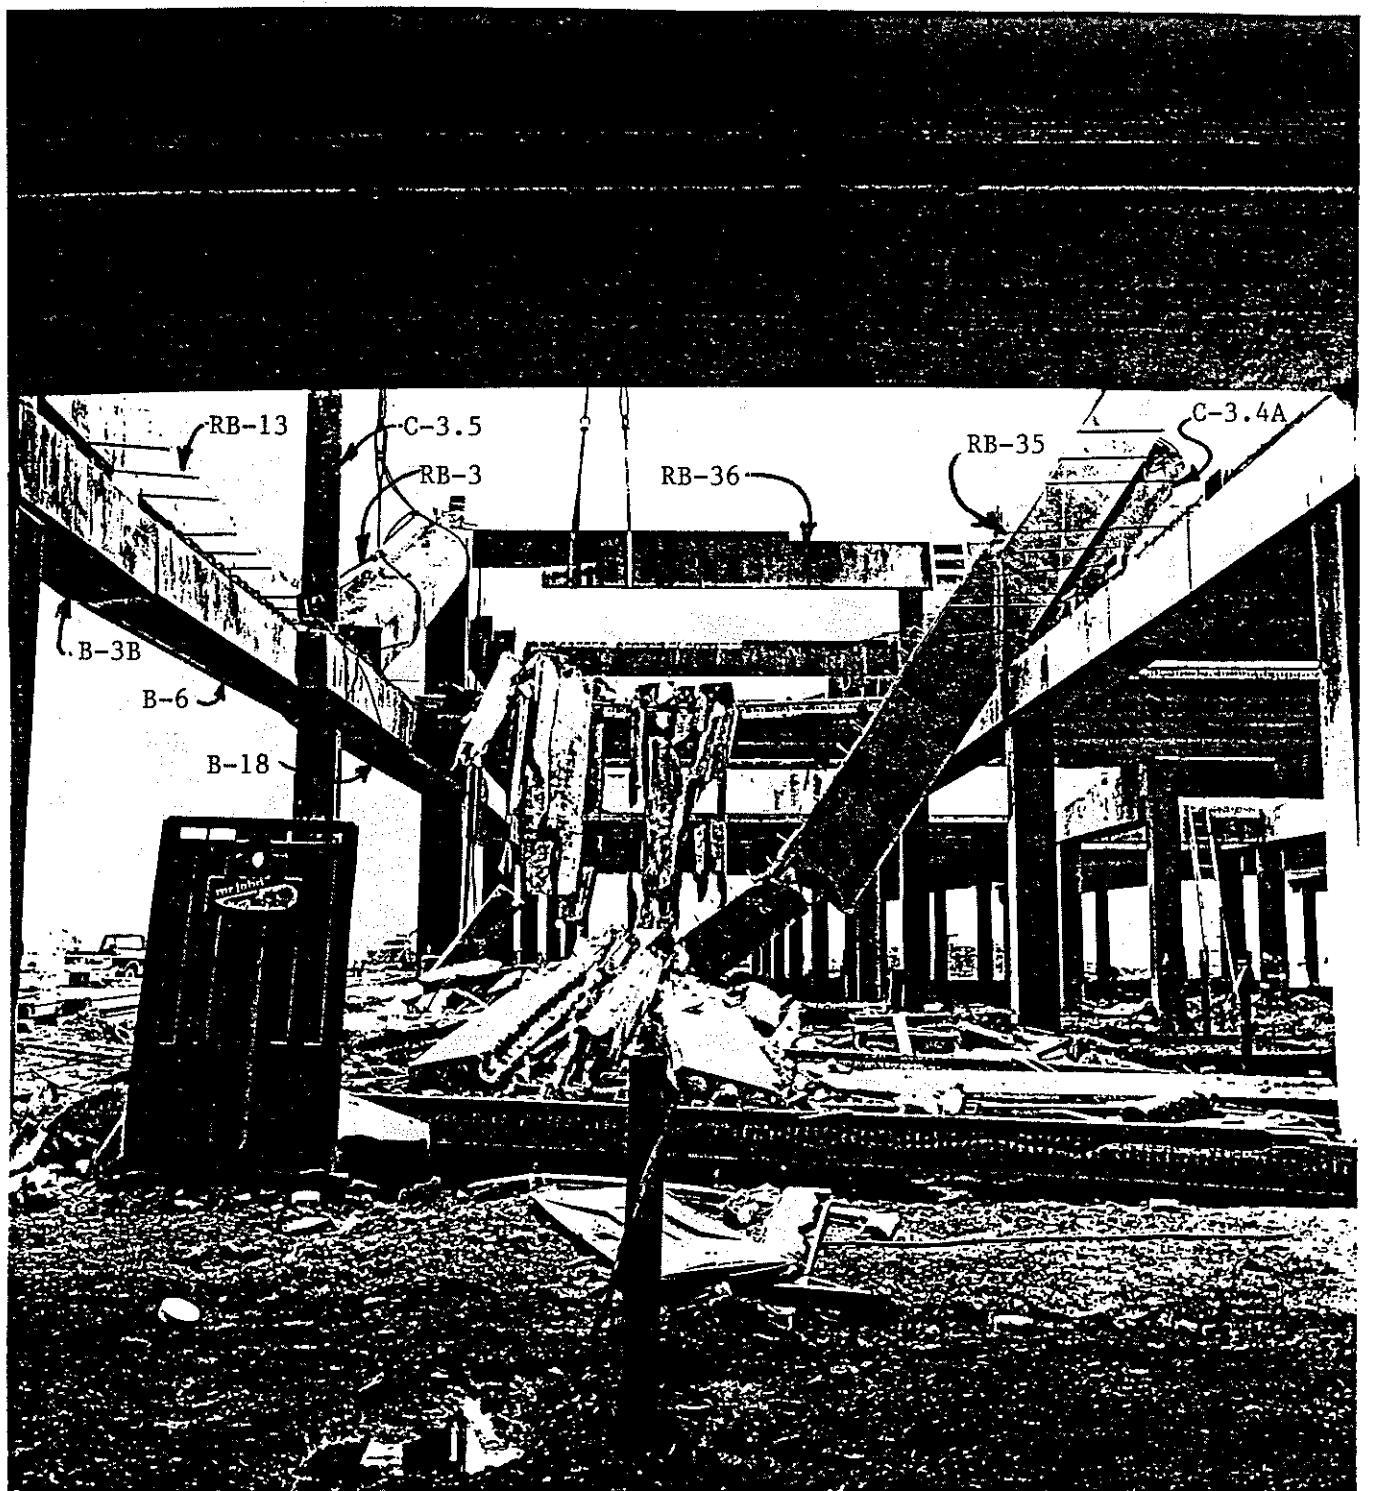
POSITION OF BEAM RB-35 AND COLUMN C-3.4A AFTER THE COLLAPSE (LOOKING TOWARD SOUTH)

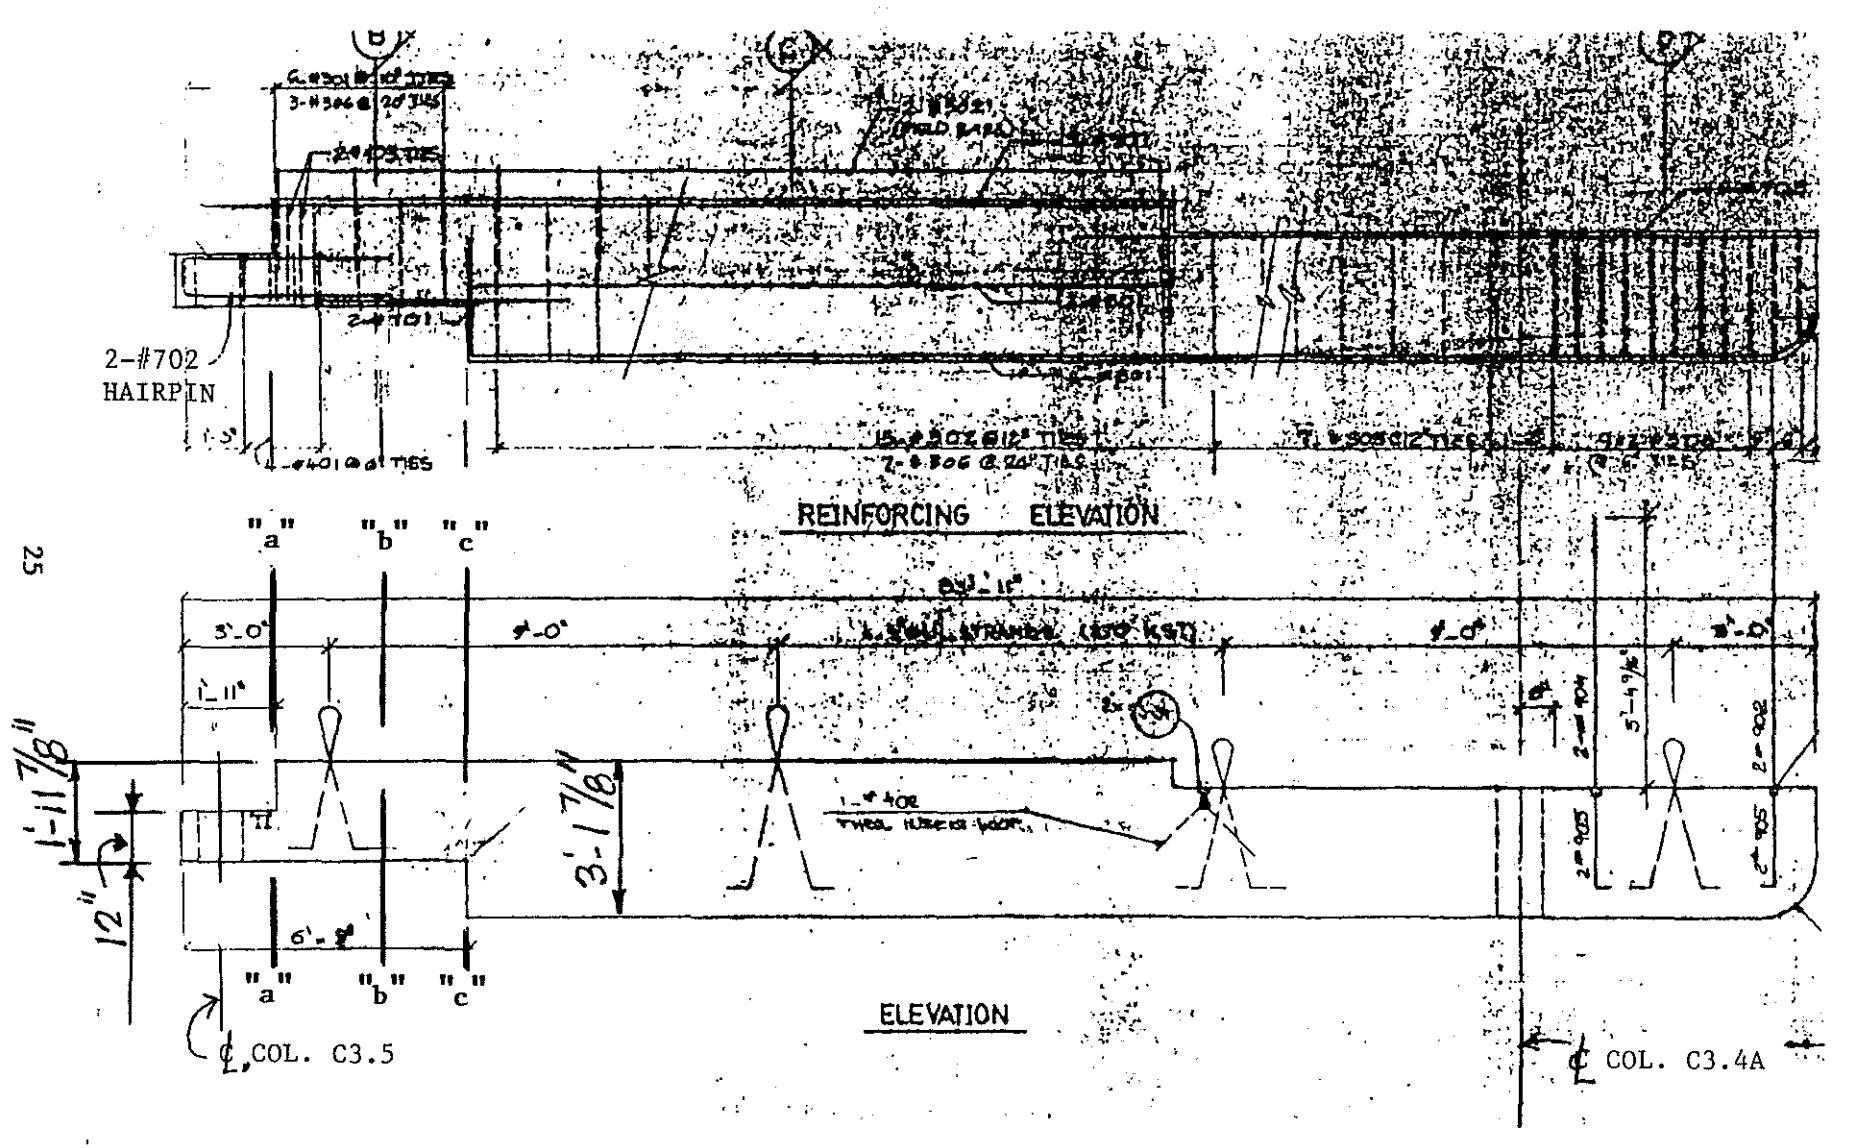
Figure 3.18

BEAM MARK RB-35

An examination of the collapsed beam marked RB-35 revealed a number of inconsistencies with the approved shop drawing. Figures 3.18 and 4.01 show the elevations and sections of the precast beam, as approved for the project to be manufactured in the precast concrete plant. Figures 3.24, 3.25, 4.02 and 4.03 show the partial elevation and sections of the damaged RB-35, based on actual field examination. The following observations were made.

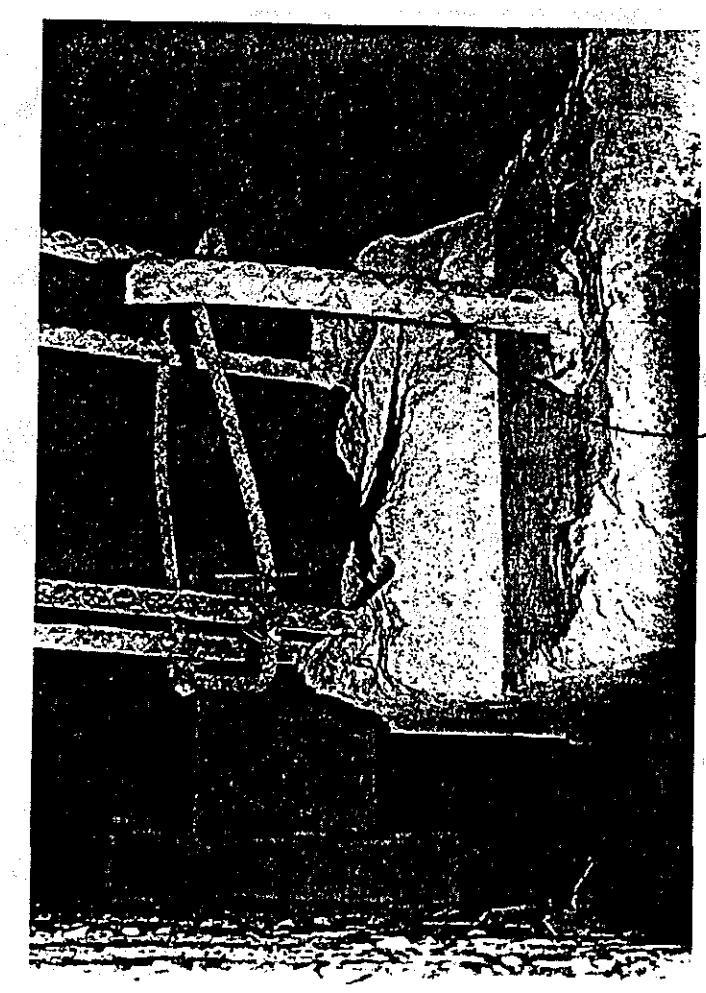
THE CENTER #9 TOP BAR EXTENED 12" FROM THE CONCRETE FACE. TWO OTHER #9 BARS WERE FLAME CUT AT THE FACE.

OTHER FAILED LOCATION OF BEAM RB-35, AT THE DEPTH CHANGE FROM 12" TO 1'-11 7/8". CONCRETE CRUSHED DURING THE COLLAPSE.

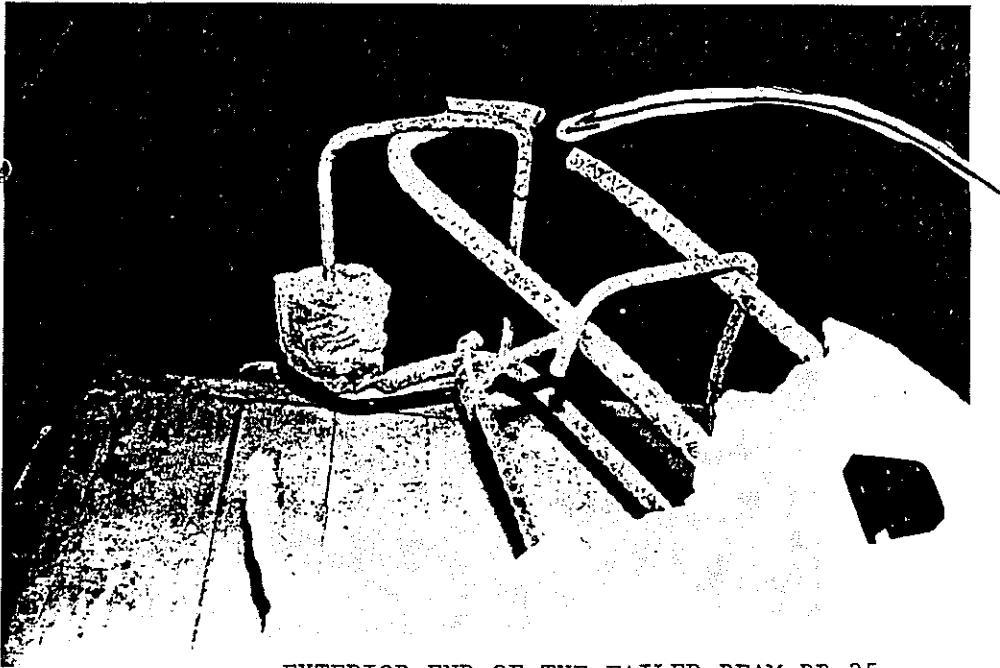
EXTERIOR END OF THE FAILED BEAM RB-35

EXTERIOR END O RB35,SHOWING 2#702 HAIRPIN-BARS FRACTURE NEAR THE EXTER BENT CORNERS.

- The two hairpin bars marked #702 were fractured at near the exterior bent corners of the bar as shown in figures 3.21, 4.02 and 4.03.
- The three #9 top bars marked #901 were observed to be flame cut, one at a distance of 12" from the plane where the beam depth changes, and two at the face of the plane itself as shown in figures 3.21, 4.02 and 4.03. These rebars were reported by the construction personnel to be cut in order to facilitate the placement of spandrel beams marked RB-3 and RB-13. These two beams were framed into and supported by the beam RB-35. Field observations were made to the beam connection on top of the column at the opposite side of this grid line (at the intersection of column lines 13 and B20) and the cutting of the similar top rebars of the roof beam, also marked RB-35 was noted.

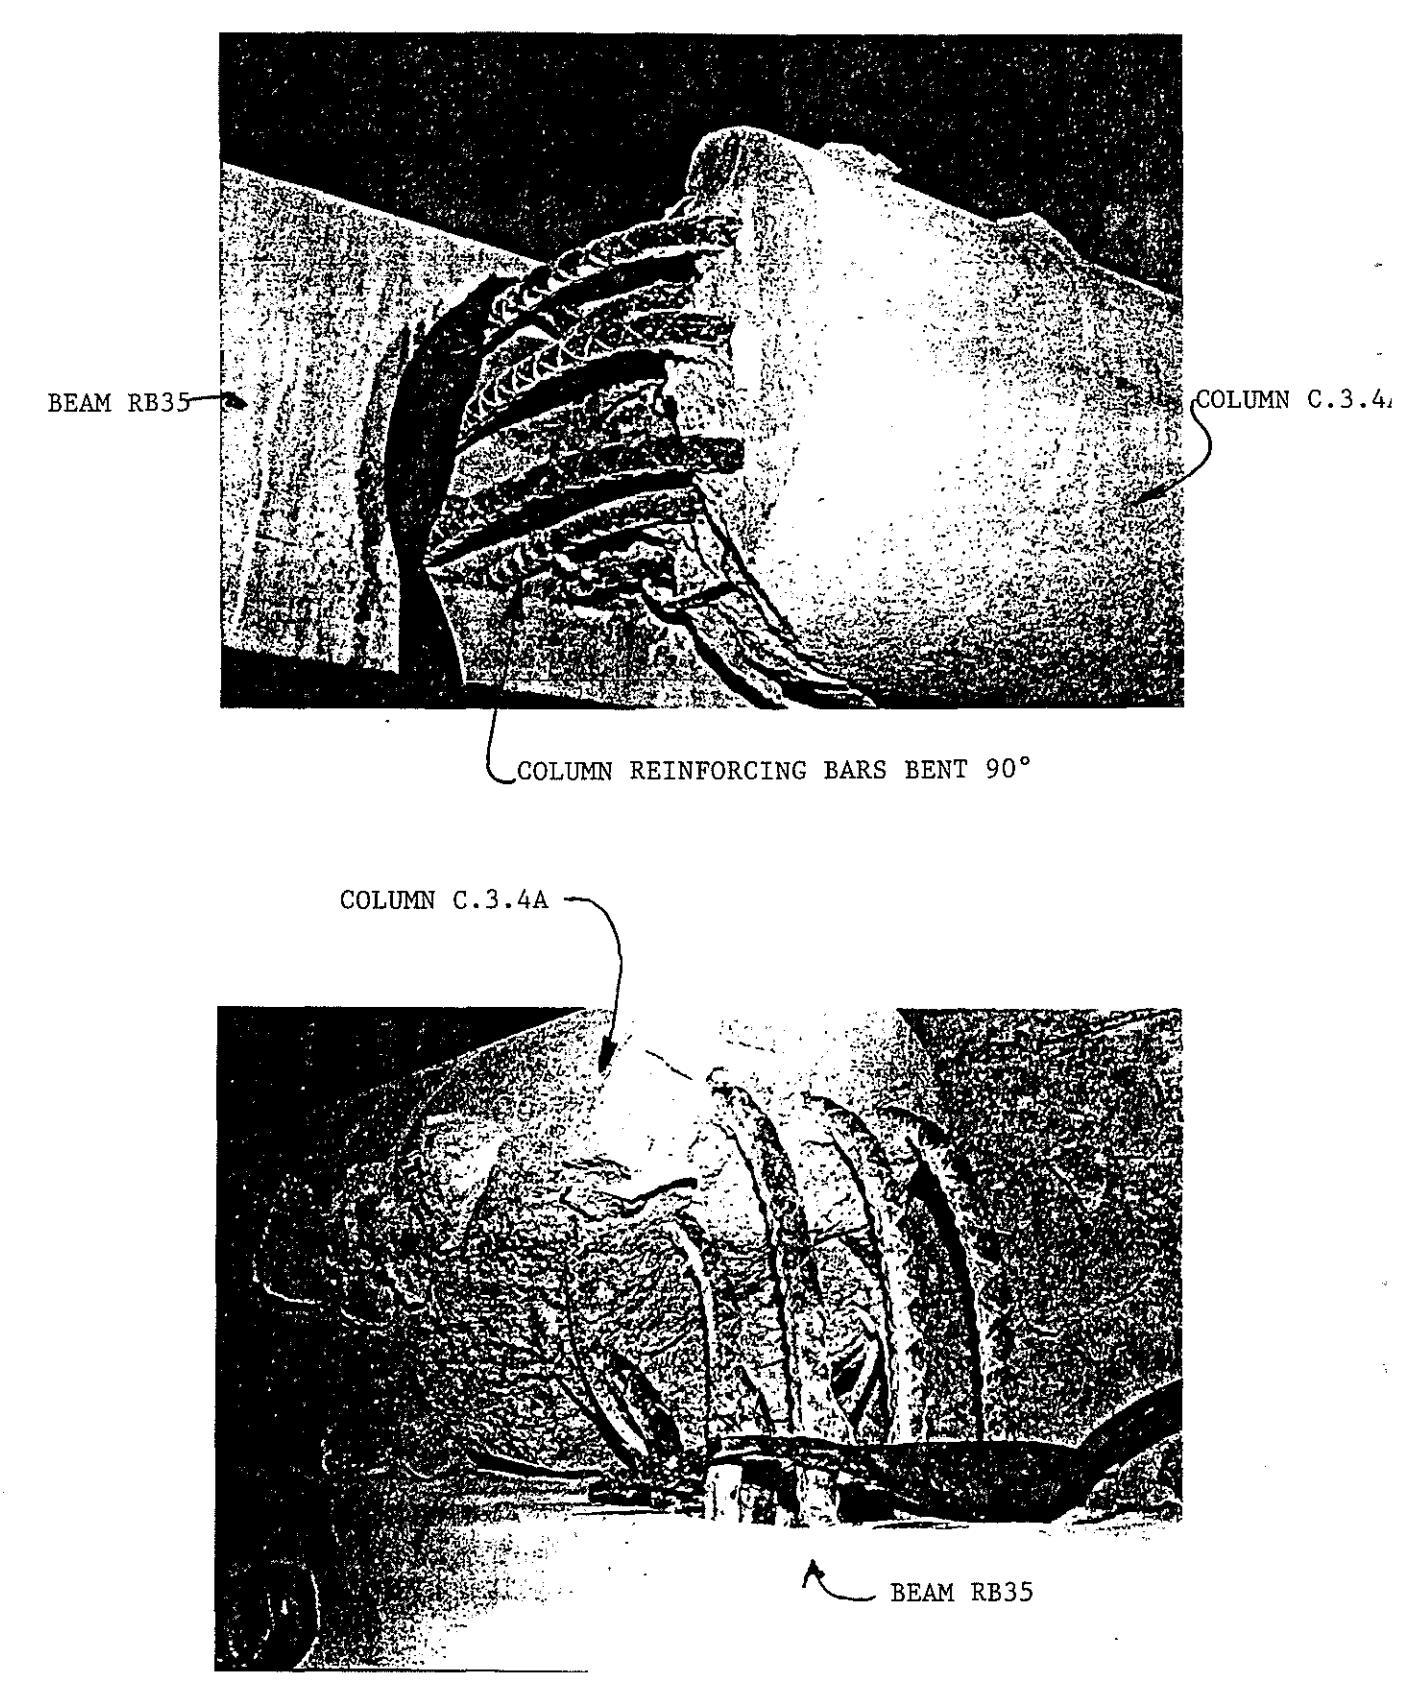
Figure 3.25 32

THE FAILED BEAM RB35 AND COLUMN C.3.4A

Column C3.4A collapsed with the precast beam RB-35, with its top end remained attached to the beam. Figures 3.24 and 3.25 show the attachment of the column top end to the beam following the collapse. All top eight bars were bent 90° and the column longitudinal axis was parallel to that of the beam. None of the bars were missing. There was spalling of concrete near the top of column on the side closest to the precast beam. Figure 4.04 shows the bottom base plate of the column. Two holes in the plate indicate slight deformations around the hole circumference.

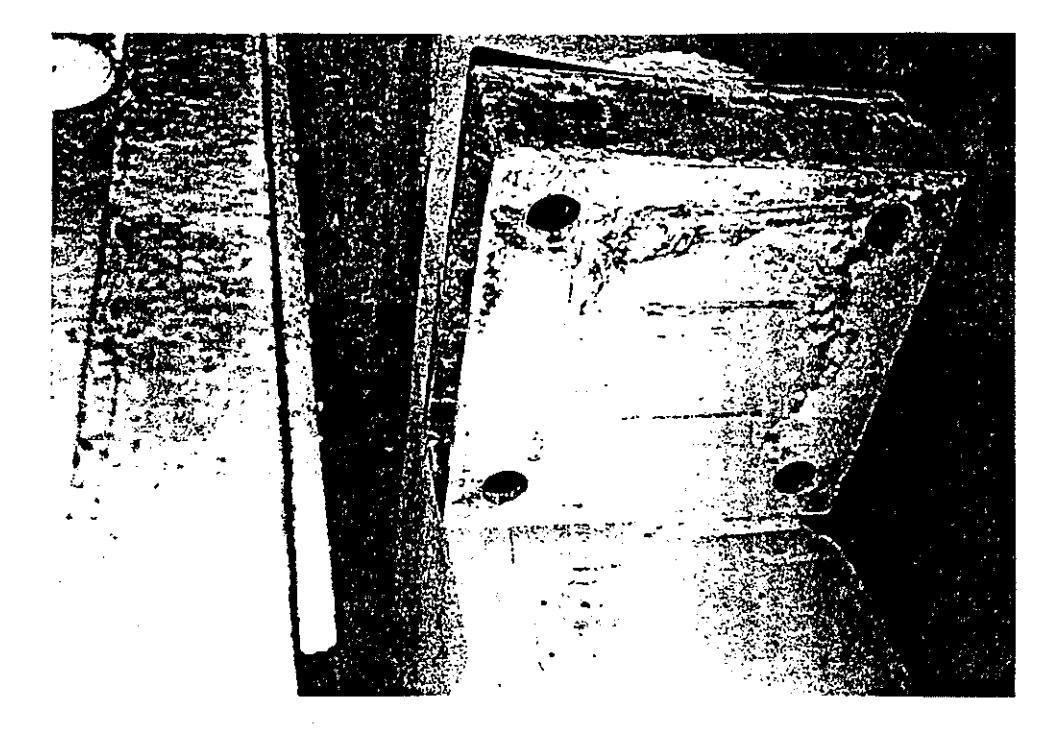
BASE PLATE OF THE FAILED COLUMN C.3.4A

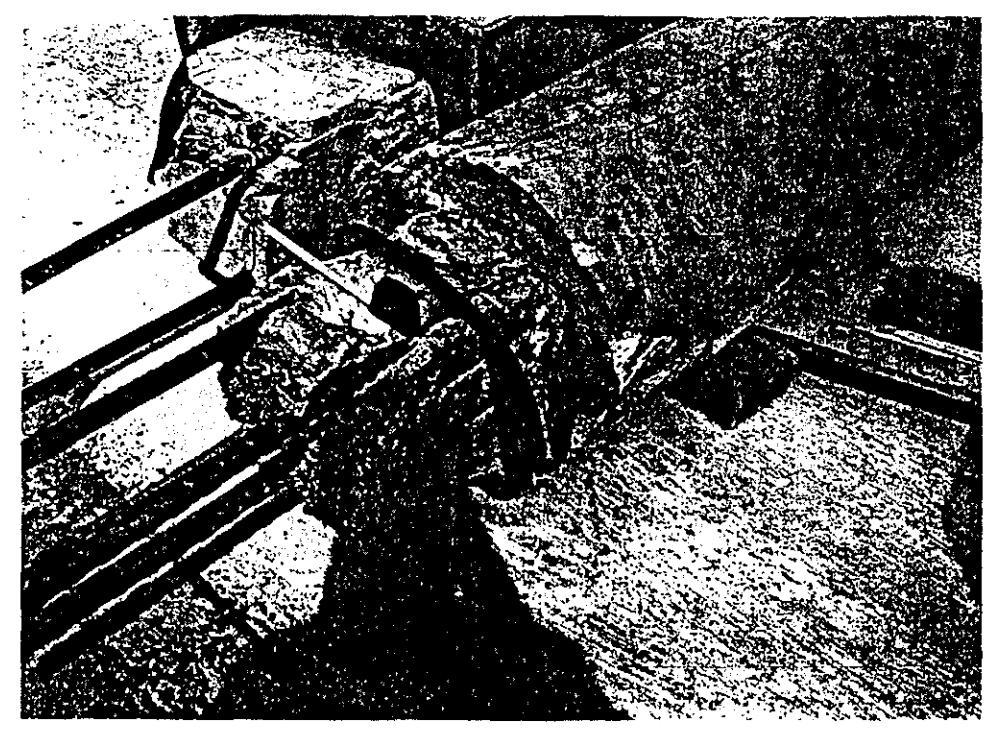
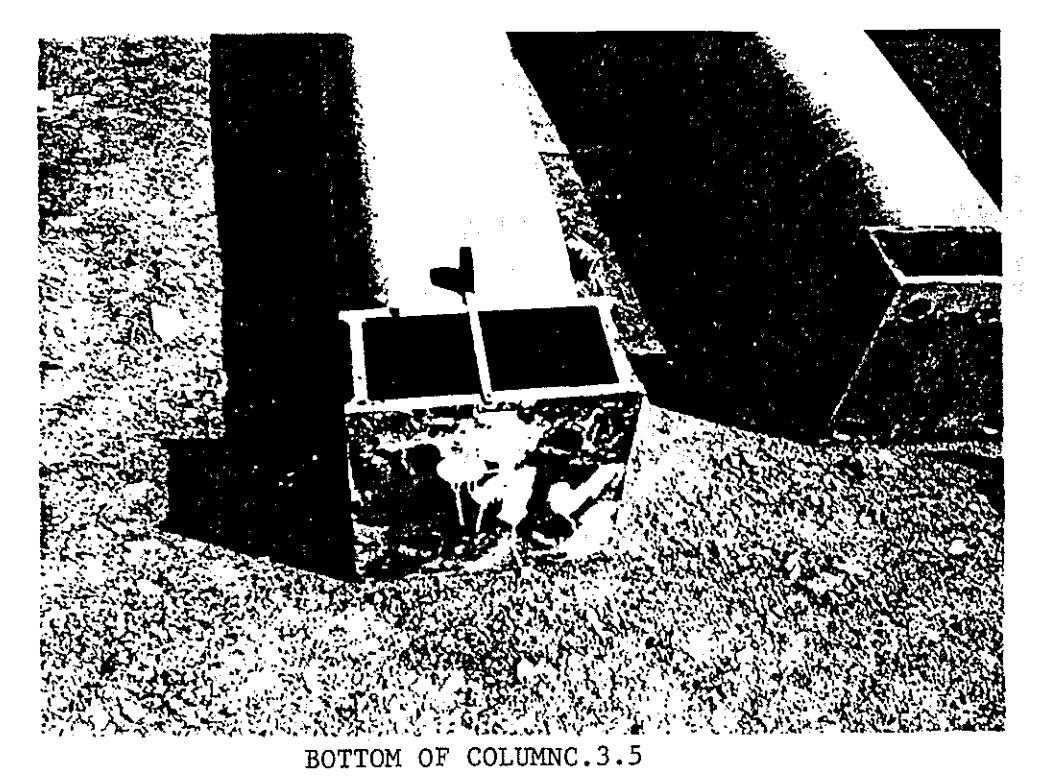
Figures 4.05 and 4.06 are copies of the approved shop drawings showing the top and bottom ends of the precast column C3.5. Figure 4.07 is a photograph taken after the accident. All eight #9 top bars extending above the beam bearing elevation were present. No deformations were noticed in those bars. The 11" x 11" grout had some minor spalling and some rebar did not seem to have desired cover. At beam RB-35

bearing, concrete had spalled. The four holes in the bottom base plate showed deformation around their circumference.

TOP OF COLUMN C.3.5

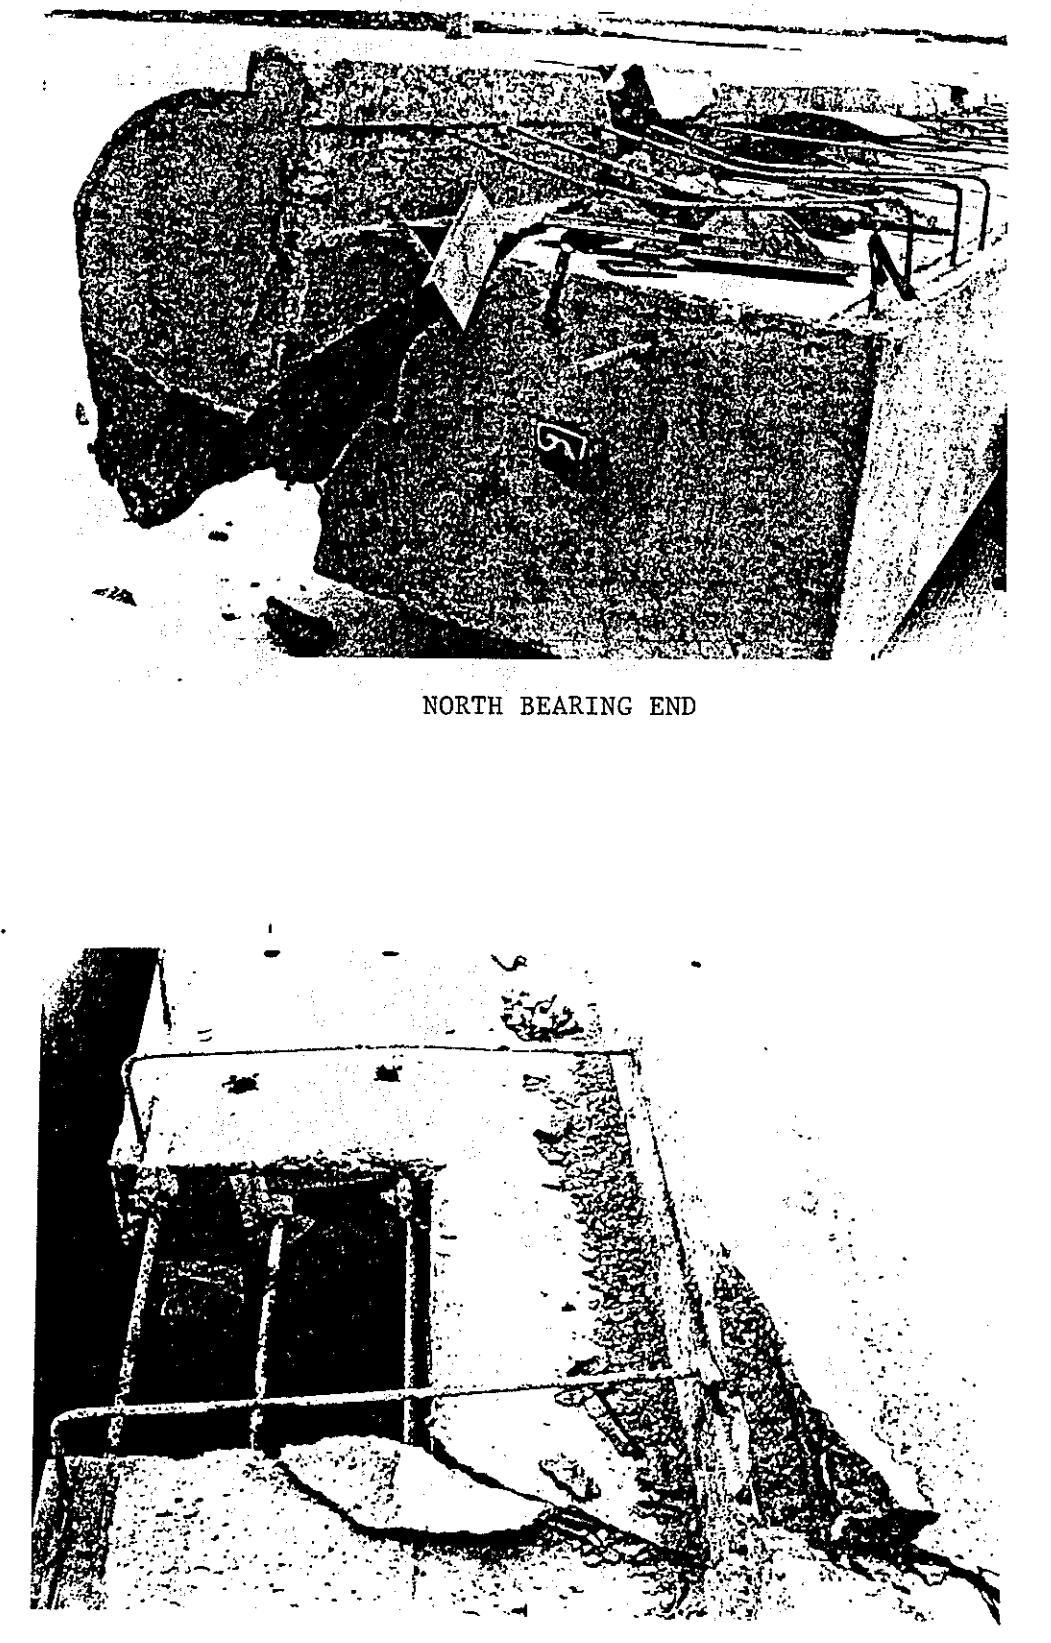
Figure 4.08

Both bearing ends of beams RB-3 and RB-13 had extensive damage as the results of the failure as shown in figures 4.08 and 4.09. Observation was not made of beam RB-22. However, a description of the failure is given in section 3.0.

SOUTH BEARING END AT COLUMN B21 & 17

BEAM RB-3 AT THE CONSTRUCTION SITE

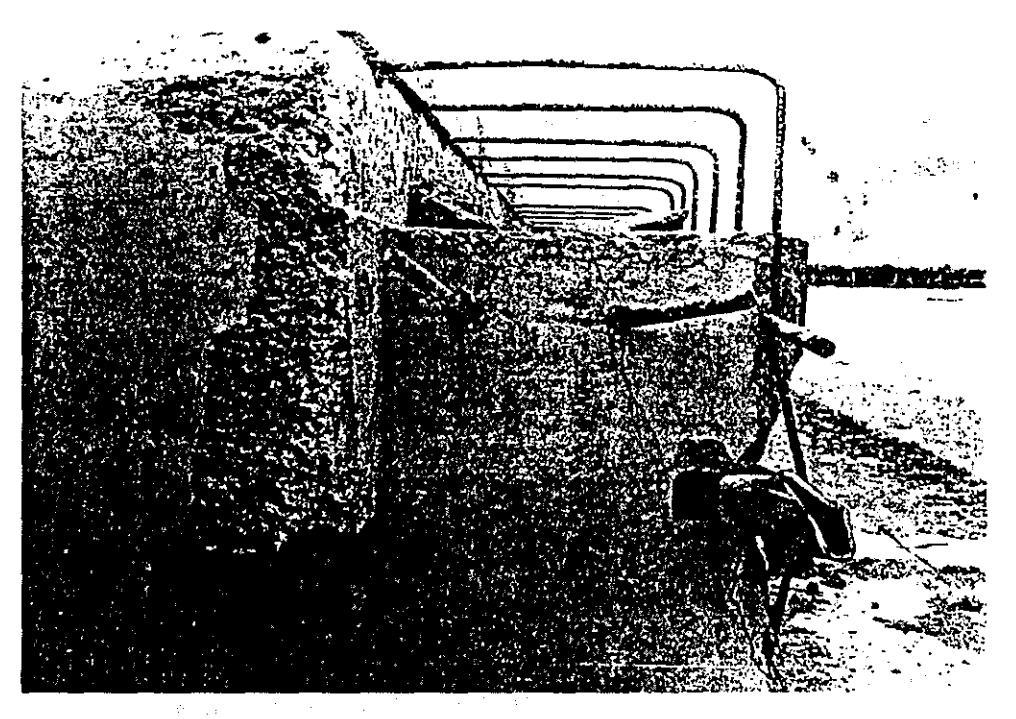
BEAM RB13 AT THE CONSTRUCTION SITE Figure 4.09 45

NORTH BEARING END

SOUTH BEARING END

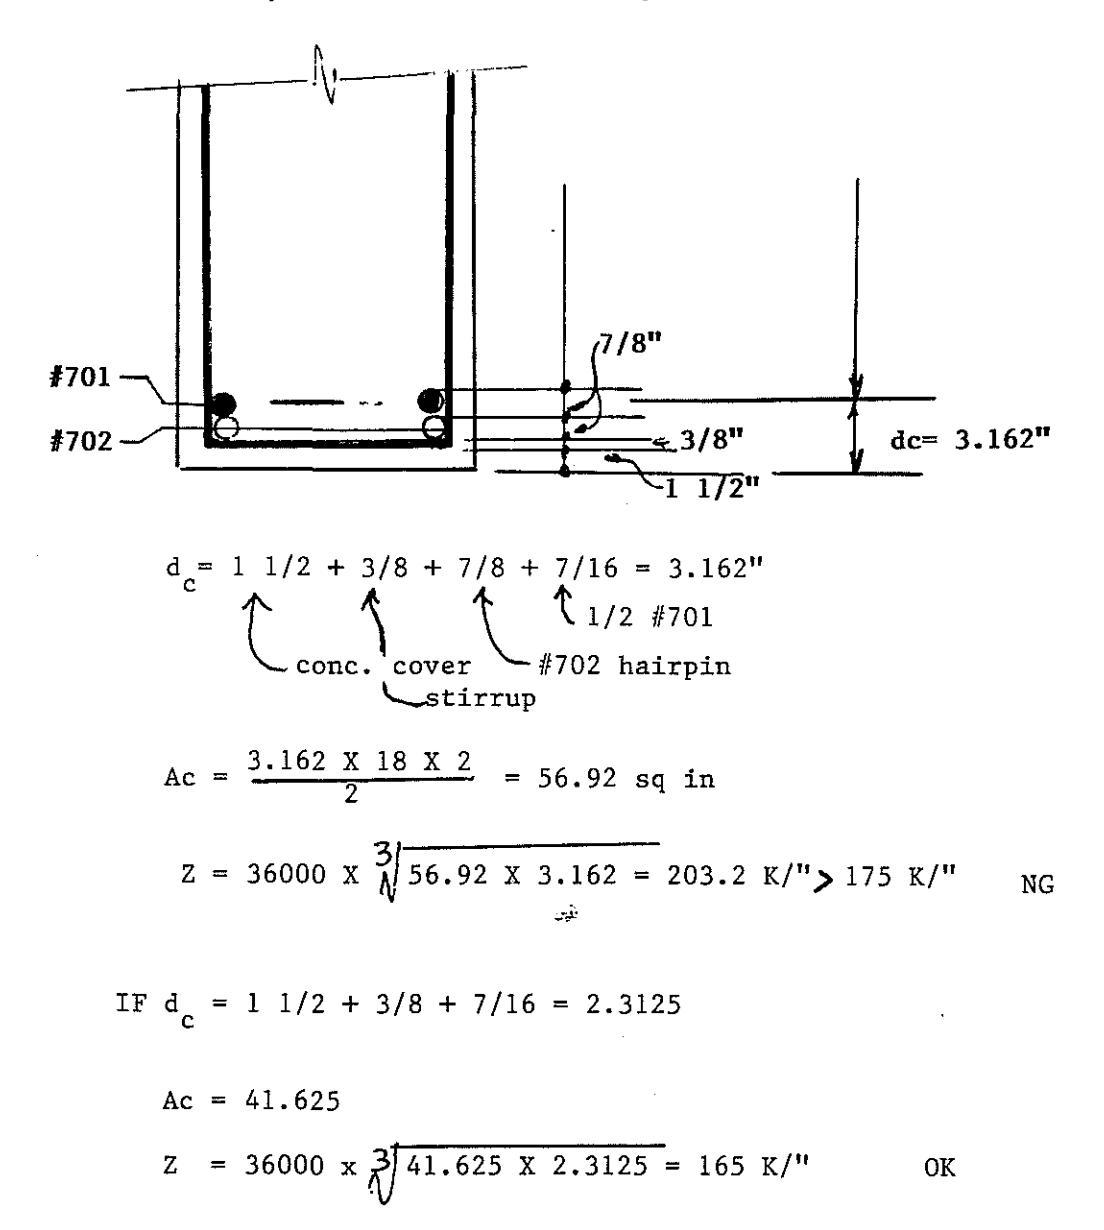
The development length of the bars marked #701 was examined. In order for the bars to be fully effective and to develop the full moment strengths of section c-c as shown in table 6.1, #7 bar should have a minimum embedment length of 21" as per ACI 318-83. As observed in the field, the actual development length of the #701 bars was 8" on the northface and 8 1/4" on the southface. An eight inch embedment length will only develop a bending strength of 42.4 ft.-kips with a capacity reduction factor of 0.9 and a bending strength of 47.1 ft.-kips without capacity reduction factor at section c-c.

SECTION c-c ; CONDITION OF REINF. @ COLLAPSE

THE AVILABLE FLEXURAL MOMENT STRENGTH OF RB-35 with 2-#7 REBARS AND A DEVELOPMENT LENGTH OF 0'-8''

$T = As X fy = \frac{2 X 0.6 X 60000psi}{21 "} X 8" = 27,428 \#$ $a = \frac{As X fy}{0.85 X f'c X b} = \frac{27428}{0.85 X 5000 x 18} = 0.358$ $\phi Mn = \phi X As X Fy X (d - a/2)$ $= \phi X 27428 X (20.8 - 0.358/2)$ $= \phi X 565.6 k"$ $= \phi X 47.1 K'$ $\phi = 1.0 \quad \phi Mn = 47.1 \text{ kip: -ft}$
