Oil and Gas Industry **Safety Alert 002**

On February 28th 2008 after acidizing a fruitland coal formation on the Mudge A # 10 in San Juan County, New Mexico; chemically created hydrogen sulfide was encountered during the flowback operations.

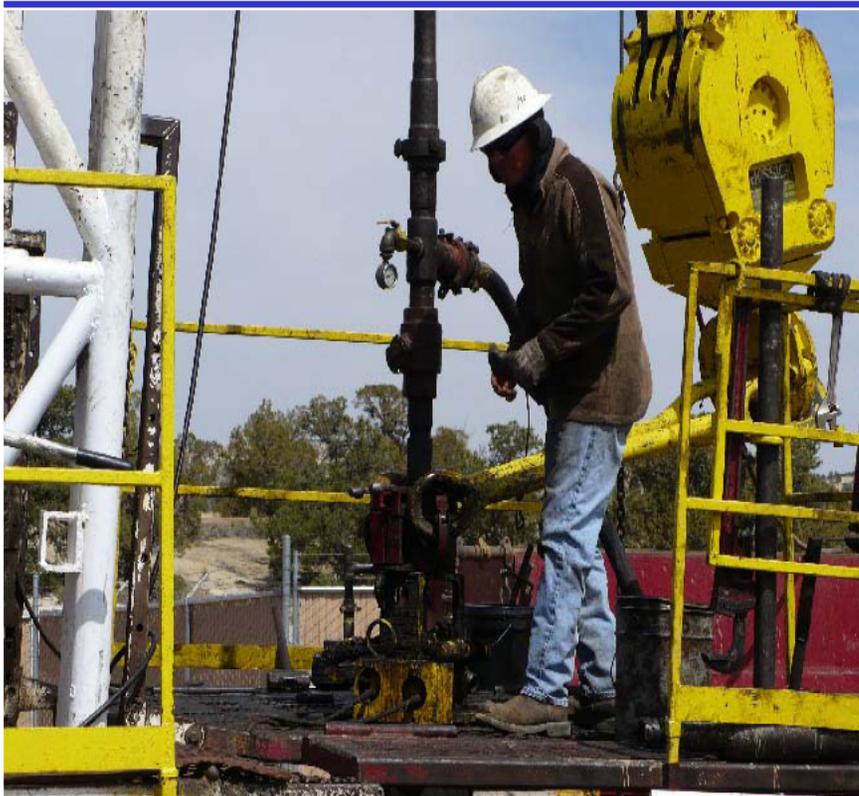
The case history of this well indicates no known history of hydrogen sulfide. After the acid treatment was performed, the completion unit crew went about their normal operations for swabbing the fluids back. On the fifth swab run, the completion foreman noticed a strong rotten egg smell. Operations ceased and the well was shut in as per proper protocol.

- Initial concentrations of Hydrogen Sulfide were detected from a rotten egg smell.
- Operations were immediately ceased and well was shut in.
- An H₂S consultant was called, levels identified were 250-2000 ppm.
- H₂S gas was created by the 15% HCL acid treatment for iron sulfide and calcium carbonate scale.

- Anticipate H₂S gas whenever treating iron sulfide and calcium carbonate scale with acid.
- Pump and treat with a H₂S scavenger prior to flow back to reduce the risk of H₂S gas on the surface.
- Verify H₂S monitors are on site and establish H₂S concentrations on flowback.
