# Investigation of the February 1, 2014 Collapse of a Telecommunication Tower at the Summit Park Community in Clarksburg, WV

U.S. Department of Labor  
Occupational Safety and Health Administration  
Directorate of Construction

July 2014

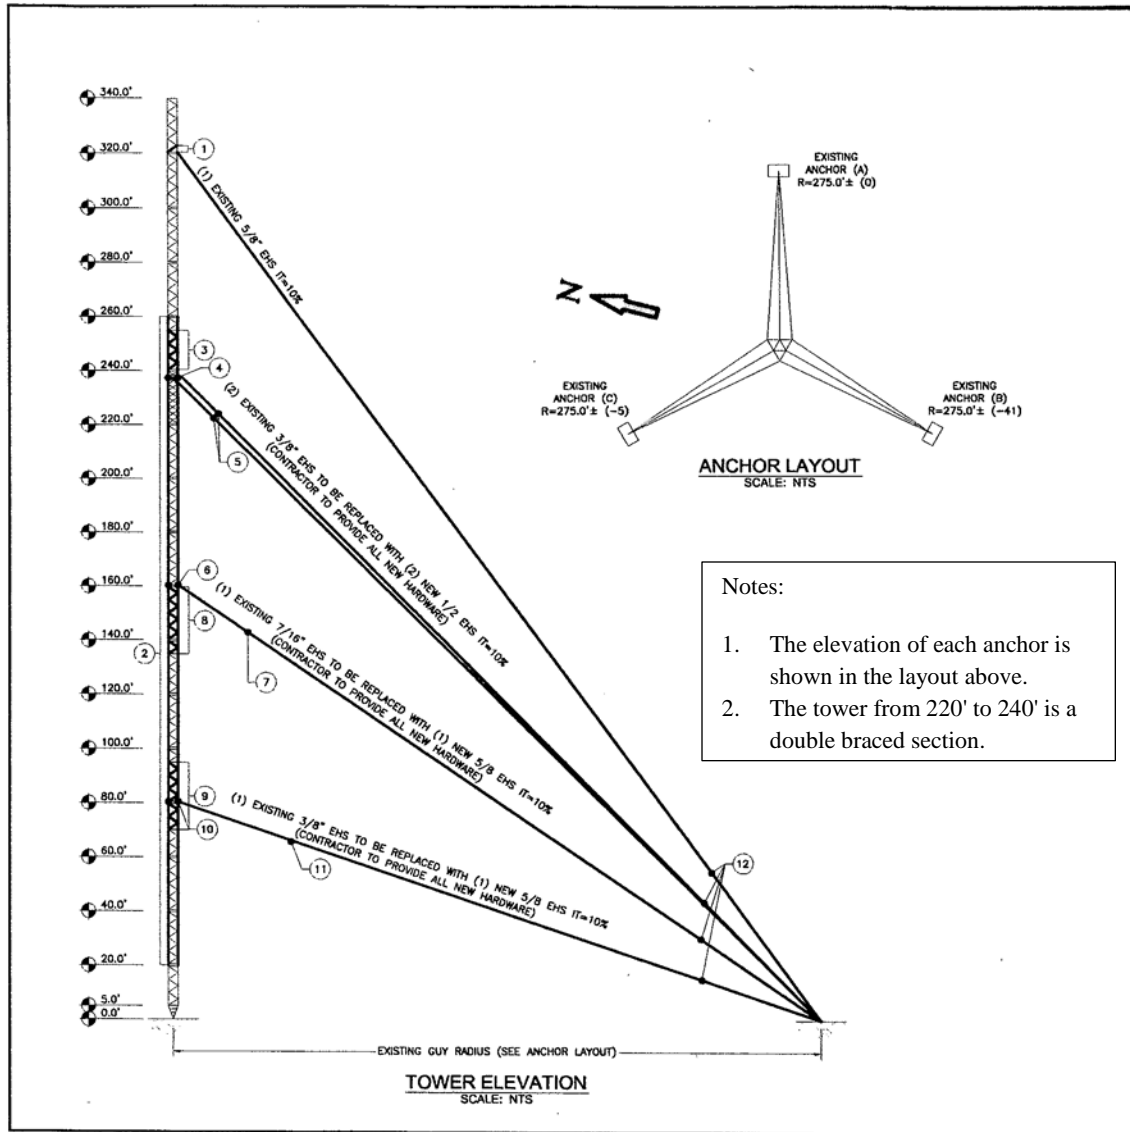
The project was to upgrade and modify an existing 340' guyed cell tower by replacing diagonals, adding angle leg reinforcements, and replacing guy wires (See Figure 1). The tower was located at the Summit Park Community, Harrison County, West Virginia. The site name was Despard (Tower 1). The site number was WV08612-A-02. The site address was 9141 Murphy's Run Road, Clarksburg, West Virginia.

Figure 1. Plan and elevation of the cell tower and its anchors before the collapse (modified from the Modification Drawings, by FDH Engineering, Inc., August 2013).

In Figure 1, the tower in this project was constructed with seventeen sections of ROHN 80. Each section was 20' in length. The bottom section had a 5' tapered base. Except for the twelfth section, from 220' to 240' above ground, the tower was double braced to support the torque arm, while the remaining sixteen sections were single braced as shown in Figure 13. From this figure,

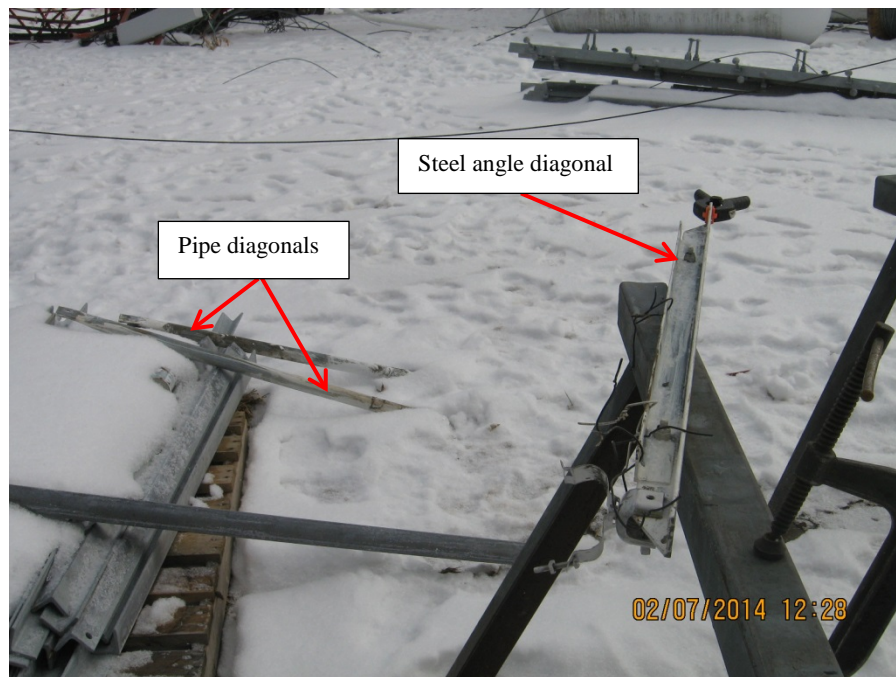
Figure 2. Two old pipe diagonals and one old steel angle diagonal were found at the workstation.

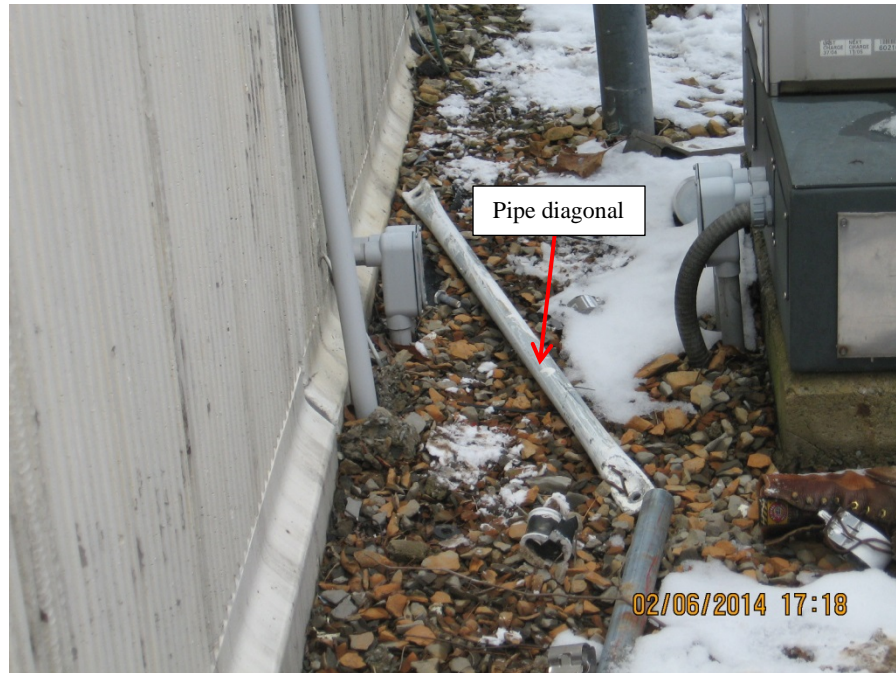
Figure 3. The fourth round diagonal, removed earlier from the tower, was found on the passageway near the tower.

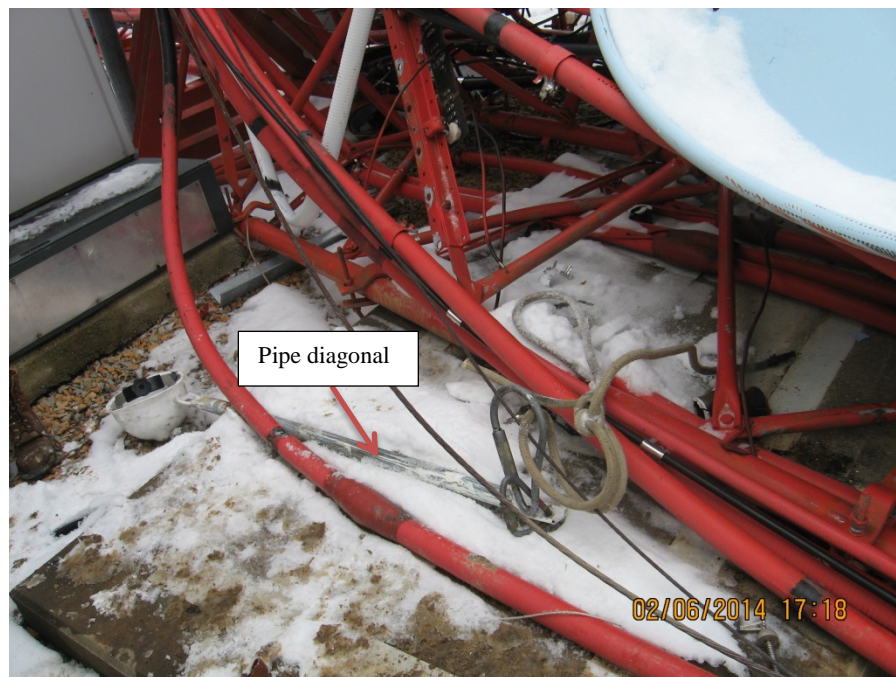
Figure 4. The fifth round diagonal, still fastened to a rope, was found on the way down from the tower.

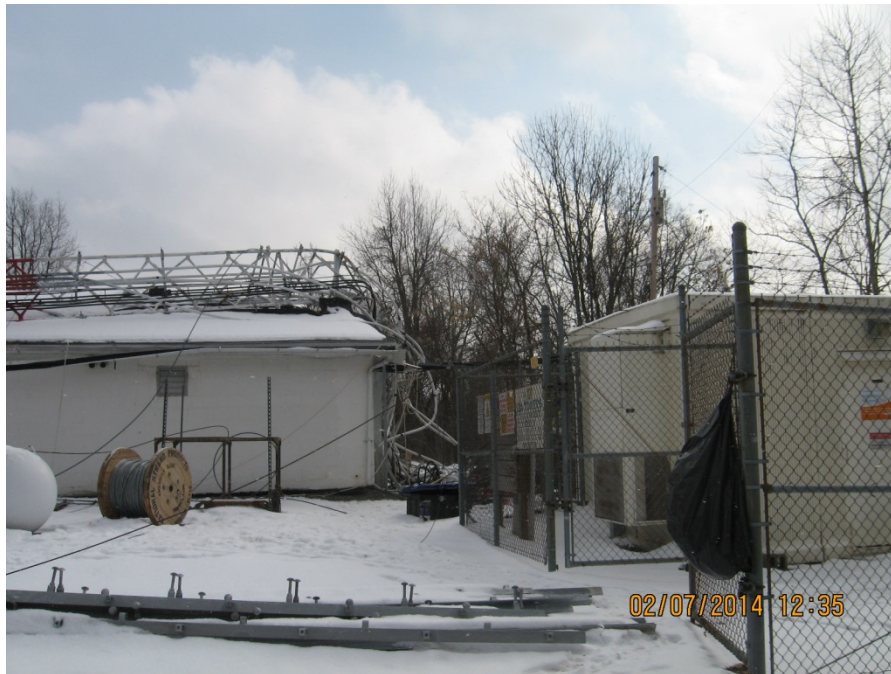
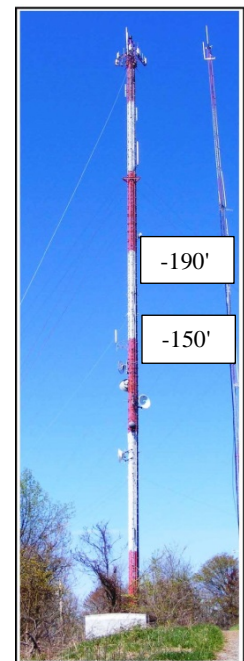
Figure 5. The upper portion of the collapsed tower, approximately from 150' to 190' above the ground (looking northeast).

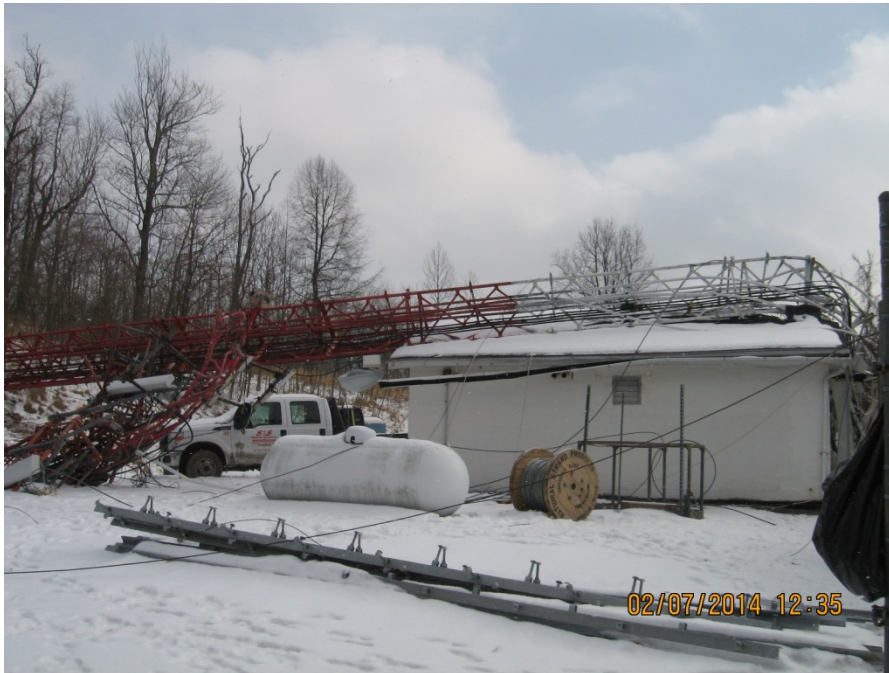
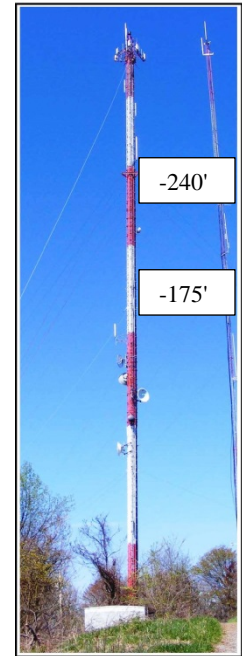
Figure 6. The upper portion of the collapsed tower, approximately from 175' to 240' above the ground (looking northeast).

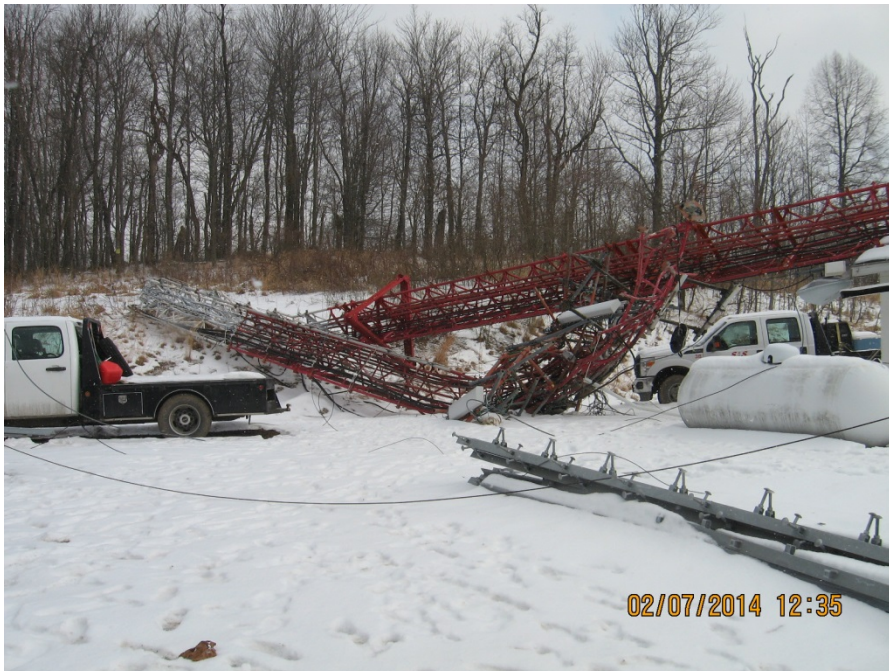
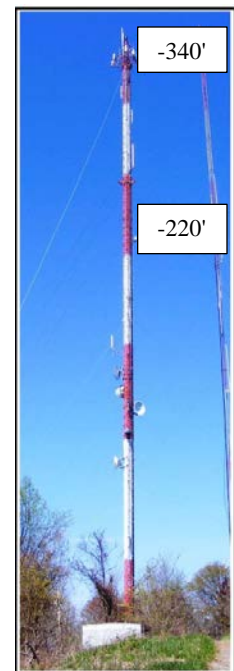
Figure 7. The upper portion of the collapsed tower, approximately from 220' to the top of the tower at 340' above the ground (looking northeast).

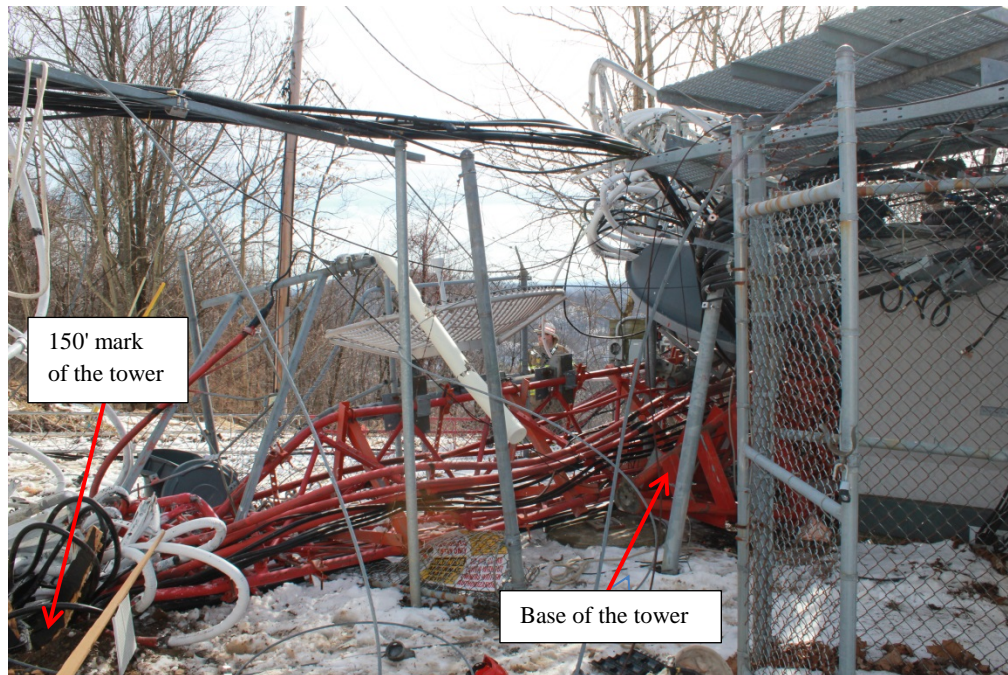
Figure 8. The lower portion of the folded and collapsed tower at its northwest end. Note that the 150' mark of the tower is at the lower-left corner of the photo and the base of the tower is at the lower-middle of the photo (WVSP Photo 5920, looking east).

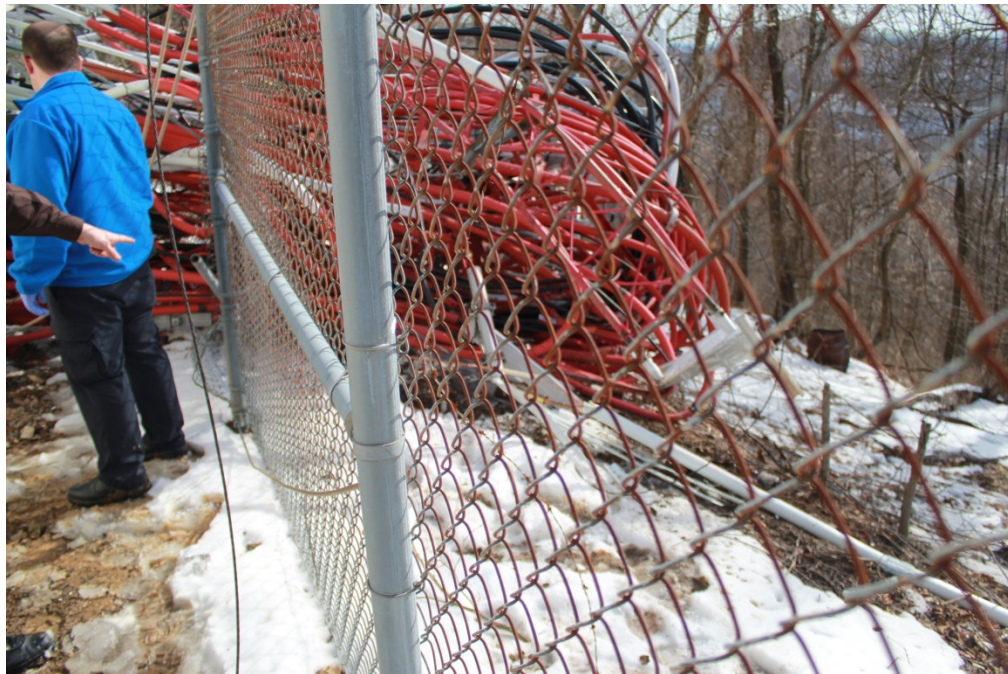
Figure 9. The lower portion of the folded and collapsed tower at its southeast end (WVSP Photo 5924, looking northeast).

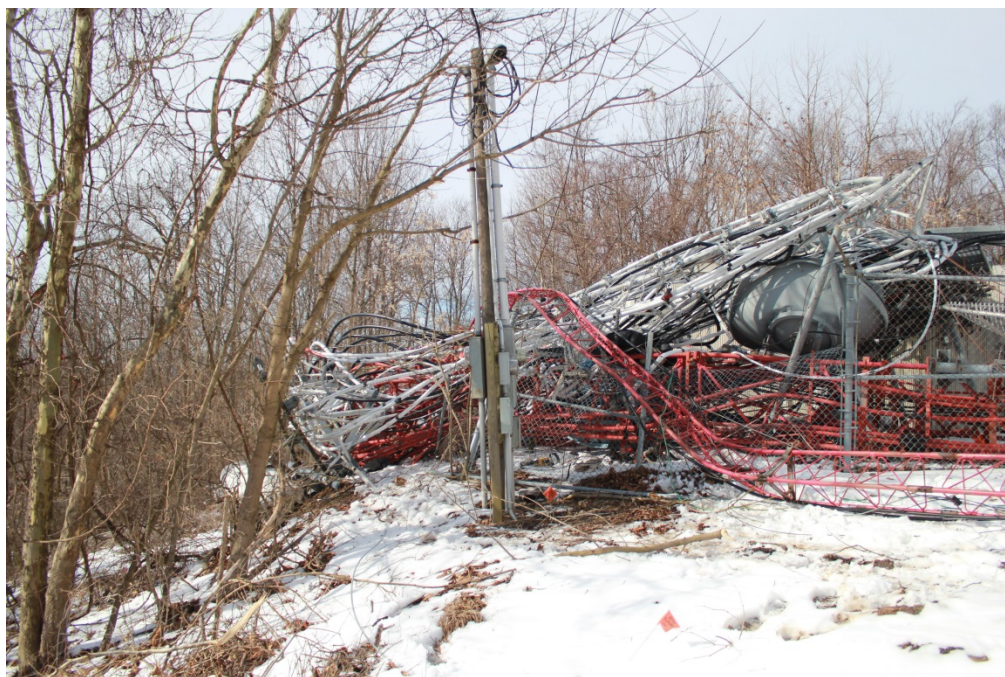
Figure 10. The lower portion of the folded and collapsed tower at its southeast end (WVSP Photo 5864, looking southwest).

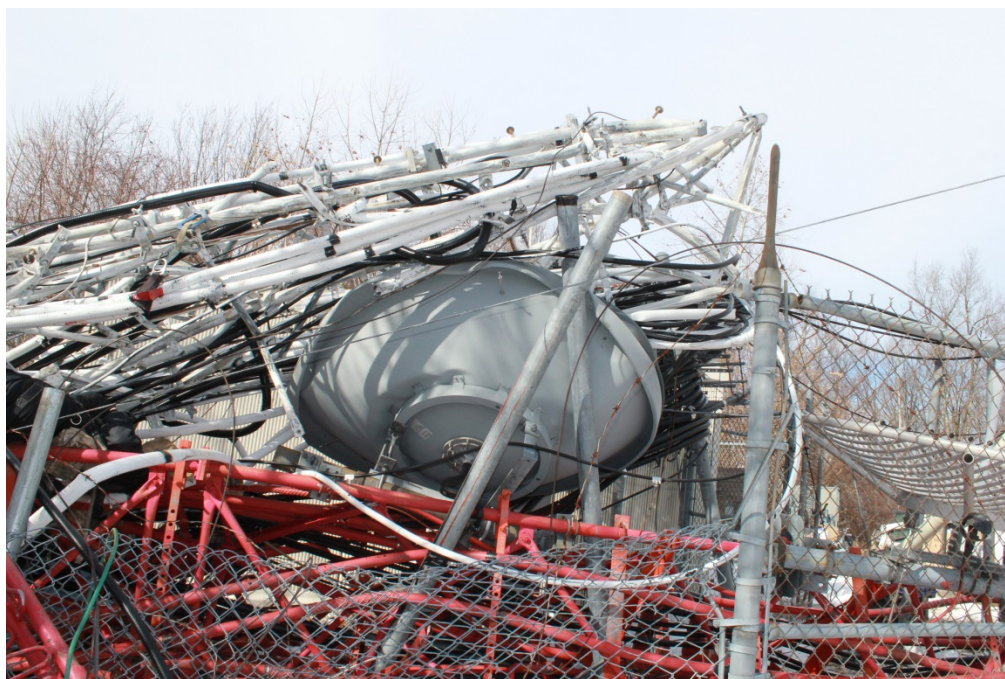
Figure 11. The lower portion of the folded and collapsed tower at the middle of the collapsed pile (WVSP Photo 5868, looking southwest).

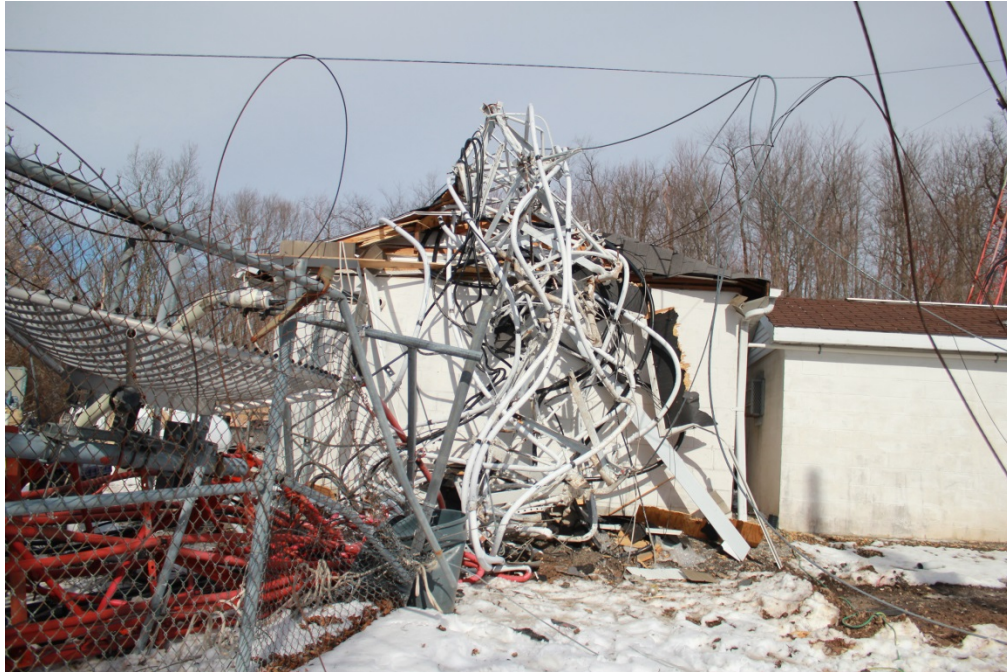
Figure 12. The lower portion of the folded and collapsed tower at its northwest end (WVSP Photo 5869, looking northwest).

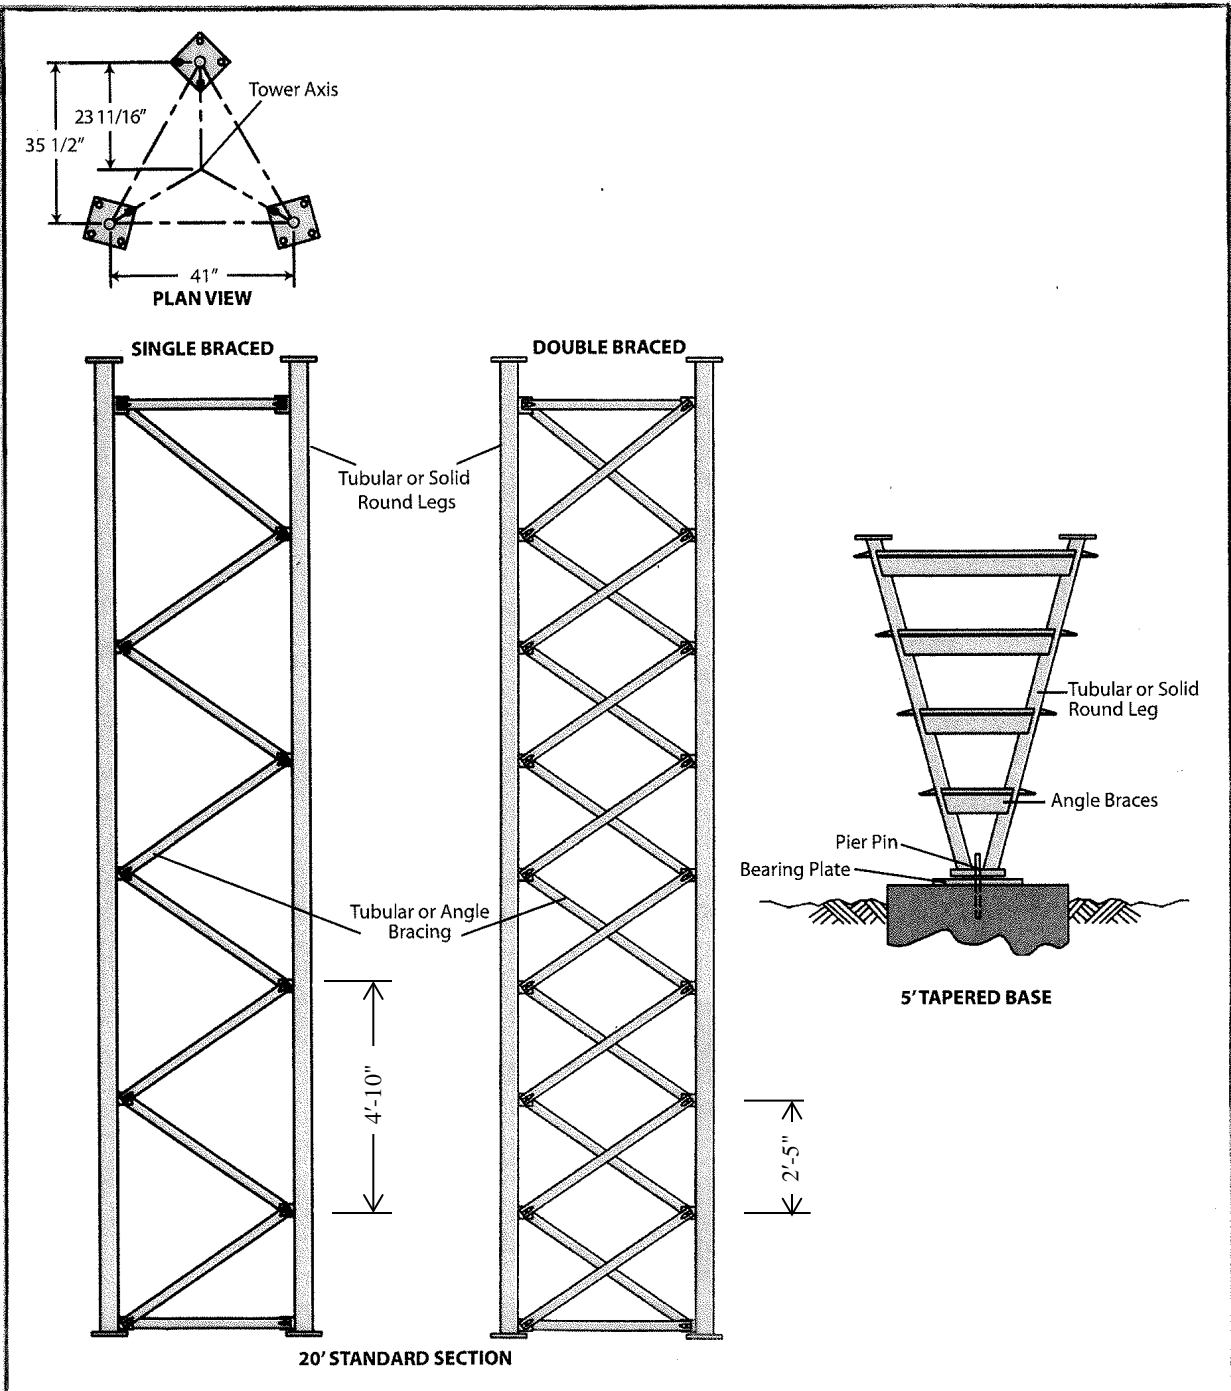
the tower was triangular in shape. Each tower leg consisted of 2" diameter steel pipes. They were 41" apart. The unbraced length of the tower leg was approximately 4'-10" for the single-braced section and 2'-5" for the double-braced section.

Figure 13. Rohn Standard 80 Series guyed tower section (modified from Rohn Products LLC, Product Catalog No. 3, Page 155, 2013).

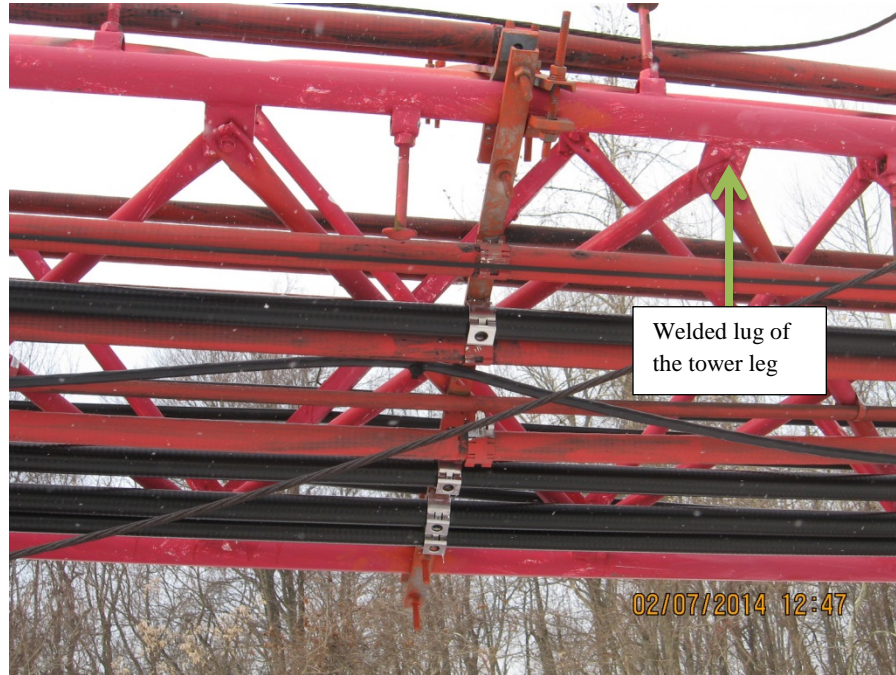
In Figure 14, at each welded lug of the tower leg, there was one bolt connecting two diagonals. One diagonal had two holes for connection, one at each end. Thus, removing one bolt would disable two diagonals, although they would still be connected to the tower at the other ends. Figure 15 shows a disabled diagonal still attached to the collapsed tower.

Figure 14. Welded lug of the tower leg; one bolt connects two diagonals.

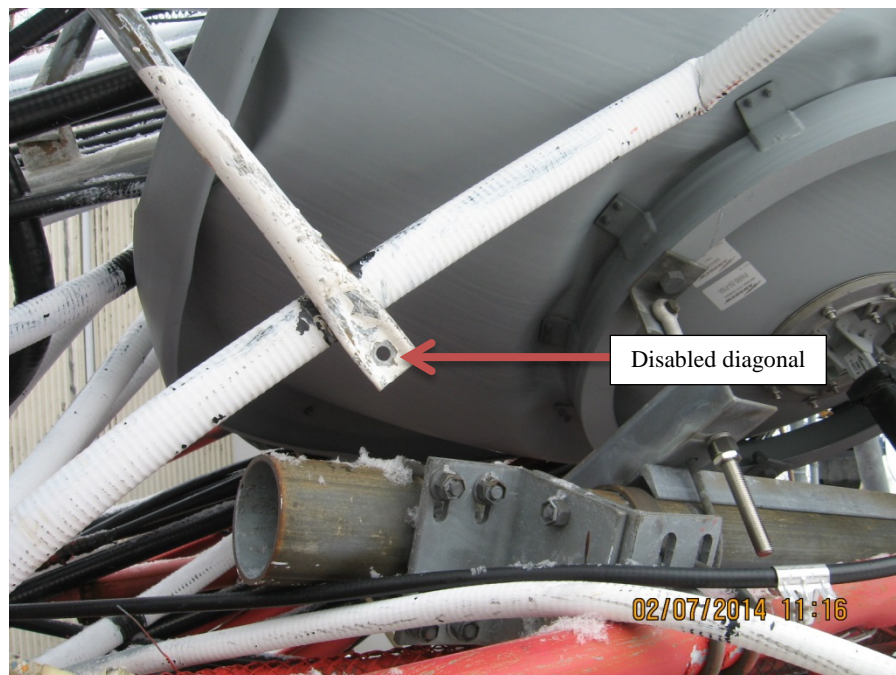
Figure 15. A diagonal disabled by being unbolted from the lug. It is still attached to the tower.

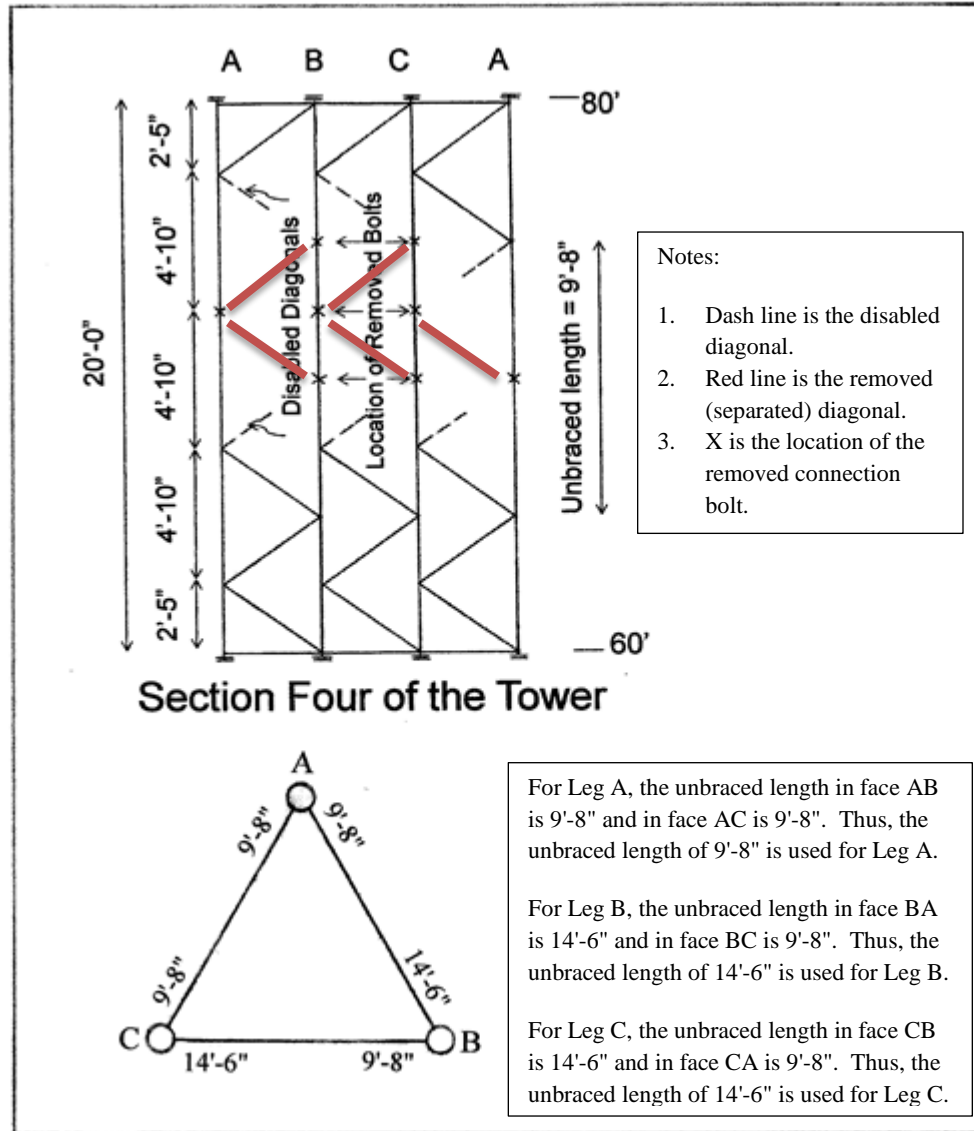
Removing bolts at each end of one diagonal would separate the diagonal completely from the tower but this would also disable two adjacent diagonals. For simplicity, three faces of the triangular tower are laid out in one plane as shown in the upper portion of Figure 16. In this figure, when eight bolts were removed, it produced six disabled diagonals (in dash lines) and five separated diagonals (in red lines). It should be noted that the numbers of removed bolts, disabled diagonals, and separated diagonals were consistent with the collections from the incident site.

Figure 16. Determination of the Unbraced Length of the Tower Legs.

Principles of structural mechanics require that a column be laterally braced in two principal directions. When the unbraced lengths in the two directions are not equal, the longer unbraced length governs, if the sectional properties of the column are same in these two directions. Thus, from the configurations and explanations in Figure 16, the unbraced length of each tower leg was estimated to be 9'-8" for leg A, and 14'-6" for legs B and C.

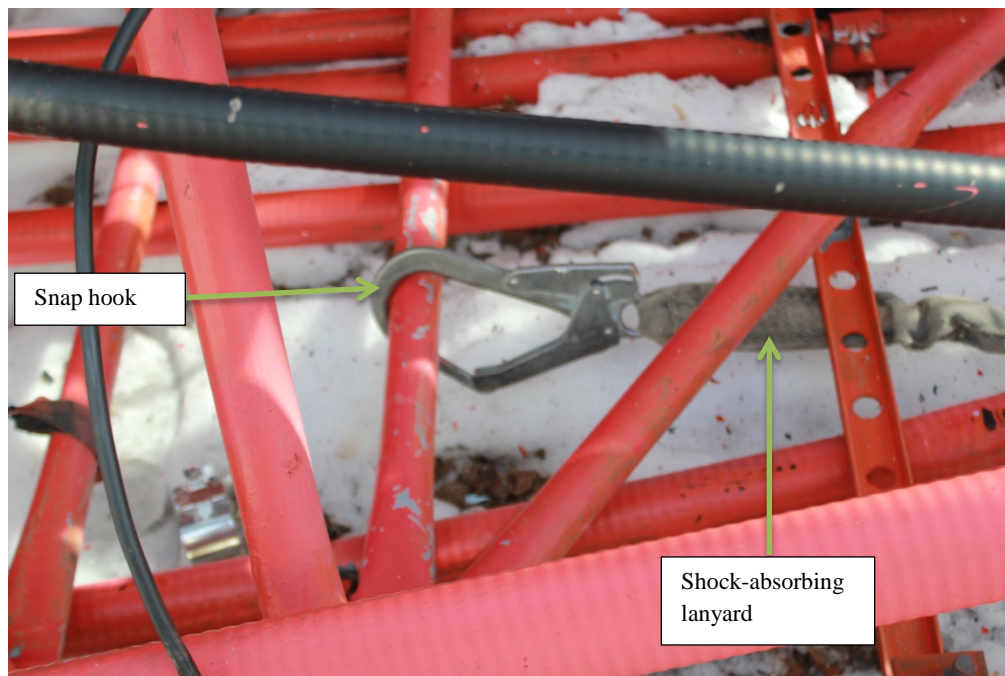
Figure 17 shows that the snap hook from one of the injured employees was attached and anchored to a horizontal bracing member of the tower. The horizontal bracing was a steel pipe with 1½" O.D. x 16 GA in size and 2'-10" in span (ROHN Commercial Products, Drawing No. C681228 R<sub>5</sub>, 1981). The maximum vertical load at the mid span, based on the plastic flexural capacity of the pipe, was estimated to be approximately 600 pounds (see Attachment B). OSHA standard 1926.502(d)(15) requires that *“Anchorages used for attachment of personal fall arrest equipment shall be ... capable of supporting at least 5,000 pounds (22.4 kN) per employee attached, or shall be designed, installed, and used as follows: (i) as part of a complete personal fall arrest system which maintains a safety factor of at least two; and...”*

Figure 17. The snap hook from one of the injured employees was anchored to a horizontal bracing member of the tower (WVSP Photo 5969).

Figure 17 also shows that the other end of the snap hook was connected to a shock-absorbing lanyard, which was typically capable of limiting the maximum fall arrest force to approximately 900 pounds. With the minimum required safety factor of two, the anchorage for the shock-absorbing lanyard must be capable of supporting a vertical load of at least 1,800 pounds without failure. But, the horizontal bracing member had a vertical load capacity of 600 pounds, much less than the required anchorage capacity. Thus, the contractor did not comply with OSHA standard 1926.502(d)(15).

3. One of the personal fall arrest systems used by the employees was anchored to a horizontal bracing member of the tower. A shock-absorbing lanyard was used in this system. Under this condition, the maximum fall arrest force was limited to approximately 900 pounds. The minimum required anchorage capacity would need to have been approximately 1,800 pounds to achieve a safety factor of two. However, the horizontal bracing member had a capacity of 600 pounds less than the required anchorage capacity. Thus, the contractor did not comply with OSHA standard 1926.502(d)(15).
4. Wind was not a causal factor of the tower collapse.
