Aurora OSHA Construction News

Trenching Still A Concern

Volume 3, Issue 2
Fall 2002

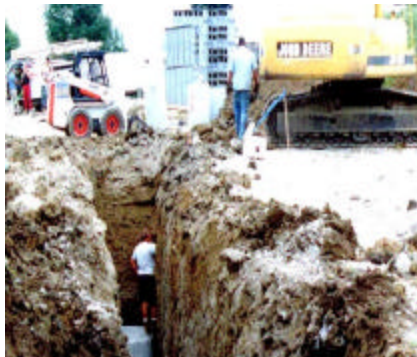
Luckily, this worker made it out of the trench alive.

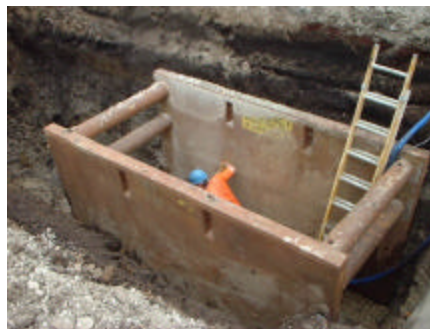
A trench box is being used—but what is wrong with this picture? Hint—what would happen if the soil on top collapsed?

A **shield**, also known as a trench box, is another common protective system used by contractors. Trench boxes are not designed to prevent cave-ins, but rather serve to "shield" workers within the structure should a cave-in occur. This is an excellent choice when placing continuous installations, as in pipe laying. The box is placed in the trench and dragged along with the progress of the work. A few important points about shields:

- Personnel should be out of the box and above ground when the shield is being moved. You could be caught between the moving box and fixed object(s);
- The top of the shield should extend at least eighteen (18) inches above the level of any materials that could cave or roll into the trench;
- Some shields are designed to be stacked, one on top of another. **Never** stack shields that are not designed for that purpose, and do not stack shields from different manufacturers, as they may not be compatible.
- The forces of a cave-in can literally push a box sideways, causing a crushing hazard. After a

box is positioned for the work, the voids between the box and the trench wall should be filled with excavated material to prevent displacement caused by a cave-in.

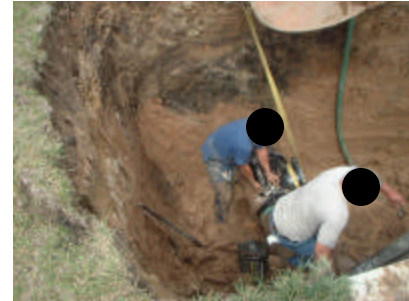
A shoring system could have been used in this trench to protect the workers.

Shoring systems are structures of timber, mechanical, or hydraulic systems that support the sides of an excavation and which are designed to **prevent** cave-ins. **Sheeting** is a type of shoring system that keeps the earth in position. It can be driven into the ground or work in conjunction with a shoring system. Driven sheeting is most frequently used for excavations open for long periods of time. Another type of sheeting, in which plates or shoring grade plywood (sometimes called Finland form) is used in conjunction with strutted systems such as hydraulic or
