MODULE 3

EVALUATING ELECTRICAL RISK FACTORS

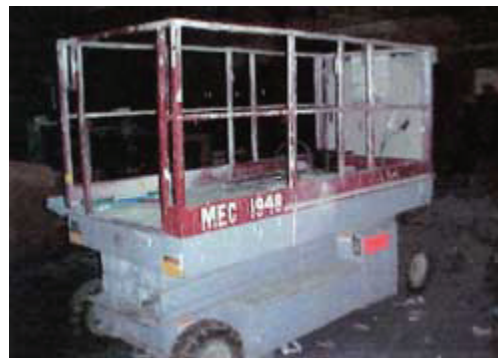
The incident occurred the afternoon of Wednesday, May 5, 2004. The two-man crew started the project, which was expected to take two to three days, during their usual 7:00 a.m. to 4:00 p.m. shift. They used a powered scissor-lift (see photo at right) to raise them to the ceiling joists of the thermoforming room. Work proceeded uneventfully through the morning and into the early afternoon.

Scissor Lift

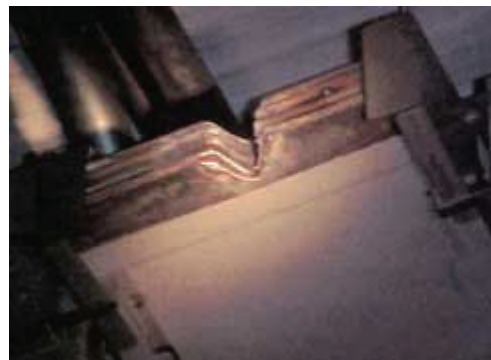
The arc burned a deep “V” into the four metal bus plates (see photo at right), caused the power to go out, and set off the fire alarm. Sparks from the arc and/or exploding voltmeter set the victim’s clothing on fire. The mechanic tried to extinguish them, setting his own clothes on fire. The mechanic lowered the lift to ground level, where a plant employee used a fire extinguisher to put out the fires. The mechanic then lost consciousness. The darkness and fire caused a panic among the employees in the area, and everyone was evacuated. The police received a 911 call from the plant and dispatched a unit. Officers reported finding the area dark and smoke filled, with the two workers unconscious on the platform of the scissor lift. The two workers were transported to the emergency room where they were treated for burns. Attending physicians did not find evidence of electrical injuries to either worker, and determined that the mechanic, who was treated and released, had 10% total body burns to his hands and chest. The victim suffered more extensive injury with 35% total body burns and smoke inhalation. Fourteen days after the incident, the victim succumbed to his injuries.

Burned “V” Shape in Bus Bar Plates

Following the incident, plant management brought in a crisis counselor to help the employees who witnessed the incident. Investigations by company management and OSHA found that the electrical contractor who installed the electrical bus bar apparently neglected to place an end-cap on the bus enclosure, leaving the electrical conductors exposed.
