**Hazards of Inadequately Securing Hydraulic Excavator  
Buckets When Using Quick Coupling Devices**

Safety and Health Information Bulletin

SHIB 07-22-2005

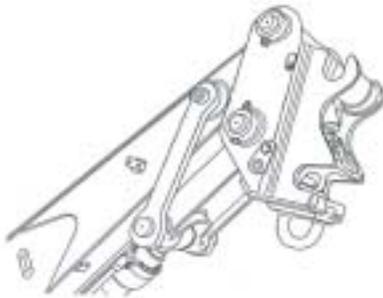
Figure 1

Most quick couplers are after-market devices that have been used on hydraulic excavators for several years and have steadily increased in popularity. They enable contractors to quickly make attachment changes on hydraulic excavators. Most quick couplers have a lifting eye to use for lifting material. (Figure 1).

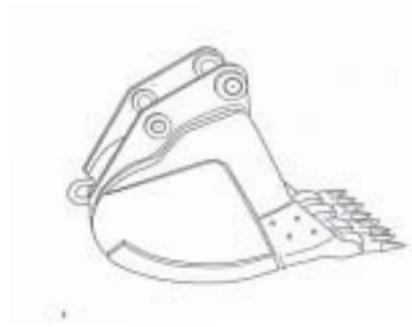
Figure 2

By removing the bucket (Figure 2), the lifting capacity of the excavator is increased by the weight of the bucket. Additionally, removal of the bucket improves the excavator operator's line of vision during lifting.

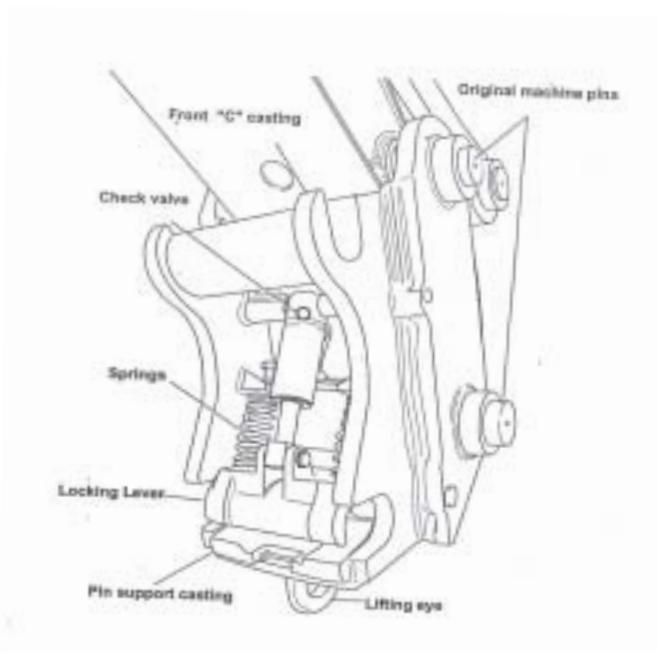
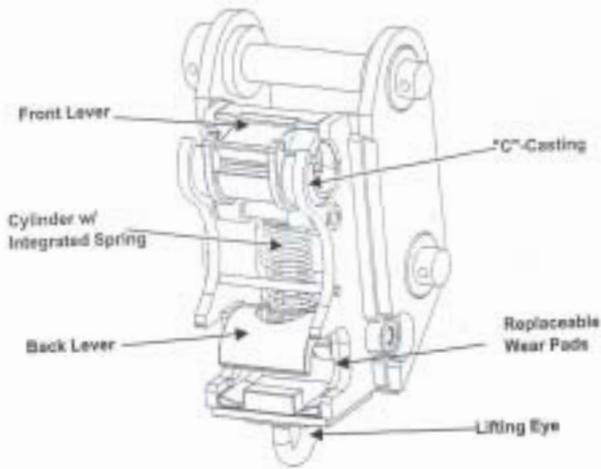
Many contractors like to use a large bucket to do the bulk of the digging and to then change to a smaller bucket for fine tuning and working in tight areas. The quick couplers also allow the operator to change from a bucket attachment to various other attachments. In most cases, the unexpected releases of buckets and other attachments are likely caused by the failure to properly engage and lock the quick couplers. (Figures 3 & 4).

- Inspecting all quick couplers to determine if they are subject to unexpected release hazards. Determine whether a manually installed locking pin and installation procedures (or other retrofitting methods) have been provided by the manufacturer.

- If appropriate, obtaining and installing retrofits recommended by the manufacturer, including positive locking pins and other devices that need to be manually installed.

- Using an independent secondary system to retain the bucket/work tool from falling, in the event of a failure of the primary system. The secondary system can be manual or automatic with a verification procedure for the user to check for proper attachment.

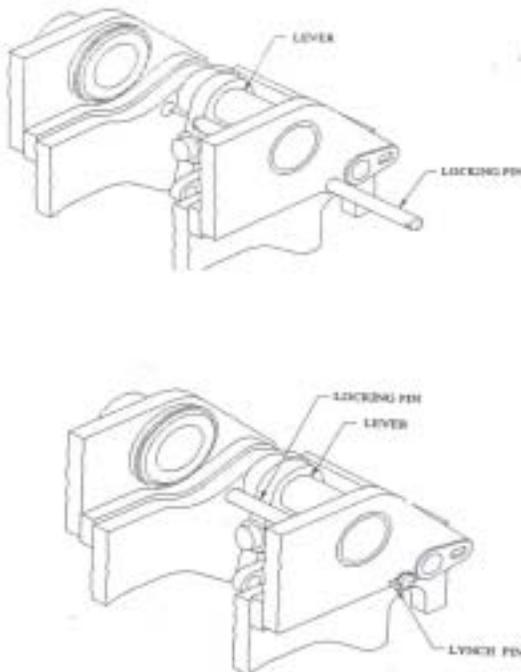
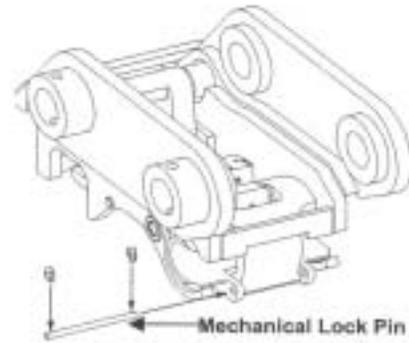
Quick couplers are made by various manufacturers. Manufacturers of quick couplers have recognized the hazard of the bucket or other attachments being unexpectedly released from the quick couplers and, in many cases, have provided users with a retrofit locking pin (Figures 5 & 6) which is manually inserted behind the front lever (stick pin) or rear lever (link pin) of the couplers to prevent unintended releases.
