## Case Study #1 – Amputation in Meat Grinder

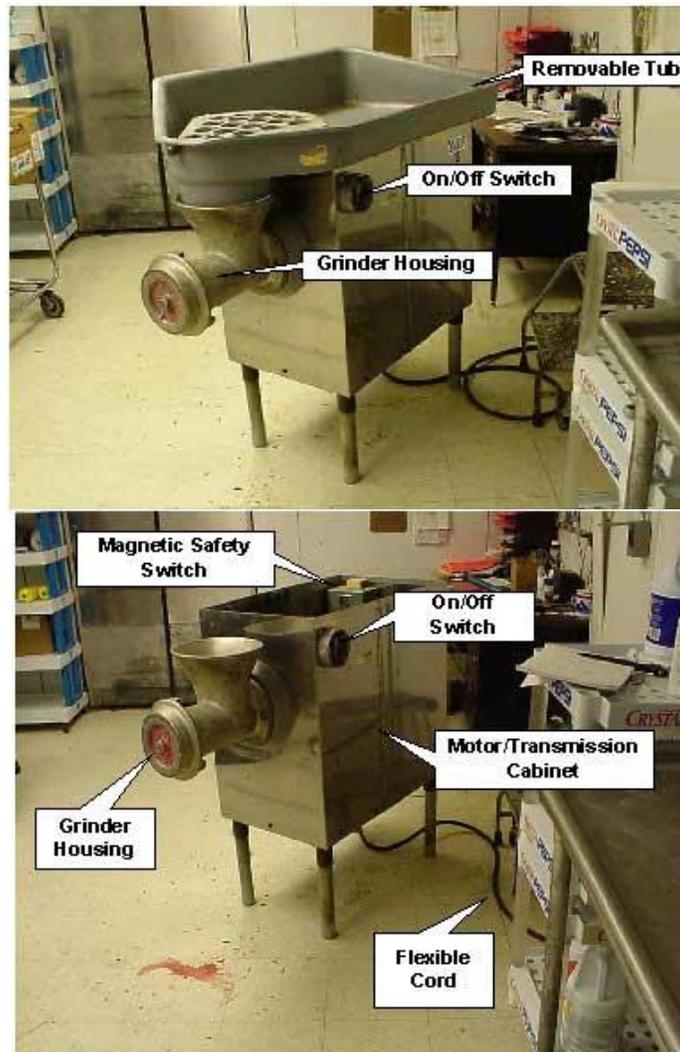
A 15-year-old part-time worker (the victim) at a retail grocery store suffered amputation of the right arm as a result of being caught by the auger of a meat grinder while he was reassembling it. The victim, working after school, had completed washing and cleaning the disassembled parts of the grinder and was reassembling it without de-energizing and locking out the machine's power supply (See Photos Below). He inserted the auger into the grinder's housing and reached through the feed-throat with his right hand to guide it into engagement. As he did so, he bumped against the unprotected on/off lever switch mounted about waist high on the machine's side. The grinder started and the auger pulled his hand and arm into the housing. He turned the machine off, pulled his arm from the grinder housing and ran toward the front of the store. The store manager applied pressure to his bleeding arm while a coworker called 911. The victim was transported to a local hospital. His right arm had been amputated just below the elbow. A magnetic safety switch mounted on top of the motor starter was designed to prevent operation when the Removable Tub was taken off. The safety switch had not worked for over 16 years and employees were not aware that the safety switch existed. (Source: <http://www.cdc.gov/niosh/face/In-house/full200013.html>)

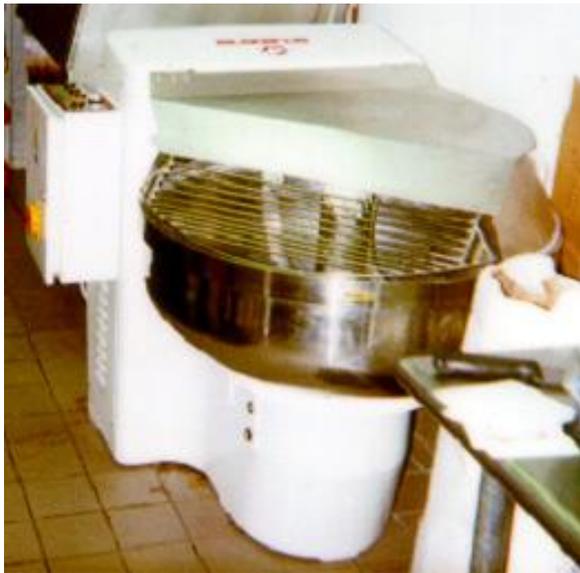
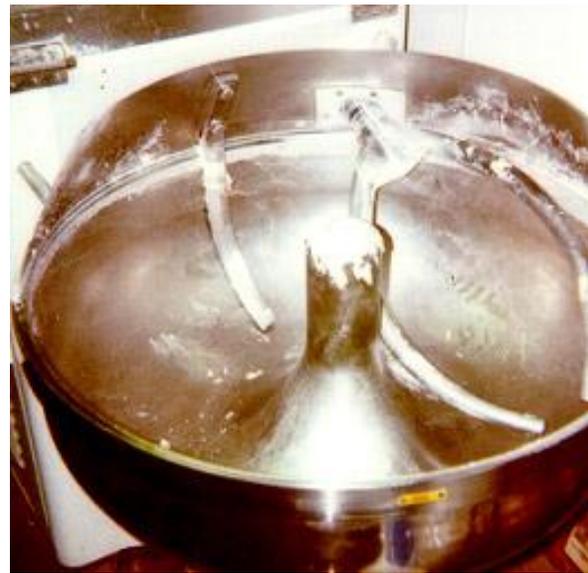
A 15-year-old male pizzeria worker was killed when he became entangled in a machine used to mix pizza dough (see photos below). The victim had arrived in the United States from Guatemala one month before the incident and had been working at the family-owned pizza restaurant for two weeks. He was paid to do odd jobs at the restaurant, mostly sweeping and cleaning. On the night of the incident, he was cleaning the pizza dough mixer as the restaurant was closing for the evening. He was working alone in the kitchen as the remaining staff cleaned the adjoining dining room. He apparently lifted the cover of the mixer, uncovering the 32-inch-diameter mixing bowl, and started the machine. As he reached in to the bowl to clean it, he became entangled on a large mixing fork (beater) that rotated inside the mixing bowl. His co-workers heard him scream, but were unable to reach him in time. The mixer cover was equipped with a safety interlock activated by a pin pressed by the hinge of the cover. On this mixer, the weight of the open cover flexed the hinge enough to disengage the interlock, allowing the machine to activate with the cover open. (Source: <http://www.cdc.gov/niosh/face/stateface/nj/01nj118.html>)

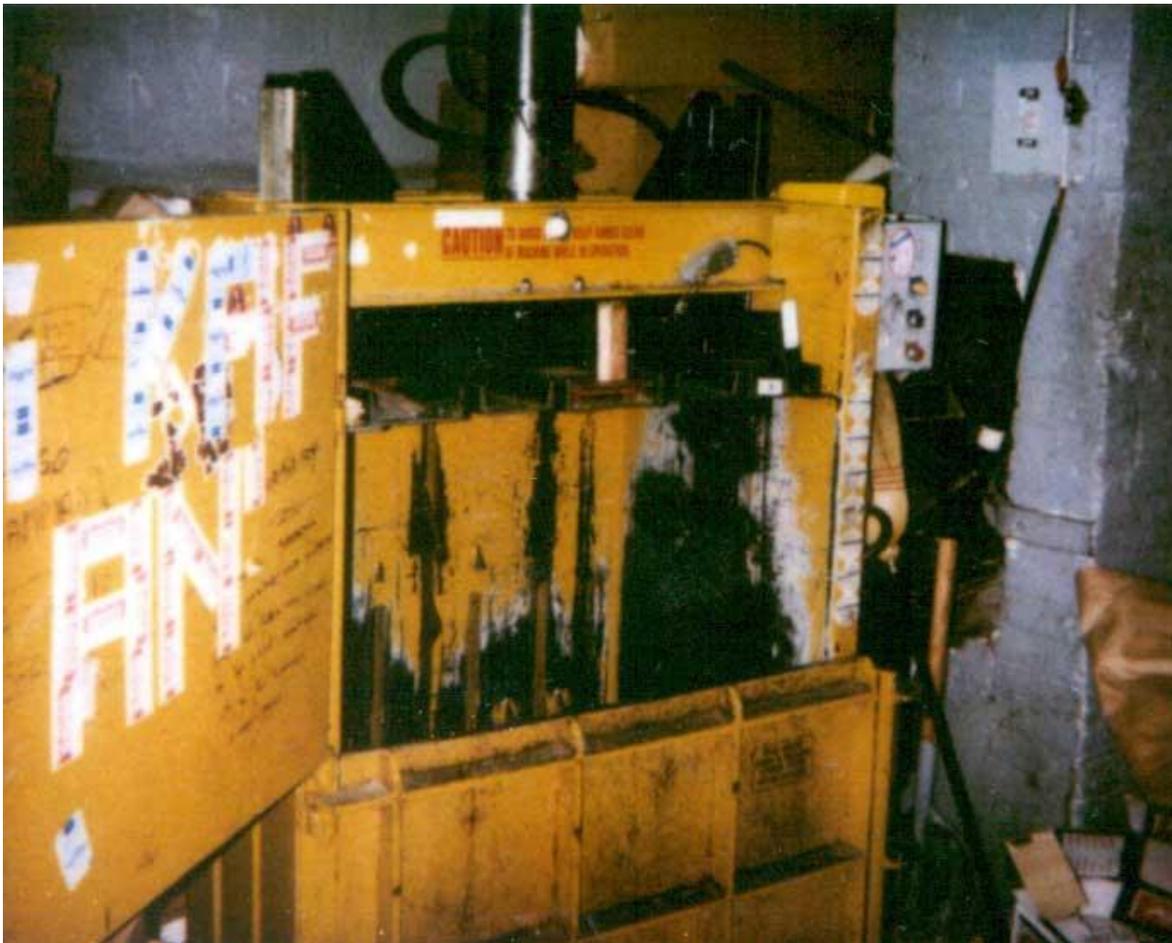
A 16-year-old male produce-market worker (the victim) died from crushing injuries after being caught in the vertical downstroke baling machine that he was operating (see picture below). The victim, working alone in the basement of a small produce market, was crushing cardboard boxes when at some point in the compacting process he was caught by the machine's hydraulic ram. The victim was discovered by an exterminator spraying the basement, who notified the store manager to call police and emergency medical services (EMS).

Subsequent examination by investigators revealed that the safety interlock had been bypassed, allowing the machine to operate with the loading door in the open position. The victim may have reached into the baling chamber during a compression cycle to adjust a tie wire or a liner box and was caught by the ram platen. (Source: <http://www.cdc.gov/niosh/face/In-house/full200019.html>)

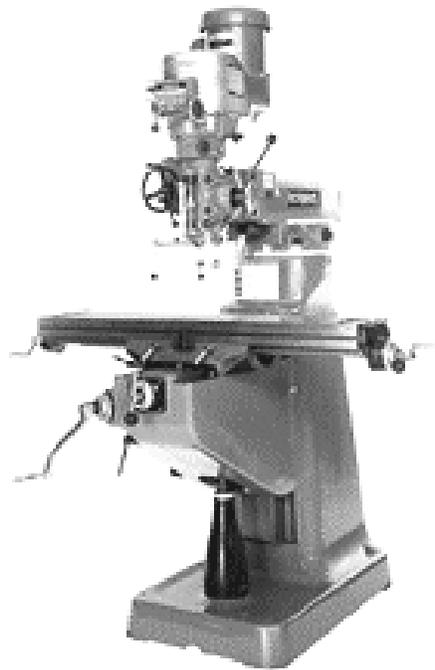
A 57-year-old male supervisor/drill press operator (victim) was fatally injured after his shirtsleeve was caught by the rotating drill bit of the drill press he was operating. The rotating bit tightened the shirt around his neck, strangling him. The victim, working alone, was clamping eight-inch by eight-inch by half-inch thick steel plates to the drill press table while the drill bit was rotating. A co-worker was passing by and noticed the victim caught in the running drill press. The co-worker shut off the drill press as another co-worker arrived to help. Both co-workers were trying to hold up the victim while a third co-worker went to call for emergency assistance. The victim was transported to a hospital in a neighboring state where he was pronounced dead. (Source: <http://www.cdc.gov/niosh/face/stateface/ma/99ma033.html>)

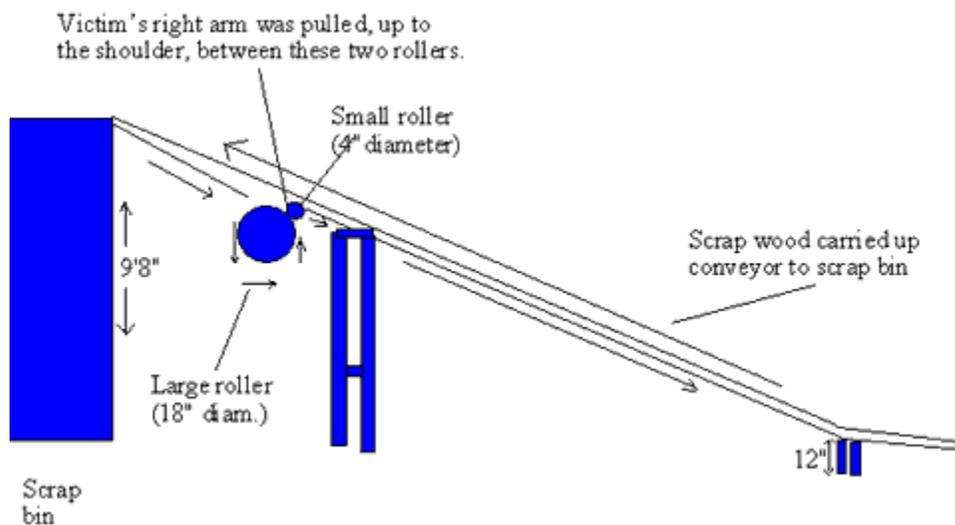
The supervisor finally located the victim, entangled in the inclined portion of the conveyor belt. The victim's right arm, up to the shoulder, had been pulled into the roller mechanism underneath the belt at a point where the bottom of the roller was almost six feet above the floor (see Figure below). The supervisor, upon seeing the victim, immediately shut off power to the belt at a wall panel four feet beyond where the victim was entangled.

Since there were no eyewitnesses to this incident, it is not certain how the victim became caught. The roller mechanisms were too high to have caught him or his clothing (sleeveless shirt, jeans) as he walked by unless he jumped up or reached up. The victim was not wearing any gloves or other personal protective equipment (PPE). The conveyor belt was in constant operation when the plant was running so workers throughout the plant could place scraps on it at any time. It is possible that the victim might have been climbing up the conveyor belt and may have caught his hand in the roller from above. Coworkers reported having seen the victim riding the raised portion of the belt on previous occasions, and he had received written reprimands for this. It is also possible that he reached up as he was walking under the belt, catching his hand between the rollers. (Source: <http://www.cdc.gov/niosh/face/stateface/ky/98ky044.html>)
