## Module 2, Scenario 5

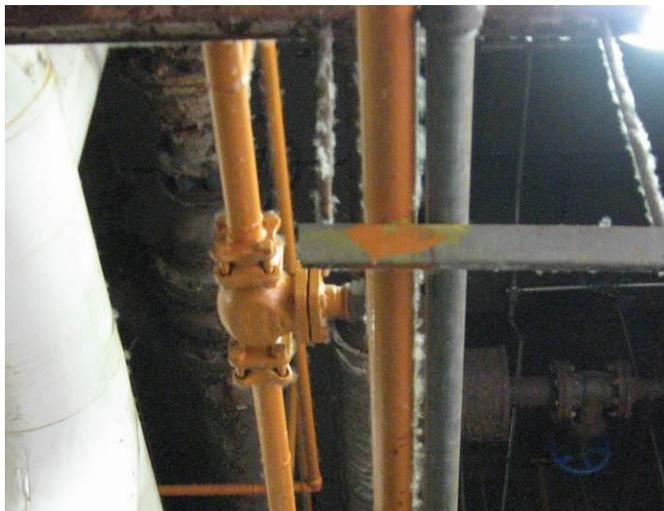
Employee #1, of a cold storage company in Los Angeles, CA, was helping to remove a valve housing assembly. When the housing parts were separated, a portion of the line fell and released pressurized ammonia. Employee #1 sustained third-degree burns on his hands, legs, and abdomen. Subsequent investigation revealed that the employer had purged the pressurized ammonia from the lines, and the gauges attached to them read zero. However, a 6 ft section of line had not been depressurized, and the rear pressure check valve was in the 'up' position when it was supposed to be down. Employee #1 also stated that the bolts holding the valve assembly should have been slightly loosened, but they had been completely removed.
