Oil and Gas Industry **Safety Alert 004**

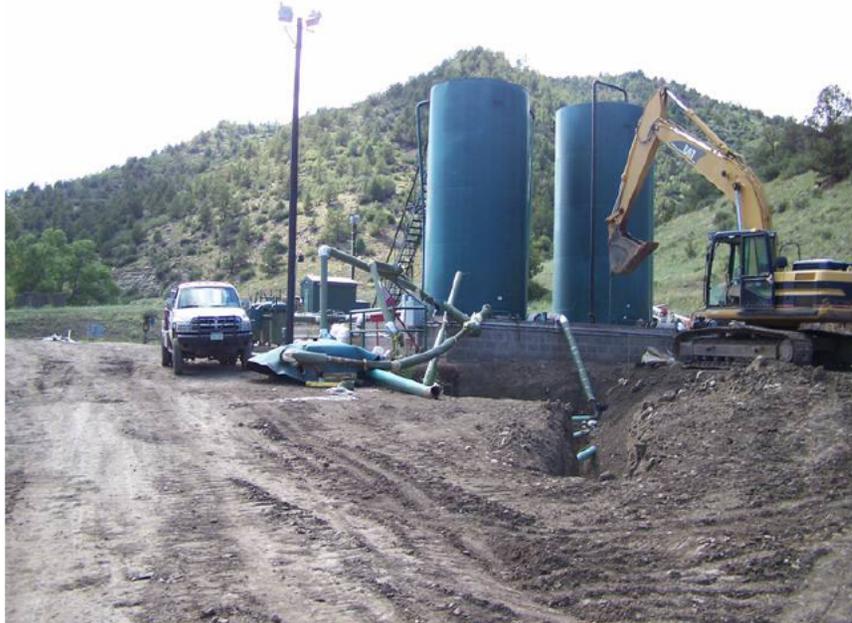
On 08-11-08 at 3: 45 p.m. a welder was attempting to cut a riser on the east tank in the containment at the AC 19-10 SWD when the top of the tank blew off. A Hot Work Permit had been initiated by a contract foreman earlier to do some work on the tank. The immediate area was checked for LEL along with the riser on the tank prior to cutting the riser with a torch. A fire watch had been established and the area was being monitored during the cut on the riser. Once the welder had cut approx ¾ of the circumference of the pipe, an explosion was heard and the top of the tank came off. The tank lid piping was still connected to the tank thus limiting the tank lid from becoming a projectile and damaging the surrounding equipment. The tank had not been isolated from the west tank in the facility and that tank in the facility was still operating at the time of the incident. Neither contractor nor employees had LOTO'd the tank on location that was being worked on. There were no injuries reported and damage was limited to the east tank and piping connected to the tank. The west tank and piping was not damaged in the incident.

- No LOTO and isolation of equipment was performed prior to doing Hot Work on the tank.
- XTO Safety Handbook Hot Work procedures identifying the correct protocol for isolation and LOTO prior to Hot Work were not followed.
- The riser was not removed and moved to a safe area to do Hot Work.
- The Hot Work Permit was incomplete.

- Ensure a thorough walk through prior to job initiation with Representative and Contract Inspector along with contract personnel to identify all isolation necessary and install LOTO on all equipment that is pertinent to the job.
- Follow and implement Hot Work standard as stated in the Safety Handbook to ensure all measures have been taken to prevent incidents.
