Investigation of the July 13, 2007 Collapse of Roof Trusses in Township of Franklin, NJ

U.S. Department of Labor
Occupational Safety and Health
Directorate of Construction
October 2007

Report Prepared by
Mohammad Ayub, PE, SE
Office of Engineering Services
Directorate of Construction

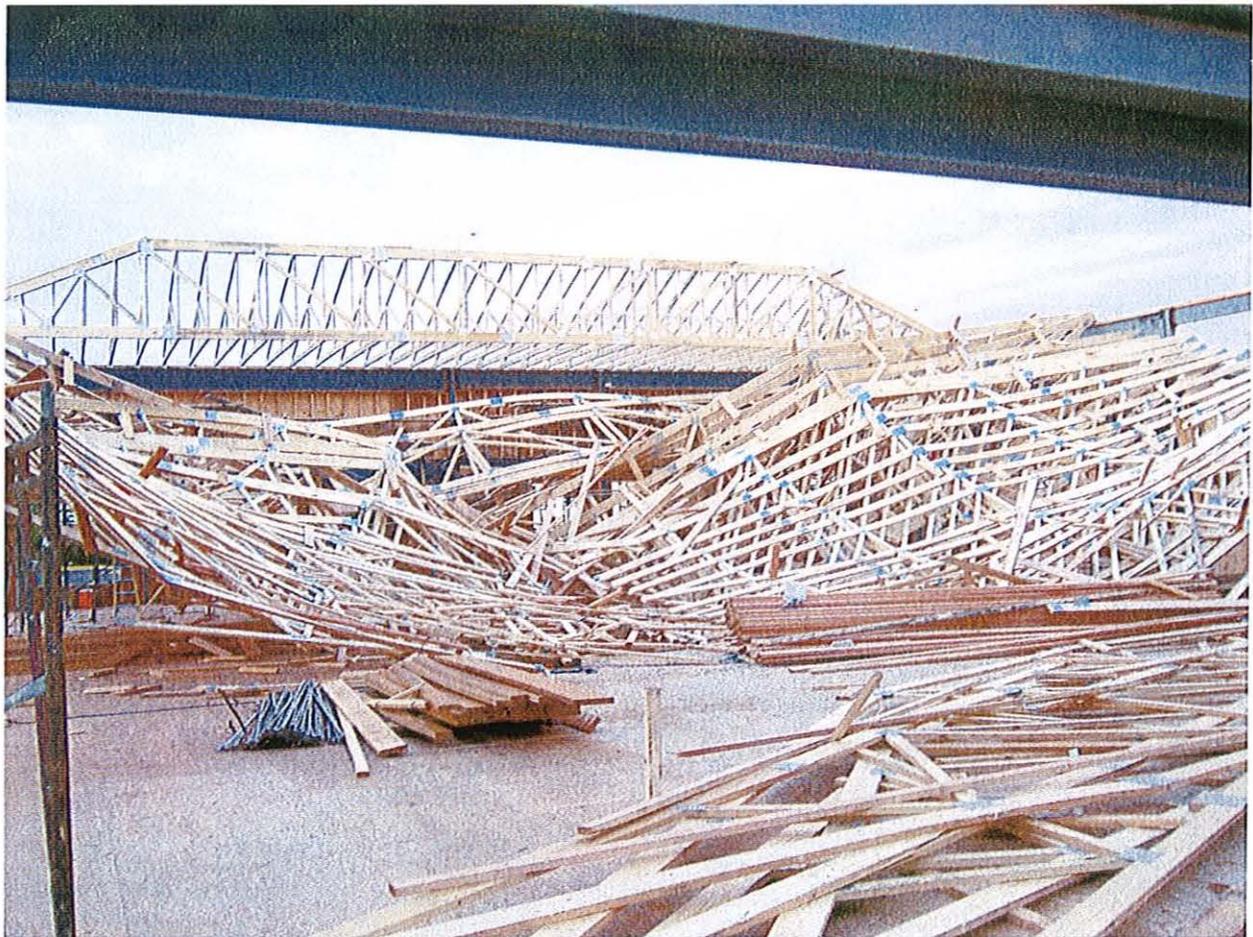
This report is limited to the roof area where the incident occurred. The roof trusses spanned approximately 81' between supporting steel beams over steel columns. There were a total of 41 trusses consisting of 16 "Drop TC Hip" trusses and 25 trusses known as "Hip" trusses. On the top of the 25 hip trusses, 25 gable trusses were to be mounted at the top to meet the architectural roof configuration. At the time of the incident, gable trusses were yet to be erected but all 41 drop TC hip trusses and hip trusses were set in place, see Fig. 1.

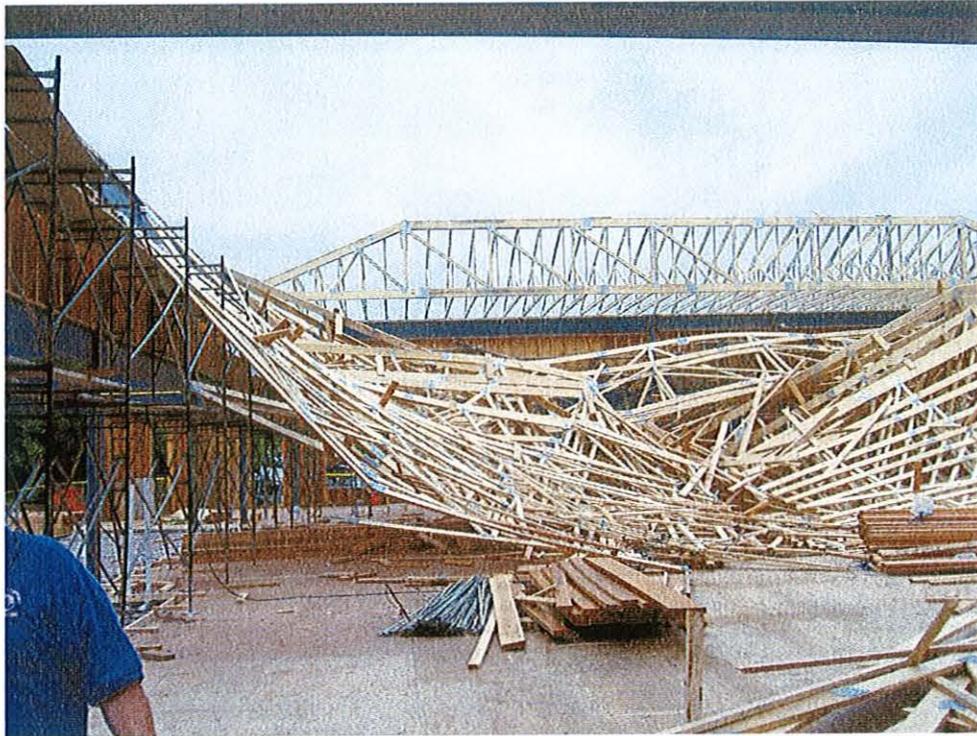
FIGURE 2

reported to be 50 pieces of 2x4x24' long pieces spread over the bottom chord. There were approximately seven employees on the trusses near the center of the trusses. Shortly after the three bundles were placed the employees observed, at approximately 2:10 p.m. that the roof trusses, except for the five trusses on the south side, suddenly collapsed at the center. The employees reported that the trusses fell just in the middle in a vertical direction, see Figures 2 to 5. The ends of the trusses remained generally connected to the supporting beams.

1. The cause of the incident was the placement of three bundles of 2x6x12' long pieces over the top chord of the hip trusses shortly before the incident. The weight of the bundles in combination with the weight of the employees working on the trusses, and other 2x4s spread over the bottom chord of the truss caused the compressive stress of the top chord to exceed its ultimate capacity. The failure was caused by lateral torsional buckling of the top chord.
