# Investigation of the July 27, 2011 Systems-engineered Metal Building Collapse in San Marcos, TX

U.S. Department of Labor  
Occupational Safety and Health Administration  
Directorate of Construction

January 2012

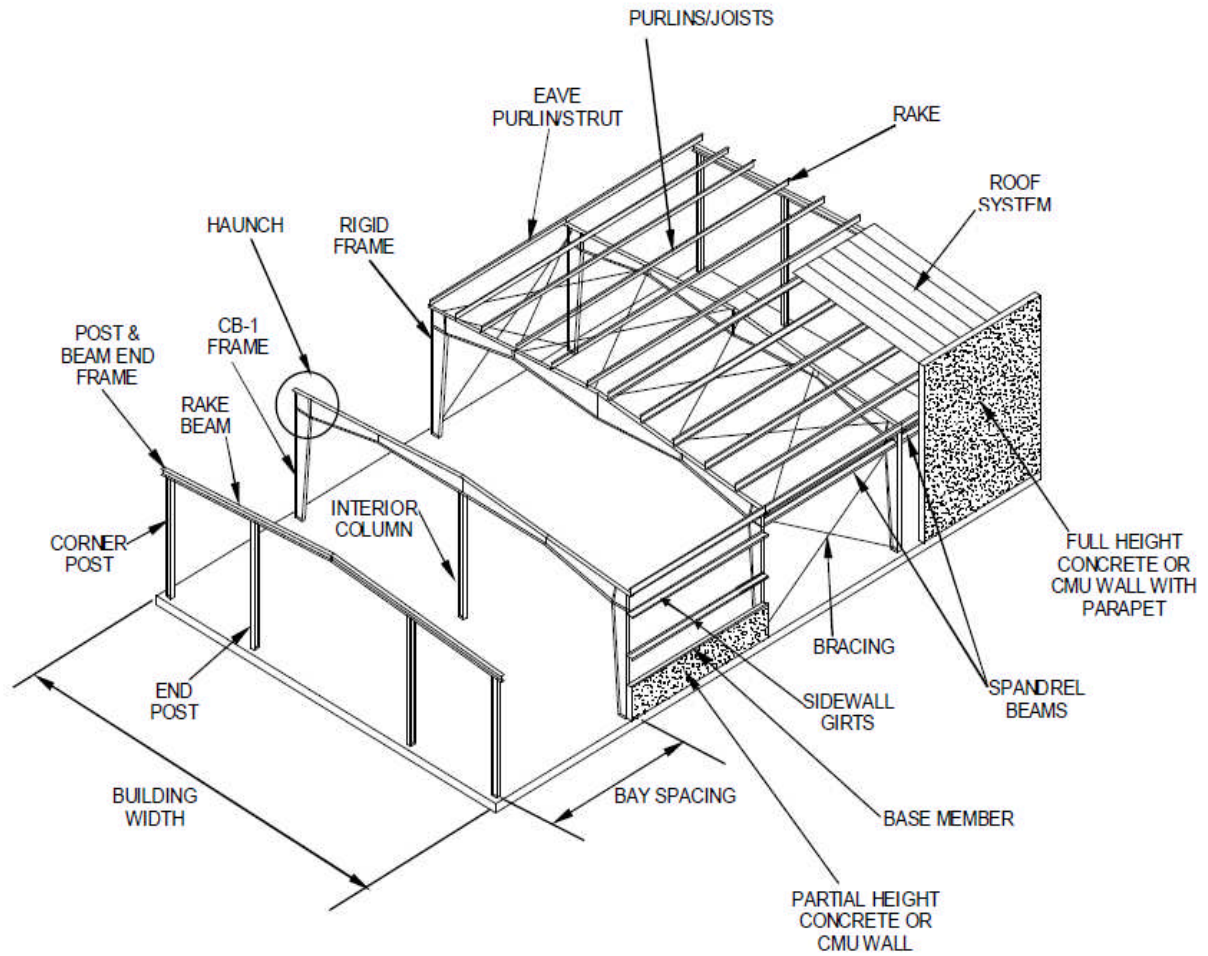
Fig. 1 Typical components of a systems-engineered metal building (source VP Buildings Hardwall Application Guide - Ref. 15).

Systems-engineered metal buildings are comprised of rigid frames (moment-resisting frames) spanning the short direction of the building; purlins, girts, sidewall bracings to resist lateral loads in the direction perpendicular to the frames; vertical bracings located in endwalls primarily to resist lateral loads acting in the direction parallel to the frames; and roof diaphragm; and a system of horizontal braces that help to distribute loads among the lateral load-resisting elements (see Fig. 1).

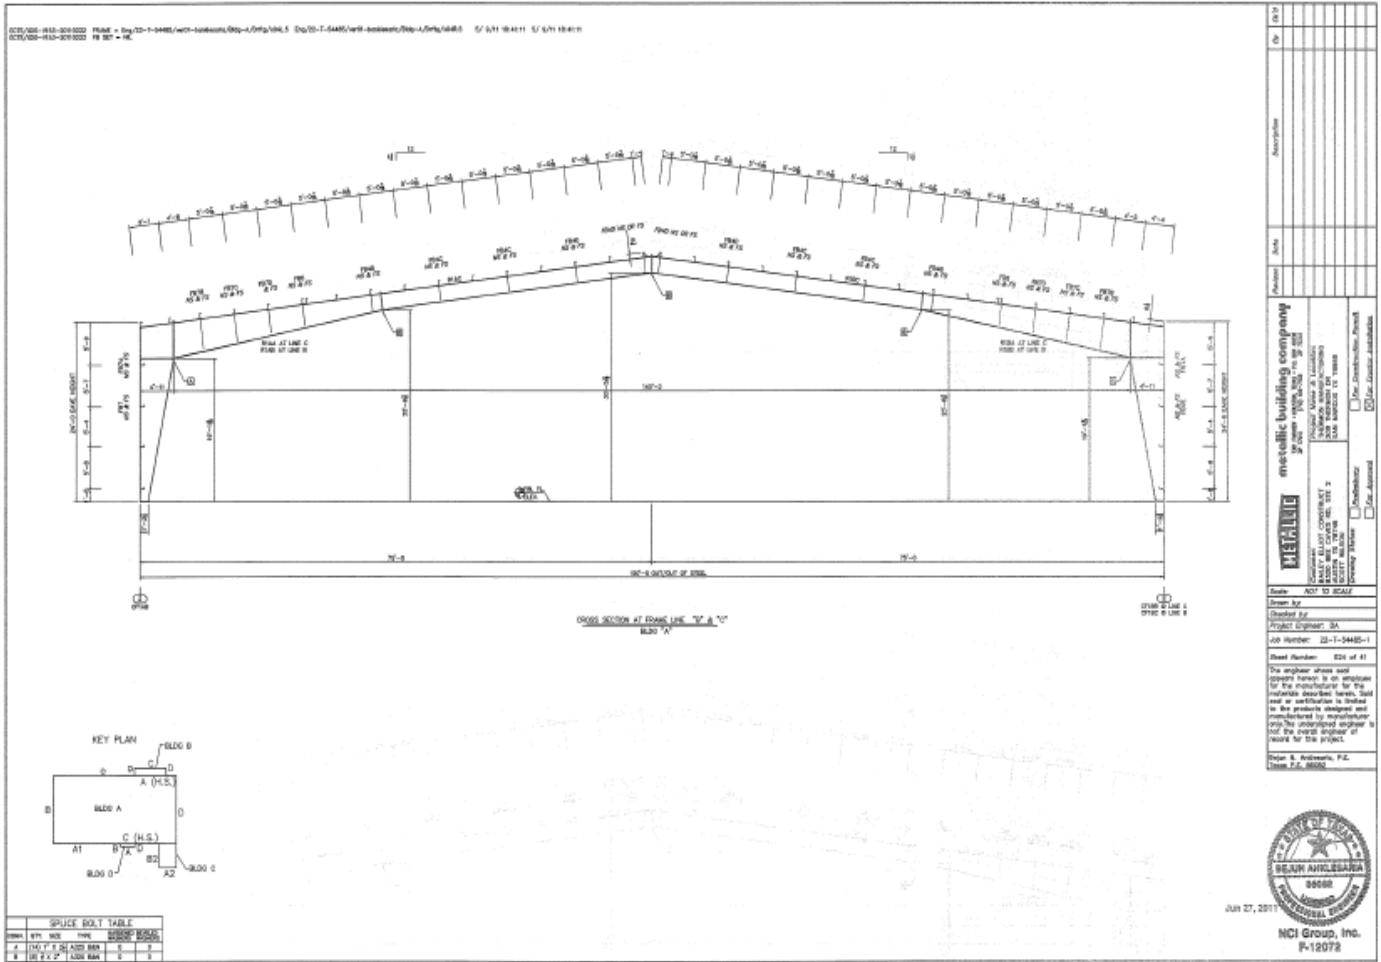
Fig. 3 Typical Primary Frame for Building A (see Ref. 1).

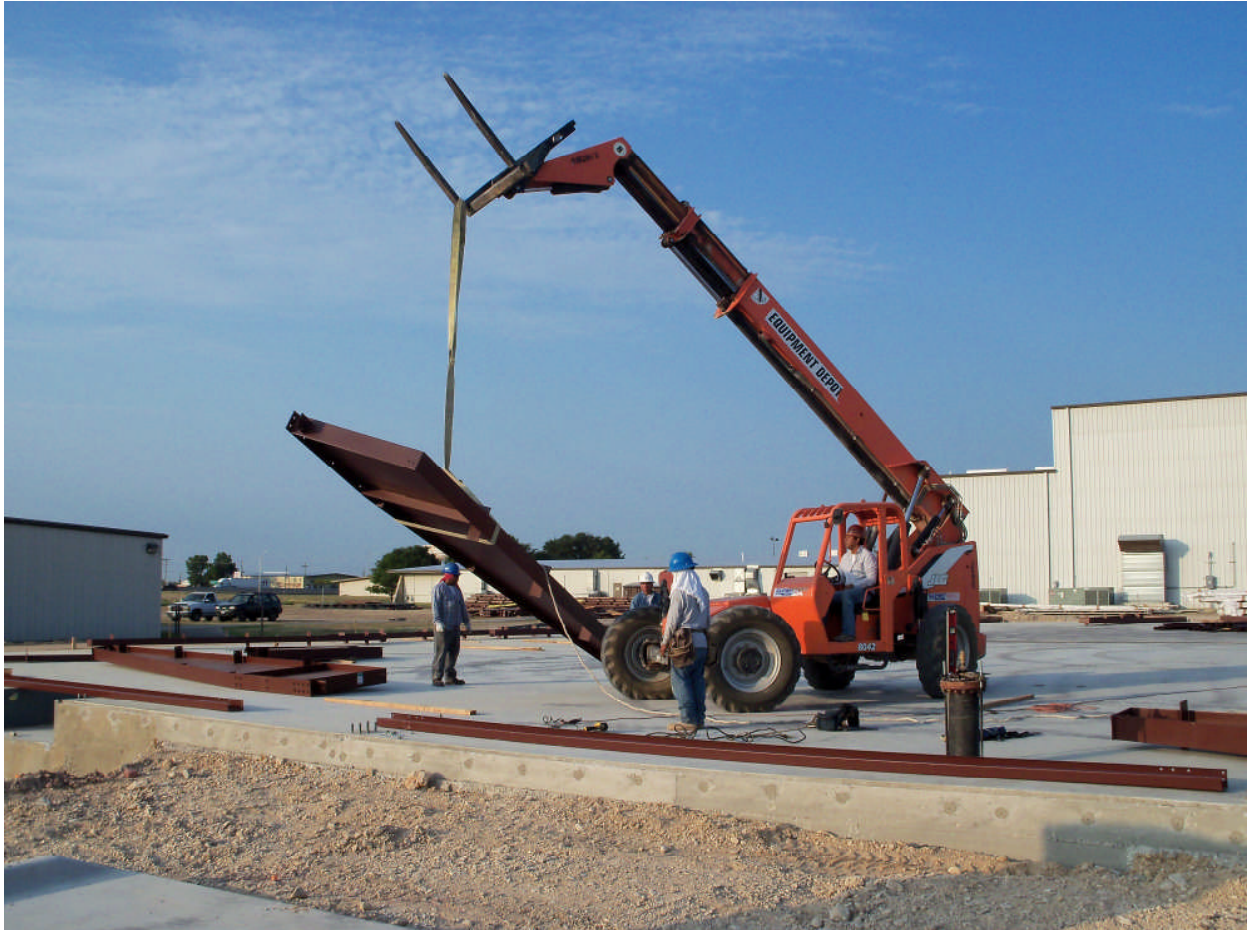
Fig. 5 Primary Frame Column being Hoisted to be Erected.

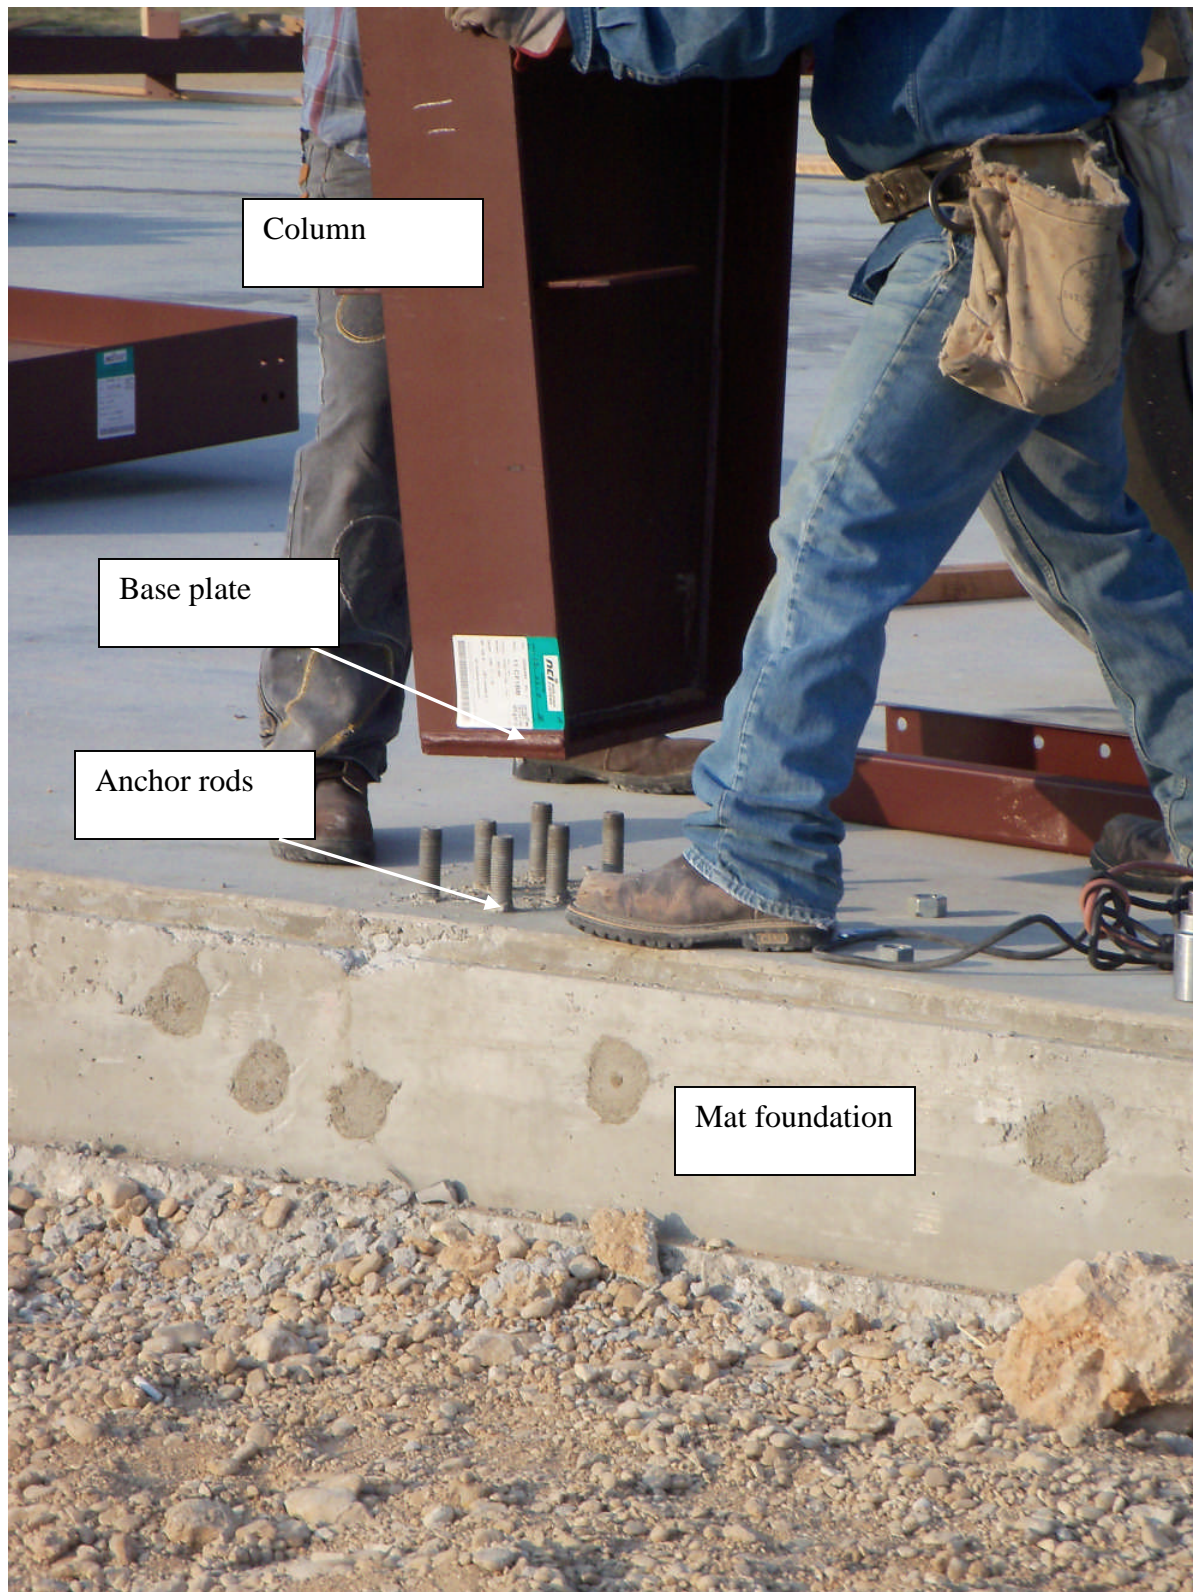
Fig. 6 Primary Frame Column being Erected.

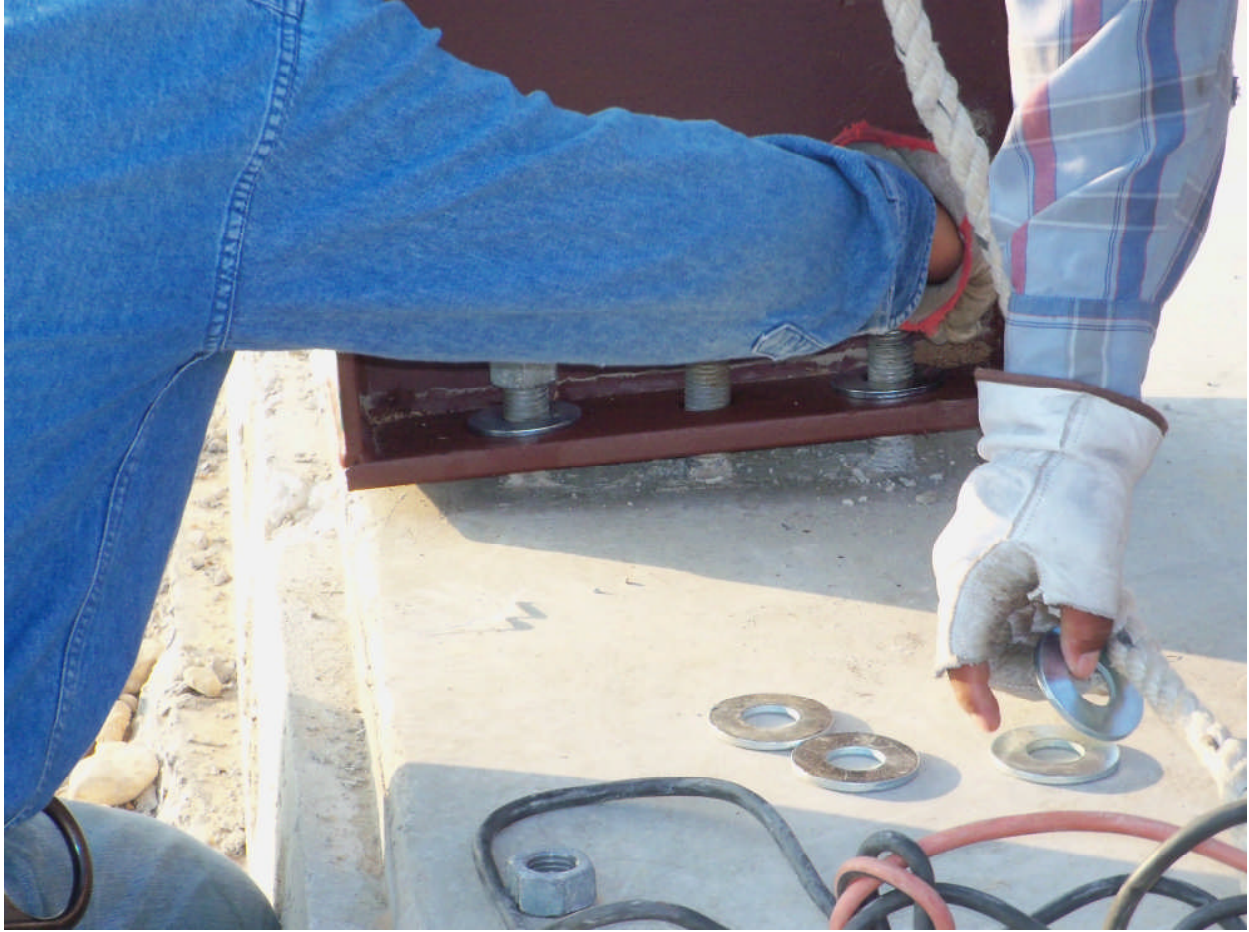
Fig. 7 Primary Frame Column being Bolted to the Foundation Slab.

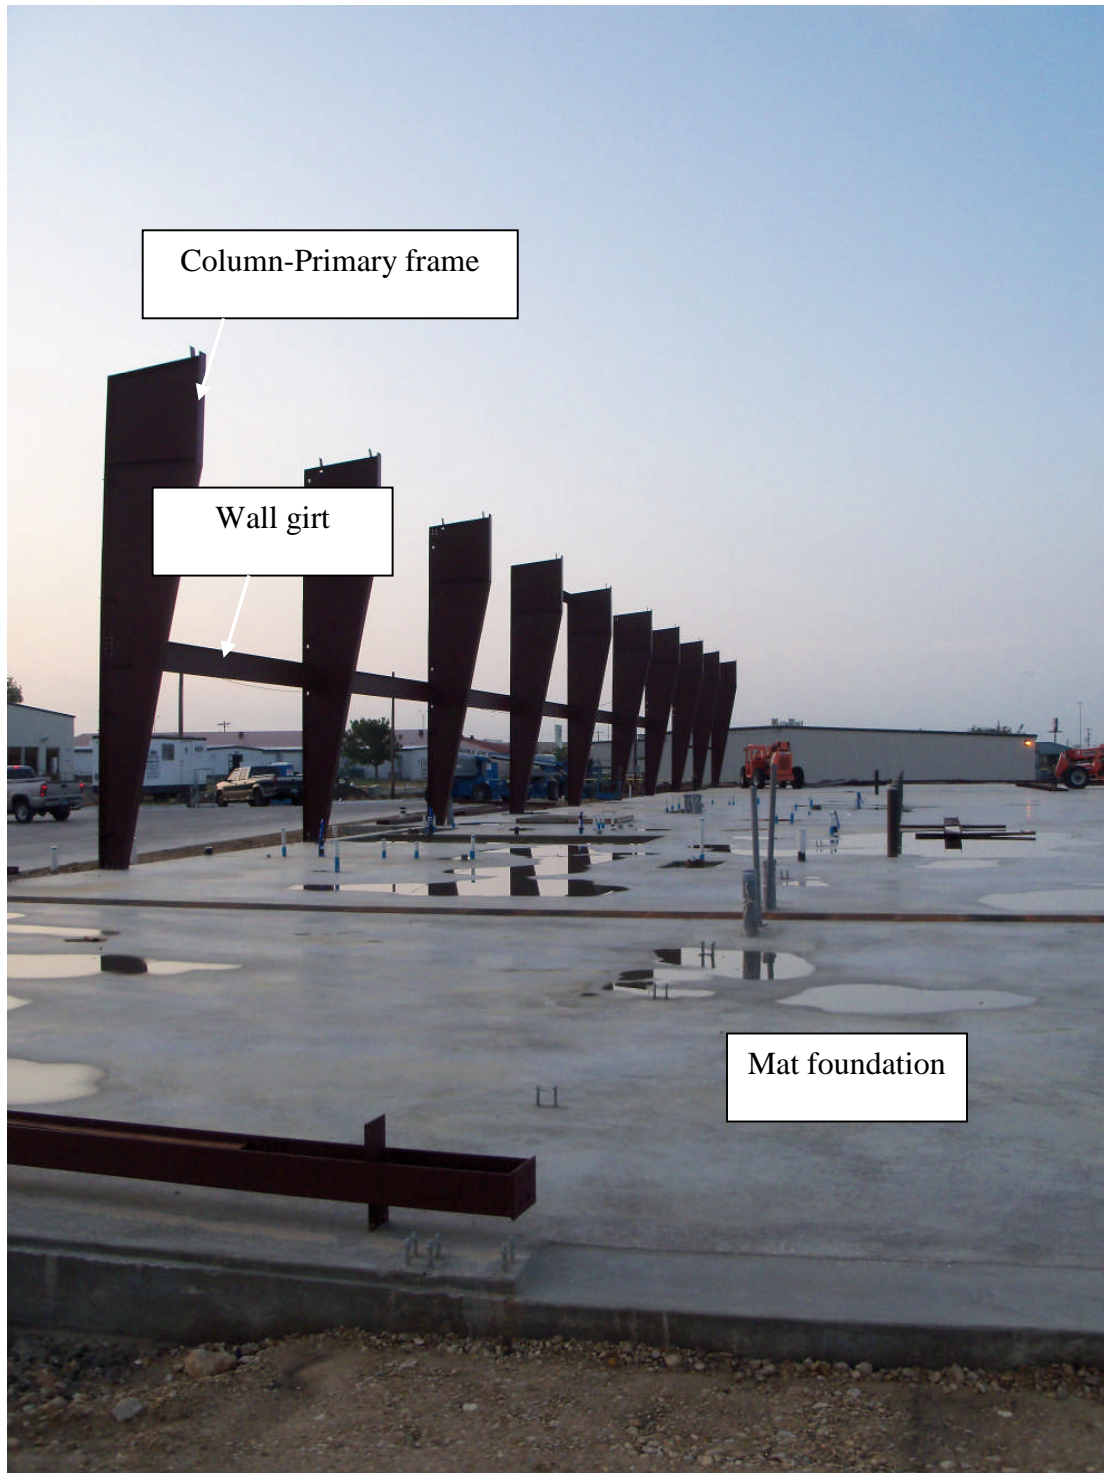
Fig. 8 Columns of the North Sidewall during the First Phase of the Erection of the Systems-engineered Metal Building.

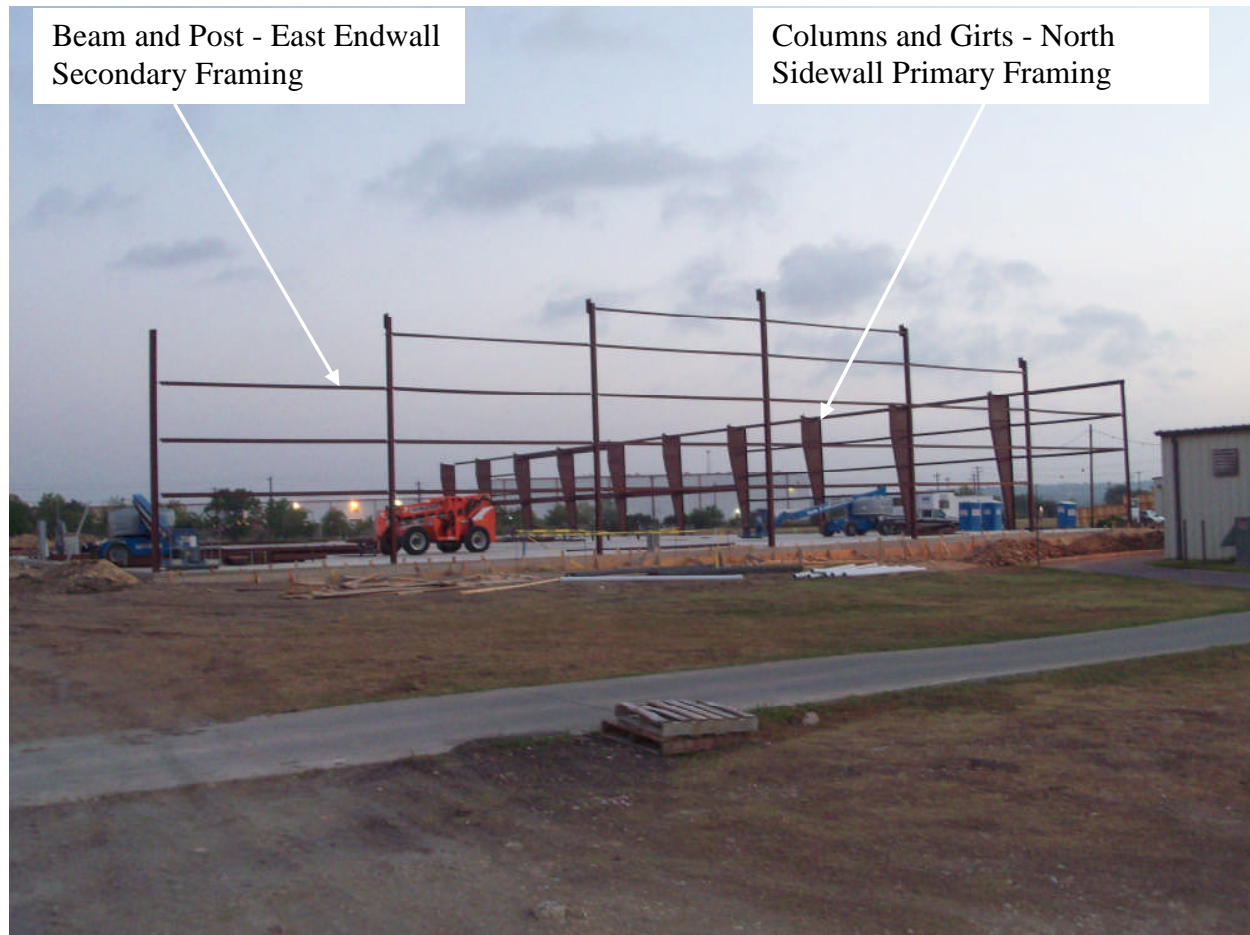
Fig. 9 North Sidewall and East Endwall Framings.

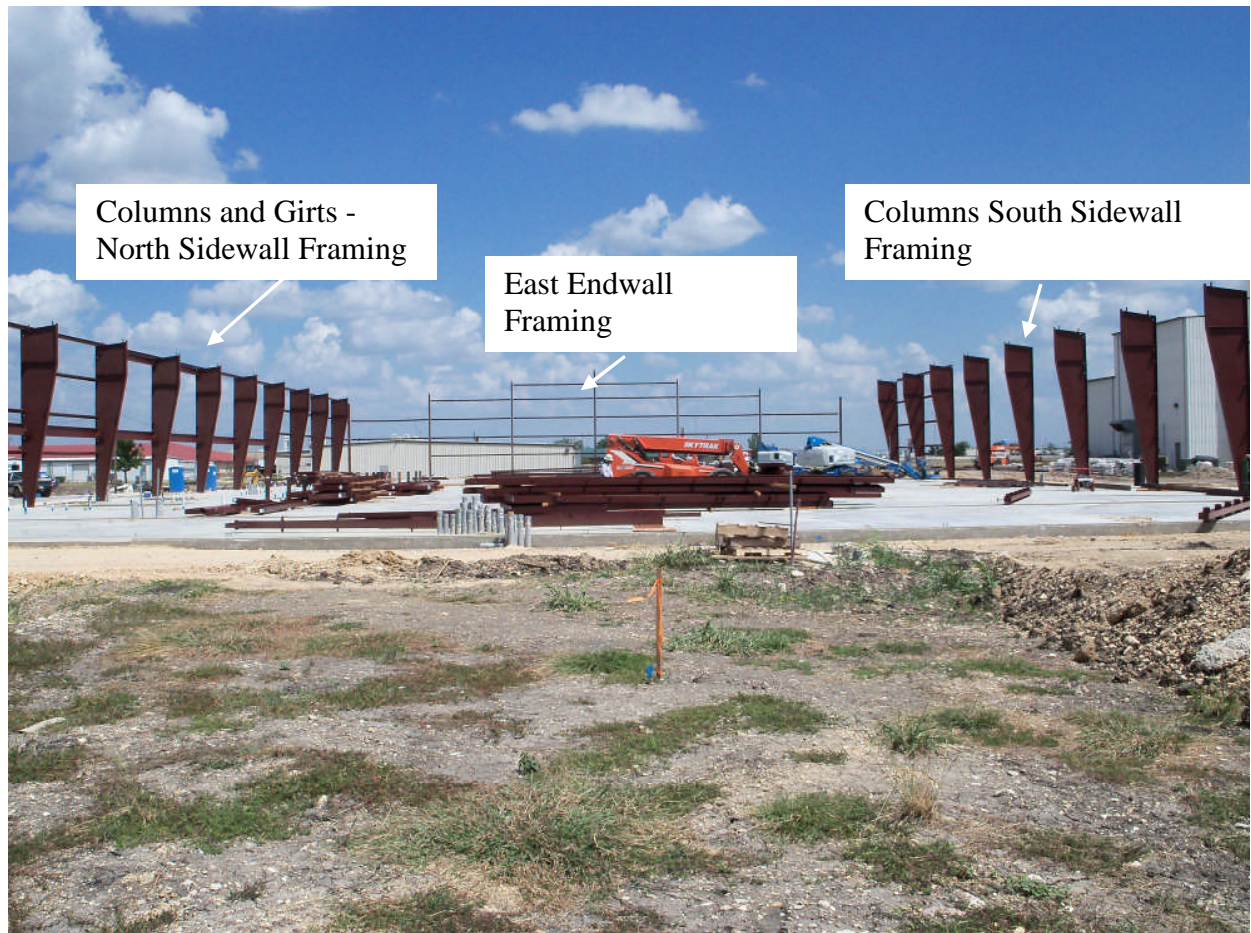
Fig. 10 Columns of North and South Sidewalls and East Endwall Framing.

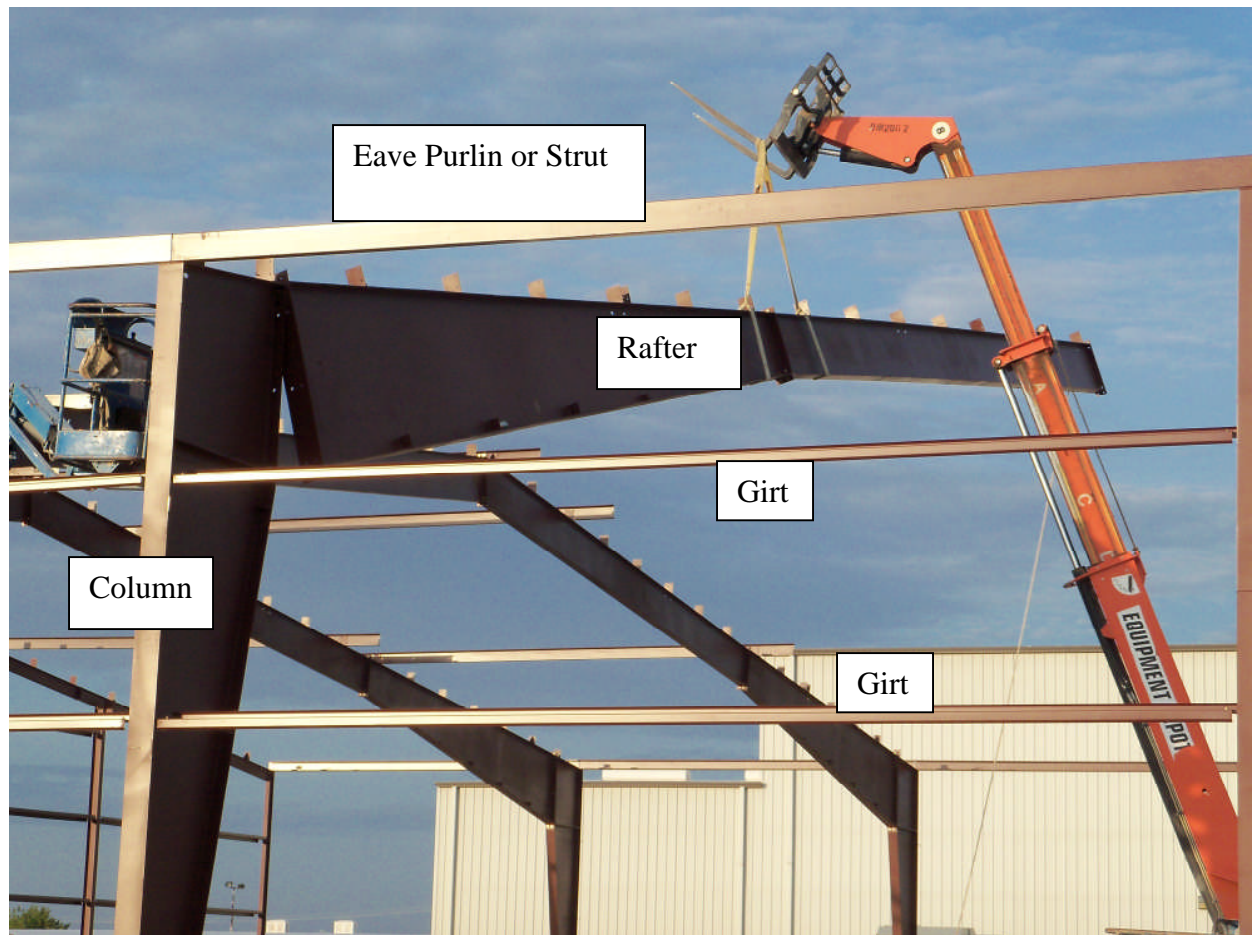
Fig. 11 Rafter being Connected to a Primary Frame Column.

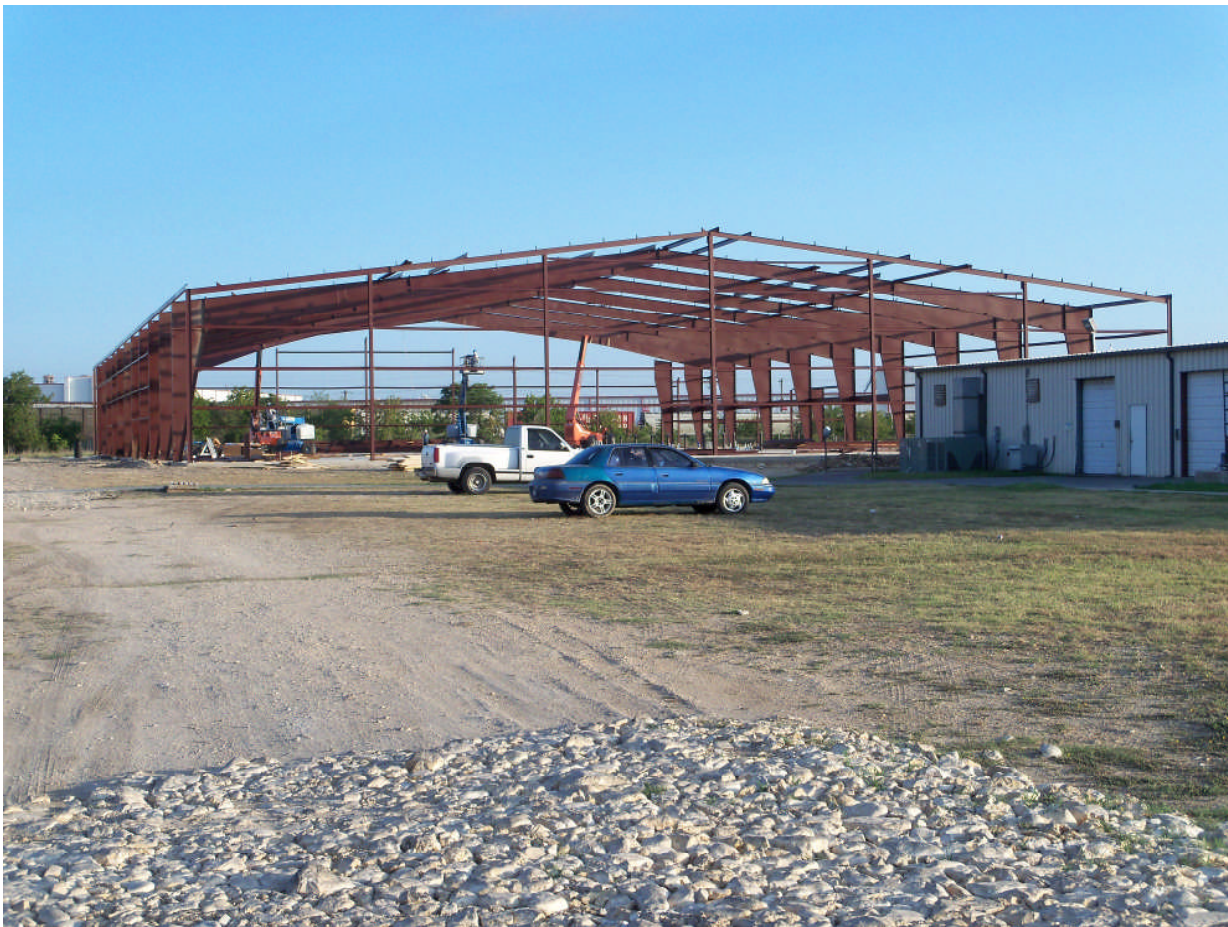
Cold formed Z-section sidewall girts at spacings of 5'-8", 5'-4", and 5'-7" were specified in the manufacturer's construction drawings (see Ref. 1). Some but not all of the sidewall girts were installed prior to the collapse of the building (Fig. 12).

The construction drawings showed for Building A four  $\frac{1}{2}$ " diameter x-braces for the north sidewall (see drawing E9 in Ref. 1), four  $\frac{3}{8}$ " diameter x-braces for the south sidewall (see drawing E10 in Ref. 1), one  $\frac{1}{4}$ " diameter x-brace for the east endwall (see drawing E12 in Ref. 1), and one  $\frac{1}{4}$ " diameter x-brace for the west endwall (see drawing E13 in Ref. 1). The drawings indicated for Building B one  $\frac{1}{4}$ " diameter x-brace for the south sidewall (see drawing E15 in Ref. 1) and for building C one  $\frac{1}{4}$ " diameter x-brace for the north sidewall (see drawing E11 in Ref. 1). These permanent braces were provided by the manufacturer to resist lateral loads. None of these braces was installed prior to the collapse of the building (see Fig. 12).

The roof of the systems-engineered metal building had a low-profile slope of  $1\frac{1}{2}$  -to-12. The manufacturer's drawing indicated  $\frac{1}{4}$ ",  $\frac{5}{16}$ ", &  $\frac{3}{8}$ " diameter x-bracings between the roof framing lines D & E and K & L (see sheet number E5 in Ref. 1). Cold-formed Z-section purlins at a spacing of 5' were specified to support the roof panels. None of the x-braces indicated in the roof framing plan was installed and not all purlins were put in place prior to the collapse of the building (see Fig. 12).

Fig. 12 The Systems-engineered Metal Building before Collapse.

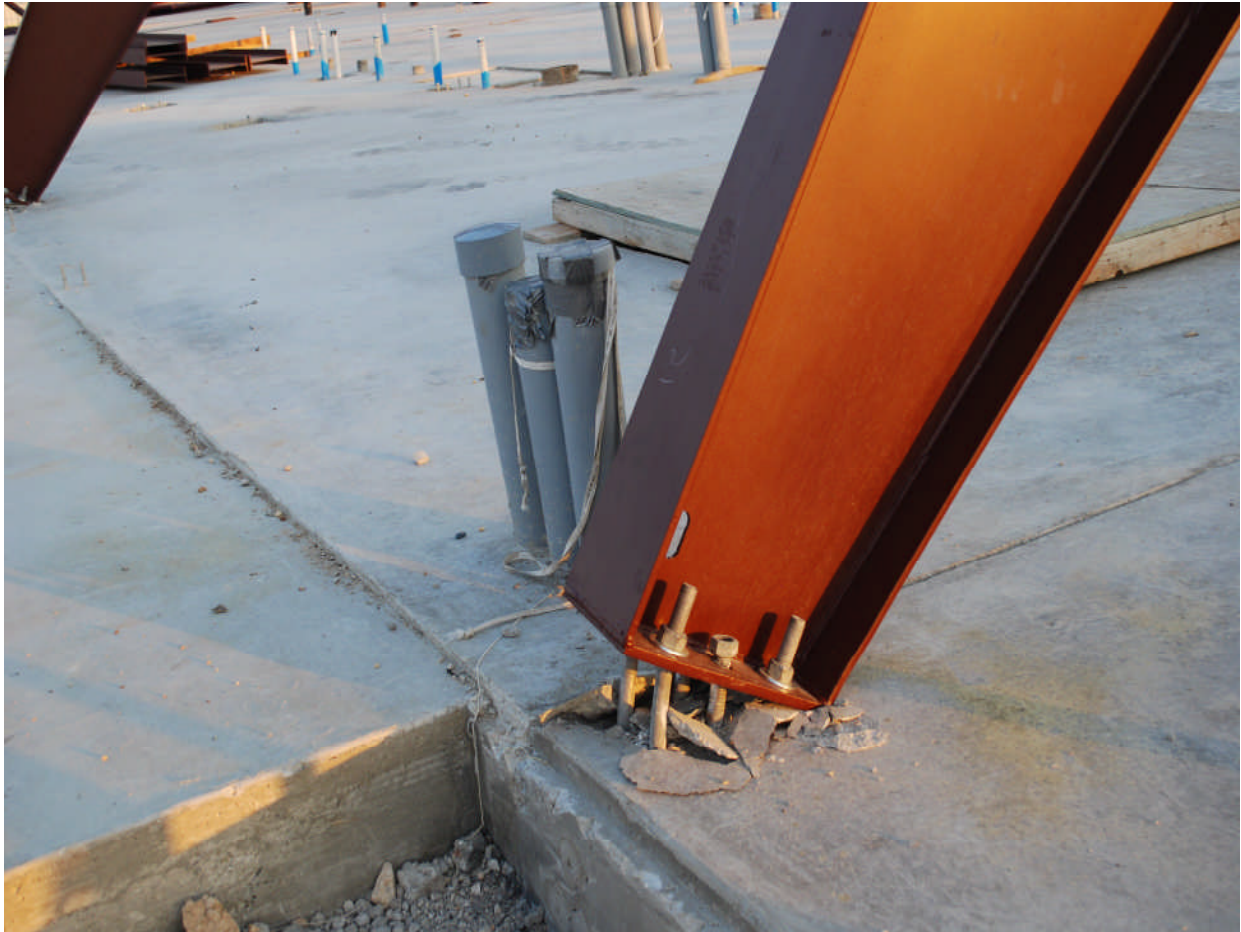
We observed during our site visit that the anchor rods of the north primary framing columns pulled out from the foundation with insignificant breakout of the portion of the surrounding

concrete (see Fig. 13). The anchor rods at the south primary frame columns were observed to be failed in tension. Fig. 14 shows when a column was being cut to obtain samples that can be used for testing the plates and fillet weld connections. The anchor pullout mode of failure in the north primary frame columns was believed to be caused by the lateral torsional buckling of the rafters that had no flange braces followed by the failure of the south primary frame columns at their base (see Figs. 15-to-18).

Fig. 13 North Sidewall Column Anchor Pullout Failure.

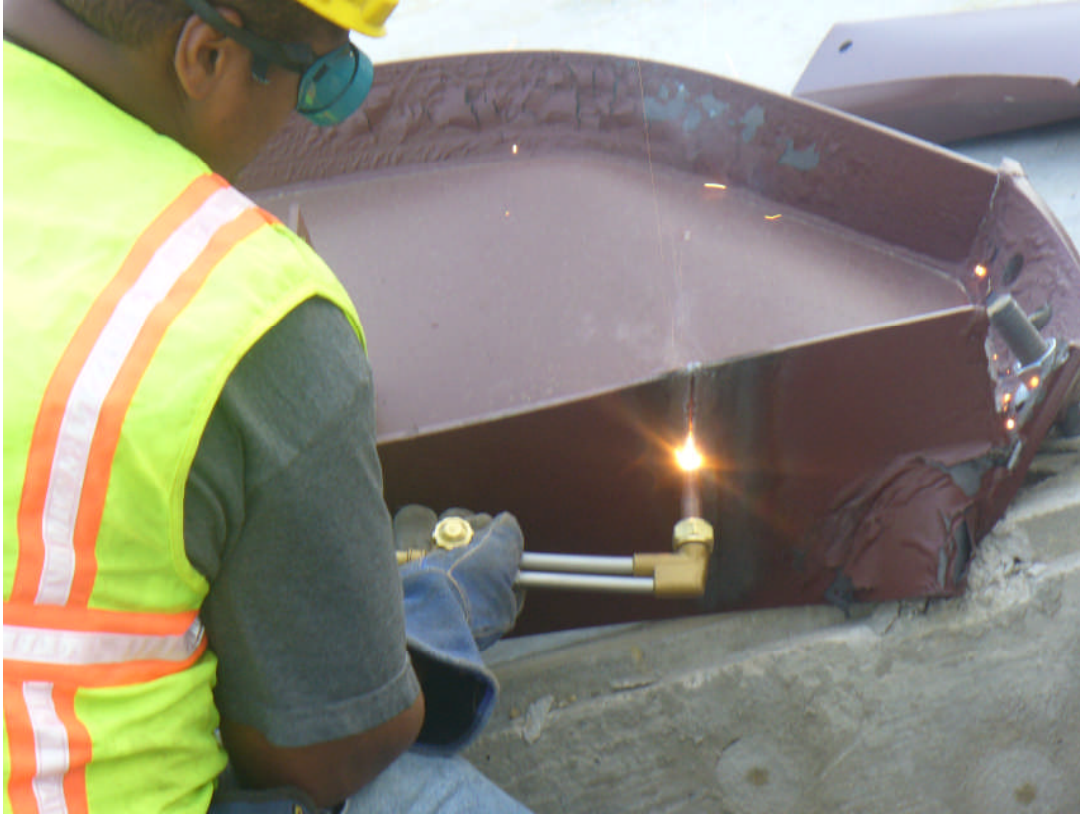
Fig. 14 Primary Frame Column being Cut for Testing.

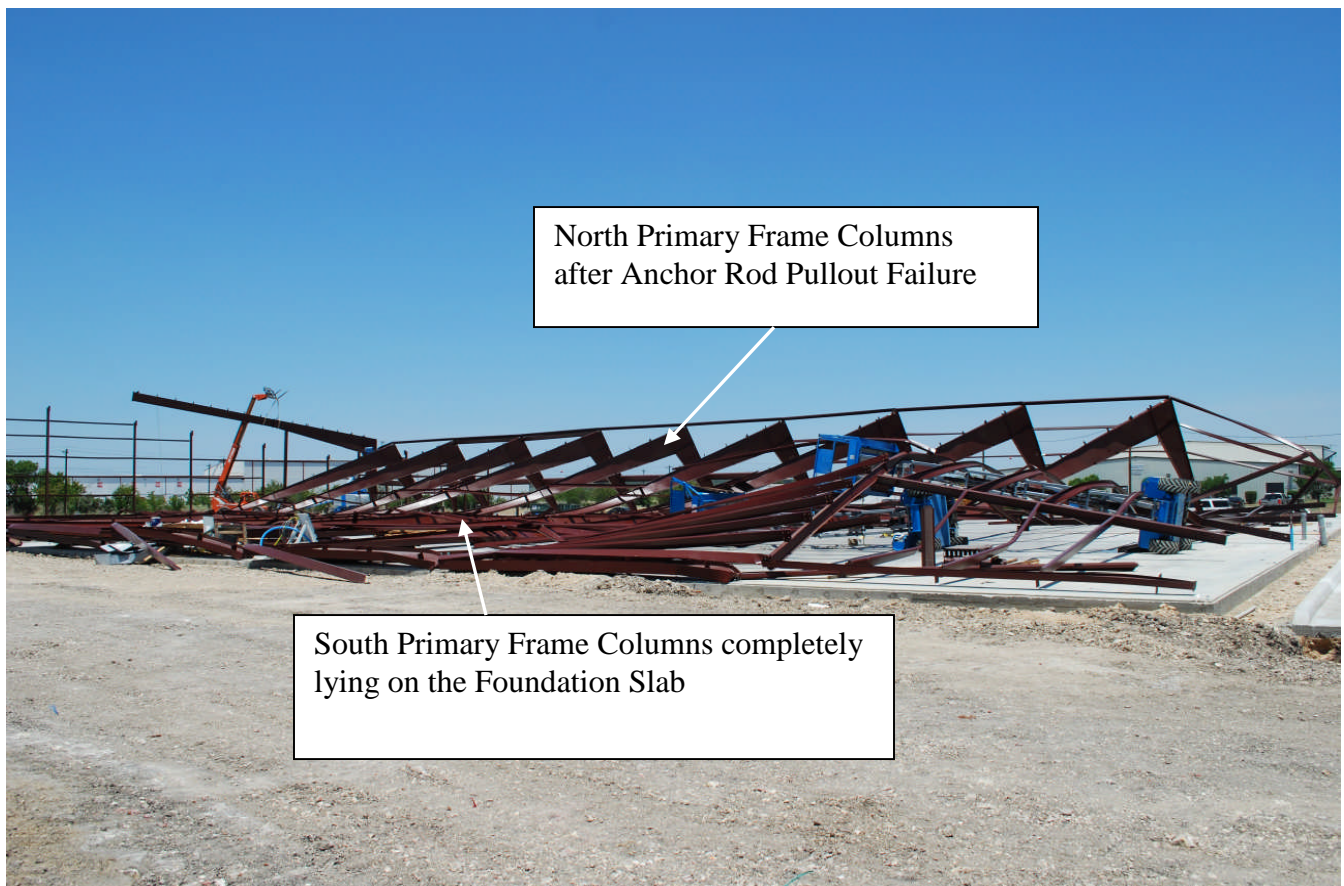
Fig. 15 The Systems-engineered Metal Building after Collapse.

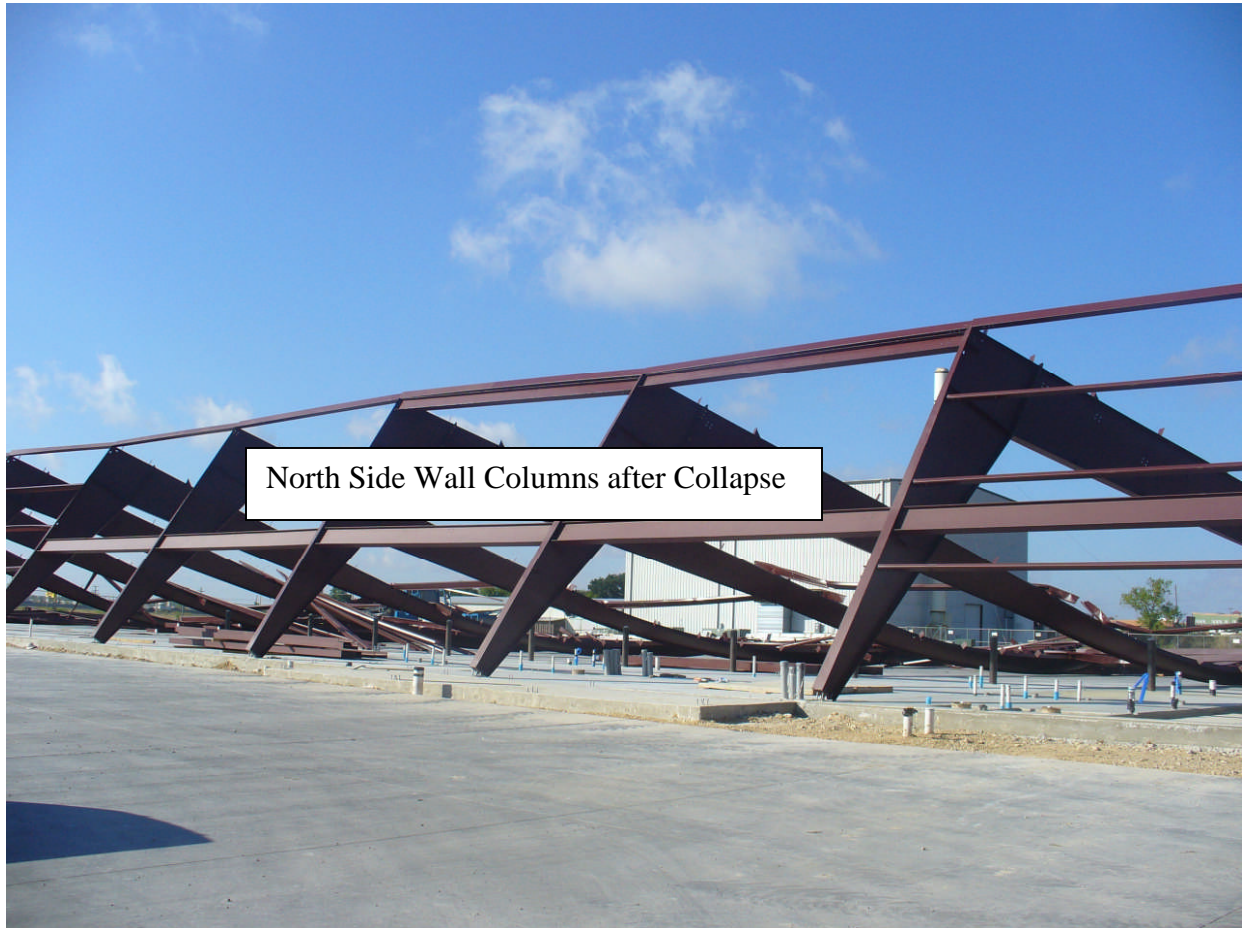
Fig. 16 North Sidewall Columns Anchor Pullout Failure.

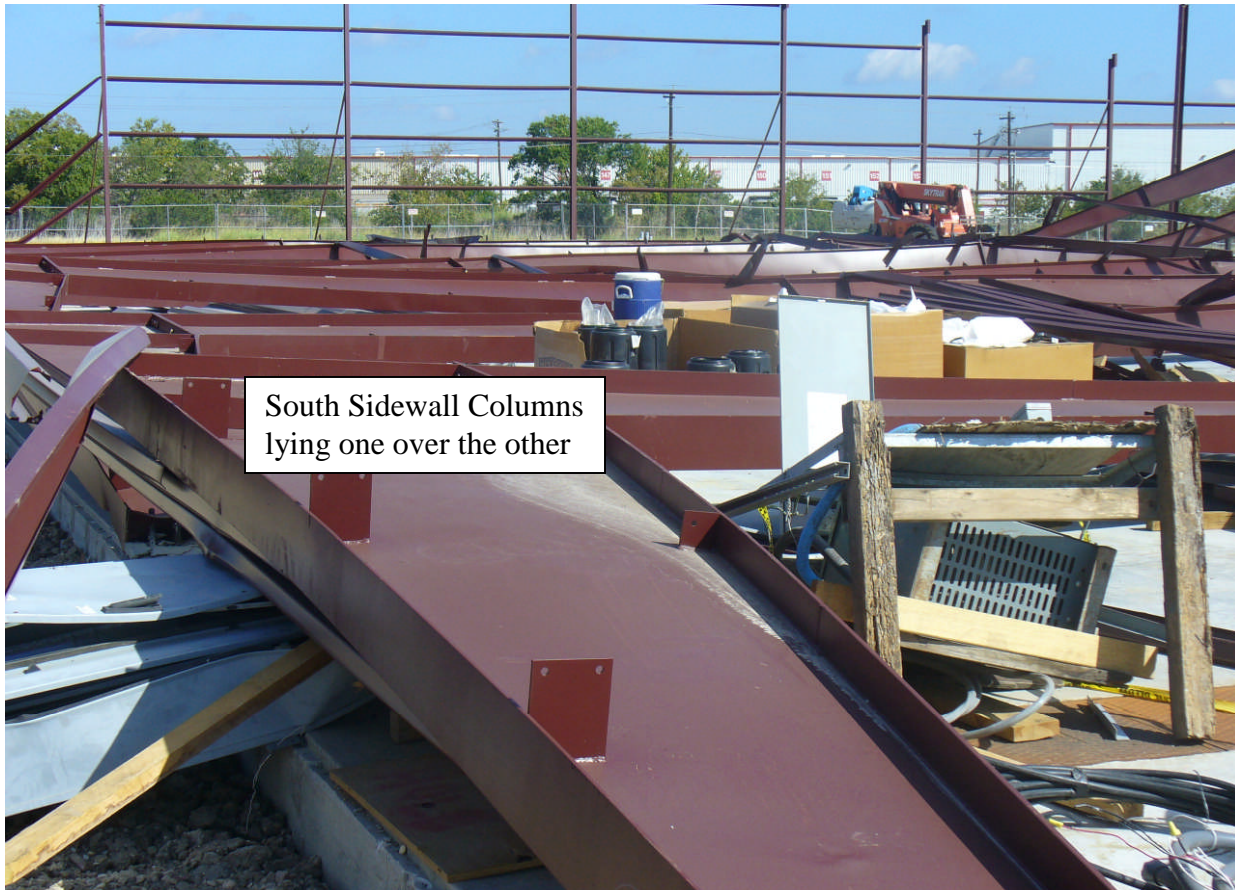
South Sidewall Columns  
lying one over the other

Fig. 17 South Sidewall Columns after Collapse.

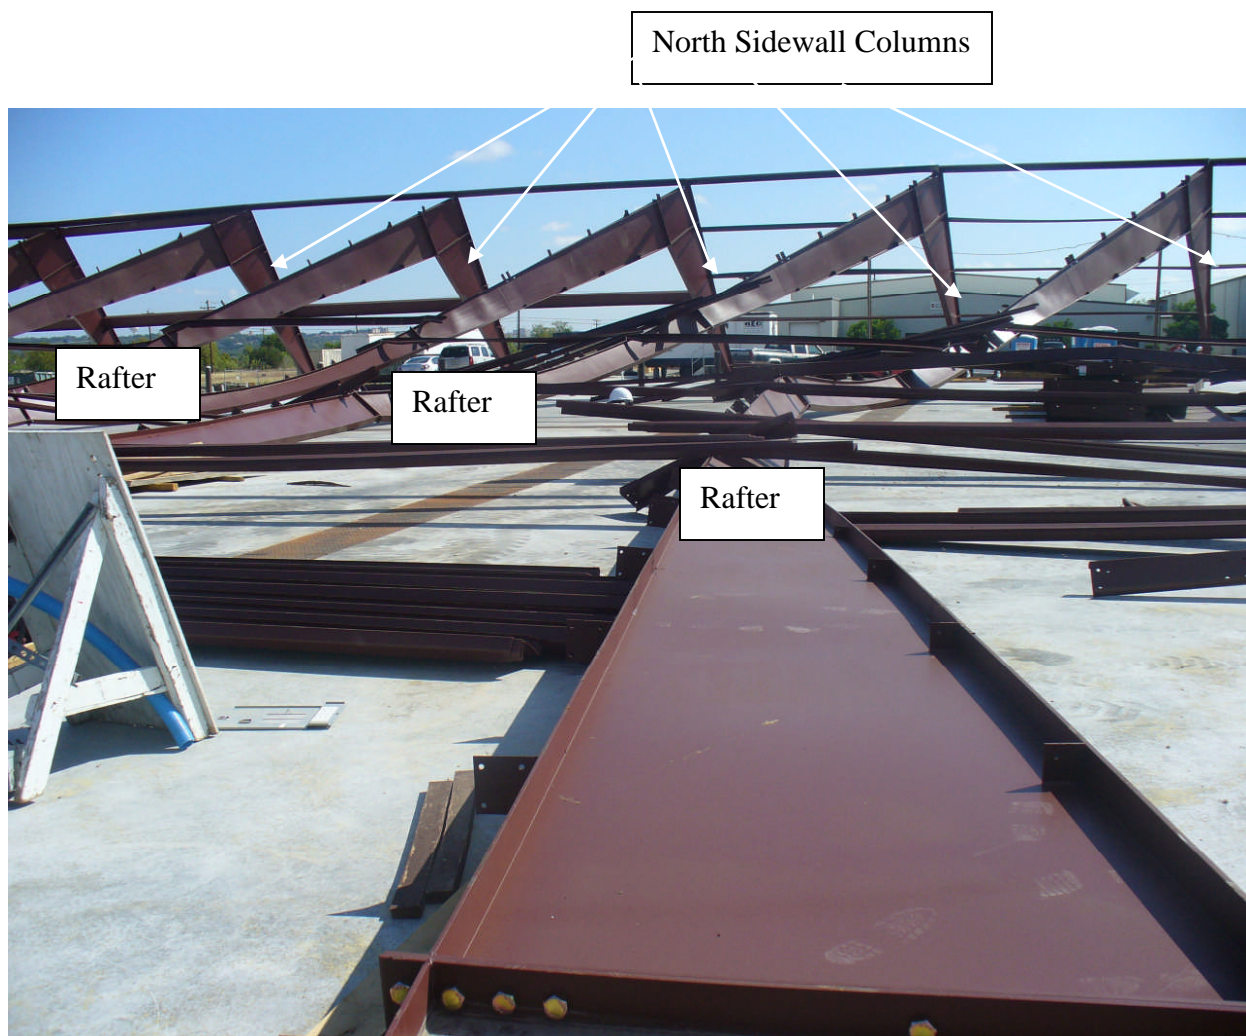
Fig. 18 North Sidewall Columns and rafters after Collapse.

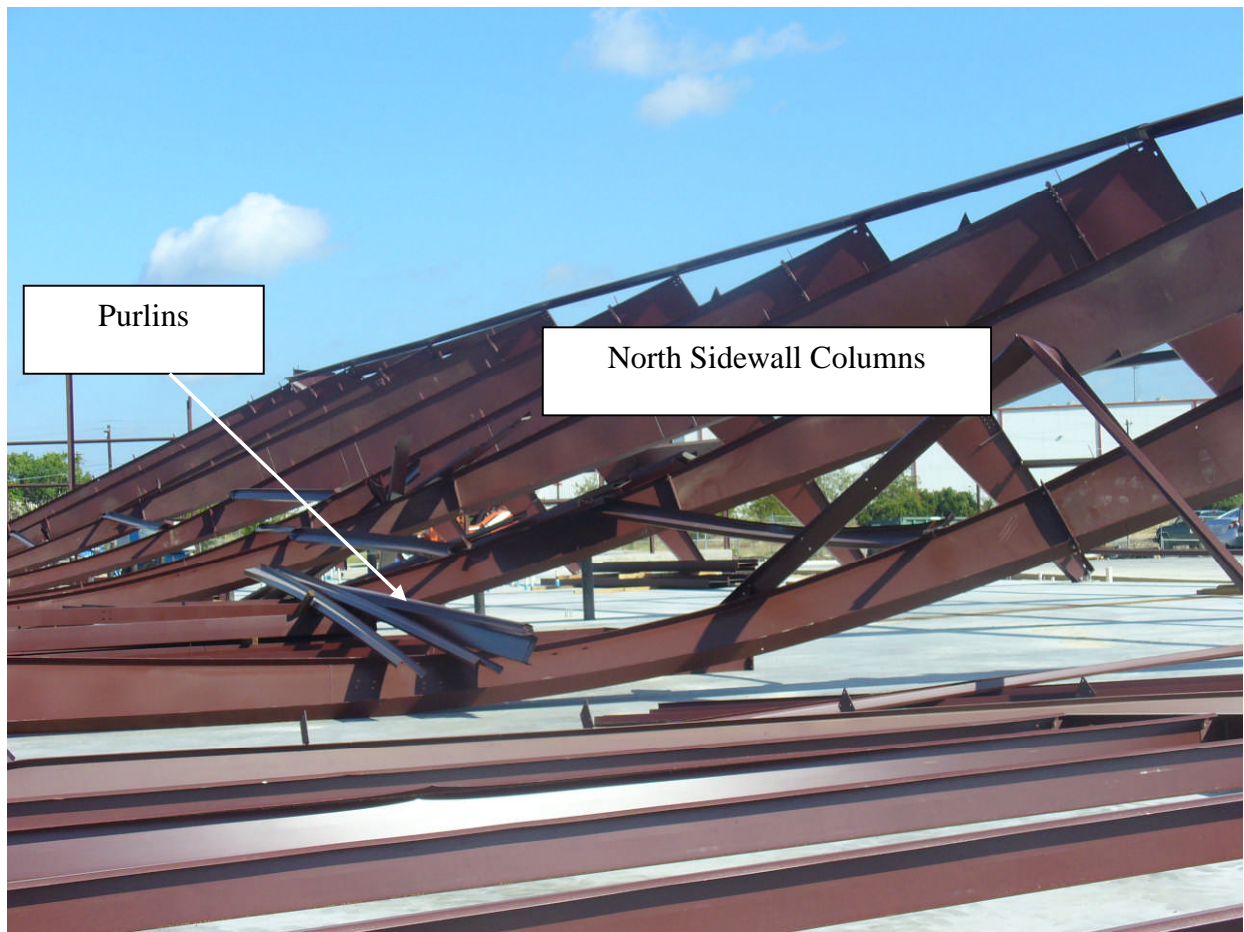
Fig. 19 Unfastened or Unsecured Purlins Lying on the Rafters.
