Occupational Safety & Health Administration

SAFETY
H and
I HEALTH
P INJURY
S PREVENTION
SHEETS

Working with the Shipyard Industry

SHIPFITTING

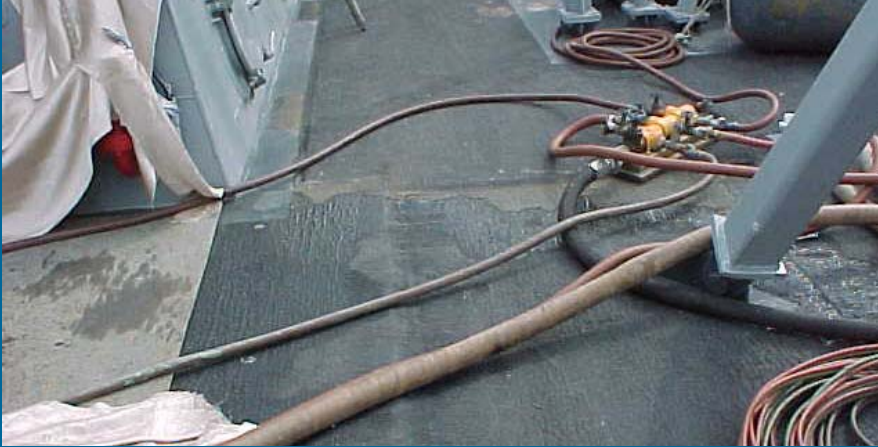
Service lines, hoses and leads on deck that cross over walkways present potential tripping hazards.

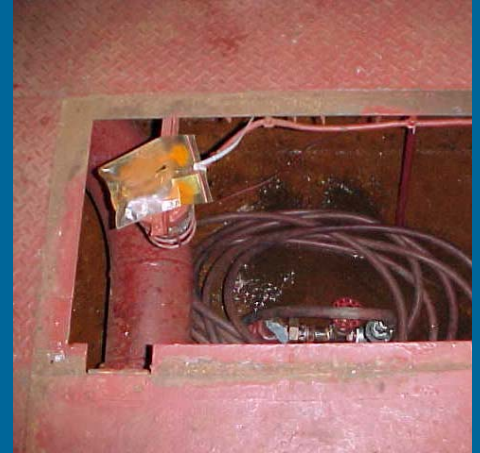
Missing plates or grating may cause injury to shipfitters, particularly if they are carrying equipment, tools, or other material that prevents them from seeing the hazard.

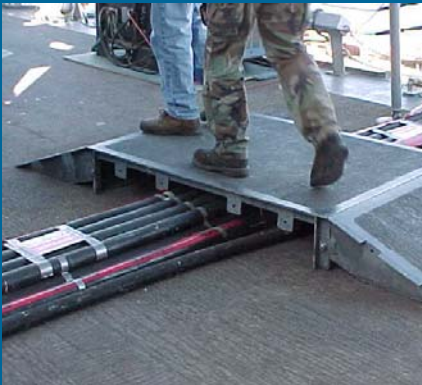
Option 1

Neatly arranging the lines, hoses and leads, and using ramps as crossovers, will help eliminate tripping hazards and lessen the possibility of damage to service lines.

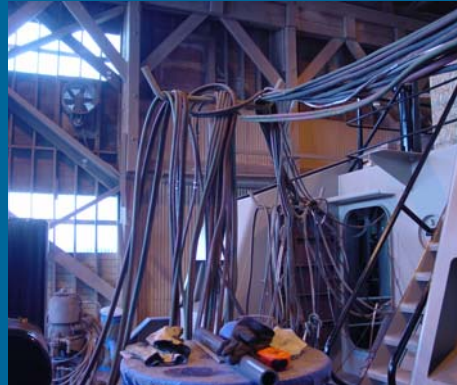
Option 2

Using brackets made of pipe, often referred to as "trees," is another method for keeping lines, hoses and leads off the deck. Below decks, hangers may be used to keep passageways free of trip and fall hazards.

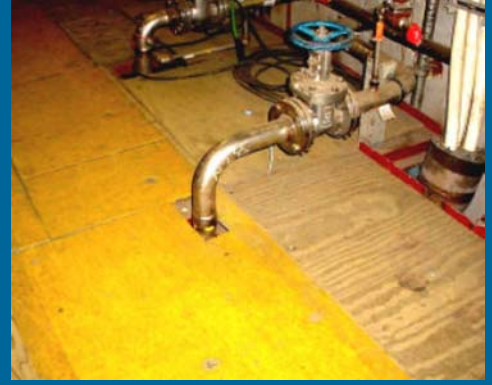
Replacing grating when leaving the work area or covering deck openings with temporary covers (as shown here) are good methods for preventing injury.

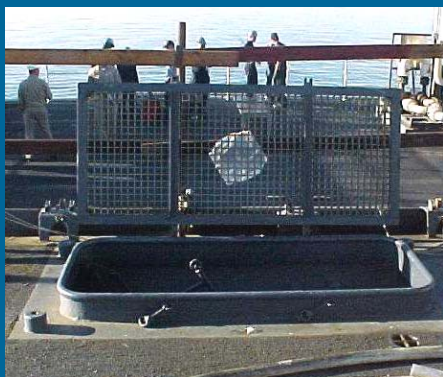
Deck openings or penetrations create fall hazards if not properly guarded.

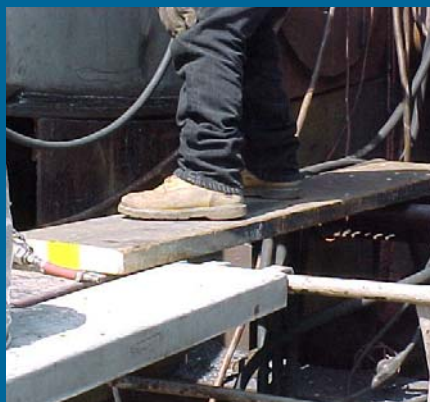
Horse staging is frequently used to access areas where work is to be done. While fall protection such as back rails is not required unless the staging is above five feet, working from a single plank is not a safe or acceptable practice. A fall of just a few feet can result in serious injury.

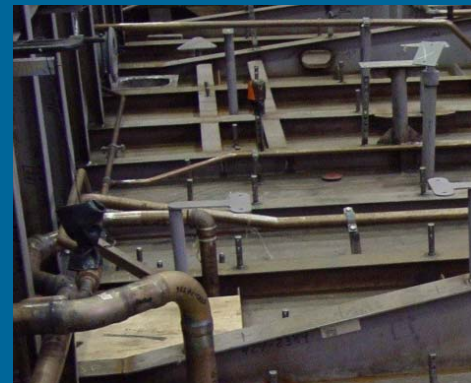
During ship construction or refitting, trip hazards may be unavoidable and may pose the potential for impalement.

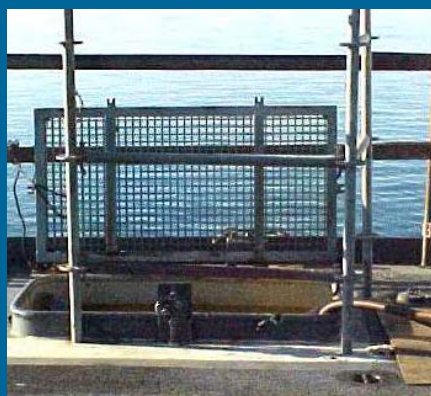
Pipe guardrails can be quickly erected to provide adequate fall protection. Make sure that the materials to provide fall protection are readily available on hand prior to removing the cover or to making an access cut. This will eliminate the need for the shipfitter to leave the unguarded opening unattended while obtaining the necessary materials for fall protection.

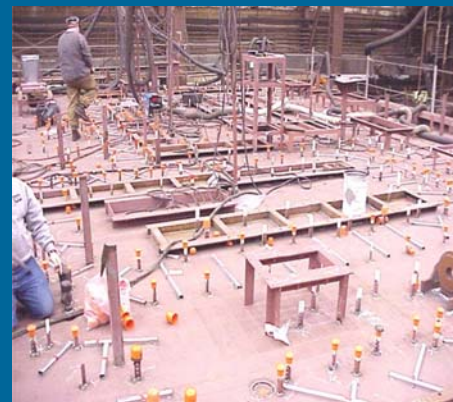
Studs and pipe caps (as seen here) can prevent trip or fall hazards from resulting in impalement.

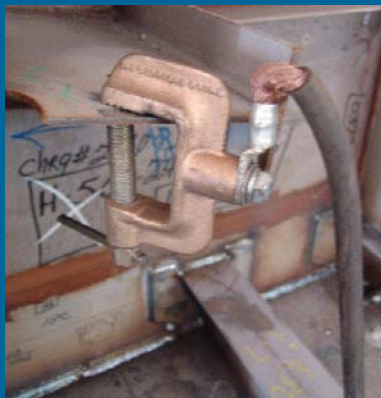
Paint build-up or corrosion can create a poor grounding condition when using welding equipment.

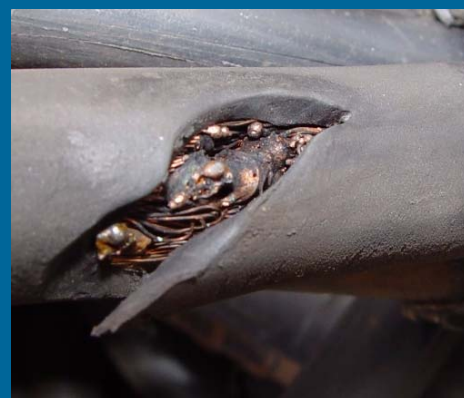
Sharp edges in the shipbuilding and ship repair workplace can easily damage cable insulation. Cable exposed by the missing insulation can create a potential for injury.

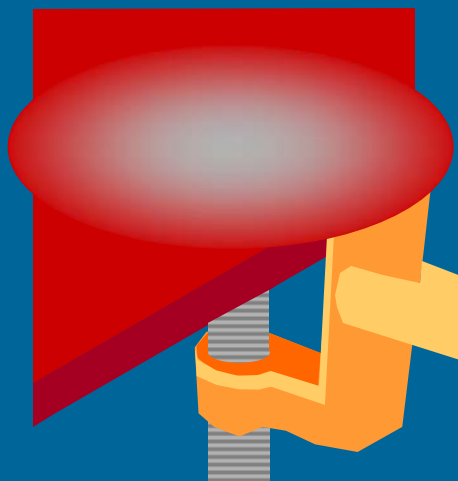
In welding operations, one of the cornerstones of shock prevention is creating a good electrical ground when using welding equipment. Removing paint build-up or corrosion from the contact area with wire brushing or a grinder will ensure successful grounding.

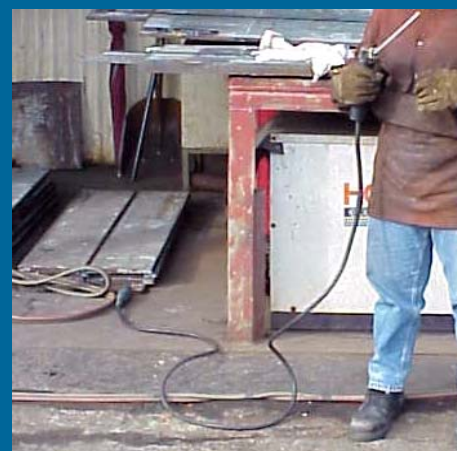
All welding cables must be completely insulated and capable of handling the maximum current requirements of the job. Before starting a welding job, a shipfitter needs to make a quick visual check of the entire cable to identify potential shock risks.

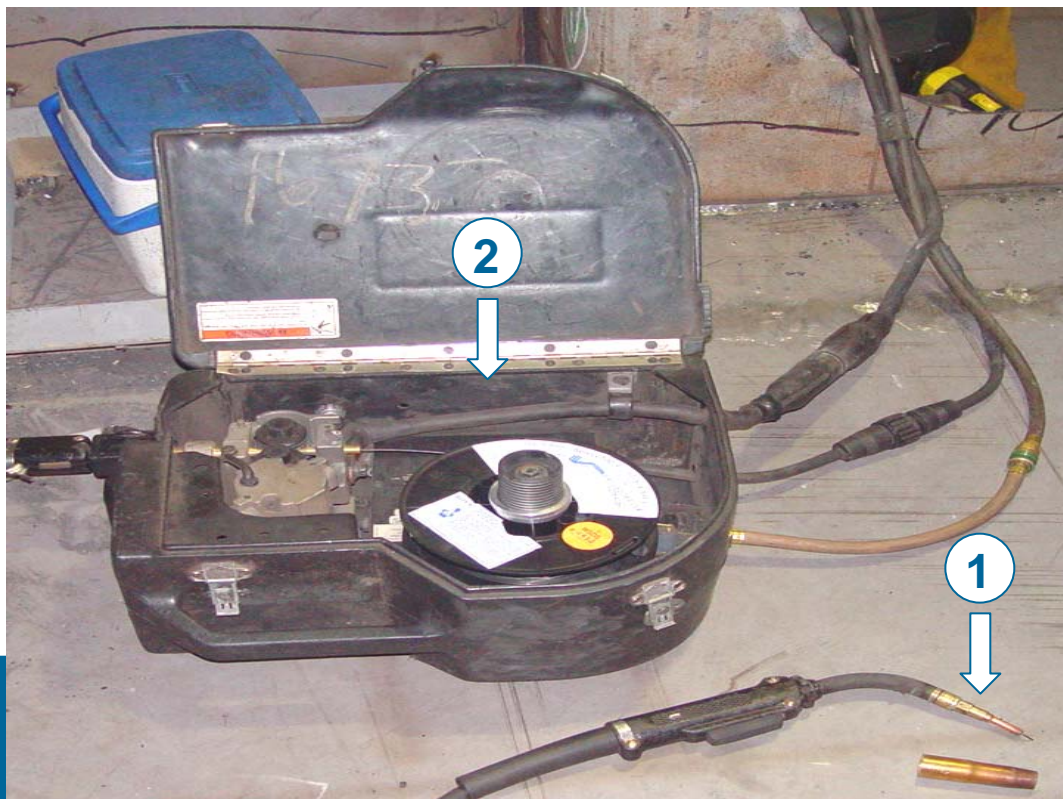
A shipfitter was setting up his welding equipment. As he installed the whip to the feeder, one hand came in contact with the metal end or nozzle of the whip (1) his other hand grasped the wire from the feeder (2). This completed the 80-volt electrical circuit which allowed the 80 volts of electricity to run across his chest.

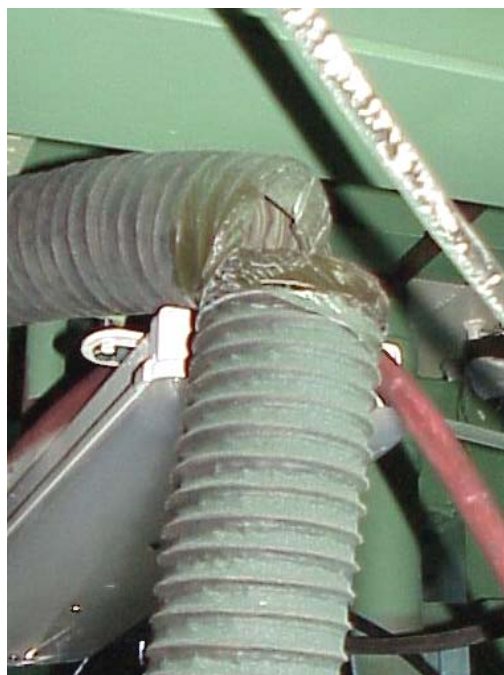
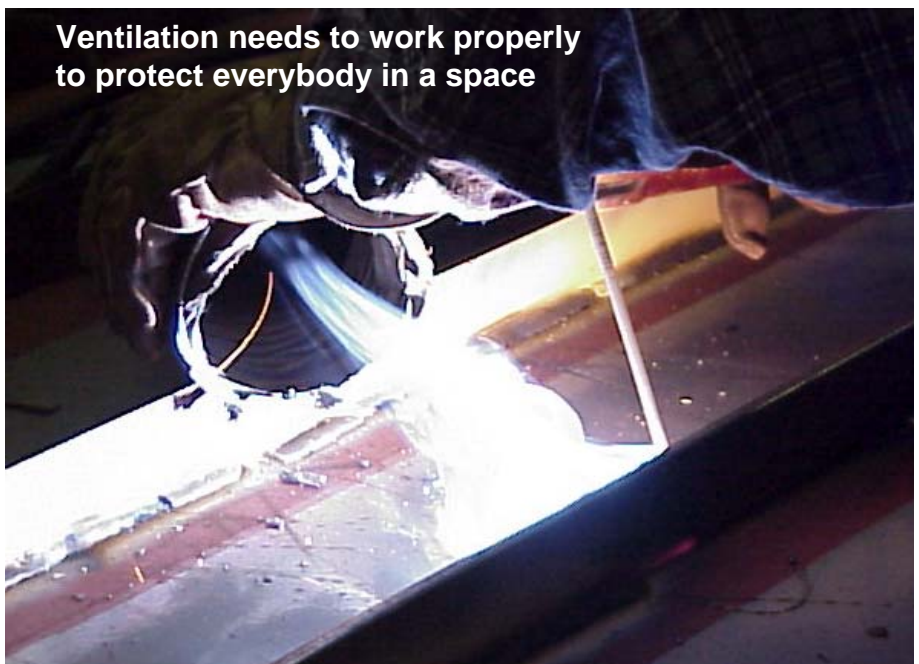
Following the ventilation tube back through the ship, it was discovered that a splice in the vent tube had failed. As a result, there was not adequate ventilation in the confined space where the employee was working. The shipfitter should inspect the vent before and during work to ensure proper air flow.

Ventilation needs to work properly to protect everybody in a space

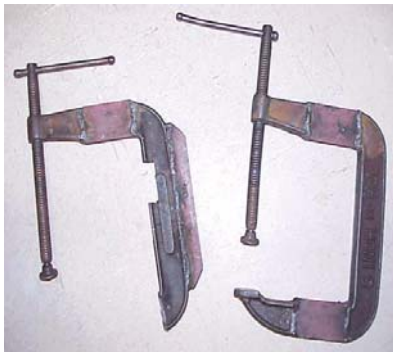
The C-clamps shown at right were modified with good intentions, but actually created a hazard.

In the top photo, the clamp on the left failed under load, causing the metal being clamped to suddenly be released.

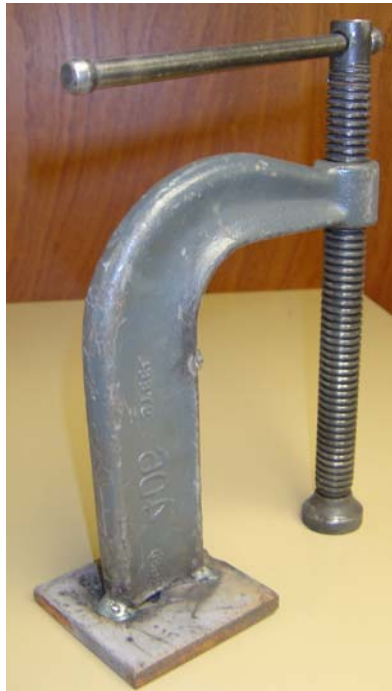
The clamp shown in the bottom photo was identified and removed from the worksite before it could be used. Later examination indicated that it would have failed under the intended load.

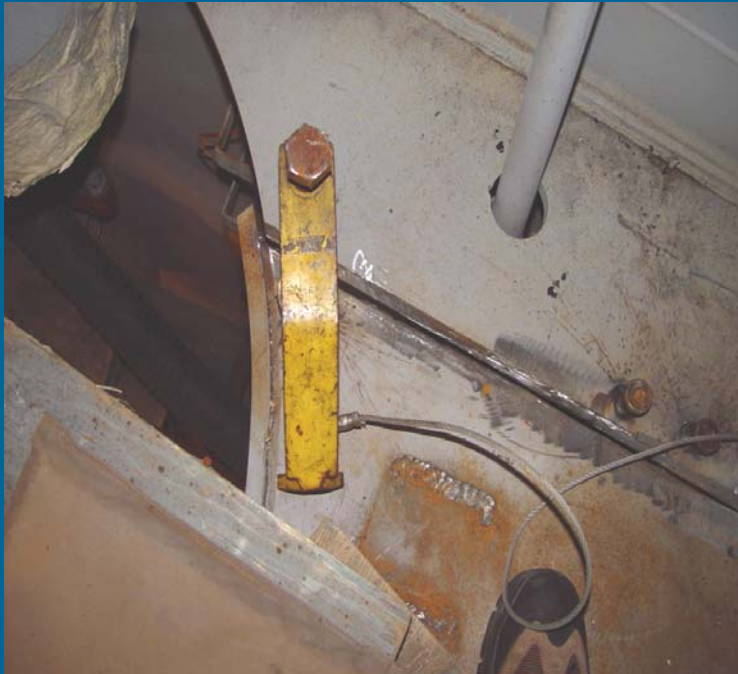
A shipfitter was fairing the deck with fishtails at the time of the accident. He was using an air ratchet to tighten the fourth fishtail when the stud holding the first fishtail broke free. The bolt from the fishtail struck him high on the left side of his forehead causing a serious head injury. At the time of the accident, the shipfitter was not wearing his hard hat.

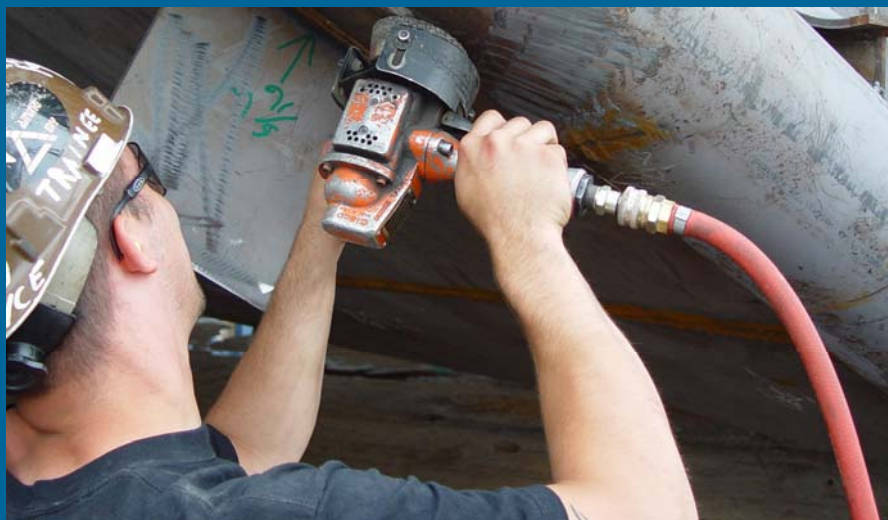
Wearing standard safety eyewear, even if it has side shield protection, may not be enough to prevent foreign bodies from getting embedded in the eyes during operations such as grinding. High-speed grinding operations can produce fast-moving particles that can fly under or over the safety glass frames and get into employees' eyes.

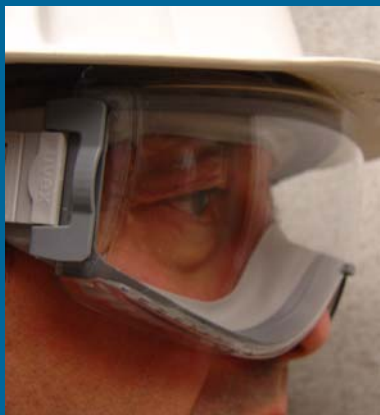
Option 1

Safety goggles with a seal can provide more complete protection against grinding dust getting into employees' eyes if safety glasses with side vents are not sufficient. Goggles have ventilation and/or special lenses to prevent fogging.

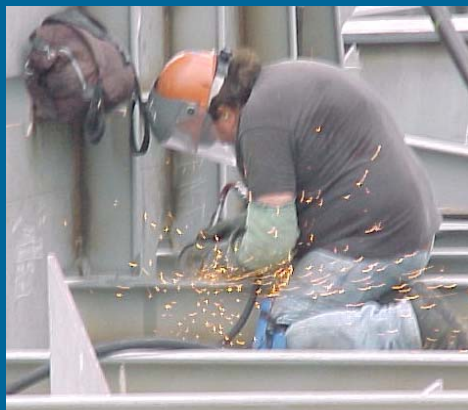
Option 2

Wearing a safety face shield that covers the entire face or wearing a face shield over safety glasses are options that may provide necessary additional protection from grinding dust, especially if the dust is dropping from above. If respiratory protection is required, a full-face respirator provides the needed level of protection against both grinding dust and respiratory hazards.

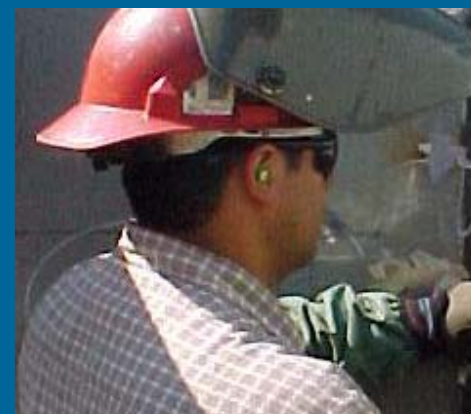
Safety glasses under the welding hood are necessary to provide protection from flying particles that may be generated by adjacent operations. This is a safety requirement in most shipyards.
