# **INVESTIGATION OF THE OCTOBER 30, 2003, FATAL PARKING GARAGE COLLAPSE AT TROPICANA CASINO RESORT, ATLANTIC CITY, NJ**

U. S. Department of Labor  
Occupational Safety and Health Administration

April 2004

This report was prepared by  
Mohammad Ayub, P.E., S.E.  
Office of Engineering Services  
Directorate of Construction

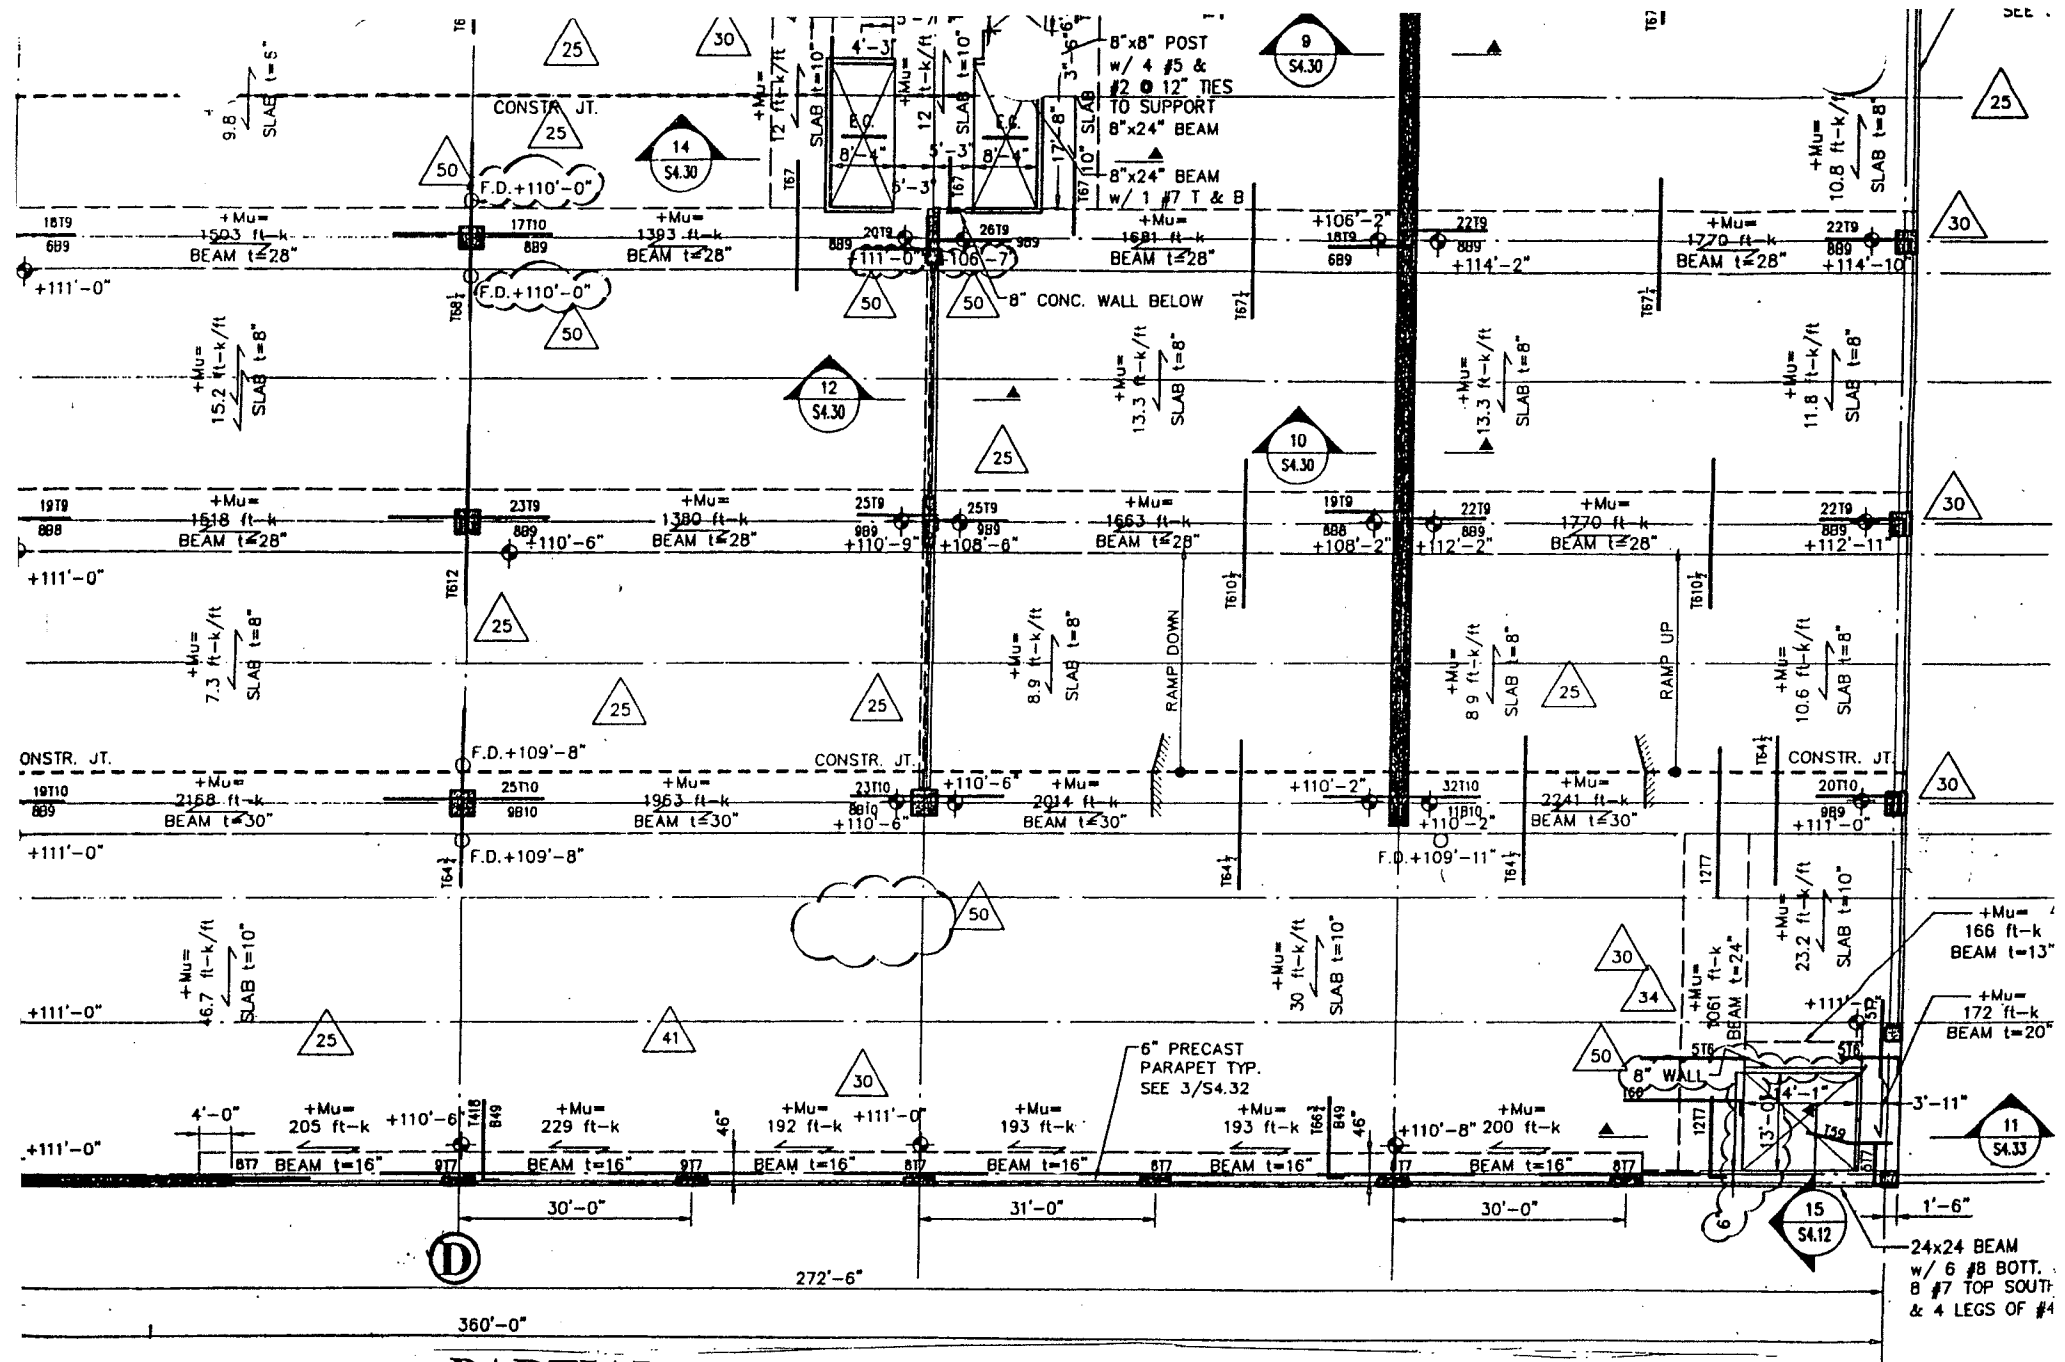
**FIGURE 11**

Structural drawings indicate that B49 rebars, i.e., #4@9" reinforcing rebars at the bottom layer, be provided in 10-inch slabs in the E-W direction, terminating near the exterior edge of the edge beam and the columns on grid line 1. Structural drawings are, however, not consistent in indicating such rebars. For example, on S1.34 (see figure 11), B49 is shown in two locations, but on S1.35 (see figure 12), B49 is shown in only one location. Similar inconsistencies are found on S1.36 (see figure 13) on grid line 1. It is believed that the SER intended to indicate B49 at all locations on grid line 1 where the 10-inch slab framed in to the exterior edge beam. Correcting shortcomings such as these, during the shop drawings review process, is an accepted practice in the construction industry.

The SER produced project structural drawings that contained certain inconsistencies. The B49 bottom rebars were not consistently shown on plans for levels P4 thru P7. On drawing S1.34 (see figure 11), B49 is shown at two locations, but on S1.35 and S1.36 (see figures 12 and 13), B49 is shown at only one location. Extent of the placement of B49 rebars is not shown. It is not clearly understood whether or not B49 was intended to be placed in the slab framing into the shear wall.

**PARTIAL P4 FRAMING PLAN** (CONTRACT DRAWING S-1.34, REV. 50)  
(NTS)

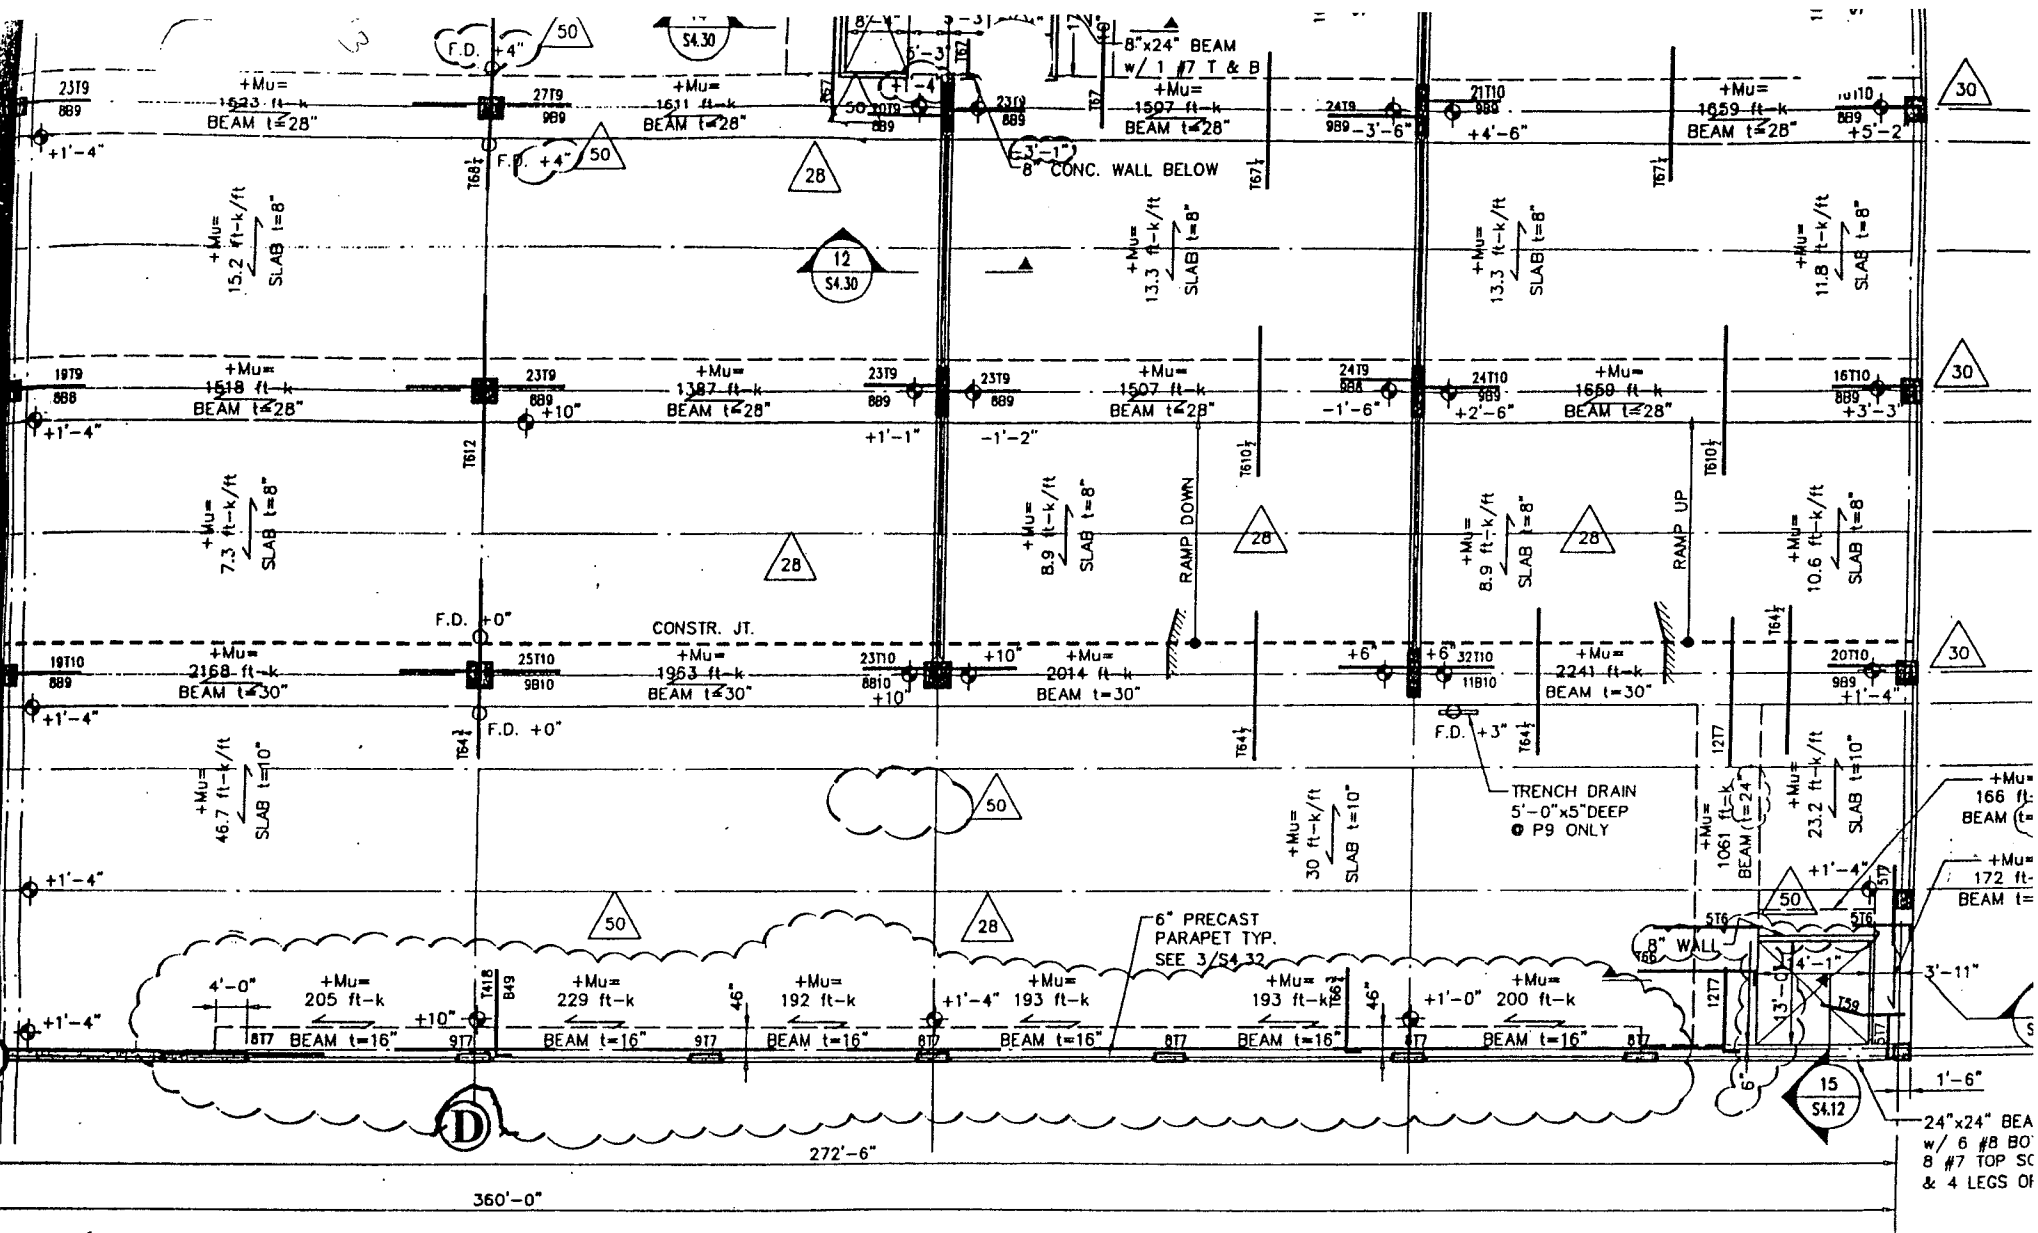
**FIGURE 13**

**PARTIAL P6 TO P9 FRAMING PLAN** (CONTRACT DRAWING S-1.36, REV. 50)  
(NTS)

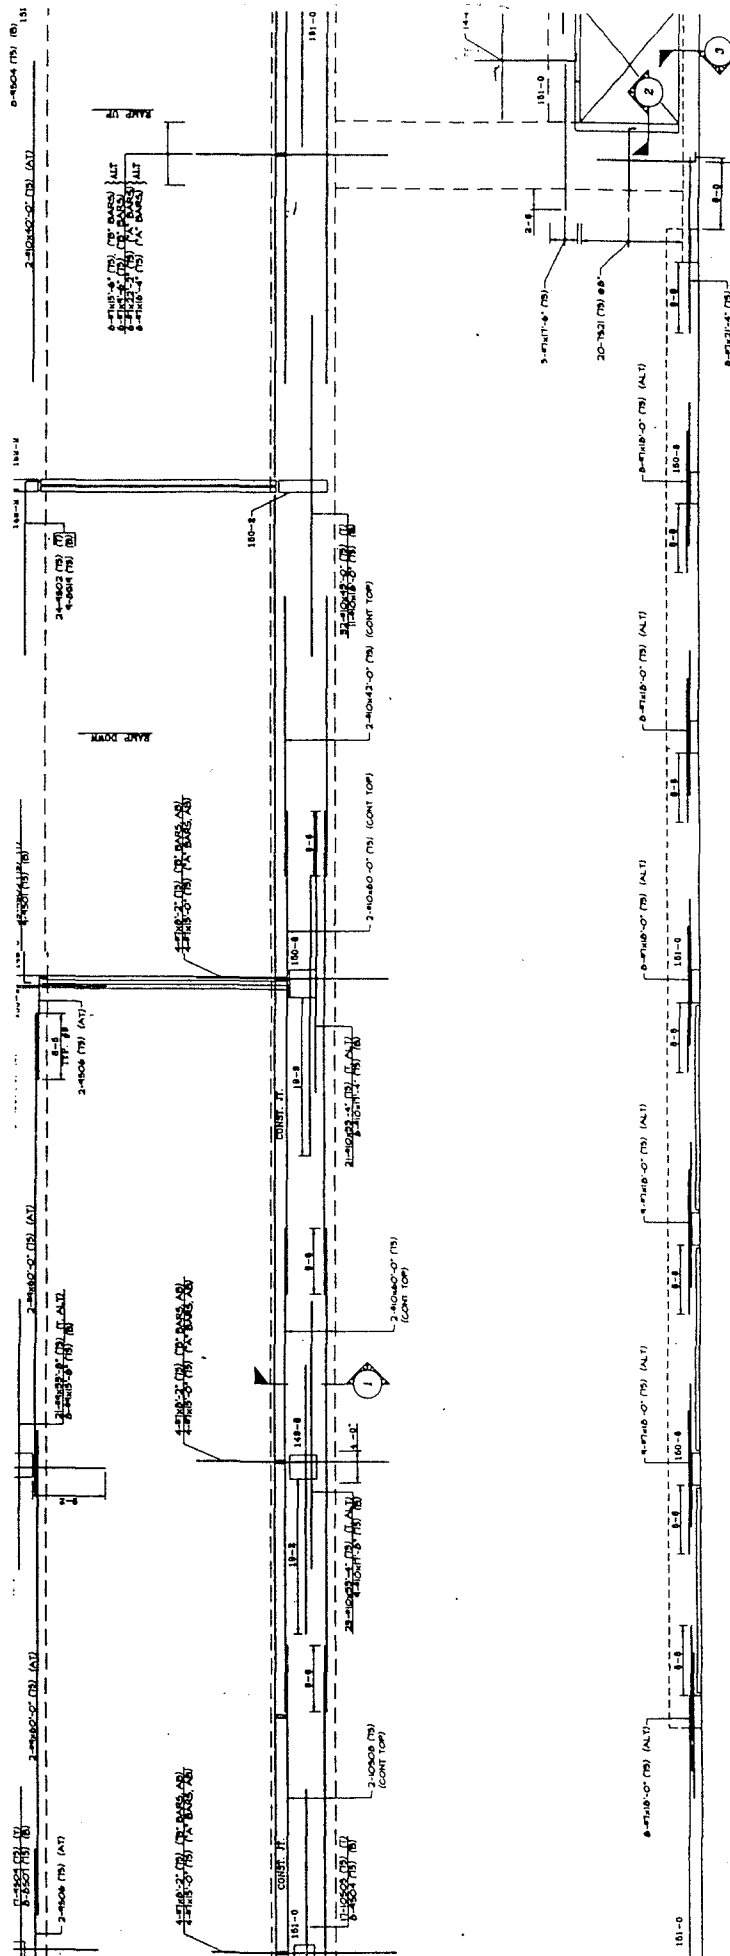
FIGURE 27

Fabi contracted with Southwest Rebar to produce shop drawings for reinforcing steel. Southwest detailed the reinforcing steel, but failed to detail B49 rebars on the shop drawing (see figures 24 to 29), even at those locations where they were indicated on the structural drawings (see figures 11 to 13). Southwest typically would discover the inconsistencies in the structural drawings regarding B49 rebars, as discussed above, and then bring inconsistencies to the attention of the structural engineer for clarification. This did not happen. Southwest did not even detail the B49 rebars at the indicated locations on the structural drawings.

# TOP N-S REINFORCING STEEL AT LEVEL P8
