Investigation of the December 6, 2007 Fatal Parking Garage Collapse at Berkman Plaza 2, Jacksonville, FL

U.S. Department of Labor
Occupational Safety and Health Administration
Directorate of Construction

May 2008

Report Prepared by
Mohammad Ayub, PE

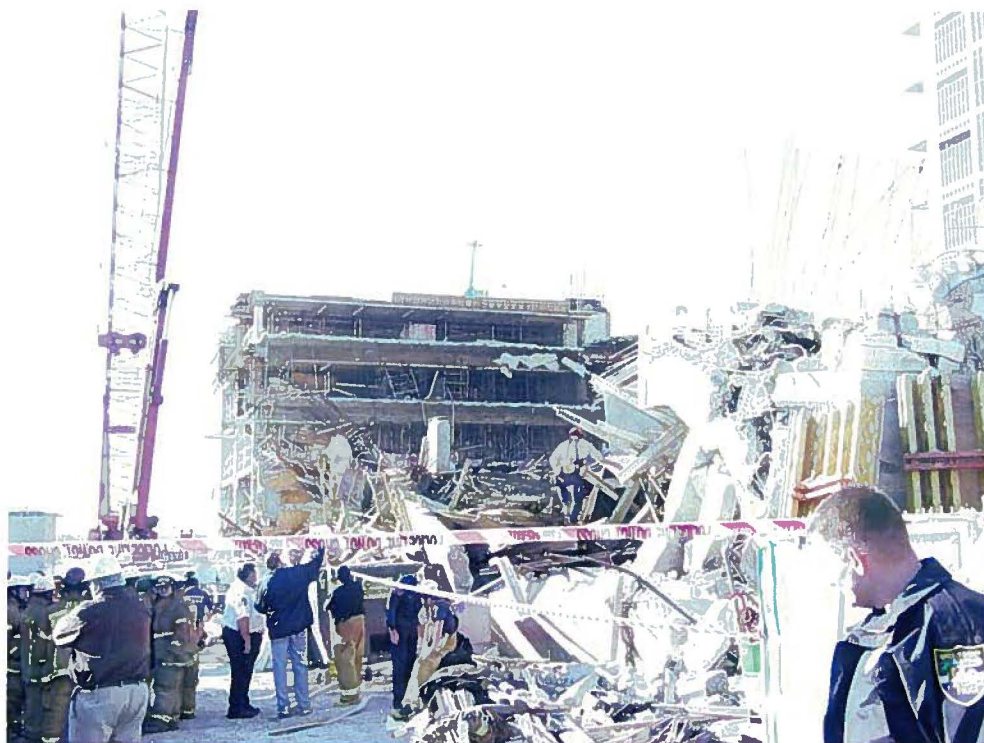
FIGURE 5

The collapse was massive as it encompassed all the elevated slabs from columns grid lines A to G and column grid lines 2 to 4. The slabs fell generally on the top of each other with the columns crushed in between. The shores and re-shores were also crushed between the collapsing slabs and beams. See Figs 5 thru 18 for the extent of the collapse. Two bays on the south side, however, remained standing with slabs north of column grid line G hanging towards the north, still connected by rebars and post-tensioning cables, see Fig. 17. The failure included the shear wall on column grid line A and the shear walls enclosing stair G1 near column grid line 2.
