# Structural Investigation of the January 20, 2014 Plant Collapse at International Nutrition Facility in Omaha, NE

U.S. Department of Labor  
Occupational Safety and Health Administration  
Directorate of Construction

July 2014

Report Prepared by  
Mohammad Ayub, P.E., S.E.  
Office of Engineering Services  
Directorate of Construction

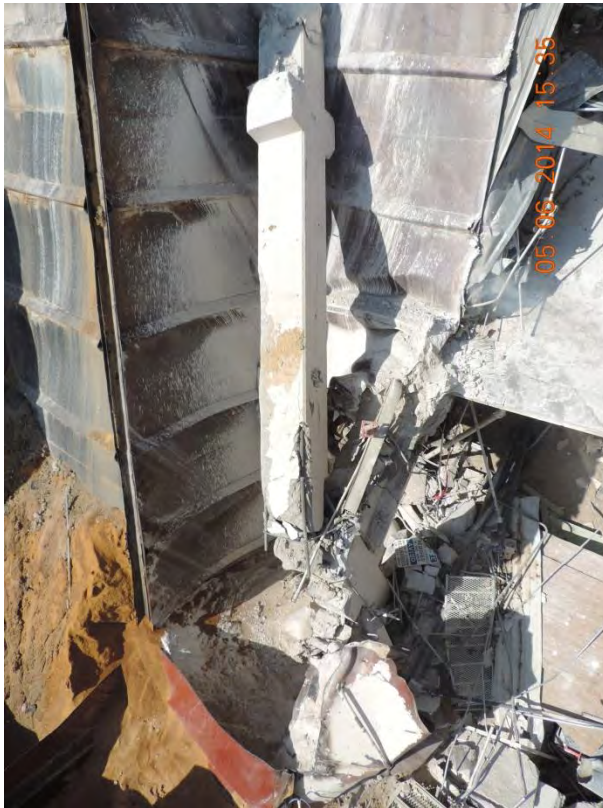
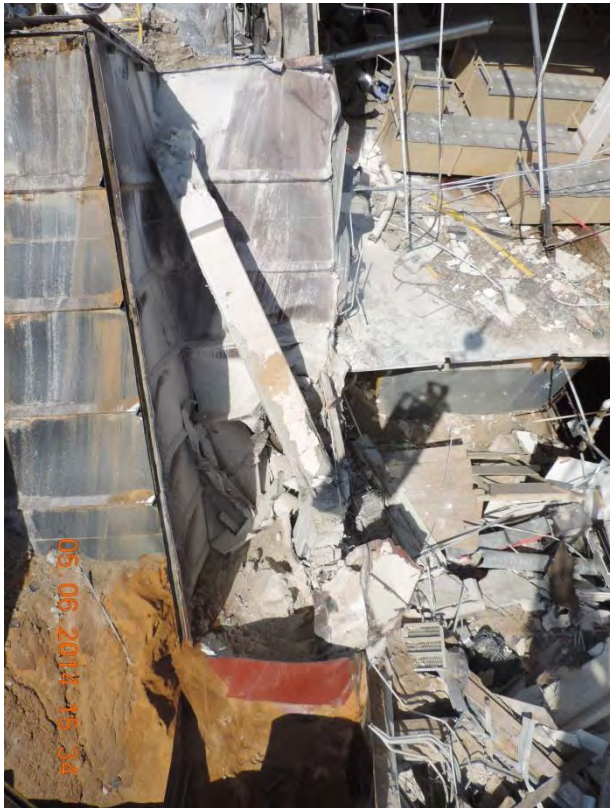
**Fig. 12** NE concrete column in bin No. 1

During the collapse, all four concrete columns remained intact except the NE column which was sheared at approximately the level of the inverted tee beam at the third floor, and was found inside bin No.1 during the demolition and recovery. The reason of the shear at that location was the lack of adequate lap splice of the longitudinal bars on one face of the column, see Figs. 99-103.

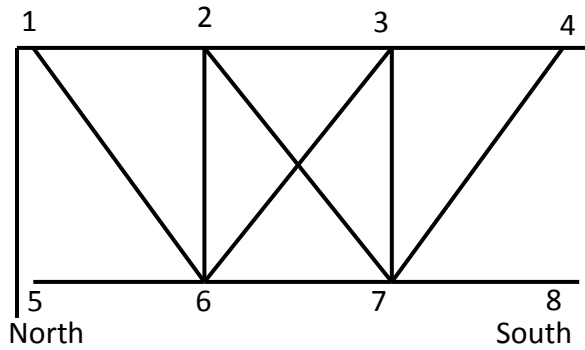
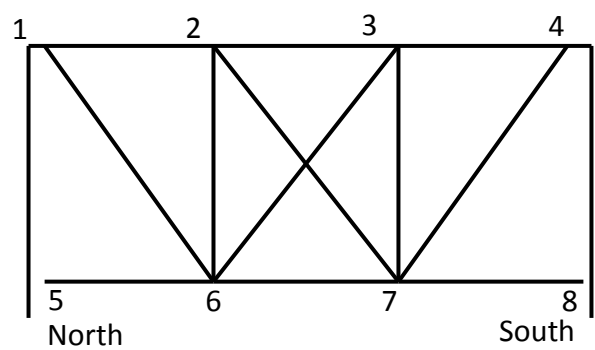
**Fig. 88** East Truss

The four seated connections of the north and south trusses over the column cap plate did not exhibit any signs of failure except the damage sustained during the collapse. The top chords of all exterior trusses did not exhibit severe buckling except at some panel points, although it cannot be determined whether the buckling occurred pre- or post-collapse. The bottom chords of all the exterior trusses contained severe distortions; see Figs. 21, 22, 32, 41, 42, 49, 50, and 107 believed to have occurred during collapse. The connection plates at the bottom chord of all the exterior trusses to W8x40 remained intact, and the bottom chords near the connections remained relatively undamaged.

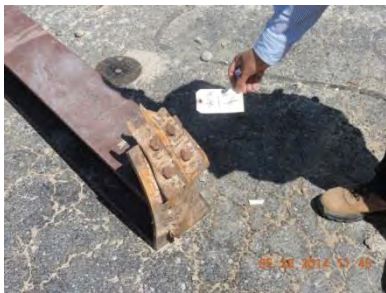
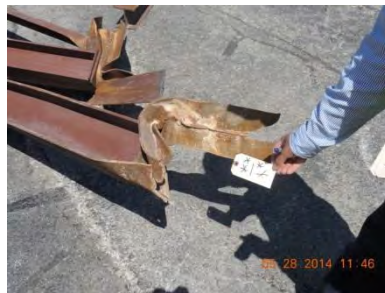
**Fig. 34**– Joint 1 – East truss

All four beam-bearing connections on the east and west exterior trusses failed when the 3/8" stiffener plate buckled. The four connecting bolts remained mostly intact, see Figs. 34, 39 and 44. The north and south trusses are shown in Figs. 86 and 87 respectively. Their joints are shown in Figs. 16 thru 33 below.

The weakest link in the structure was the four stiffened seated connections of the top chords of the east and west trusses at each end. The bottom flanges of the top chords of the east and west exterior trusses, W6x15, were bolted with four bolts to the ½” cap plate of the corner column projecting beyond the column flanges. The cap plate was welded to the column. A stiffener plate 3/8” thick was provided underneath the cap plate. The seated connection was subjected to a vertical load coming from the east and west trusses and a horizontal force equivalent to the compressive force in the truss top chords. Both the vertical and horizontal forces created eccentricity on the connection, and it was determined that a single stiffener plate would overstress the seated connection to failure. If either a north or south connection was provided with a sliding joint to relieve the horizontal force, the connection with only one stiffener plate would have been able to resist the loads satisfactorily. Alternatively, if two stiffener plates were provided as was done in the cases of the interior trusses, the stresses would be satisfactory. As stated earlier, all four stiffened seated connections failed, see Figs. 34, 35, 38, 44 and 47.

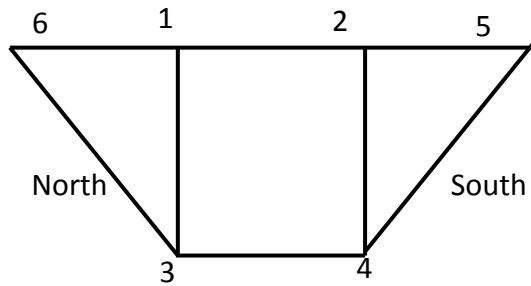
**Fig. 108**– East Interior Truss

The four interior trusses escaped serious damage and emerged relatively intact from the debris see Figs. 104 and 105. The top chords of the north and south interior trusses were continuous

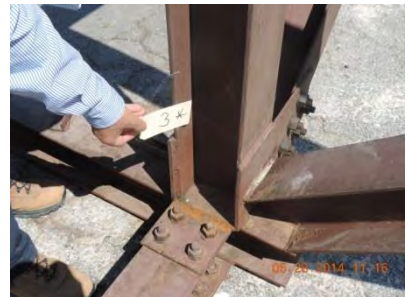
**Fig. 54** – Joint 3 – East interior

and were connected to the east and west exterior trusses by four bolts on an extended gusset plate. The top chords of the east and west interior trusses were simple spans and were connected by two bolts to the north and south interior trusses. It is noteworthy that the bottom panel joints of all four interior trusses were practically undamaged; see Figs. 54, 55, 59, 60, 66, 67, 74 and 75.

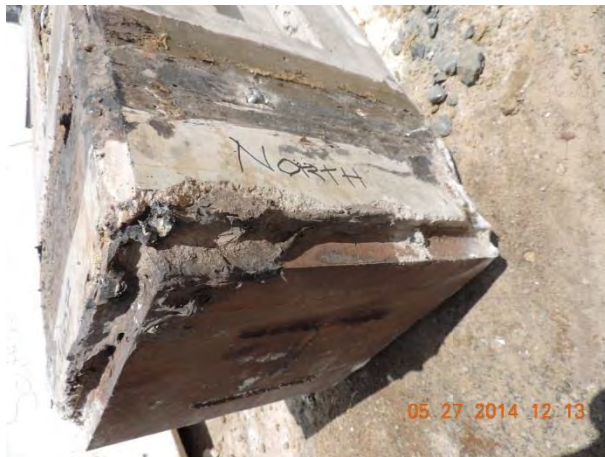
**Fig. 84** – W8x40 base plate

The four corner columns, W8x40, remained intact and did not exhibit any signs of distress. The failure occurred at the bottom of the columns where the welds to the column base plate failed, see Figs. 78 thru 85. The column base plate remained connected to the embed plates of the concrete columns; see Figs. 78 thru 85 and 95. For typical hoppers pictures after they have been retrieved from the debris, see Figs. 96 thru 98.

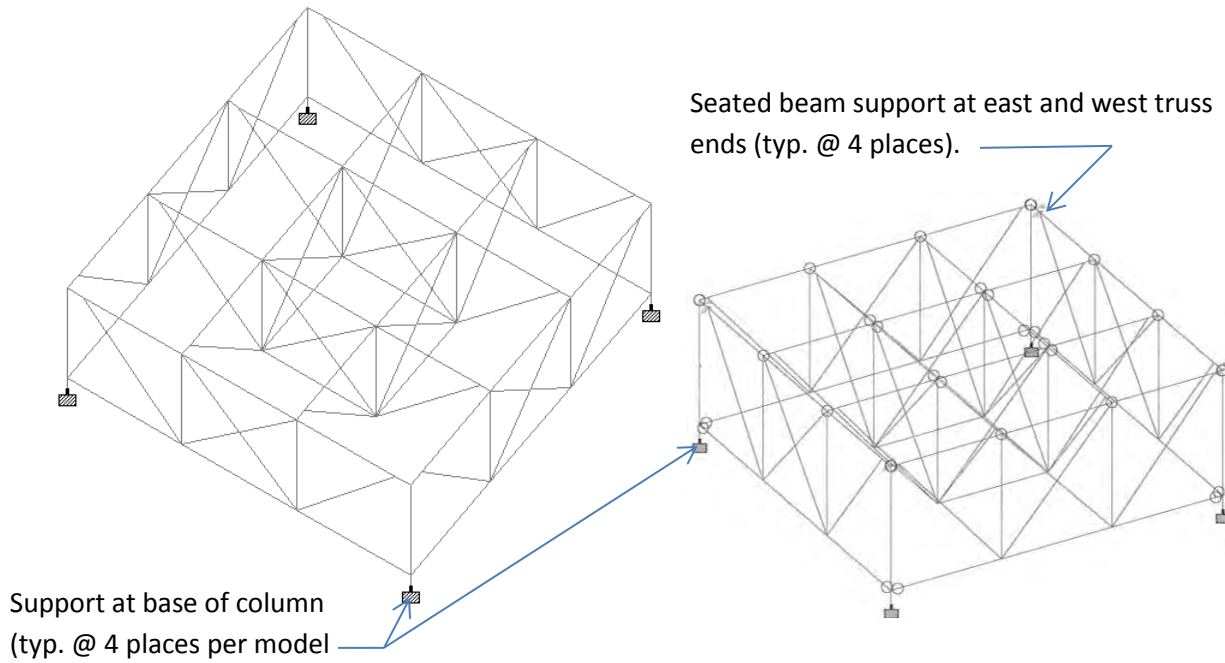
**Fig. 90**

Two models were created to assess the stresses in different members of the trusses under different loading conditions. The first model provided the forces imposed on the stiffened seated connection by the east and west trusses at the north and south ends, and the second model provided the forces and stresses in the truss members. The first model more accurately reflected the existing framing conditions at the stiffened seat connection. Analyses were done under the Load Resistance and Factored Design (LRFD), and under Allowable Stress Design (ASD). Under the LRFD, no increase in loads was assumed by using a load factor of 1.0, and no capacity reduction was taken by using the phi factor as 1.0. The intent under the LRFD evaluation was to compute the failure load at which a collapse could occur. ASD evaluations provided the usual factors of safety in accord with the industry practice. A finite element analysis and hand computations were performed to compute the load that the stiffened seat connection could carry. Three dimensional views of the two models, and the finite element plate analysis are shown below, see Figs. 90 thru 94.

**Result: All truss members passed but the seated beam connections failed.**
2. Case 2: Same as Case No.1 but using model No. 2. Again no factor of safety.

**Result: All truss members passed but the seated connections failed**
3. Case 3: To determine whether the existing structure could safely support limestone in four corner bins, and rice hulls in the remaining five bins with the required factor of safety (using ASD method), as per industry standards, using model No.1. All bins were filled up to 85% of capacity.

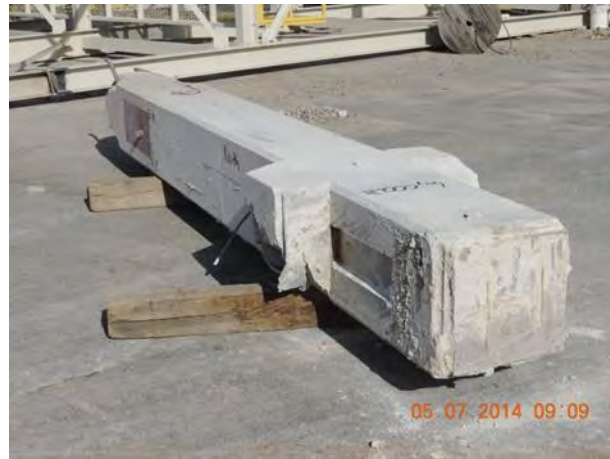
**Fig. 95** – Intact column base plate

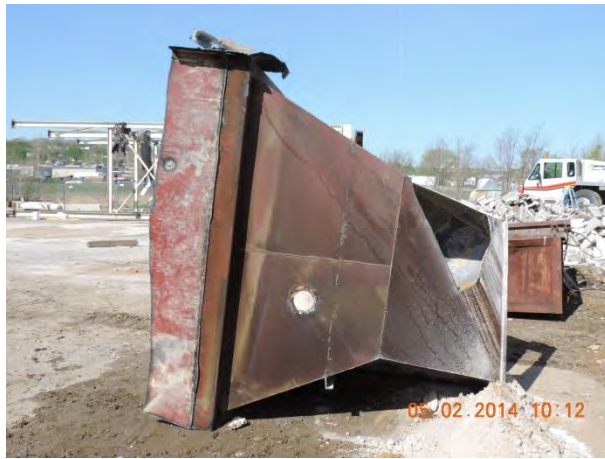
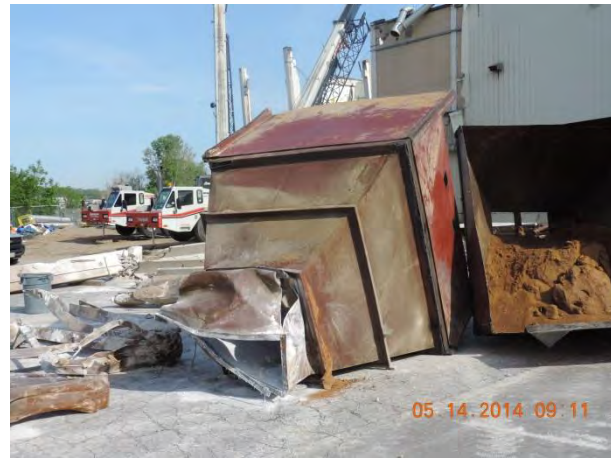
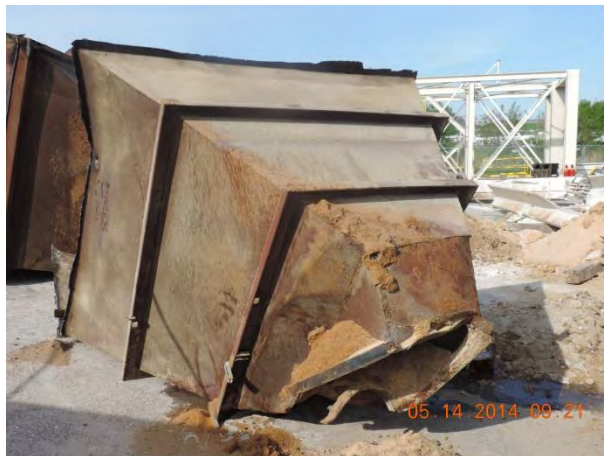
The walls of the bins were reinforced by welding 5x3x1/4" steel angles to the steel plate at 4' o.c., vertically. There was a common wall between the bins. The hoppers were welded to the bins, and were integrated to each other with a lip bearing over the top flange of the top chords of the external and internal trusses. Thus, the bins and the hoppers were one integrated structure resting over the steel beams, see Figs. 96 thru 98.

**Fig. 96** – Typical hopper

**Fig. 97**-Typical hopper

**Fig. 98** – Typical hopper
