Investigation of the Failures of Three Hammerhead Cranes on September 10, 2017, in Miami and Fort Lauderdale in the Wake of Hurricane Irma

U.S. Department of Labor
Occupational Safety and Health Administration
Directorate of Construction

September 2018

**Report Prepared by
Mohammad Ayub, P.E., S.E.
Alan Lu, Ph.D., P.E.
Office of Engineering Services
Directorate of Construction**

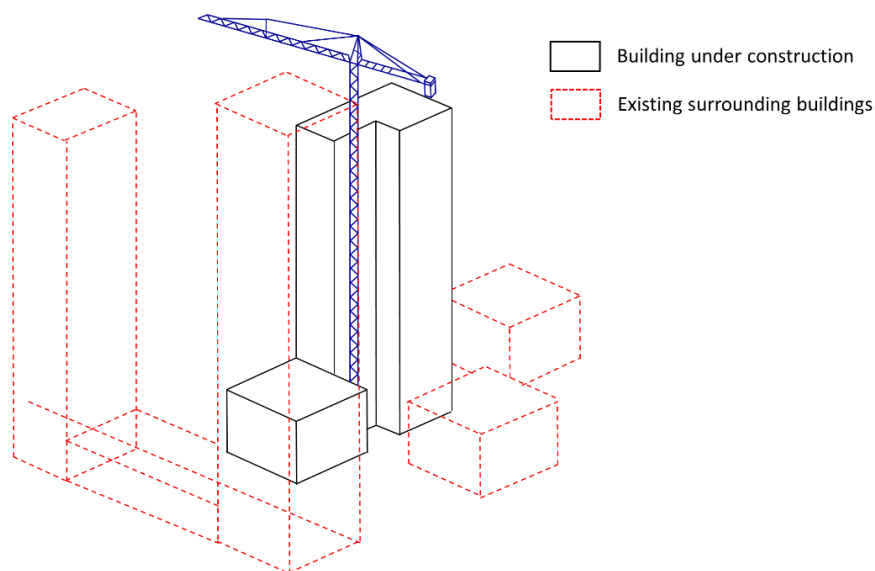
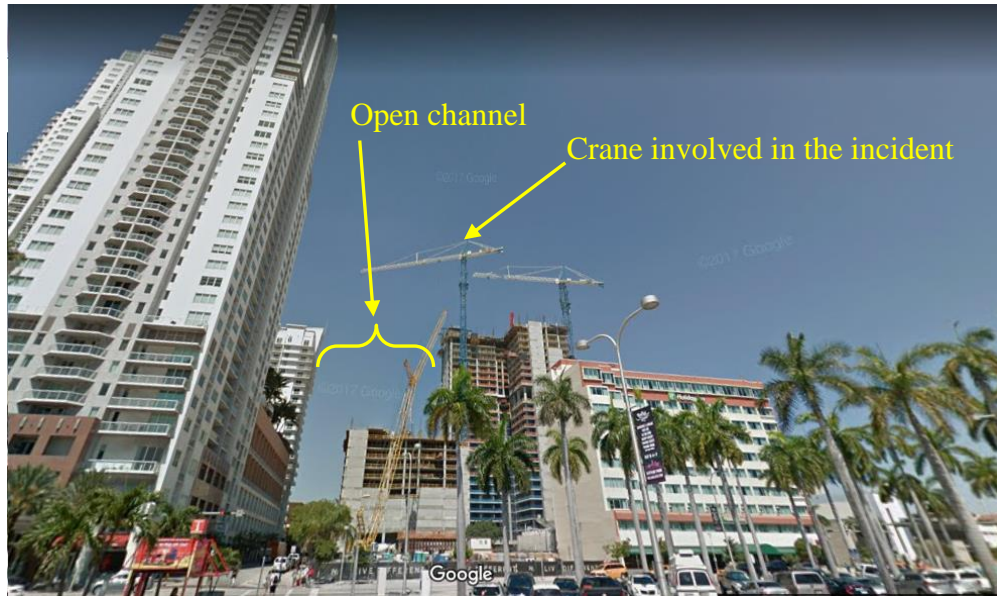
At the first failure site, the two existing high-rise buildings across the street were taller than the crane, see Figure 16. The building under construction and the existing high-rise buildings across the street formed a small open channel, see Figures 16 and 17. Within the channel area, Venturi effect is normally expected. Therefore, the speed of wind increased when it funneled through this small opening. The severity of the Venturi effect is a function of width, length, height, and size of the opening in the canyon. The local wind acceleration effects are extremely difficult to describe and to schematize. However, it is clear that the local building configuration made the wind accelerate in this restricted area. Meanwhile, the crane tower was in front of the building, facing the strong wind from the ocean. Prior to the collapse, the jib was within a shear and separation zone beside and behind the building, see Figure 18. Therefore, wind speed and aerodynamic loads at the jib side were expected to be elevated. Moreover, vortex flow beside and behind the building was expected near the jib because of the high rise buildings across the street. This was proven by the fact that upward turbulent wind was observed underneath the jib in the video footage taken when the collapse took place, see Figure 19. Since the crane's jib was approximately 70 ft. above the completed structure, it was also likely that the jib and the counterjib were above the turbulent layer, and in a more stable laminar flow.

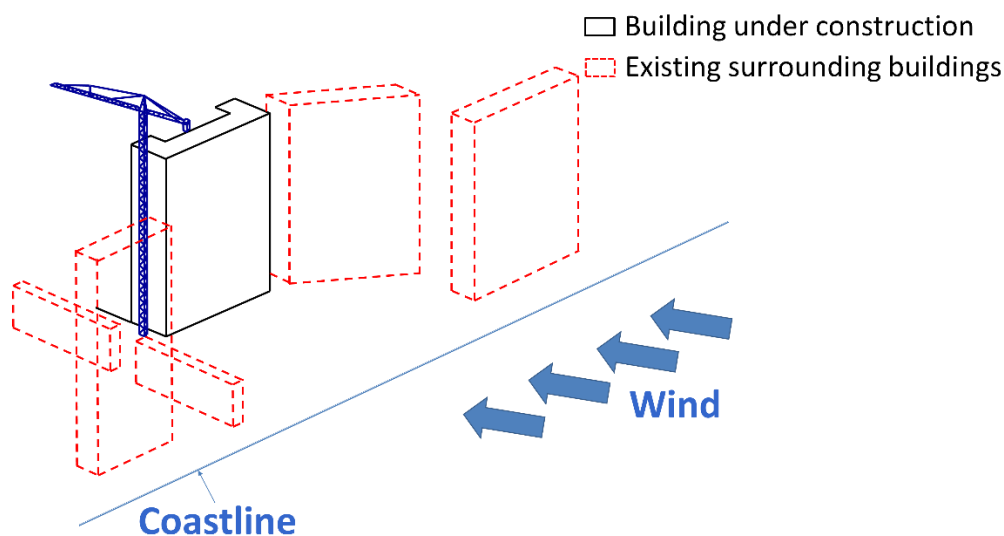
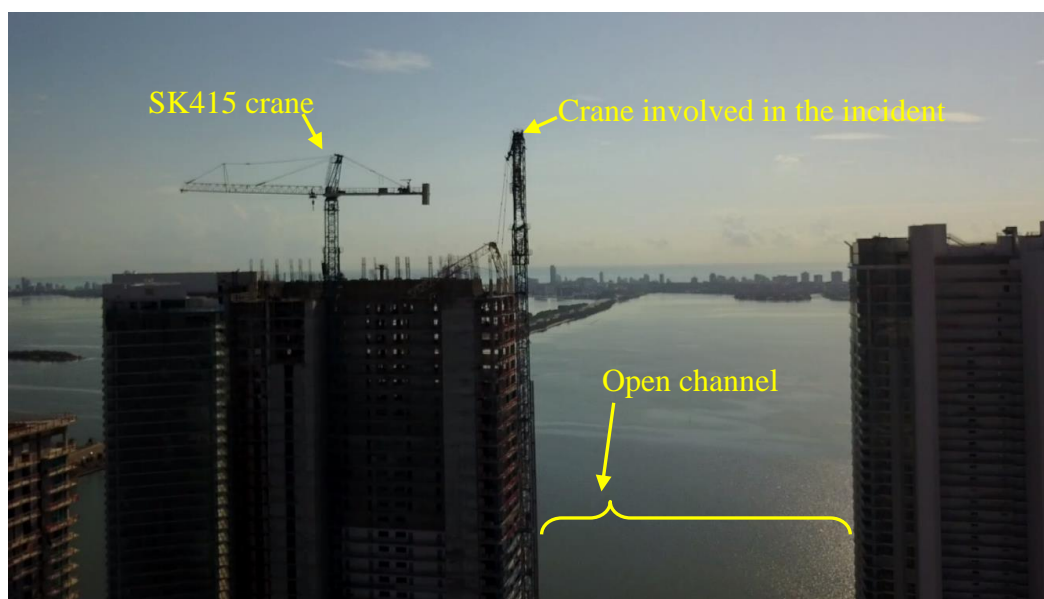
At the time of the failure, the bottom of the jib was approximately 100 ft. above the completed structure. The crane tower was against the side wall of the building, facing the strong wind from the ocean, see Figures 20 and 21. The nearest existing high-rise building in the area, which was about the same height of the completed structure, was more than 250 ft. away from the tower crane, see Figure 21. The location of the jib and the counterjib prior to the collapse was unknown. Similar to the first failure, the building under construction and the existing high-rise buildings across the street formed an open channel similar to the first failure site, as shown in Figure 21. Again, the crane was much taller than the completed structure and the nearest existing high rise building. Whether the crane was located in an area that local turbulent winds were expected was not clear. Video footage captured on September 8, 2017, showed the initial position of the two cranes less than 24 hours prior to the landfall of the storm. Compared with two other videos captured during the storm, it is confirmed that positions of the jibs of the two cranes at this site changed after the storm made landfall, as shown in Figure 22. One of the two videos captured during the storm, but prior to the crane collapse, showed the crane involved in the incident and the nearby SK415 crane,

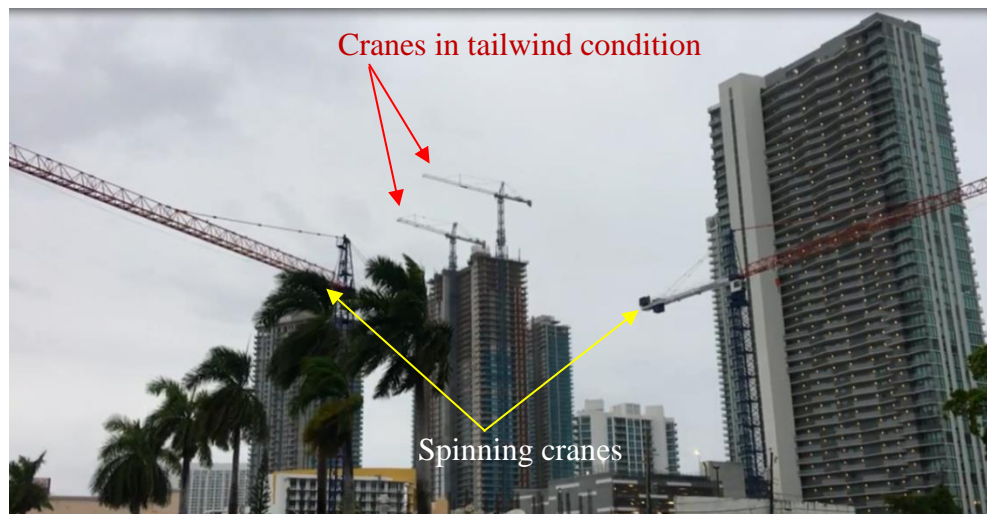
Figure 23 Tailwind condition of cranes at the second failure site – looking northeast
(Courtesy of Mr. Peter Zalewski)

were in tail wind condition, while the two lower cranes behind the high-rise buildings were spinning due to fluctuating winds, see Figure 23.

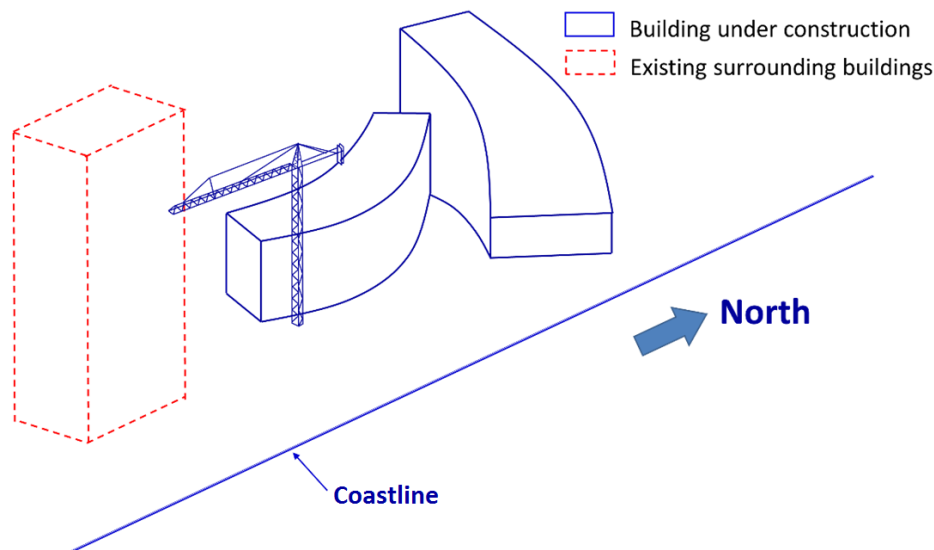
Figure 24 ISO view of the third failure site *

The built environment of the third failure site is shown in Figures 13, 14 and 24. Wind direction and probable jib location were determined based on video footages and photographs taken before and after the incident, see Figure 24.

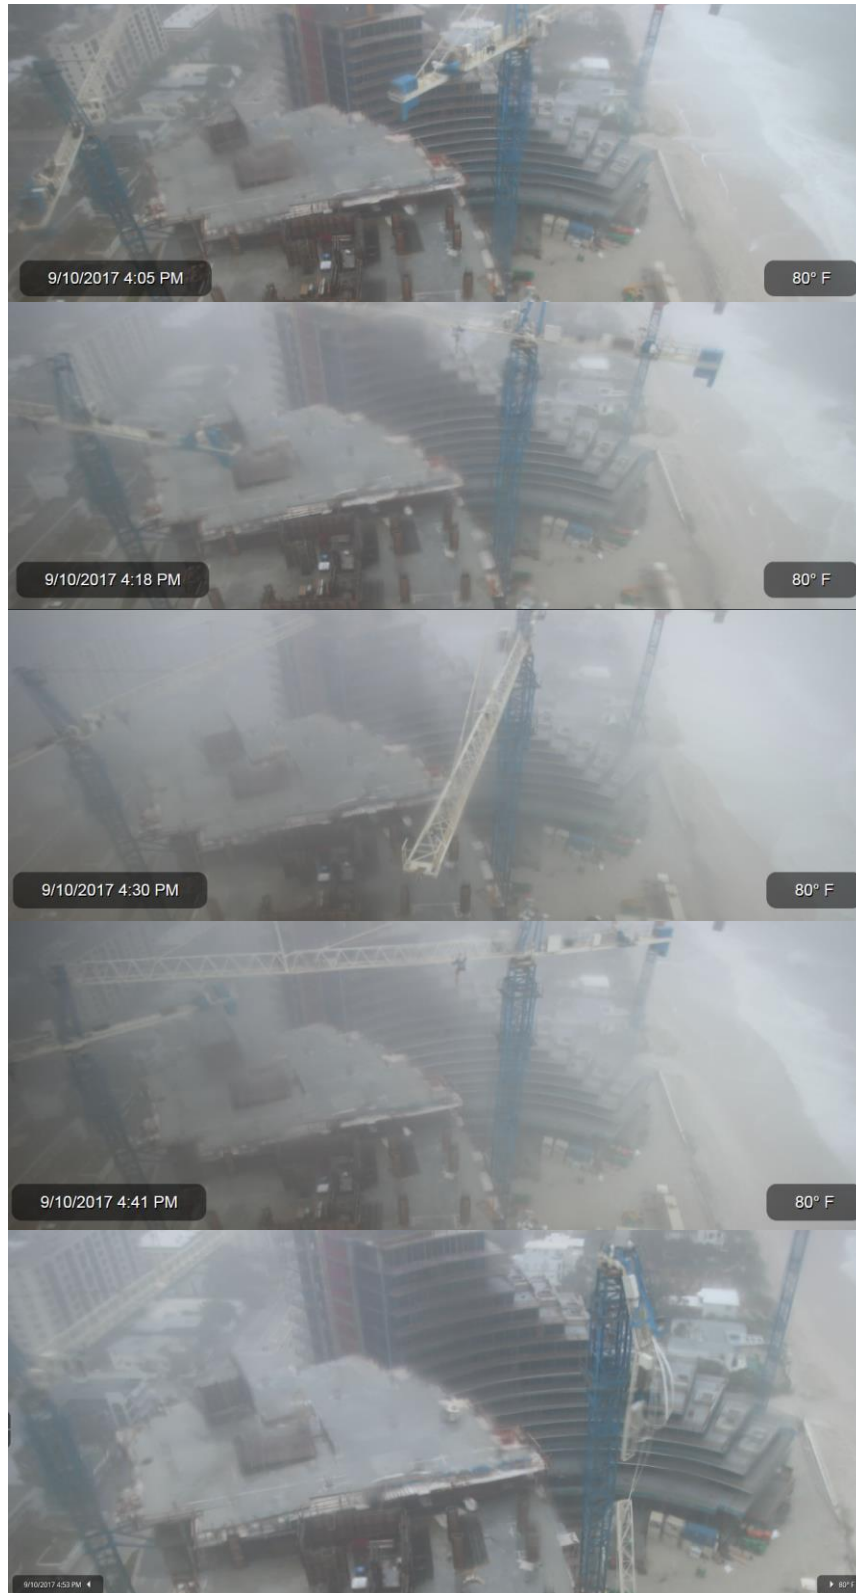
Figure 25 Spinning of the crane involved in the third failure
(Courtesy of OxBlue.com)

The crane tower was in front of the building, facing the strong wind. The bottom of the jib was approximately 80 ft. above the completed structure. The buildings under construction and the nearby existing high-rise building interfered. The local surroundings created a complicated situation where the wind was not guided but accelerated in restricted areas. The local wind acceleration effects were extremely difficult to describe and to schematize. However, it is believed that the local building configuration made the wind accelerate in this restricted area. Therefore, wind speed and aerodynamic loads at the jib were expected to be elevated. The local turbulent wind had significant effect on the crane. This was proven by the construction camera photographs taken before the collapse of the crane, which showed that the crane rotated due to local turbulent winds, see Figure 25.

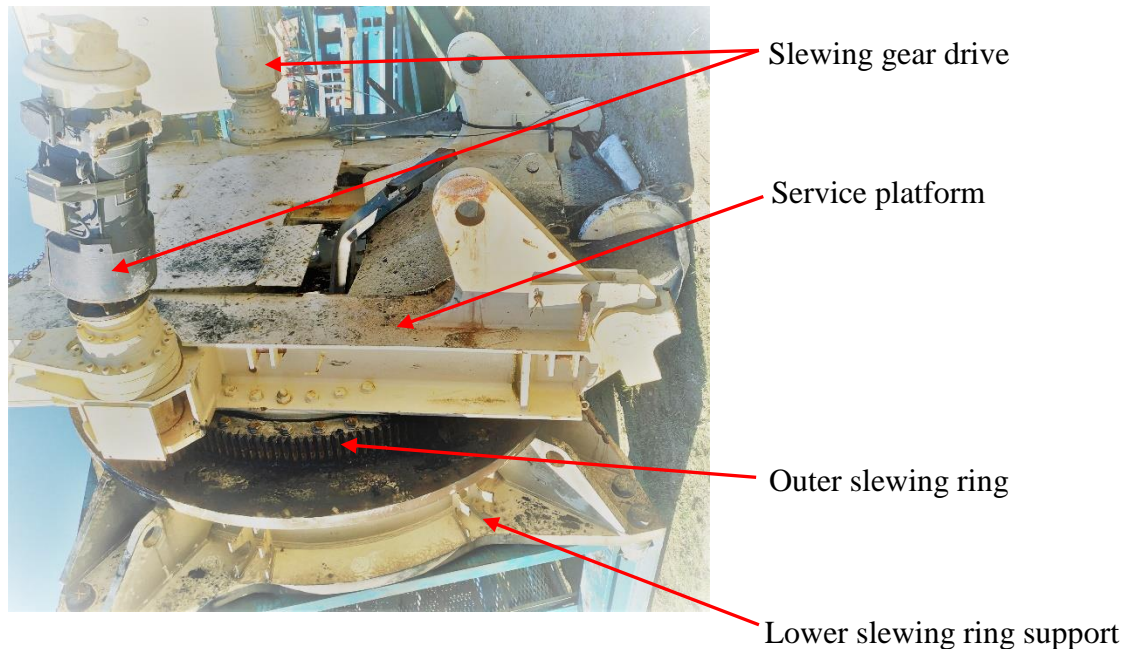
Figure 27 Slew assembly (the first failure)

The field observations of the slewing assembly focused on signs of worn slewing bearings, and on whether the slewing rings were greased and were set to weathervane as described in Section 3.2. Visual examination of the slewing bearings of the three cranes revealed that all three slewing bearings were greased, and no broken parts or missing teeth were found on the outer rings. Deadlock from debris of the slewing rings and possible jammed rings were not discovered. The wind release cases and the slewing gear brakes of the three cranes were also dismantled to verify that the cranes were set to weathervane and were able to revolve freely prior to the collapses. The disk brakes of the first and the third failure cranes were disassembled, since the wind release assemblies broke during the collapses. The brake linings of the two gear breaks had not worn down to the minimum thickness, and it was confirmed that the two cranes were set to weathervane prior to the collapses. The wind release assembly of the second failure crane was opened, and it was found that the flap was still in blocking position, which means the crane was set to weathervane.

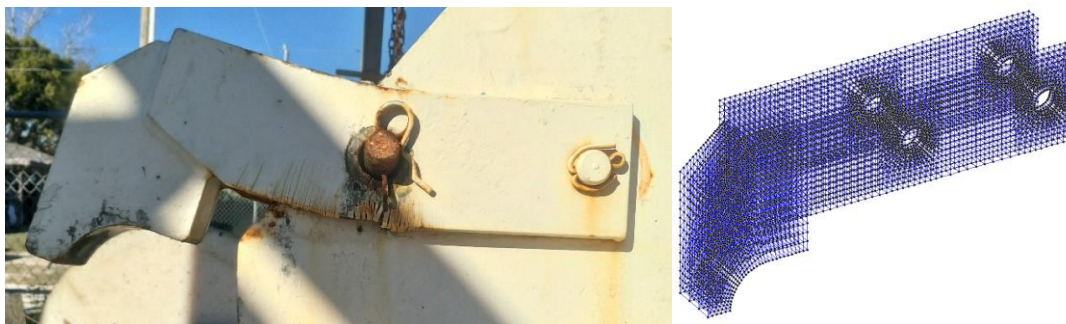
Figure 39 Turntable cradle clamp and 3D solid model

The turntable cradle clamp was modeled using 3d solid element in Staad Pro, as shown in Figure 39. Force was applied at the tip of the clamp to simulate the pulling of the pins on the bottom jib chord foot. The material grade for the clamp was S355J2G3, with a yield stress of 52 kilopounds per square inch (ksi). A minimum pulling force from the bottom jib chord pin to yield the clamp steel was determined to be 32 kips. It is noted that the existing clamp design is not able to secure the jib foot from separating, once the force from one jib bottom chord exceeded 32 kips. No design calculation or analysis documents or proof loading test results were made available to OSHA. Further evaluation could be required.

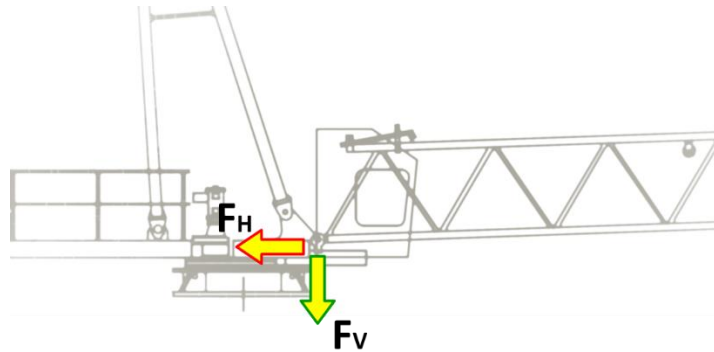
Figure 40 Jib foot loads on turntable – side view

The jib sat on the two cradles of the turntable at the end, and was suspended from two pendants. The directions of the stationary forces exerted on the turntable cradles are shown in Figure 40. The magnitudes of the forces are tabulated in Table 2.

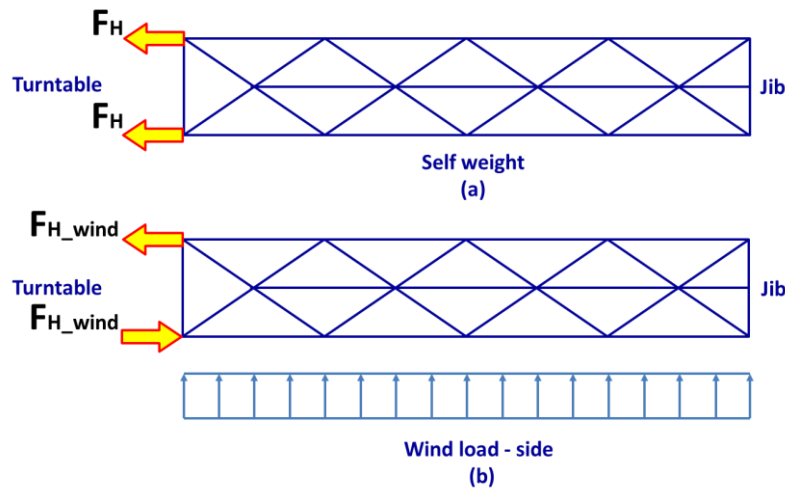
Figure 41 Jib foot loads on turntable – plan view

According to FEM 1.005, the minimum wind load to overcome the frictional moment from the slewing ring is 25 mph (40 kilometers per hour). Considering the diagrams showing in Figure 41, the coupling forces, F_{H_wind} , in the two bottom jib chord feet, where the jib was mounted to the turntable, due to the horizontal steady-state wind pressure, were determined for the three cranes, as tabulated in Table 3.

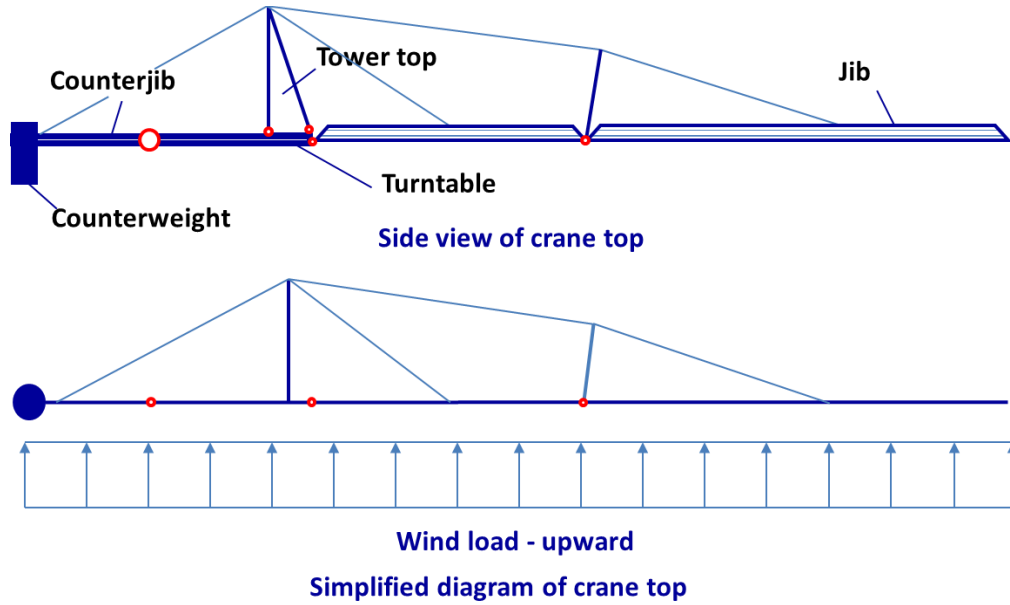
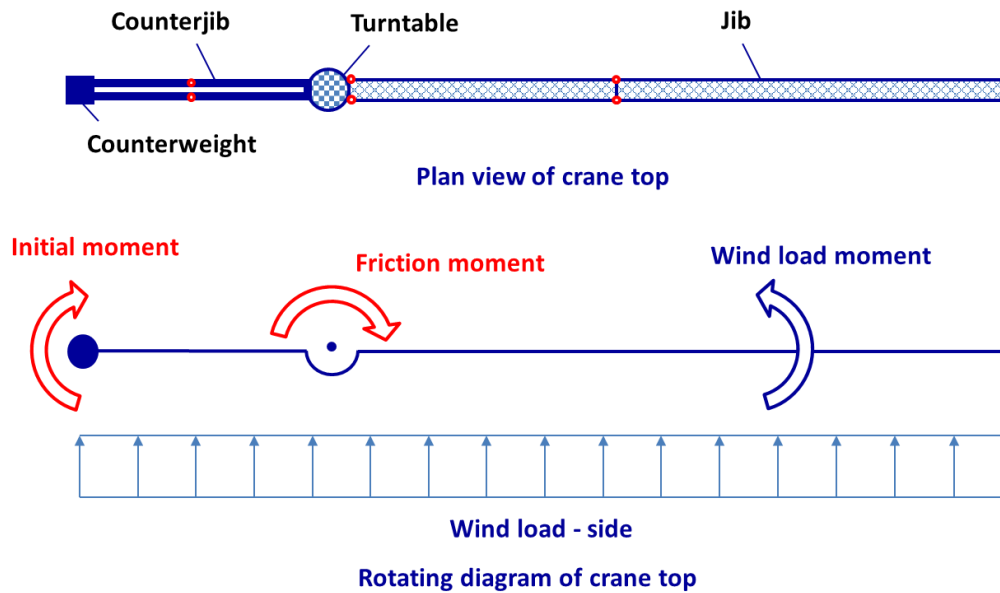
Therefore, to determine the probable causes of the three incidents, both upward and lateral transient wind loads were considered applied on the jibs at 90 degrees to represent the possible situations where crane jibs were hit by a strong vortex or impulse wind, as shown in Figures 42 and 43. In contrast to typical design practices—which considered a complete crane, including mast, tower top, jib and counterjib, to evaluate its stability and integrity—only the dynamics effects of the jib introduced by the sudden rise in wind speed (or pulse effect) were examined in this study.

It should be noted that the two analytical conditions in this section are beyond the design usual practice and are served as a study to determine the probable causes of the three crane collapses. The effects of transient wind on tower crane structures, especially on crane jibs, are not usually included in the structural design of tower cranes.

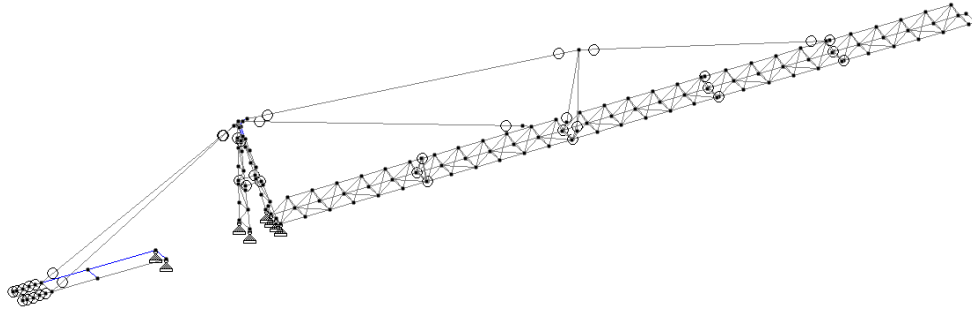
Figure 44 3D structural model of the mobile part of the crane (1st failure crane)

The 3D structural models of the three cranes, including the tower top, jib and counterjib, were developed as shown in Figure 44.

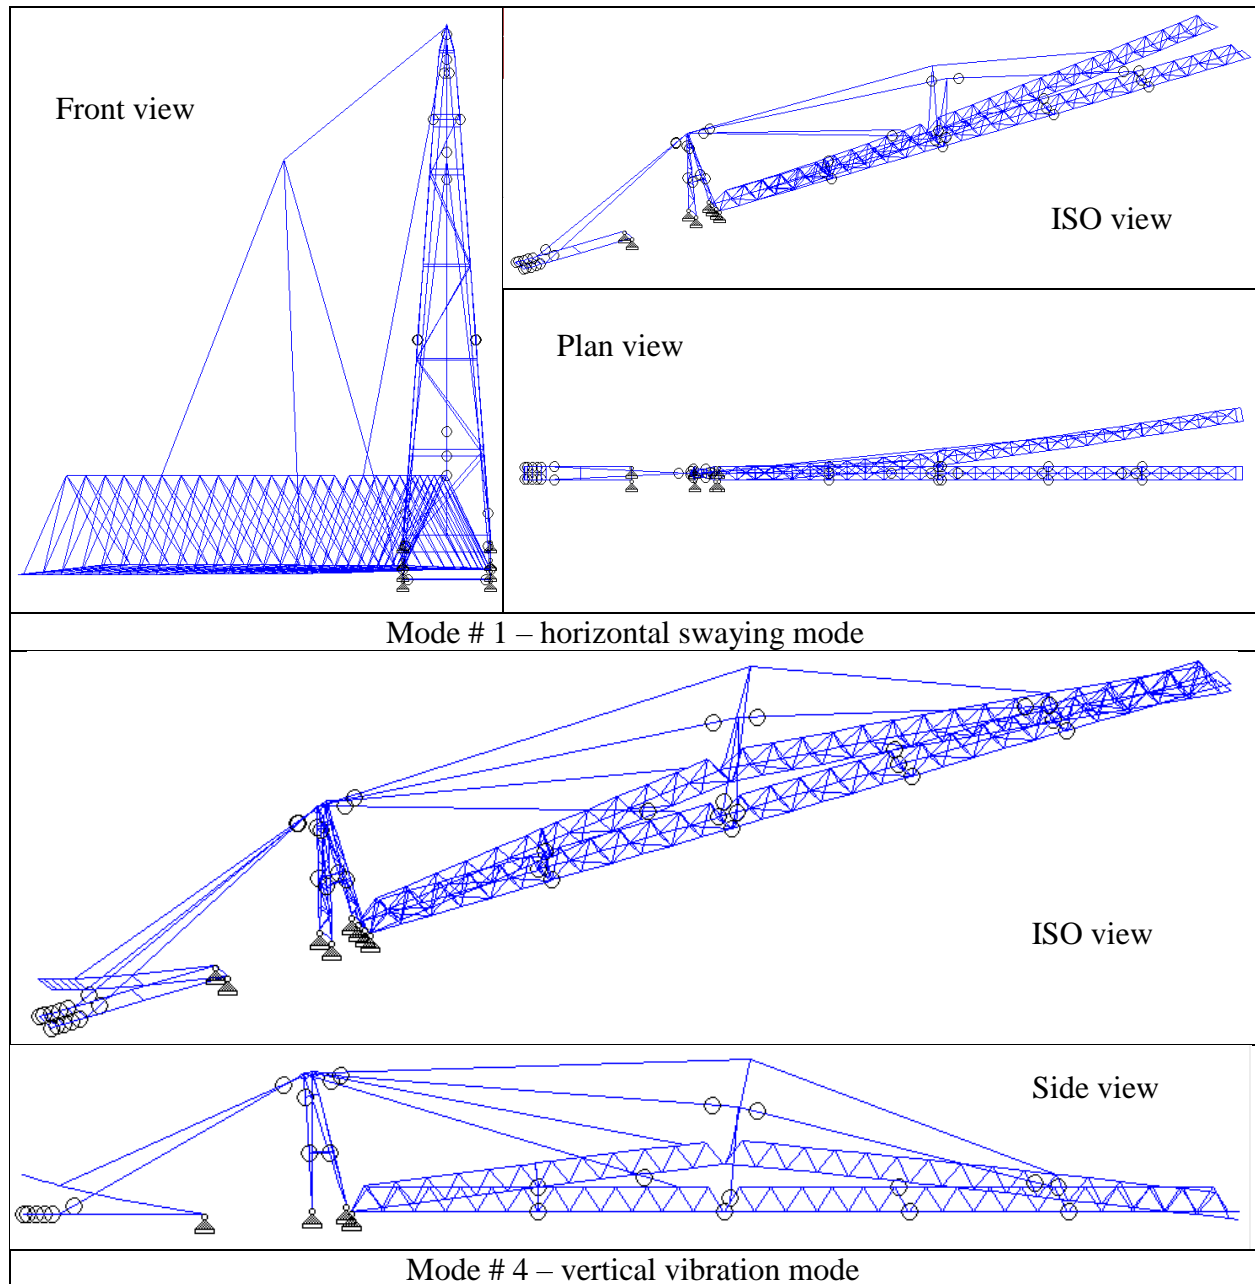
Figure 45 First two dominant modes of the crane mobile parts (1st failure crane)

It was found that the dominant modes of the crane mobile parts included both transvers swaying of the jib and vertical shaking of the jib and counterjib, as shown in Figure 45.

The wind speed fluctuates in all the frequencies between 0.0005 and 5 Hz. The first two dominant modes of both horizontal and vertical vibrations of the three cranes were within the frequency range of the typical frequencies of a wind. Therefore, the choice of the impulsive wind frequencies in this study aims to study the middle-range wind frequencies in a scale from 0.5 to 1.5 Hz, excluding the extremes of very low or very high frequencies.

As mentioned previously, the cranes involved in the first two collapses were in tailwind condition prior to the collapses; and, for the third failure, jib rotation speed prior to the collapse was not known. Whether the rotational frequency is able to excite the jib structure's natural modes, especially the transverse mode, as shown in Figure 45, is not clear.

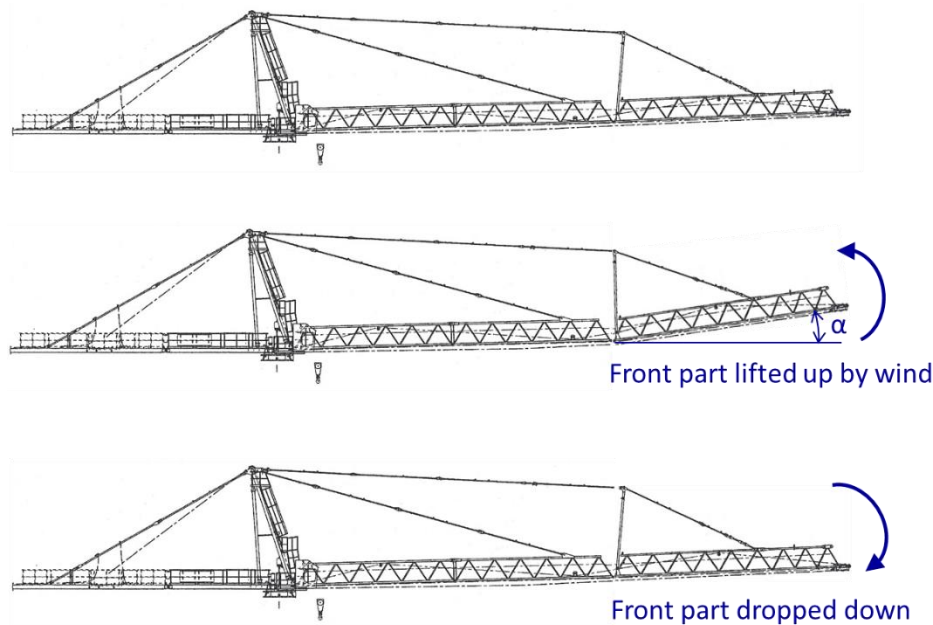
Figure 46 Front jib dropping failure

Static analyses were conducted to determine the minimum vertical wind speed to overcome the self-weight of the front part of the jib involved in the third collapse, and the minimum wind speed is about 173 miles per hour. Then, impact loads in the front pendants and the two posts of the A-frame were determined by assuming the front part of the jib as a rigid body dropping from different heights. It was found that the pendants and the A-frame would fail due to the impact force of the dropping of the front part jib if the front part of the jib were lifted up about 2° ($\alpha=2^\circ$ in Figure 46).

Therefore, it is possible that the front part of the jib involved in the third collapse was lifted by a strong vertical wind when the wind disappeared the jib section dropped down, and a significant impact force acted on and failed the A-frame. Once the jib started swaying to the side due to unbalanced suspension forces, the collapse of the jib, counterjib and tower top occurred.

Since the A-frames of the first two collapse were found intact after the collapses, the probable cause discussed in this section is only applicable to the crane involved in the third failure.

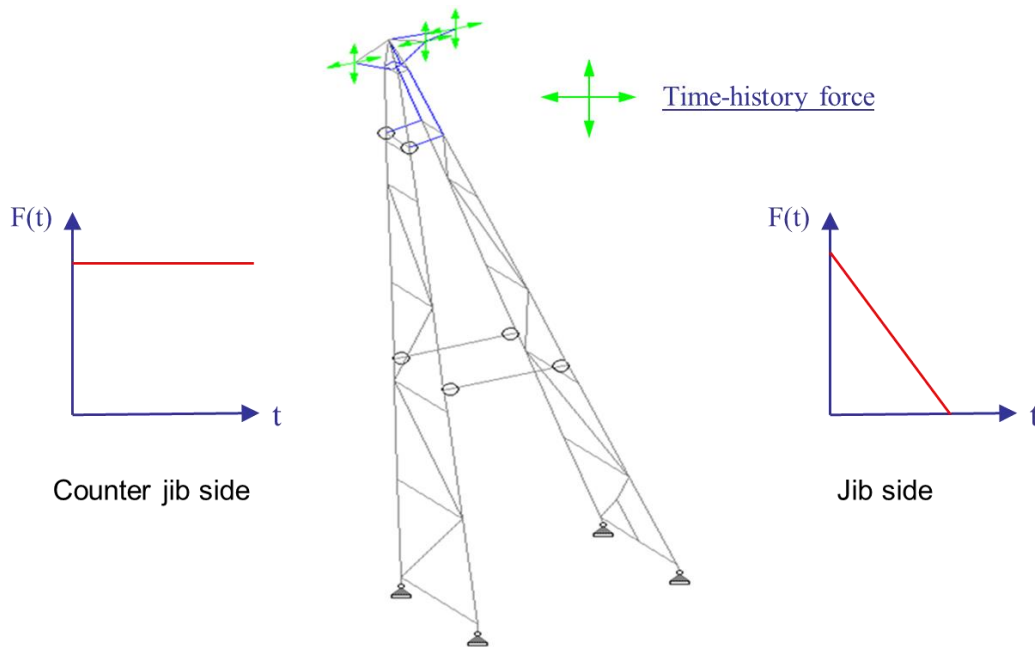
Figure 47 Frame model of tower top for dynamic analysis

As discussed in previous sections, the jib pendants were released in a short period due to the falling of the jib once it detached from the turntable. Per the video footage taken at the first failure site as discussed in Section 4.1, the time duration of the entire process could be less than 0.1 seconds. Dynamic time history analyses were carried out on 3D frame model of the tower top only, as shown in Figure 47. A linear time-history function to simulate the sudden disappearance of the pendant tension from the jib side was adopted in the analyses, as shown in Figure 47. Results indicate that the two tower top columns towards the counterjib side were overstressed and failed due to the sudden release in tension in the jib pendants. The maximum combined compressive stresses in the upper sections of the two columns toward the counterjib are 63 ksi for the crane involved in the first failure, and 59 ksi for the cranes involved in the rest two failures.

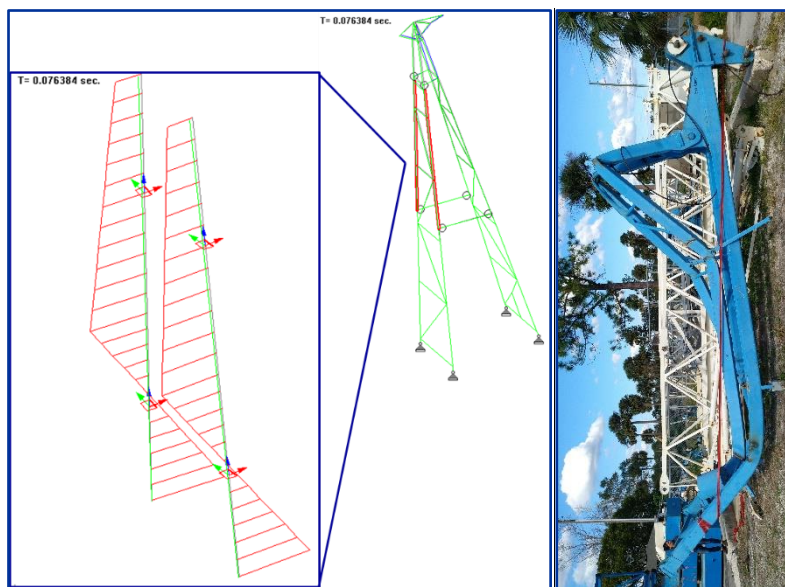
Figure 48 Strong axis bending moment diagram of the columns vs. deformed columns

The diagram of the governing bending moment in the upper sections of the two columns toward the counterjib is shown in Figure 48. It is found that the maximum compressive stress occurred at

the side of the column section toward the jib. The deformed columns of the tower top toward the counterjib are consistent with the bending moment diagrams, as shown in Figure 48.

10. To prevent catastrophic collapses of the crane tower top in the future, it is recommended that tower tops be evaluated and designed with a higher safety margin, and the design should also be based with loads applied from only the counterjib.
