# Investigation of July 20, 1992 Offshore Drilling Accident, Massachusetts Bay, Massachusetts

U.S. Department of Labor  
Occupational Safety and Health Administration

December 1992

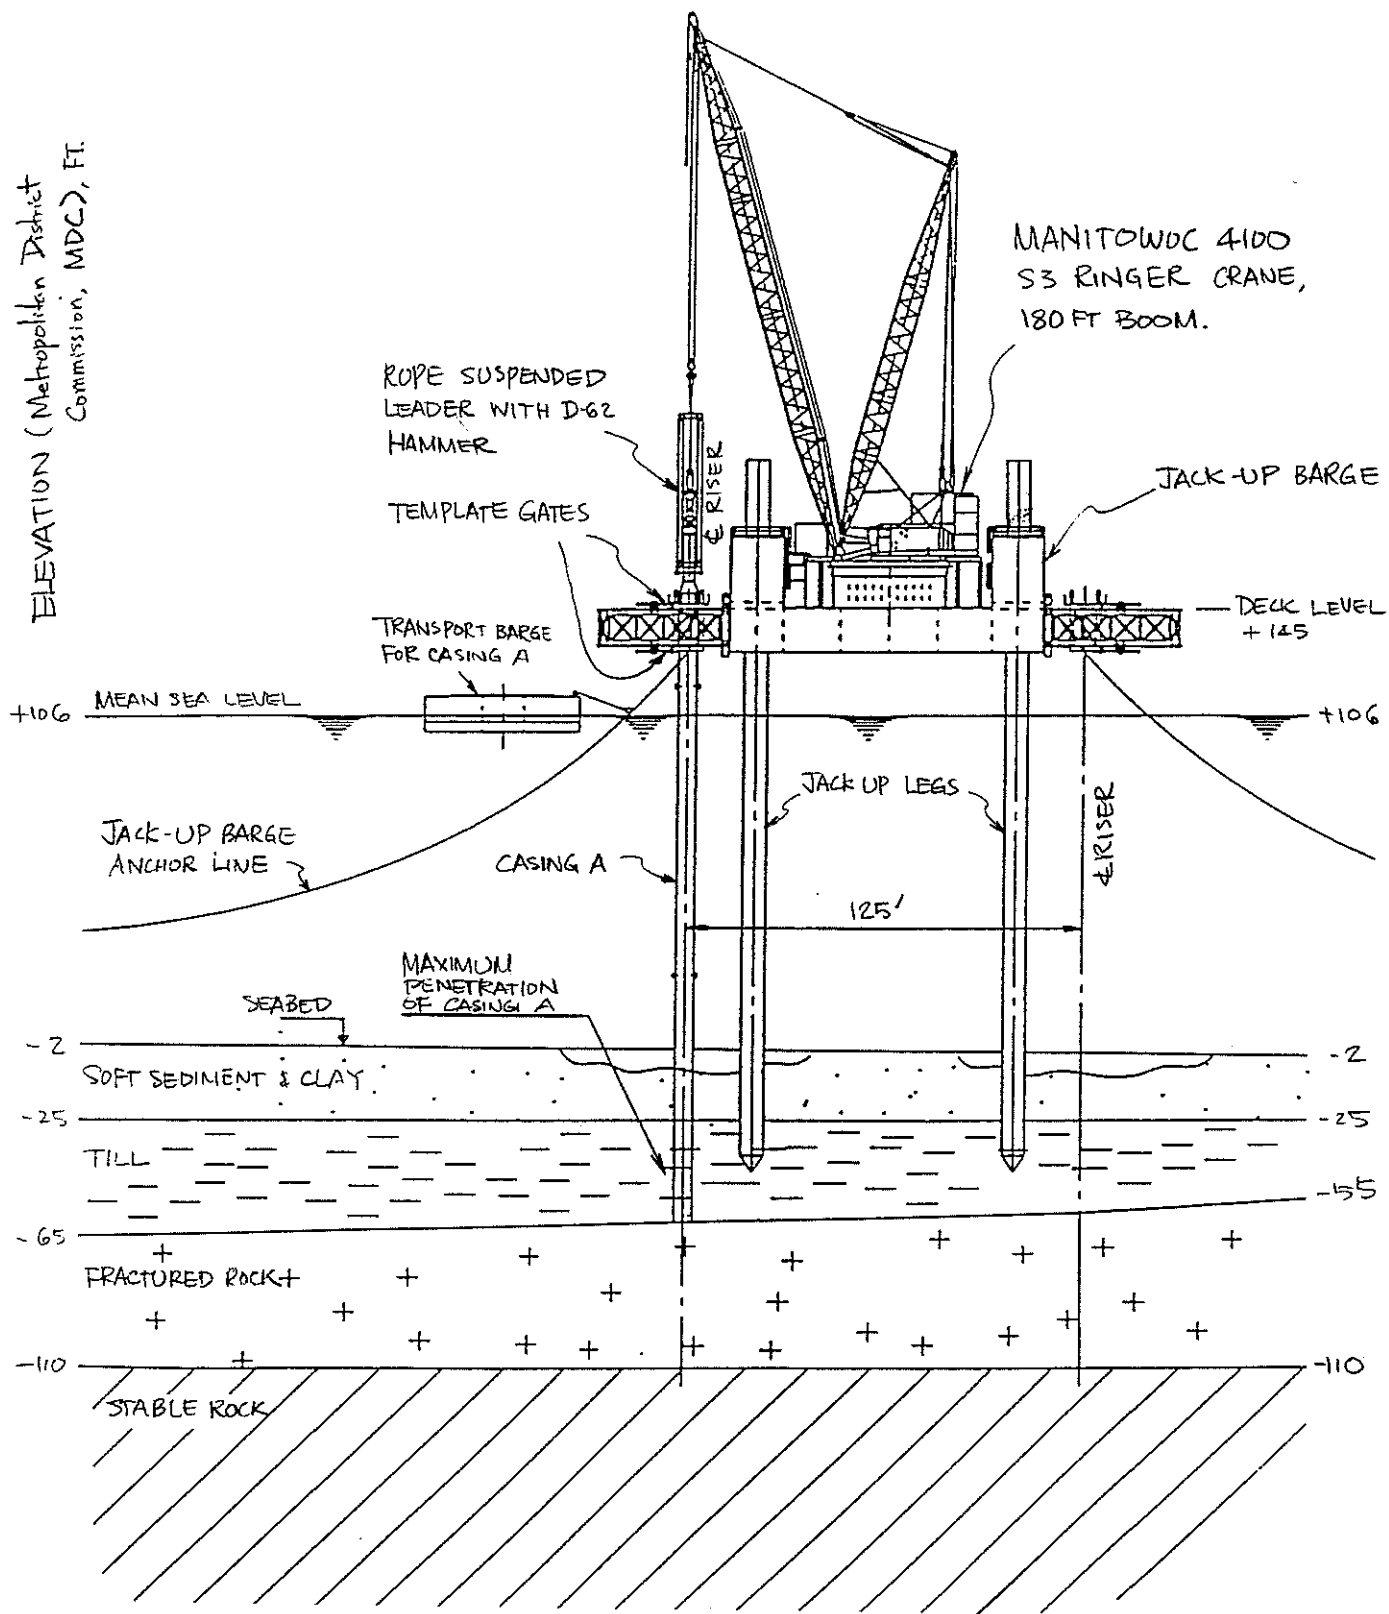
Figure 3-3 Elevation of the Jack-up Barge and the Casing A.  
(From the Contractor)

legs successively. Due to the weight of the barge and the negative friction of the other pair of legs, all four legs could be embedded into the glacial till layer. Then, jack-up the barge above the sea level to the desired elevation. (See Figure 3-3)

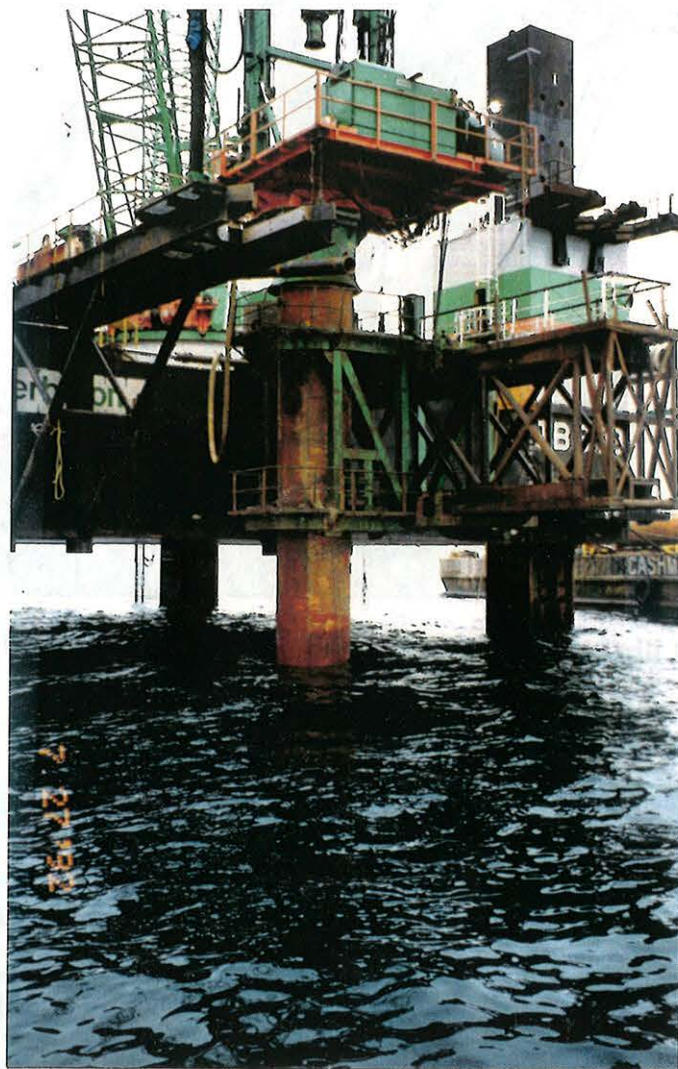
Figure 3-4

3. After the upper and lower template gates were correctly positioned, pitch the casing A into template gates and lower the casing until its weight is supported in the seabed. Note that the casing A was a temporary casing, 68 inches in diameter and 0.625 inch wall thickness, and was not required by the contract. The Contractor at his discretion used this casing to stabilize the drilled hole through the overburden material and to support the drill unit through the entire drilling process. (See Figure 3-4)

A Close View of the Casing A and the Template Gates.  
(Note: This picture was taken on July 27, 1992, when the drilling operation was complete.)

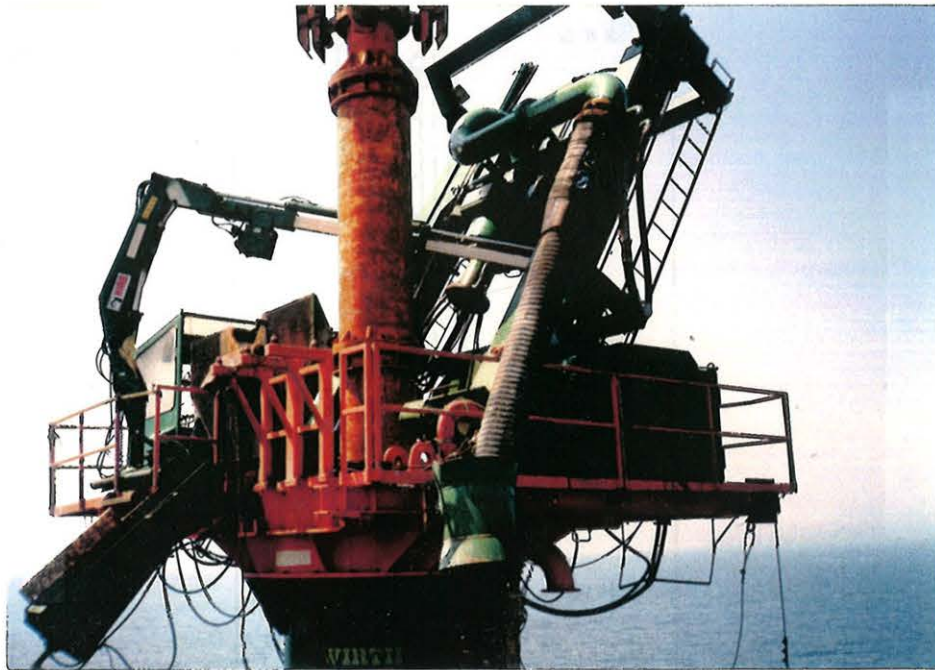
Figure 3-5

5. After the drill unit was clamped onto the casing A, lower the bottom hole assembly (BHA) through the drill unit into the casing A and suspend it on the locks of the platform doors. Figures 3-5 and 3-6 present a view of the platform door in the open position on the drill unit and a close view of the platform door and the lock. Note that the purpose of the BHA was to provide the needed weight or the downward force for the unit to drill through the overburden and rock. The BHA weighed approximately 80 tons. (See Figure 3-7) Again, the casing A will settle with the added weight to a new balanced condition.

Platform Door in the Open Position on the Drill Unit.

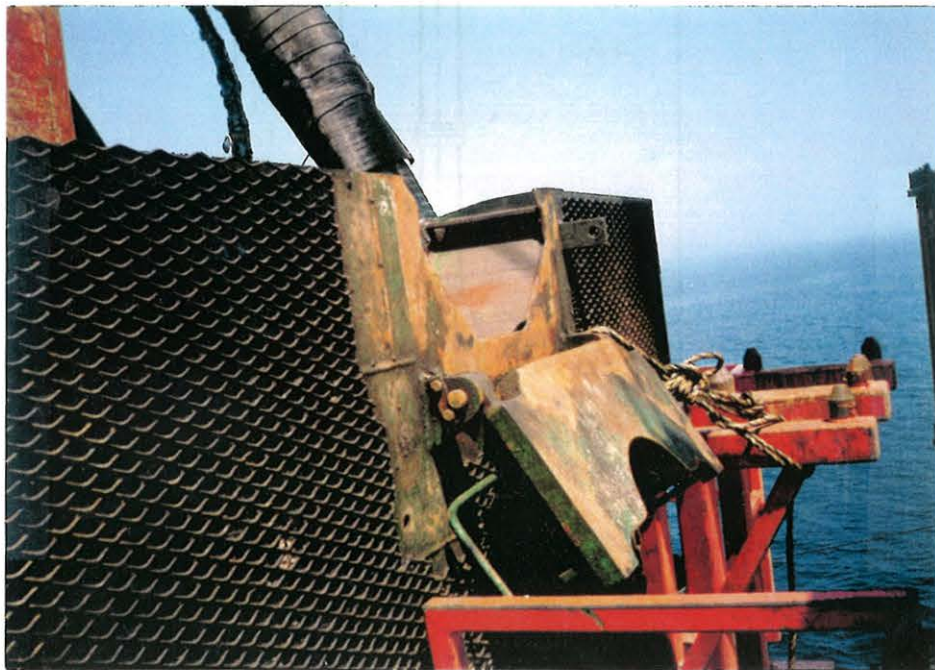
Figure 3-6

A Close View of the Upper Side of the Platform Door and the Lock.

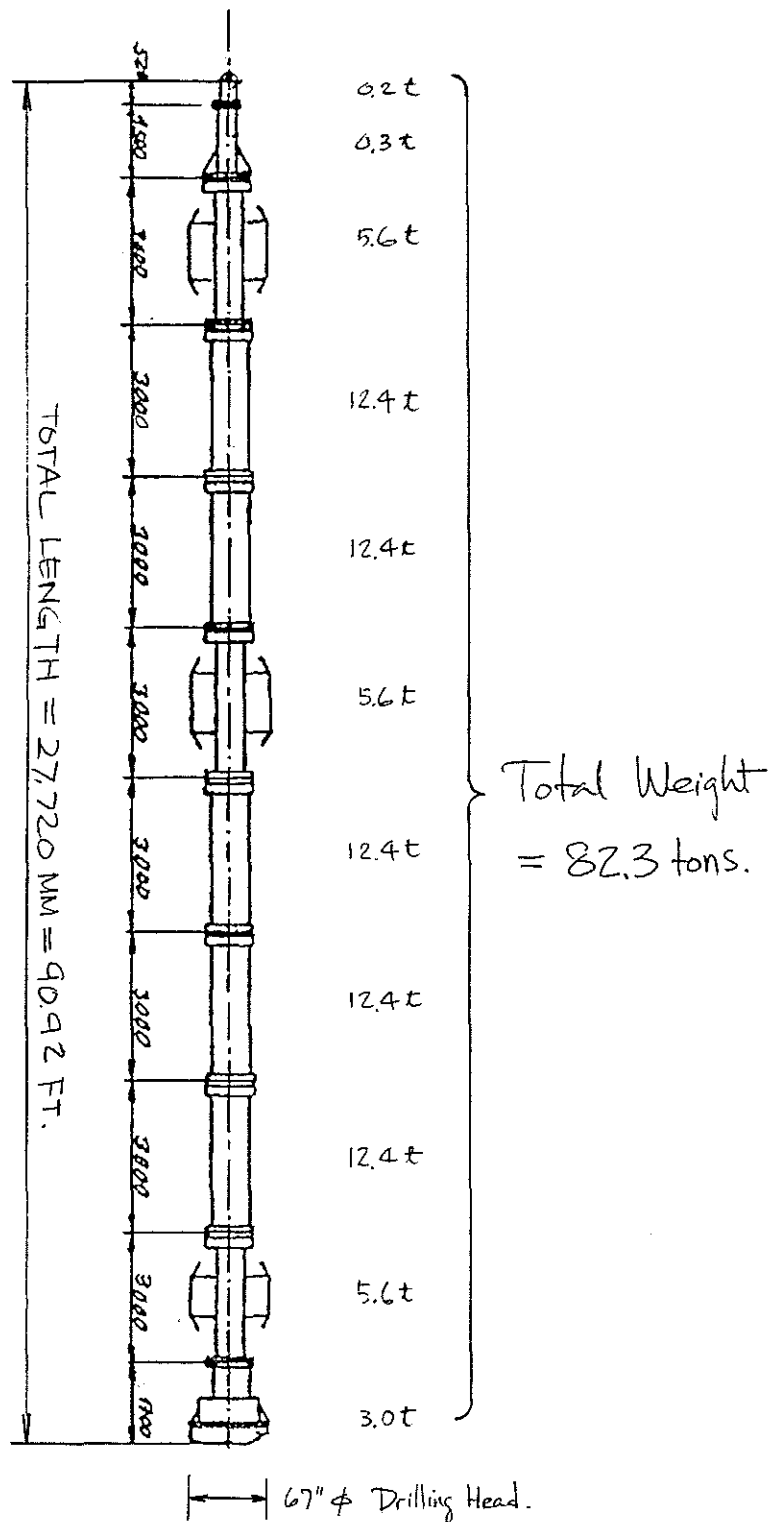
Figure 3-7

Dimension and Weight of the Bottom Hole Assembly  
(From the Contractor).

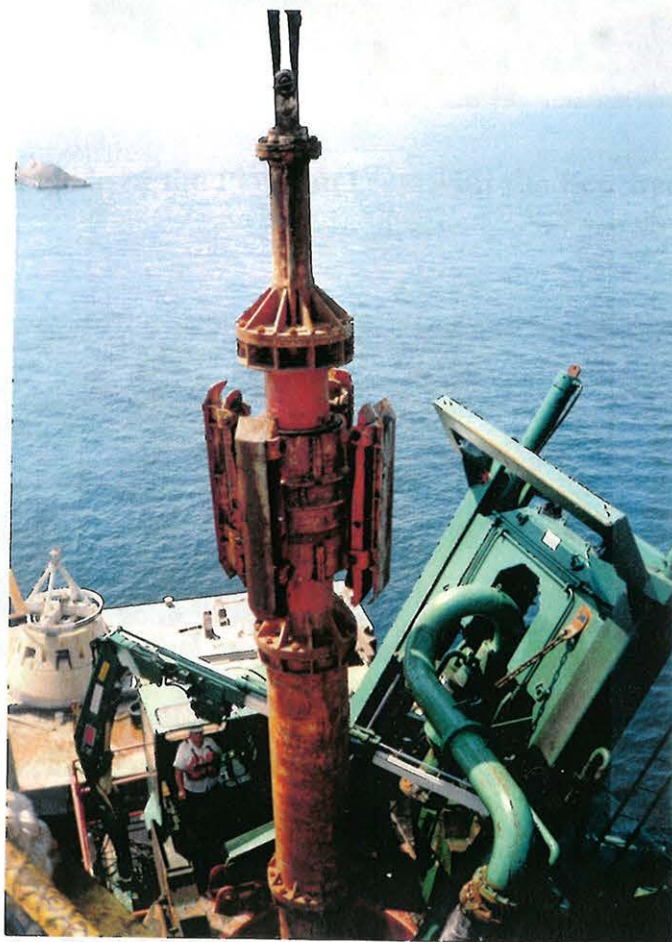
Figure 3-9

- o At this point, approximately at 6:30 am, as the total weight of the BHA was being released on top of the drill unit, a sudden drop of the casing A and the drill unit of approximately 25 feet occurred. At the same instance, the weight of the BHA was immediately supported again by the crane hoist lines thus keeping the BHA near stationary. Consequently, the drill platform doors were pushed upward by the wider part of the BHA below the doors. (See Figure 3-9). The hydraulic operating cylinders for the platform doors were destroyed. (See Figures 3-10 and 3-11)

Comparison of Sizes For Hoist Flange and the BHA to Drill String Connection.

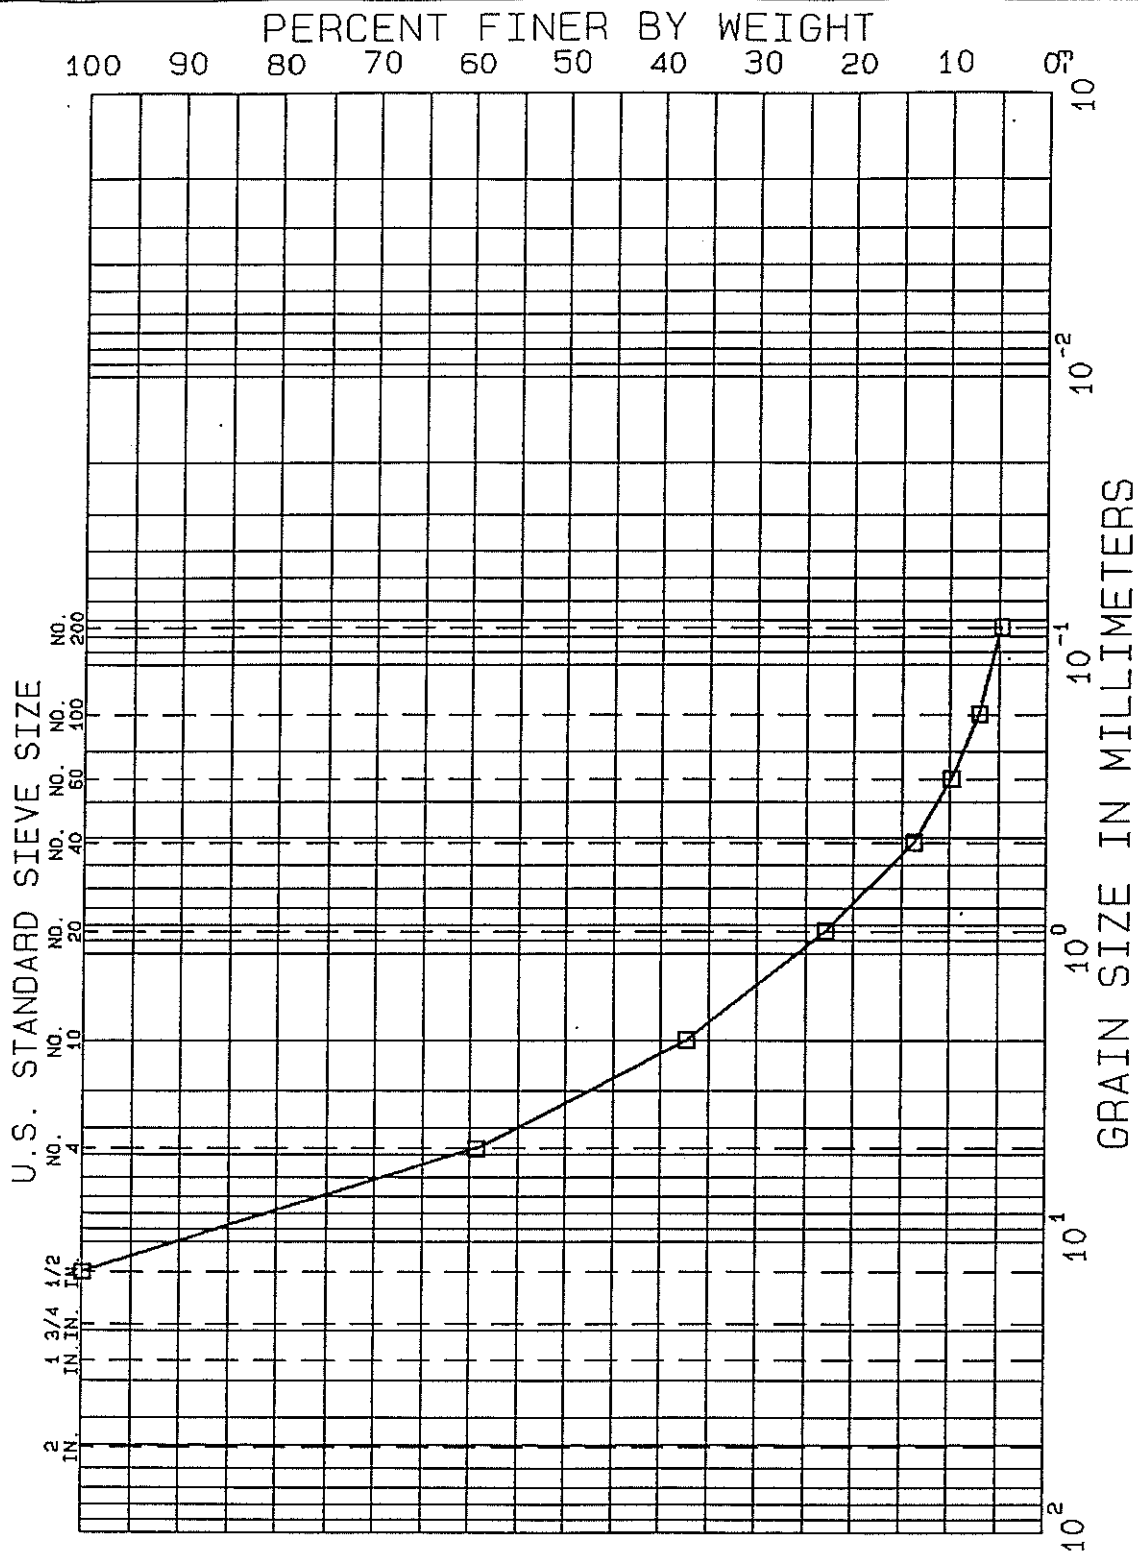
Brown m-c angular SAND and  
angular GRAVEL, trace Silt

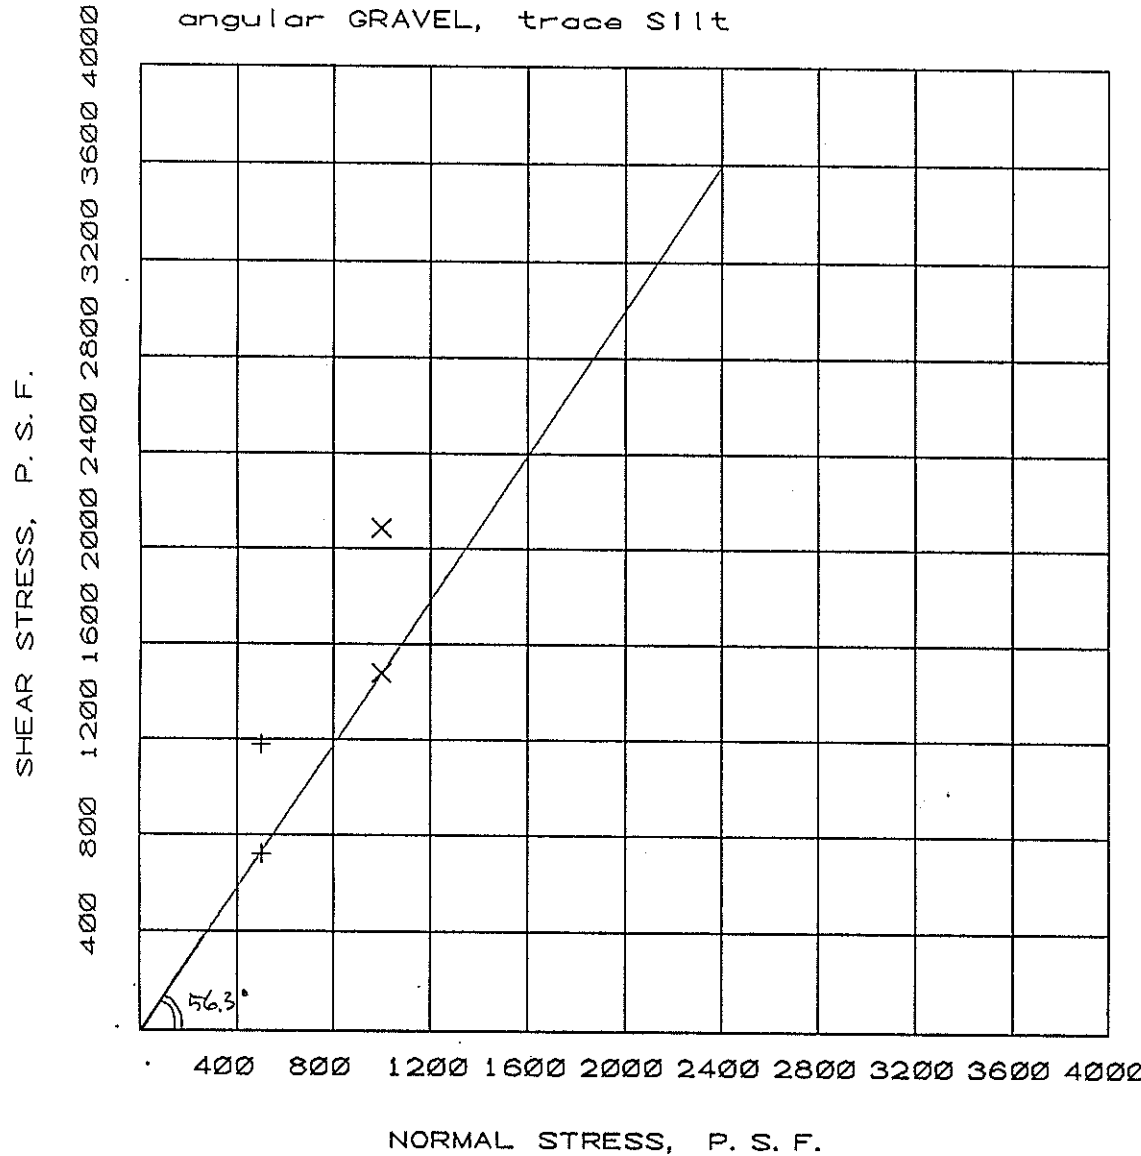
TEST NUMBER		PEAK STRESS: PSF		END POINT RESIDUAL STRESS: PSF	
		SHEAR	NORMAL	SHEAR	NORMAL
DS2. 1	+	1175	500	714	500
DS2. 2	X	2076	1000	1471	1000
