# Investigation of the April 14, 2021, Collapse of a Bridge Span under Demolition, Herbert C. Bonner Bridge, Dare County, NC

U.S. Department of Labor  
Occupational Safety and Health Administration  
Directorate of Construction

December 2021

Report prepared by  
Alan Lu, Ph.D., P.E.  
Office of Engineering Services  
Directorate of Construction

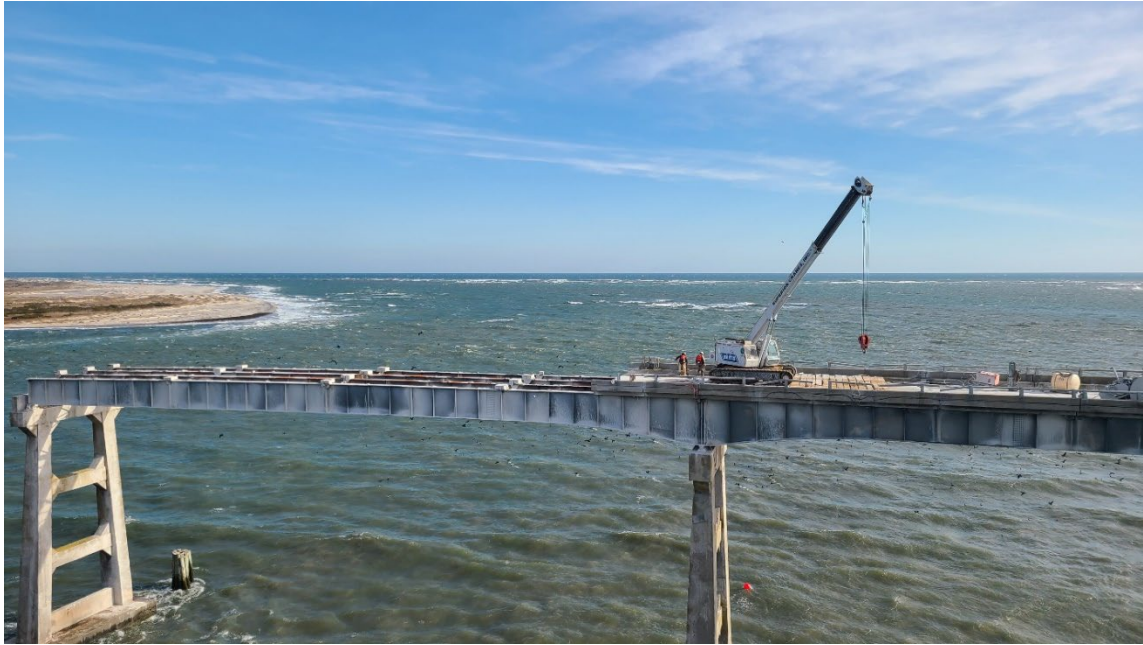
Figure 16 – Demolition of Spans 144 and 145  
(photographed on 3/2/2021 by NCDOT)

March 2, 2021, PCL began cutting the concrete deck in Span 145 (see Figure 16). PCL stockpiled deck overhang and parapet segments on Span 145 (see Figures 17 and 18). PCL did not follow KCI’s demolition plan, nor the supplemental memorandum dated February 25, 2021.

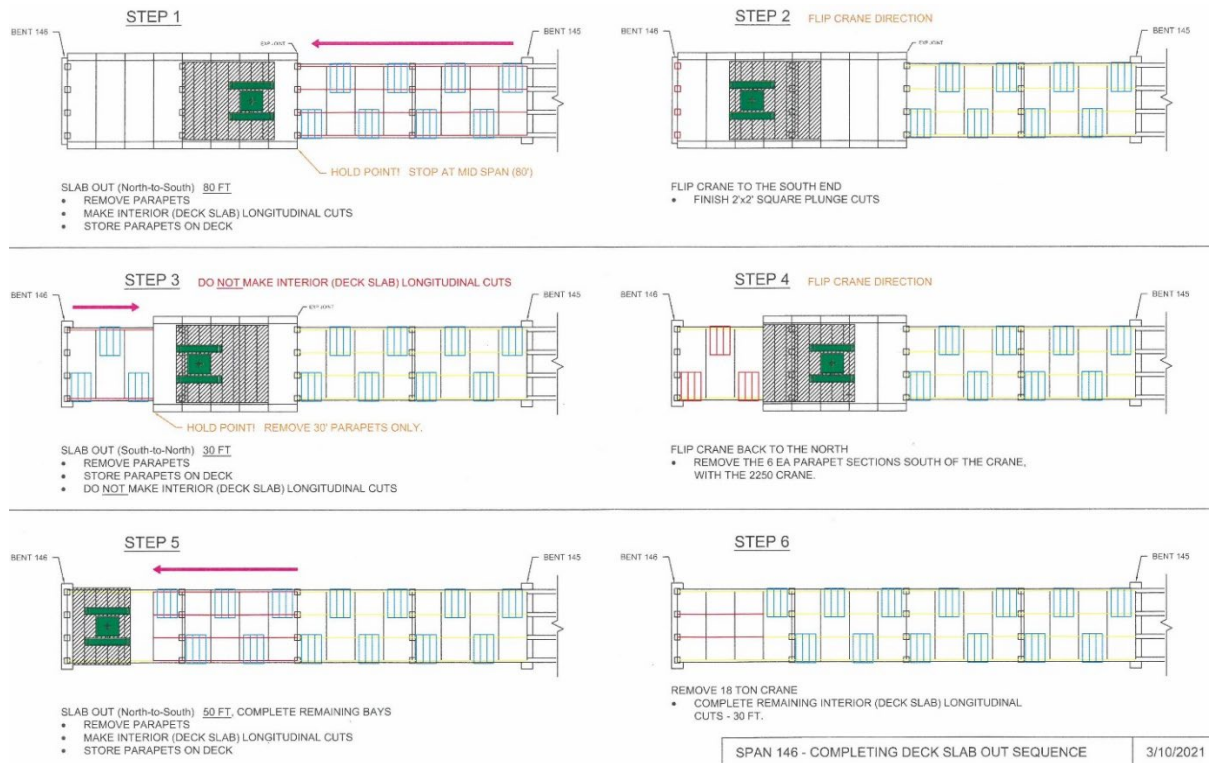
Figure 19 – PCL's demolition plan for Span 146 deck removal

March 10, 2021, PCL developed a plan for stacking deck overhang and parapet segments on Span 146 (see Figure 19). Figure 20 illustrates that PCL placed all overhang and parapet segments on Spans 145 and 146.

PCL neither consulted with KCI regarding PCL's demolition plans created on March 10 and 12, 2021, nor submitted the plans to NCDOT.

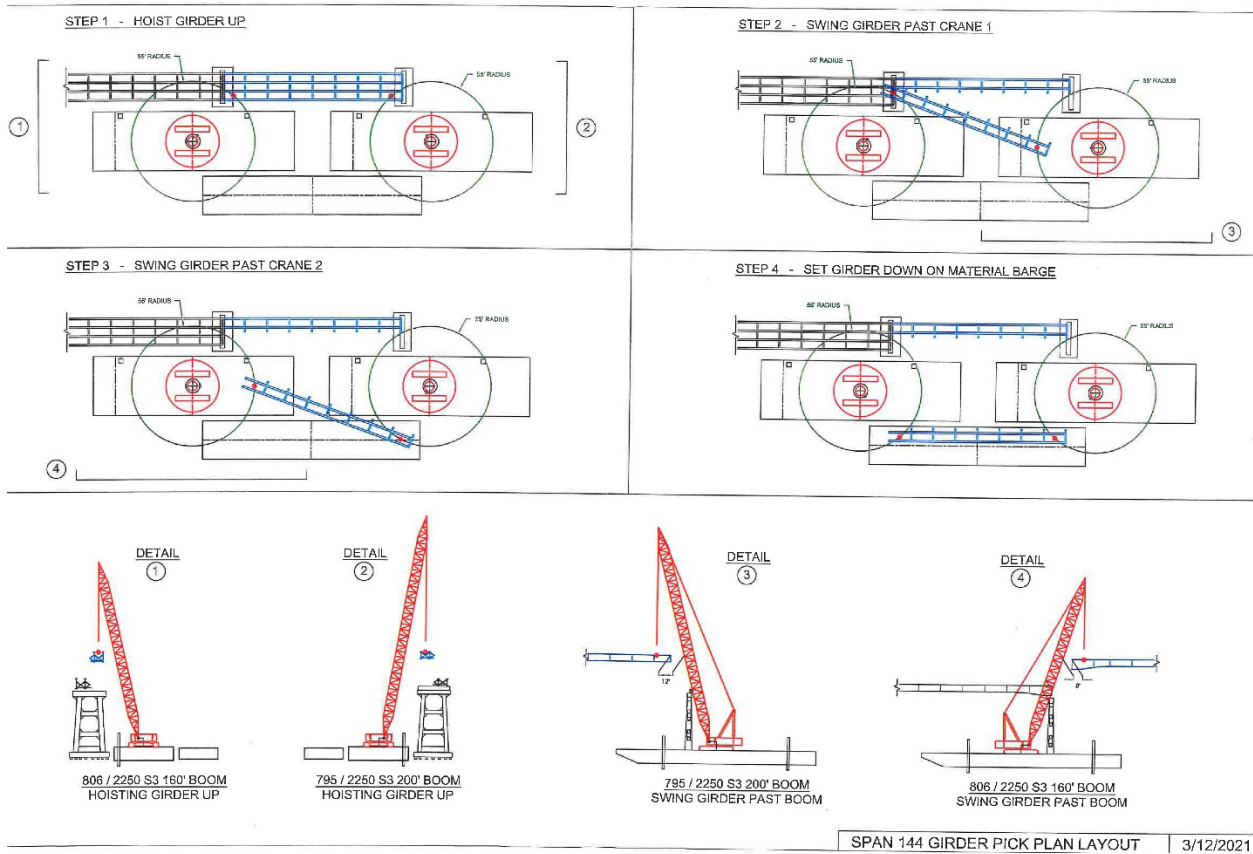
Figure 21 – PCL's demolition plan for Span 144 girder removal

March 12, 2021, PCL developed a plan for the removal of the steel girders in Span 144 (see Figure 21).

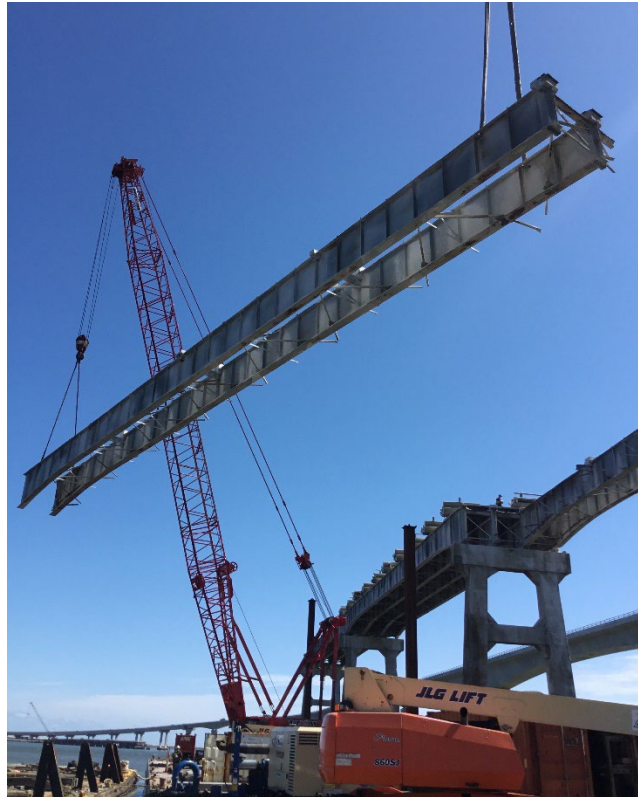
Figure 22 – Removal of Span 144 girders  
(photographed on 3/30/2021)

March 30, 2021, PCL removed all steel girders in Span 144 (see Figure 22).

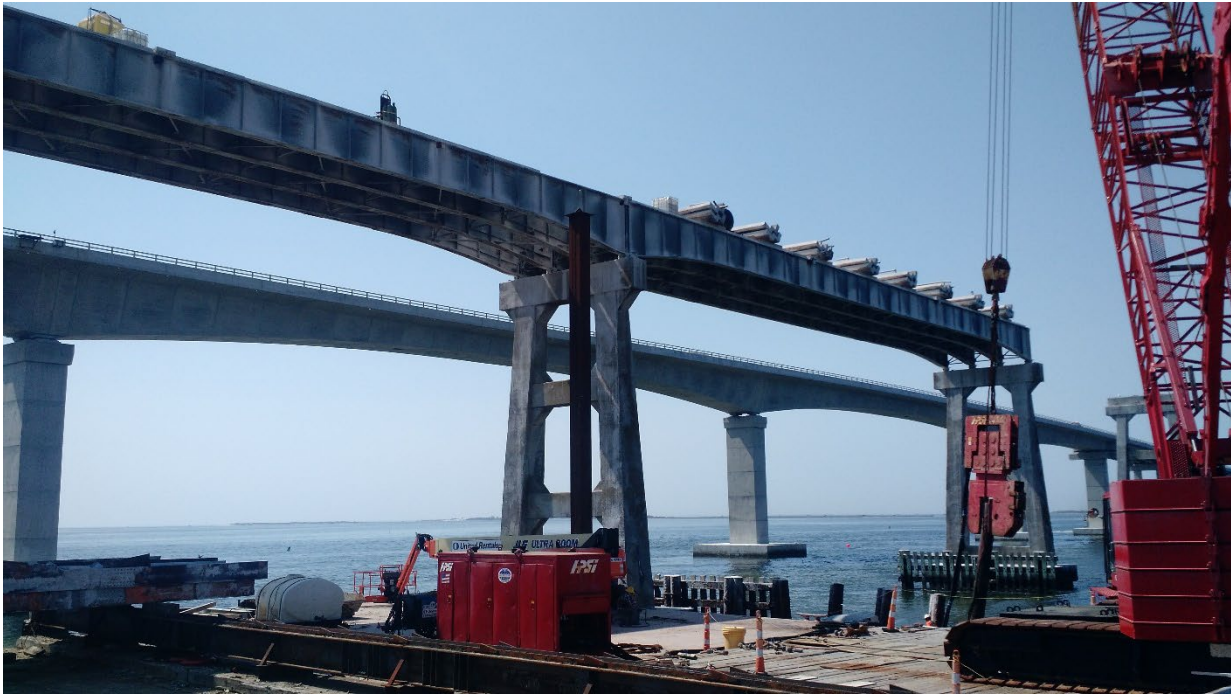
Figure 23 – Parapet segments in Span 146 had been removed  
(photographed on 4/7/2021)

April 7, 2021, PCL started removing the deck in Span 146 (see Figure 23).

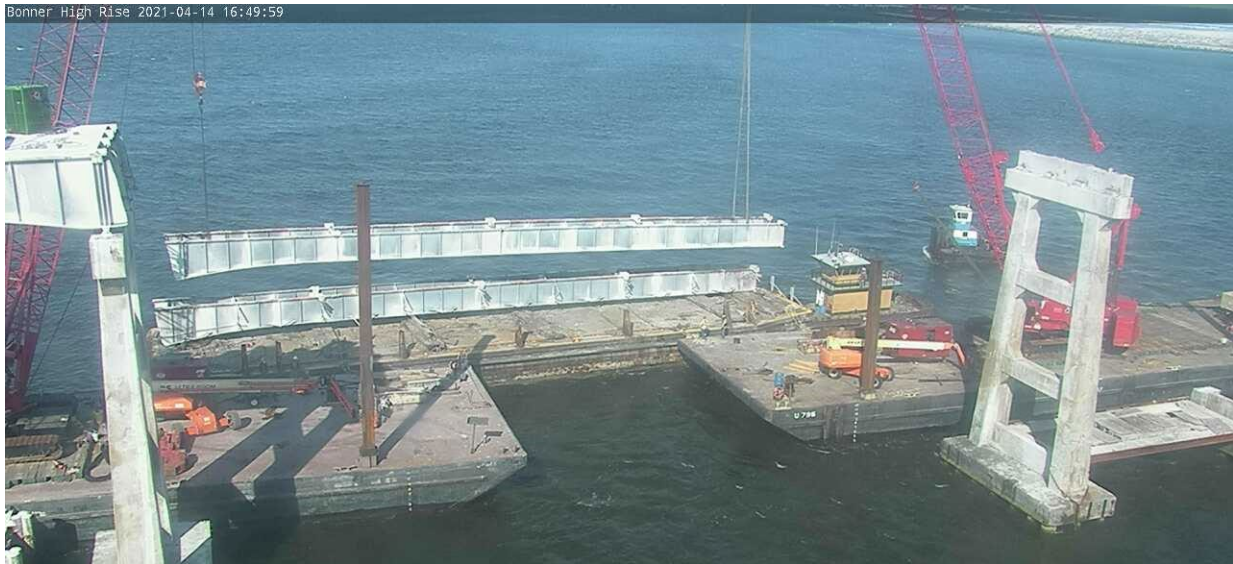
Figure 25 – Steel girders in Span 146 had been removed  
(photographed on 4/14/2021 by NCDOT)

April 14, 2021, PCL cut the four steel girders in Spans 145 and 146 at Bent 145 and removed the four girder segments in Span 146 utilizing two marine cranes (see Figure 25). Shortly after Span 146 was removed, Span 145 collapsed (see Figure 26).

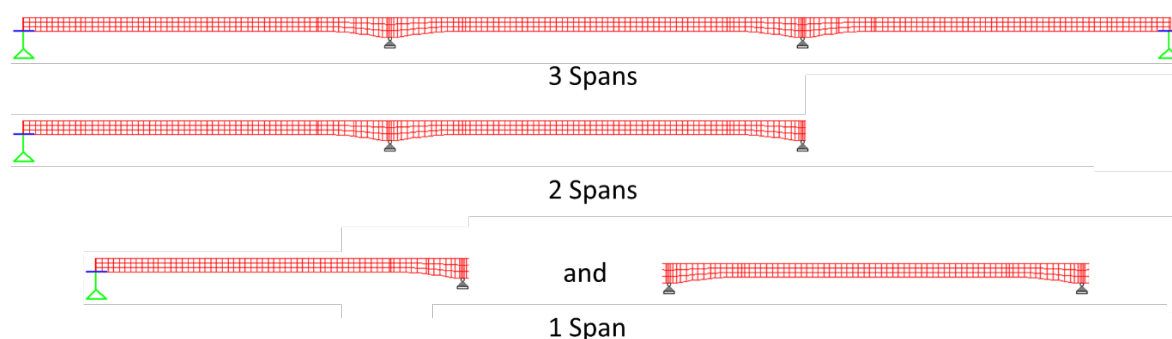
Figure 32 – FE model of steel girders in three spans

Figure 32 illustrates the 3D FE model of the steel girders created in STAAD.Pro using coarse meshes<sup>10</sup> for all analysis cases in Table 1. Main plate girder components, including flanges, webs, and stiffeners, were modeled using 4-noded (quadrilateral) plate elements, which had both attribute membrane (in-plane effect) and bending (out-of-plane effect). The supports at both ends of Span 145 were pin supports, and the supports at Bents 143 and 146 were rollers, as shown in Figure 32.

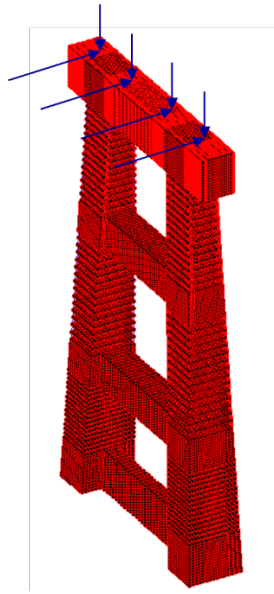
Figure 34 – 3D FE model of Bent 144/145

Figure 34 shows the 3D FE solid model for Bents 144 and 145 developed in STAAD Pro. Support reactions from the girder analyses were applied as vertical and horizontal concentrated forces at the four bearing supports on the top of the bent (blue arrows in Figure 34). The column section forces, including axial and shear forces and bending moments, were obtained after the analyses. Hand calculations were also performed using the column section and material properties from the as-built drawing to determine the load-carrying capacities of the columns (see Figure 35). We did not consider concrete deterioration and reinforcement corrosion in the columns when determining their load-carrying capacities.
