Investigation of the August 5, 2002, Collapse of Tilt-Up Precast Concrete Wall Panel In Greensboro, NC

U.S. Department of Labor
Occupational Safety and Health Administration
Directorate of Construction

September 2002

Report prepared by
Mohammad Ayub, PE
Dinesh Shah, PE

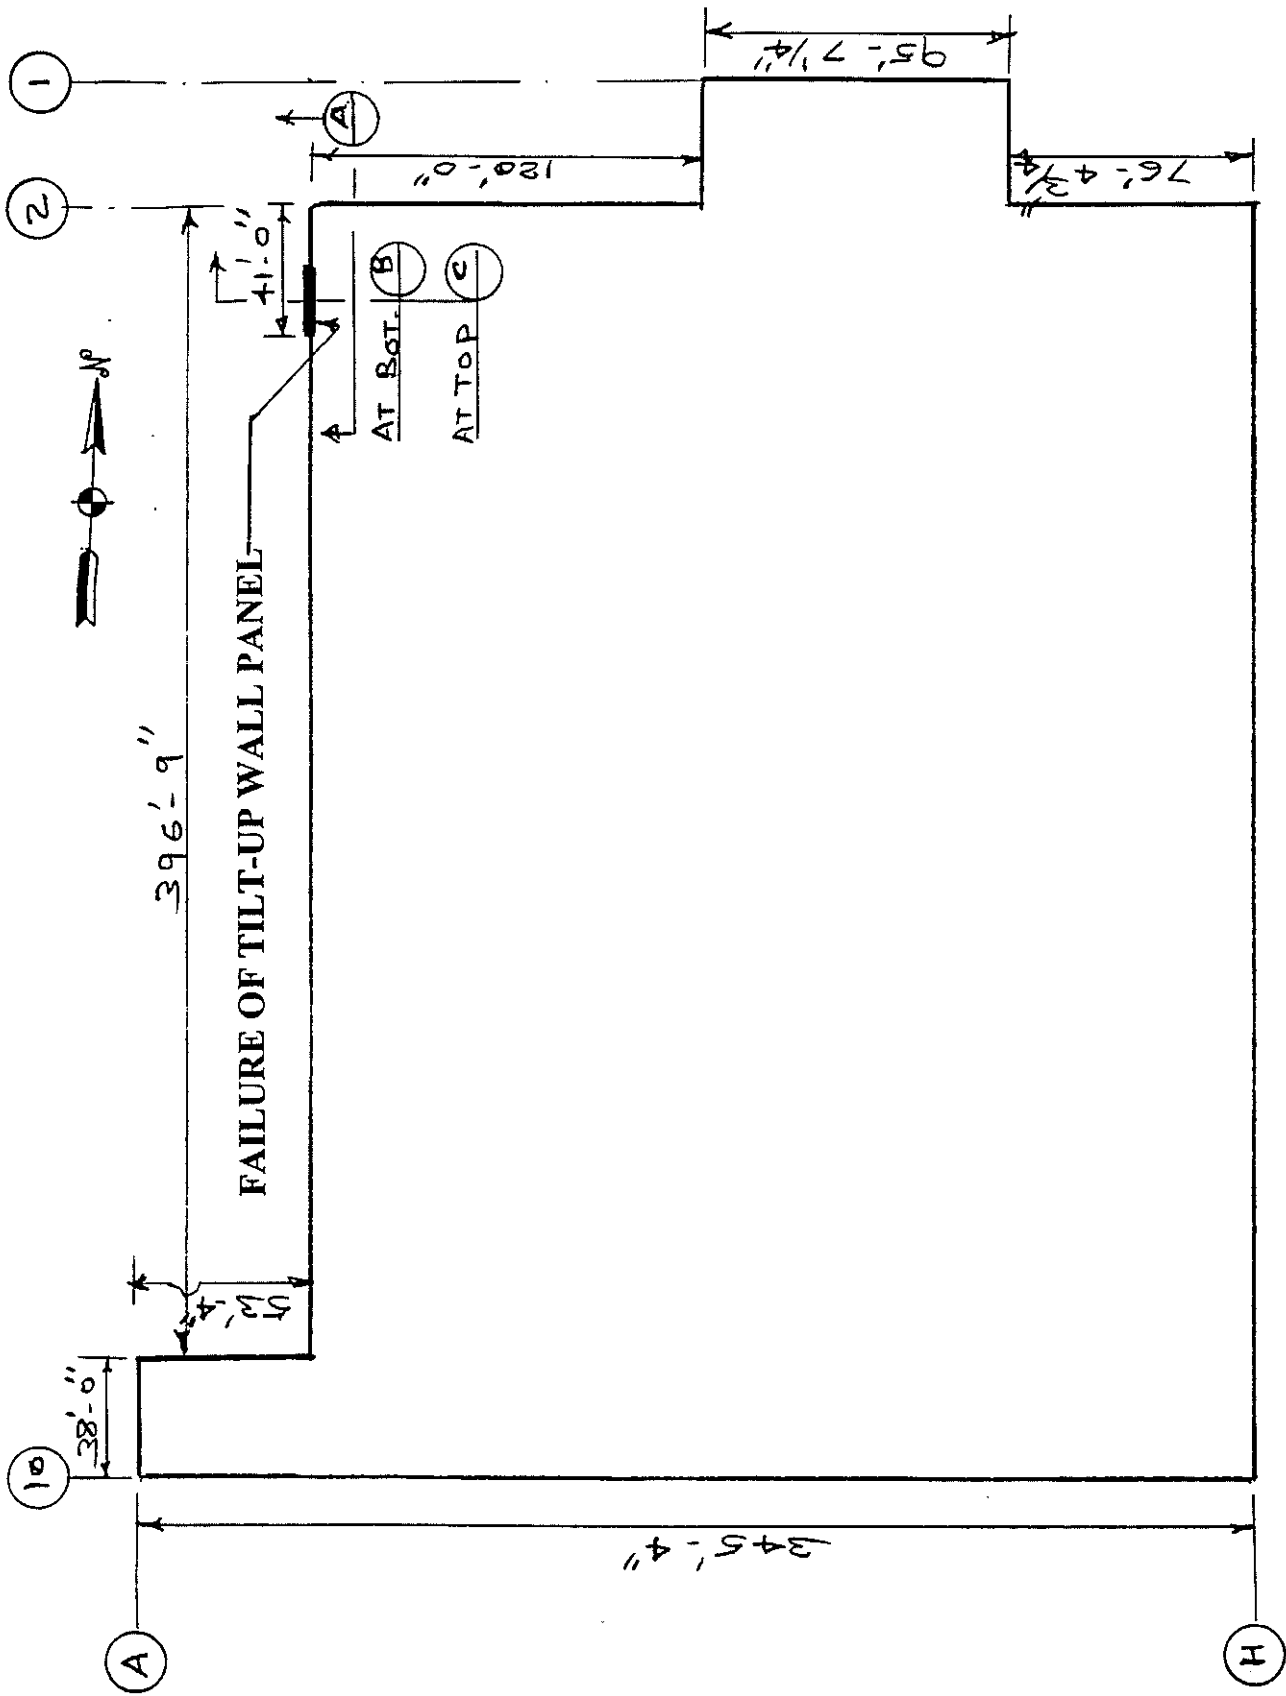
FIGURE 1

The failed wall was part of the perimeter of the building for Home Depot Store (figures 1, & 2), under construction at 2912 South Elm-Eugene Street, Greensboro, NC. The structure is comprised of steel framing with steel columns, steel joist girders and joists. The joists of the exterior bays were supported over the tilt-up wall panels. The panel in question was 6 1/2" thick, approximately 23 feet high and 20 feet wide. It was supported over the foundation wall over shims at each end. The adjoining panels on either side of the failed panel were of similar construction and were also supported on shims. Later, the space between the tilt-up wall and the foundation wall was to be grouted with high strength grout; and the tilt-up wall panel was to be connected to the slab on grade by a closure strip i.e. comprising of the last 4' of the slab on grade (figure 3). At the top of the wall, there were three steel plates embedded in the wall to support the steel joists. The embedded steel plates were 6 1/2" x 12" x 1/4".

SCHEMATIC PLAN (BOUNDARY OF TILT-UP CONCRETE WALL PANEL)
