Investigation of the June 20, 2001, Partial Collapse of the Mast Climbing Platform at Cambridge, MA

U.S. Department of Labor
Occupational Safety and Health Administration
Directorate of Construction

December 2001

Report prepared by
Mohammad Ayub, PE
Dinesh Shah, PE

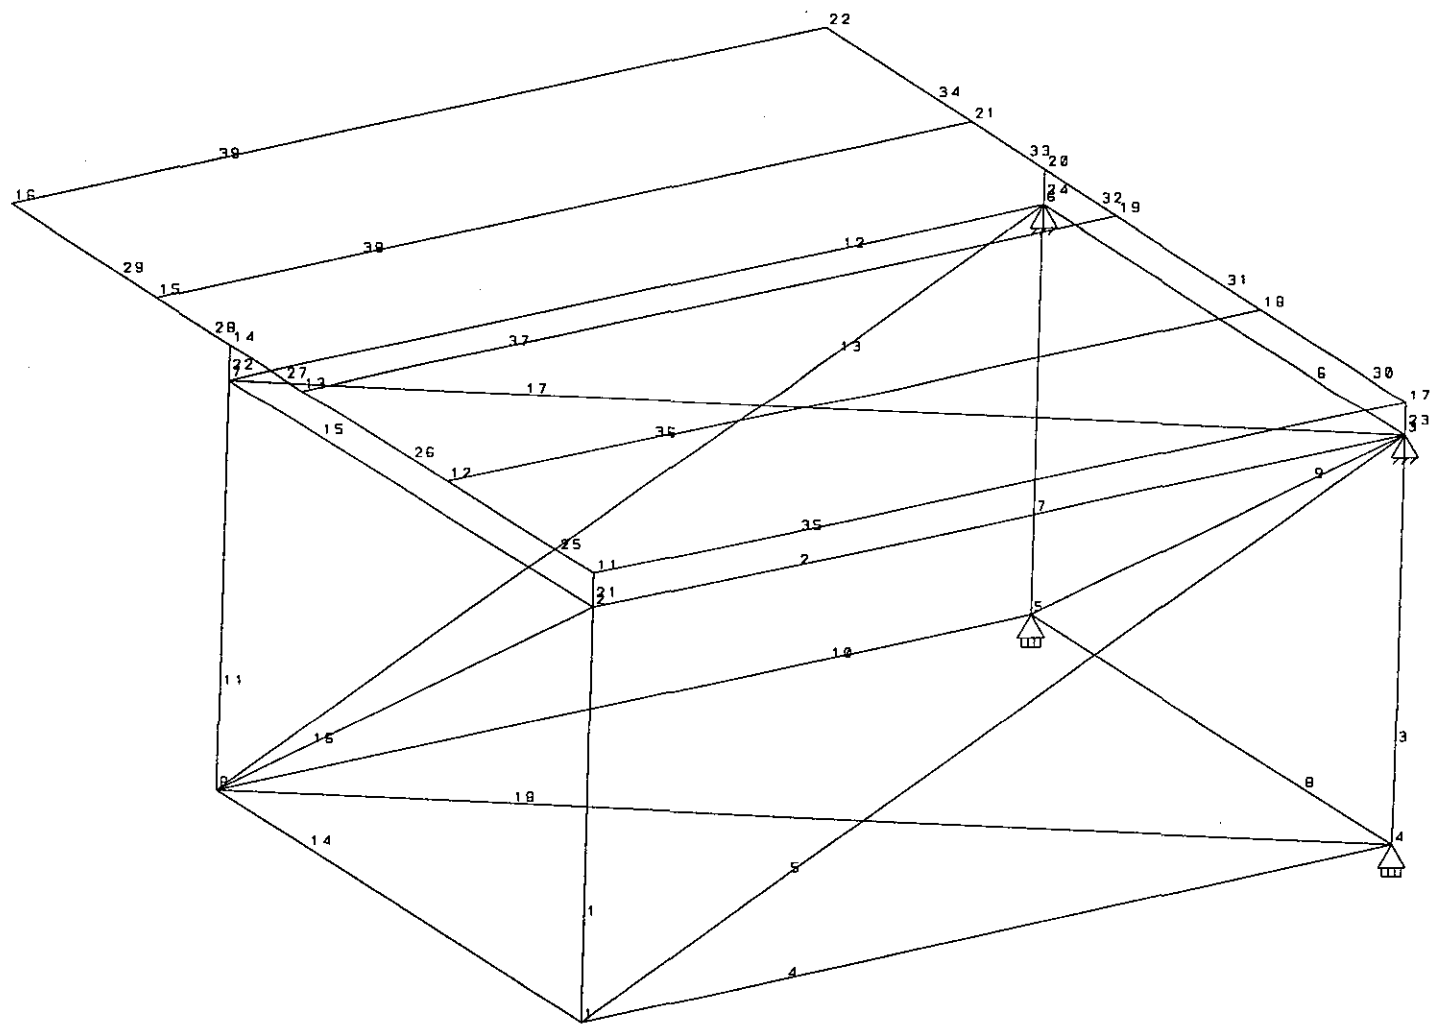
STAAD POST - PLOT (REV: 22.3a)
TITLE: "UDL IN MID PLATFORM; TW=0.125"; REV.R2T

Our analysis indicated that a bottom horizontal member parallel to the longitudinal axis of the platform was stressed beyond its ultimate capacity to the point of failure, due to the loads placed over four sections. The horizontal member was a compression member whose failure load was computed to be 16,700 pounds, based upon the full thickness of $1/8"$. However, if the thickness is assumed to be $0.1"$, as measured in the field, the failure load is reduced to 13,900 pounds. The member was subjected to a compressive load of 19,300 pounds due to the actual loads placed over four sections, and hence the failure. Compressive members are highly sensitive to loads
