Investigation of the September 24, 2002, Collapse of the 1965-foot High KDUH-TV Antenna Tower in Hemingford, Nebraska

U.S. Department of Labor Occupational Safety and Health Administration Directorate of Construction

March 2003

Report prepared by Mohammad Ayub, PE Dinesh Shah, PE

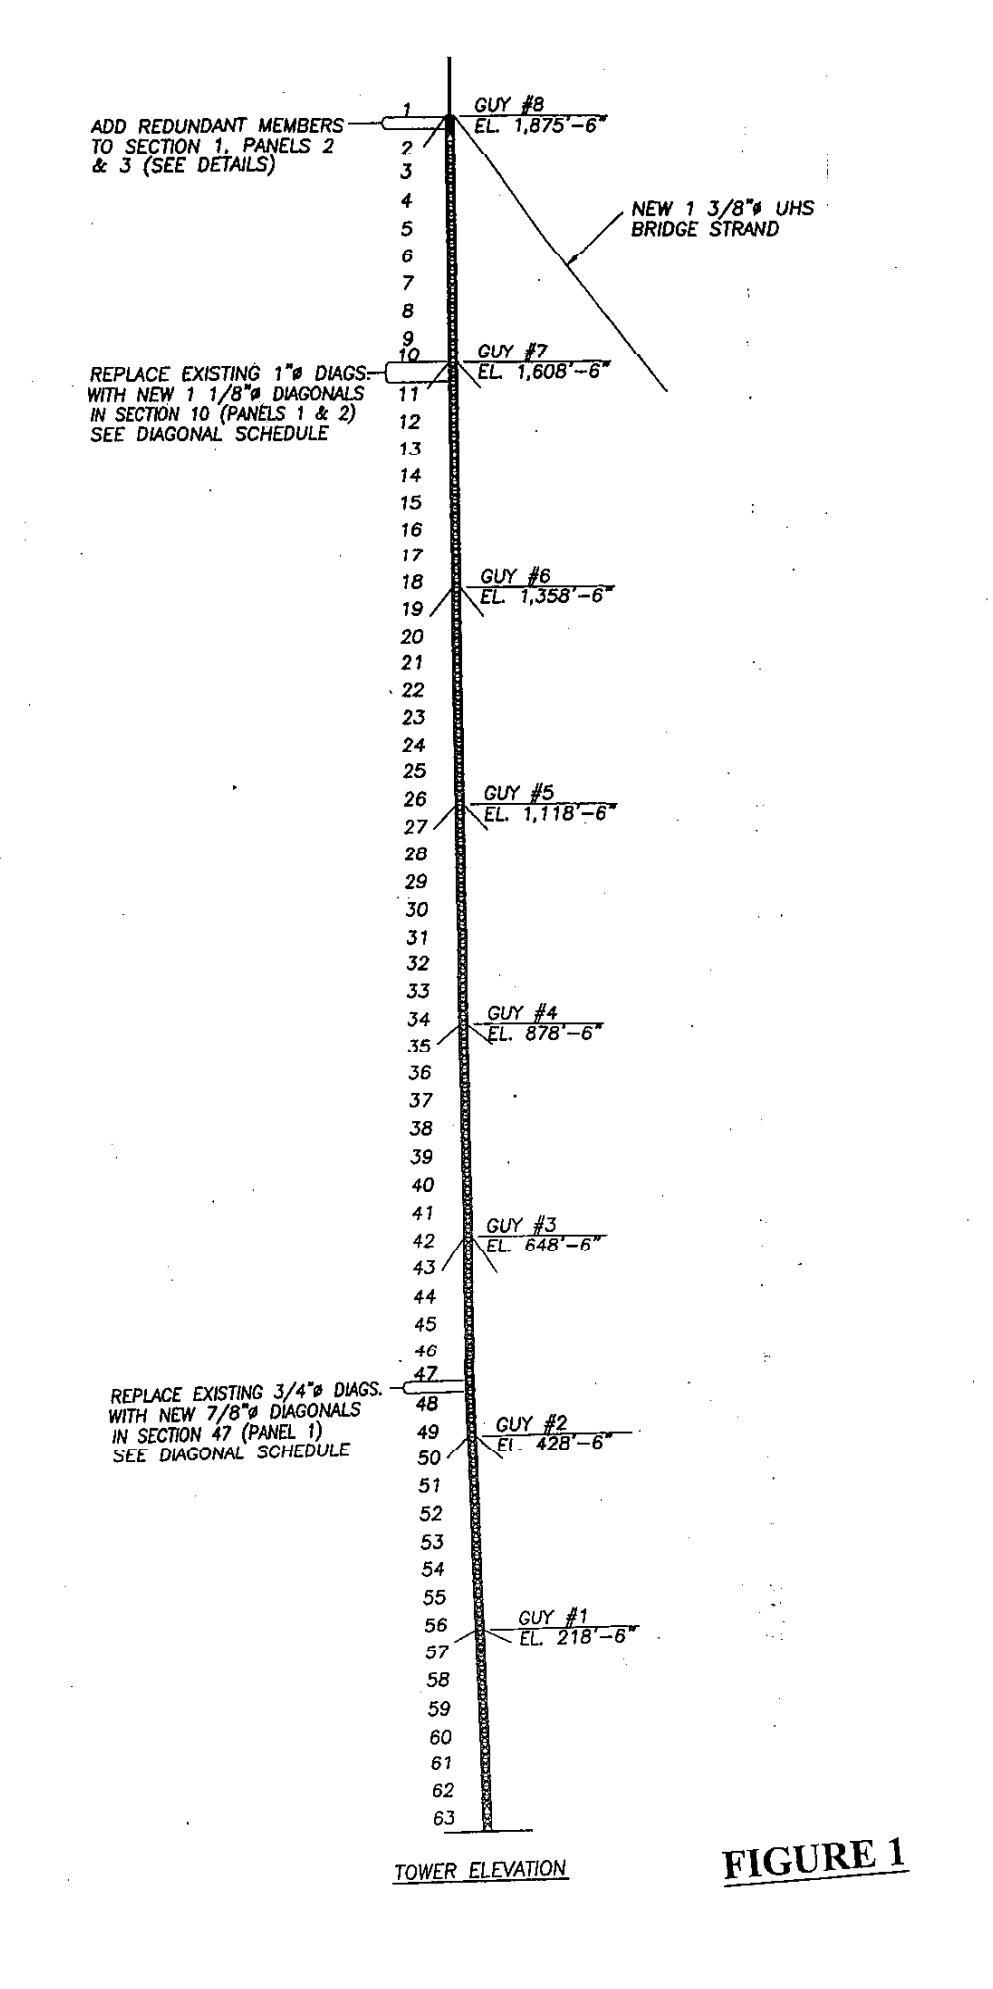
The antenna tower (Figure 1) was originally erected in 1968. To support the new High Definition TV antenna, the structural engineer of record determined that certain structural members be replaced. The tower had been previously modified in 2001 by replacing guy wires with larger guy wires. The new modifications required replacement of the structural members in sections 1, 10, & 47. The subcontractor, Mid Central, planned to begin work simultaneously on lower section 47, and upper section 10; and later on top section 1. On September 24, 2002, two employees of Mid Central were working at the site, one on section 10 and another at section 47. An employee of the Weathercraft Roofing Co. was working at the base of the tower. The tower collapsed around 11:45 a.m., when the workers were replacing structural members at section 10 and 47, killing the two workers of Mid Central. The third Weathercraft Roofing Co. employee on the ground suffered minor injuries.
