Investigation of the July 23, 2003, Collapse of Custom Cantilever Finishing Platform in Panama City, FL

U.S. Department of Labor Occupational Safety and Health Administration Directorate of Construction

December 2003

Report Prepared by Mohammad Ayub, PE Dinesh Shah, PE

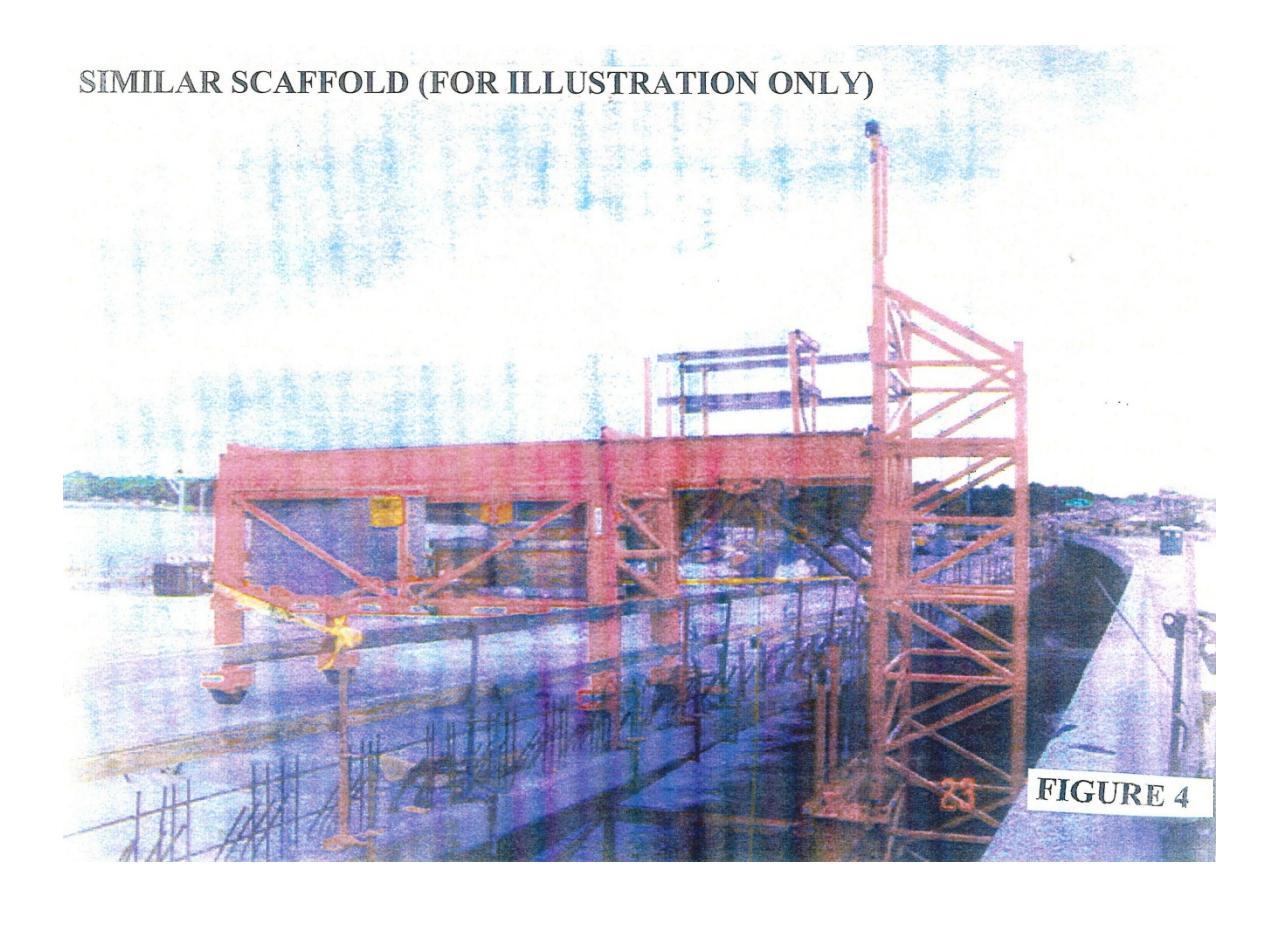
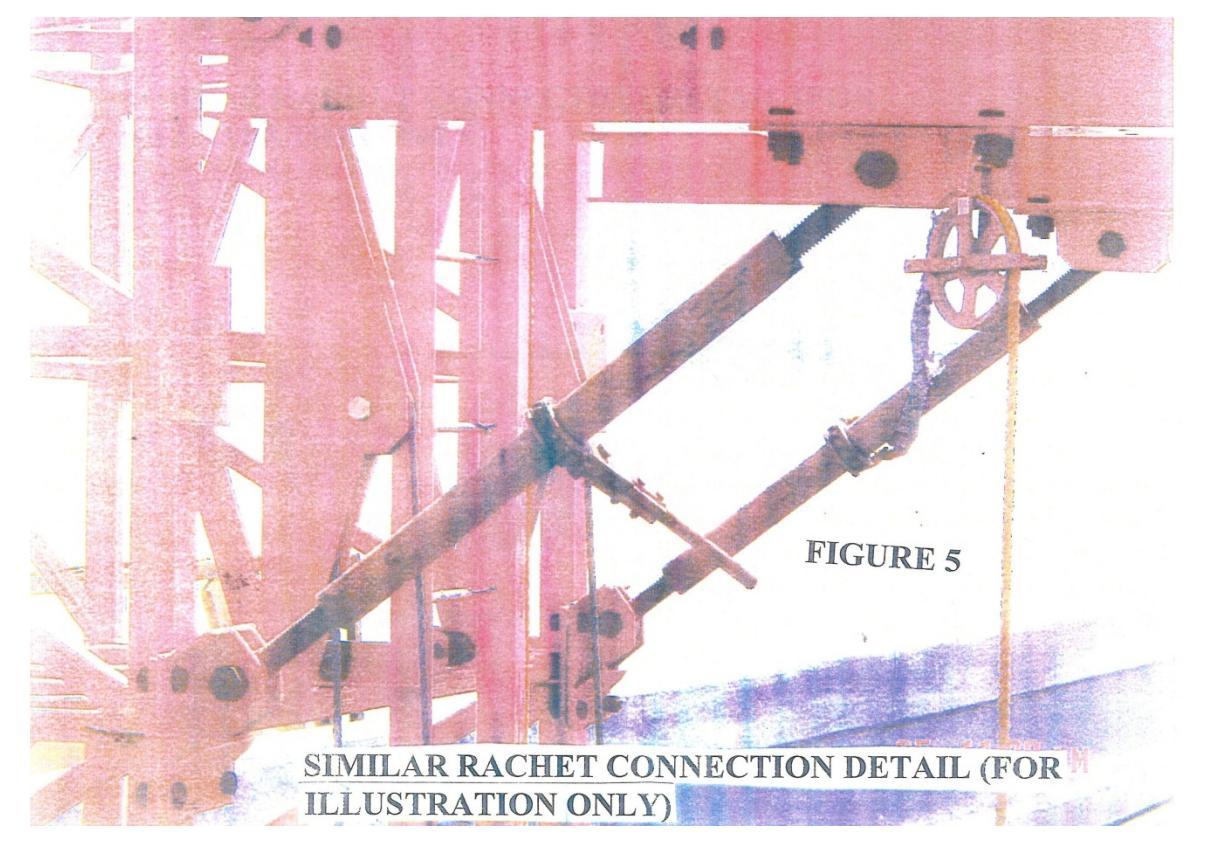
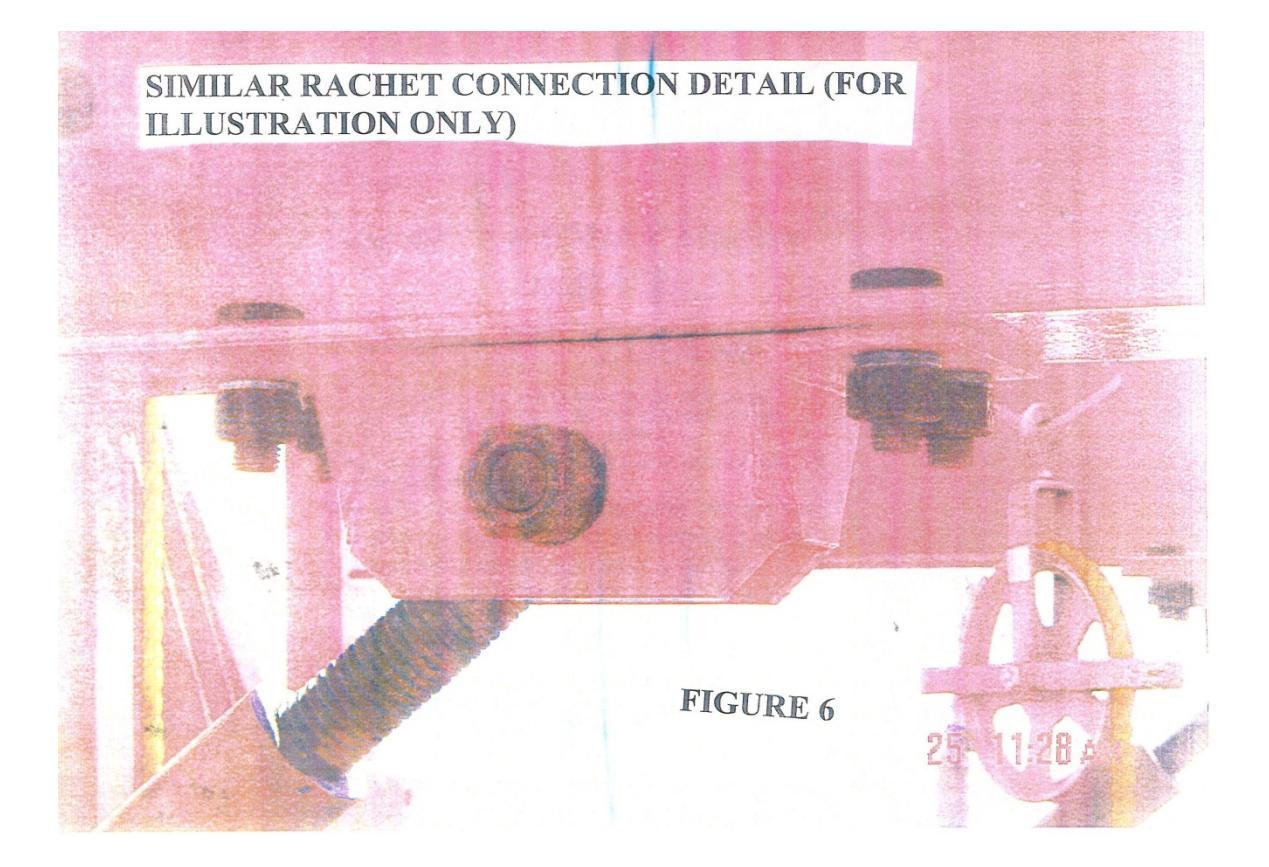
The incident occurred in the morning hours of July 23, 2003 as a work crew of four employees was placing grout bags and other materials on the cantilever section of the scaffold. The scaffold was custom-designed for the project by United Form Services, Inc., of Neodesha, KS and was known as Custom Cantilever Style Finishing Work Platform'. As the grout bags were placed on the cantilever section of the scaffold, the scaffold suddenly failed, causing the four employees to slip and fall into the water. One employee was killed but the other three survived with varying degrees of injuries. Figures 4, 5 and 6 show a similar scaffold not involved in the incident.

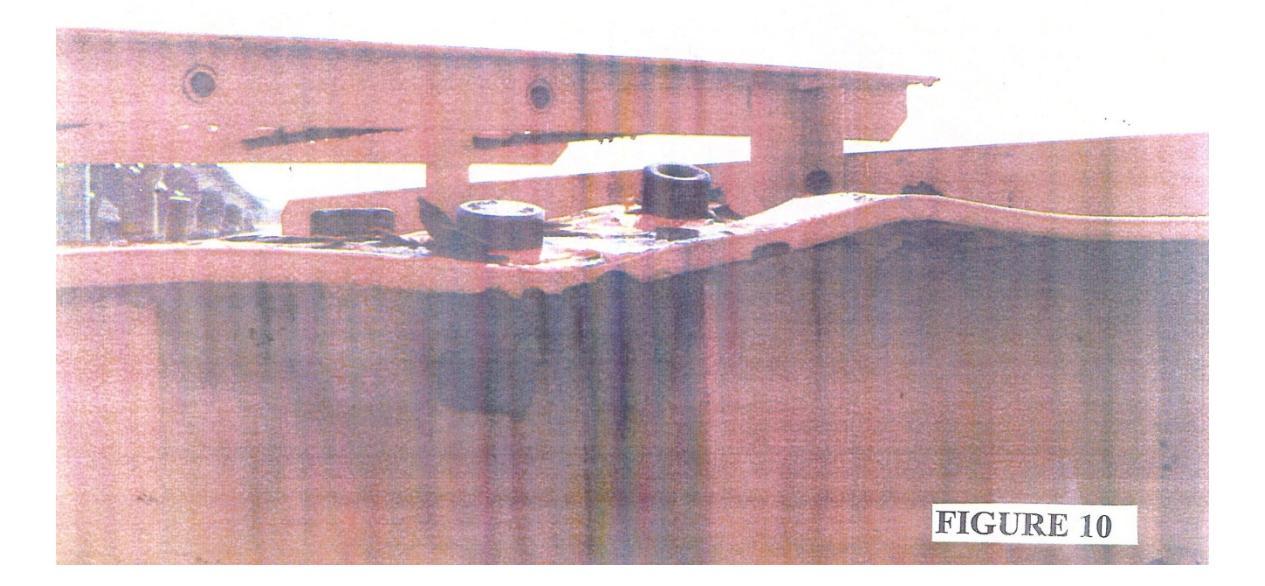
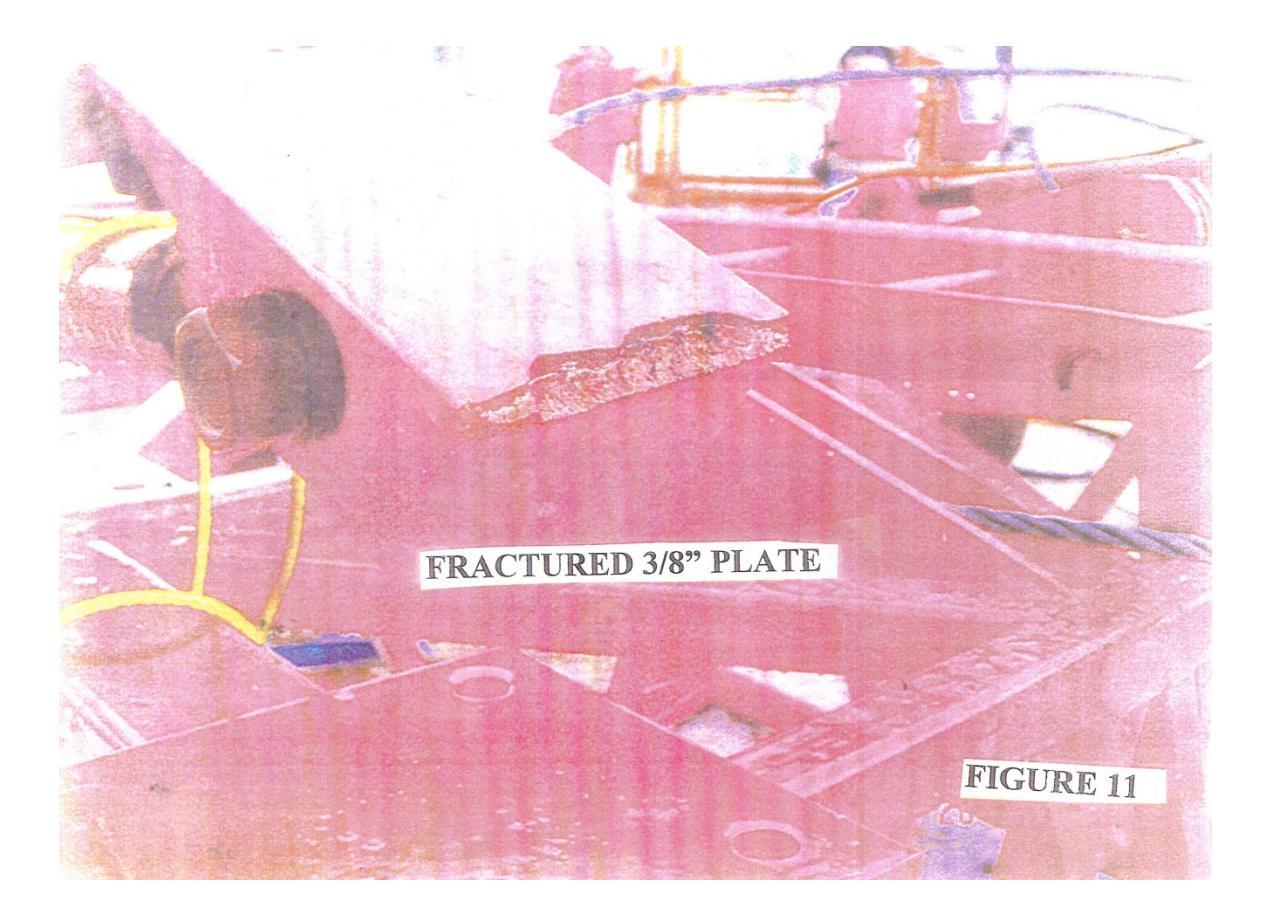
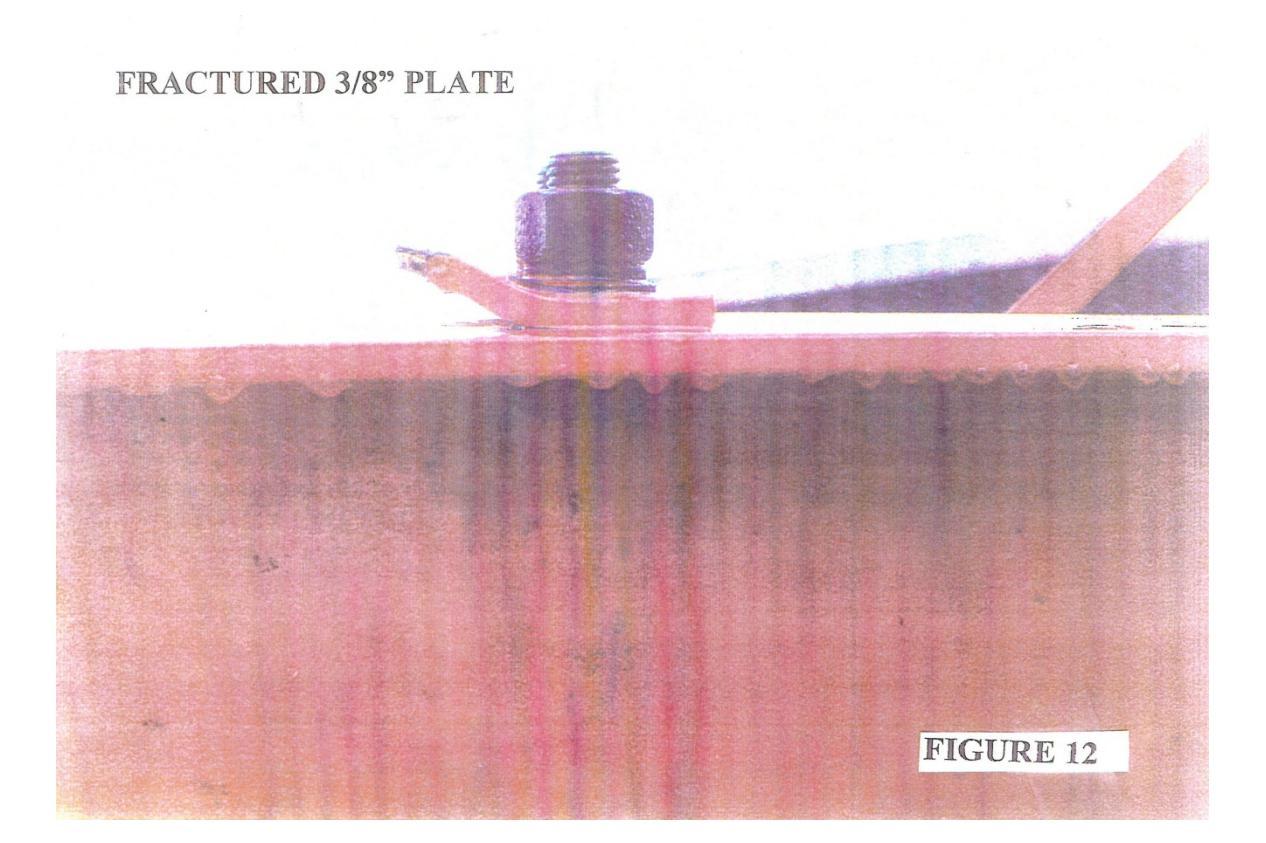
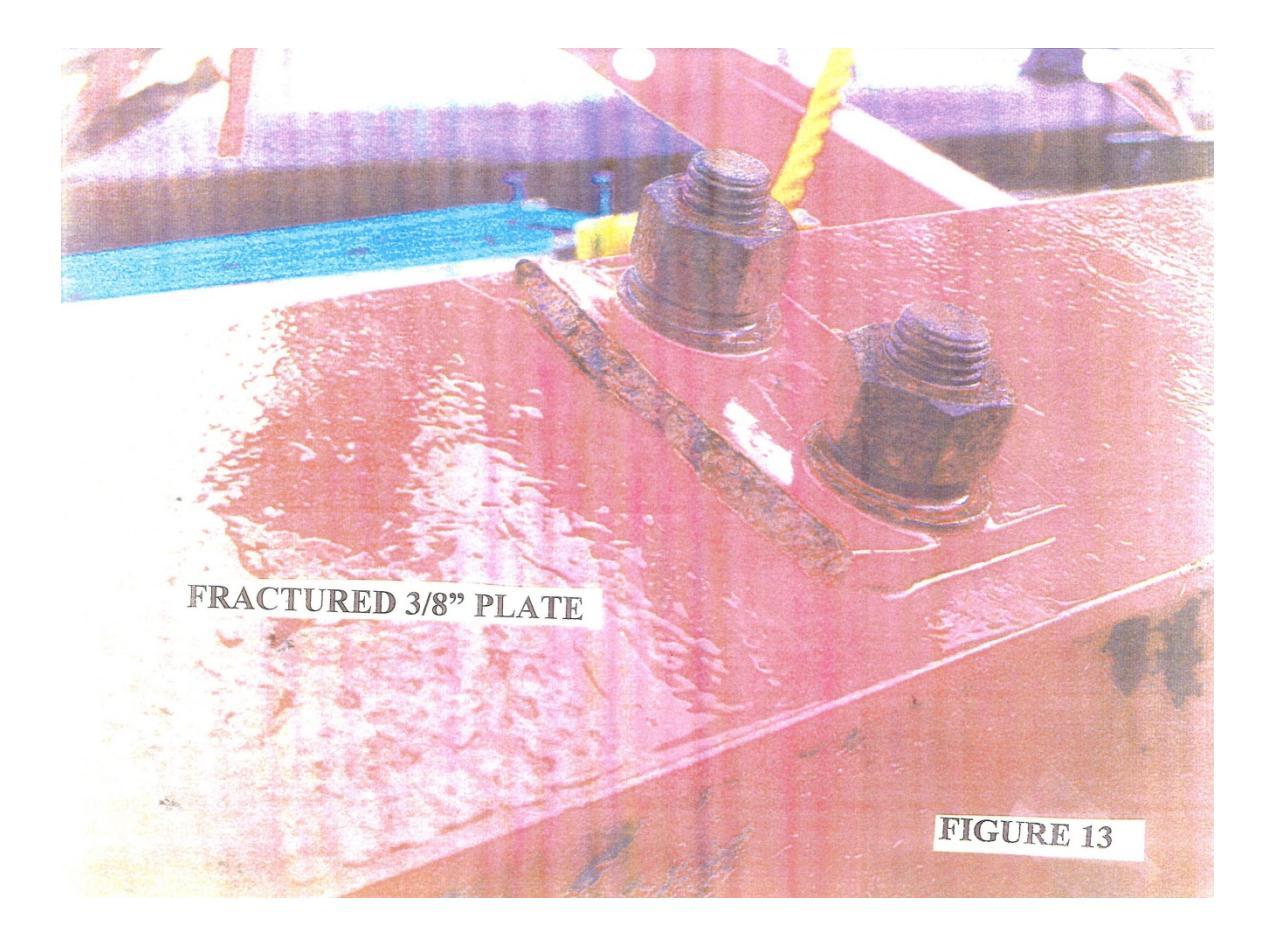
Field observation of the collapsed scaffold indicated that the critical failure occurred at the 3/8" connection plate of the ratchets to the bottom flange of the outrigger beams.
