INVESTIGATION OF THE AUGUST 22, 2006, FATAL EXCAVATION COLLAPSE AT RED HOOK, ST. THOMAS, U.S. VIRGIN ISLANDS

U.S. Department of Labor
Occupational Safety and Health Administration

February 2007

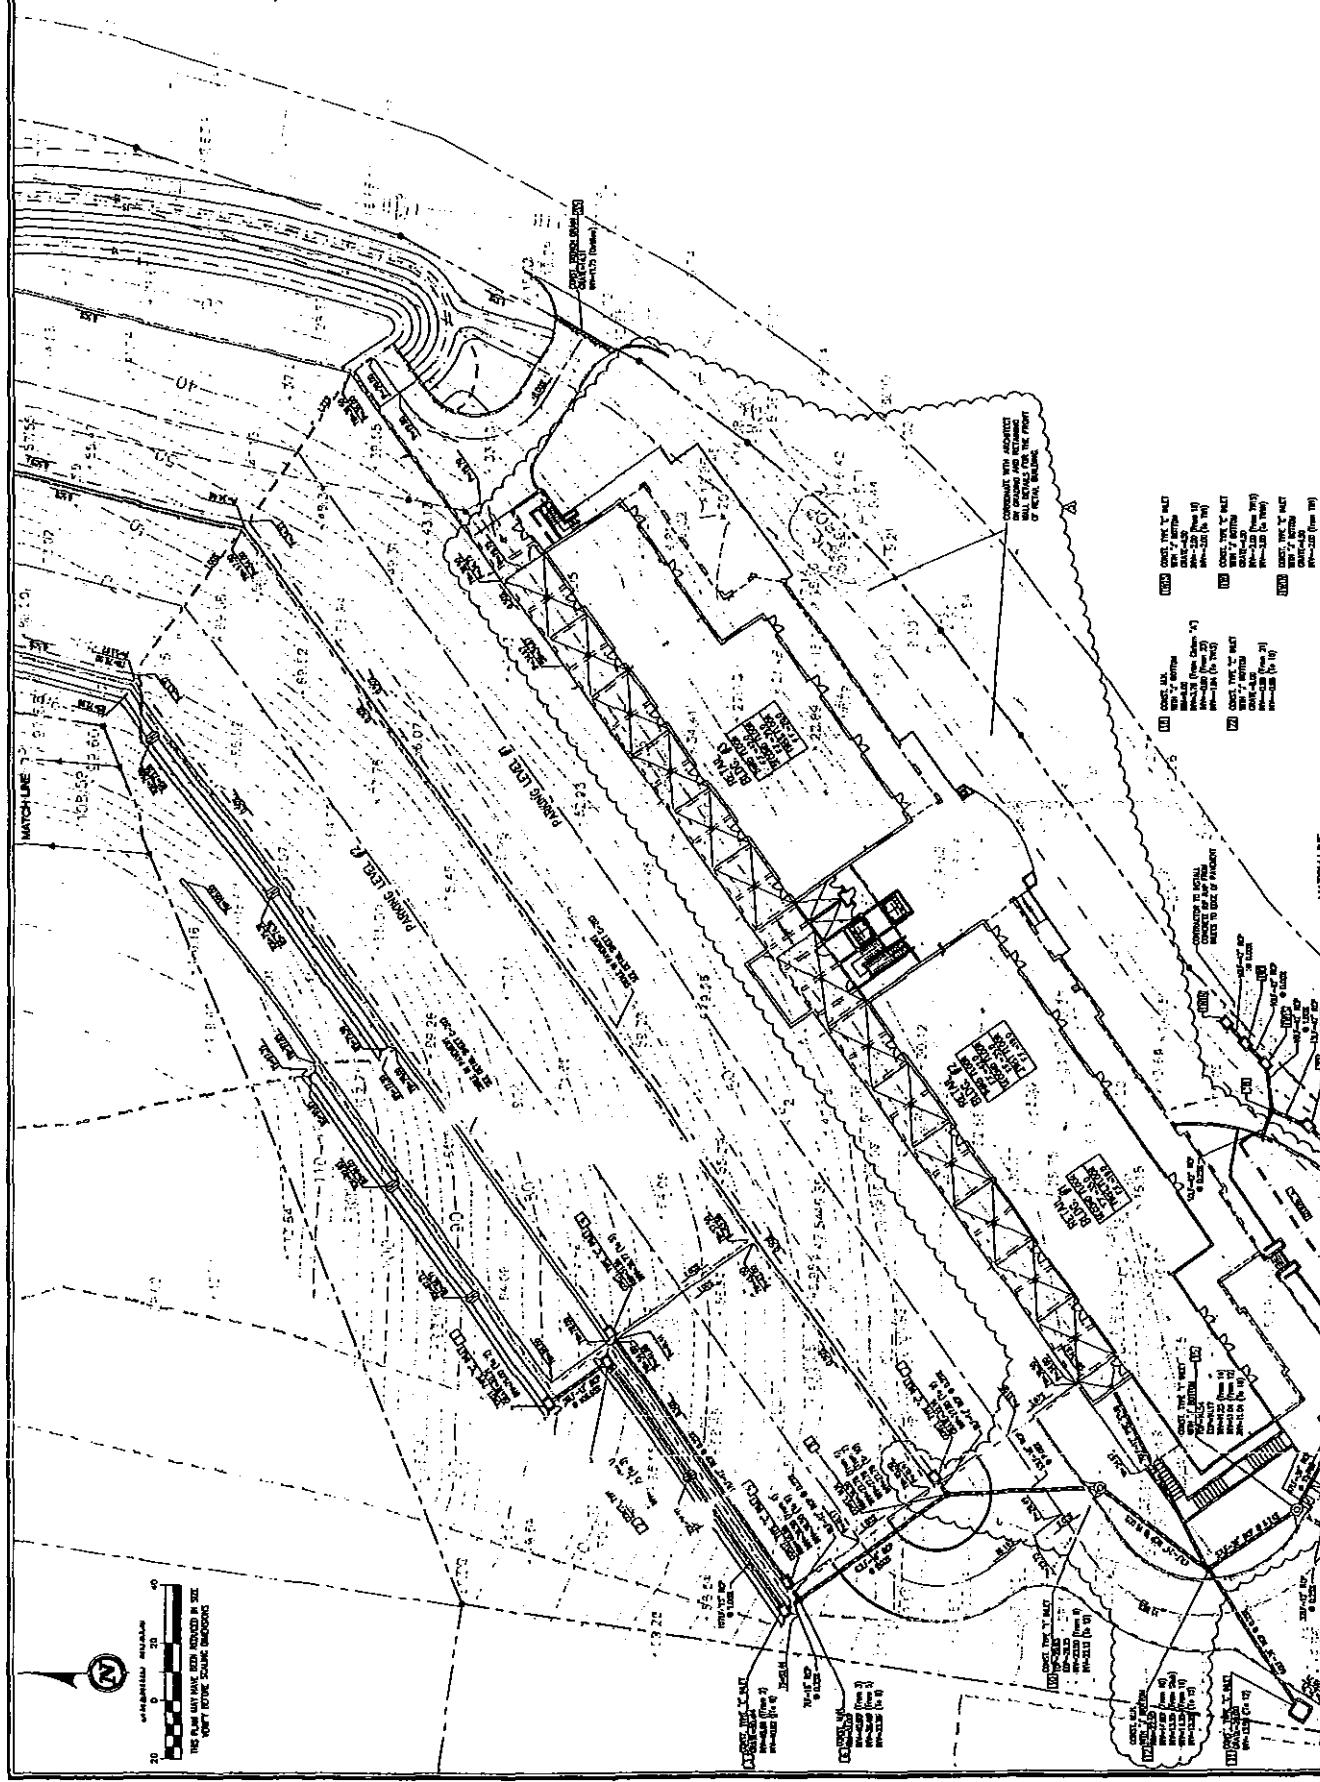
Figure 1. Project Site Grading and Drainage Plan I

The project under construction was a 40,000 square foot retail and office complex with two levels of parking. It is named East End Plaza, located at the east end of St. Thomas, U.S. Virgin Islands (USVI). The two parking levels and the plaza of the project were being constructed in steps along the slope of a mountain near its toe as shown in Figures 1 and 2.

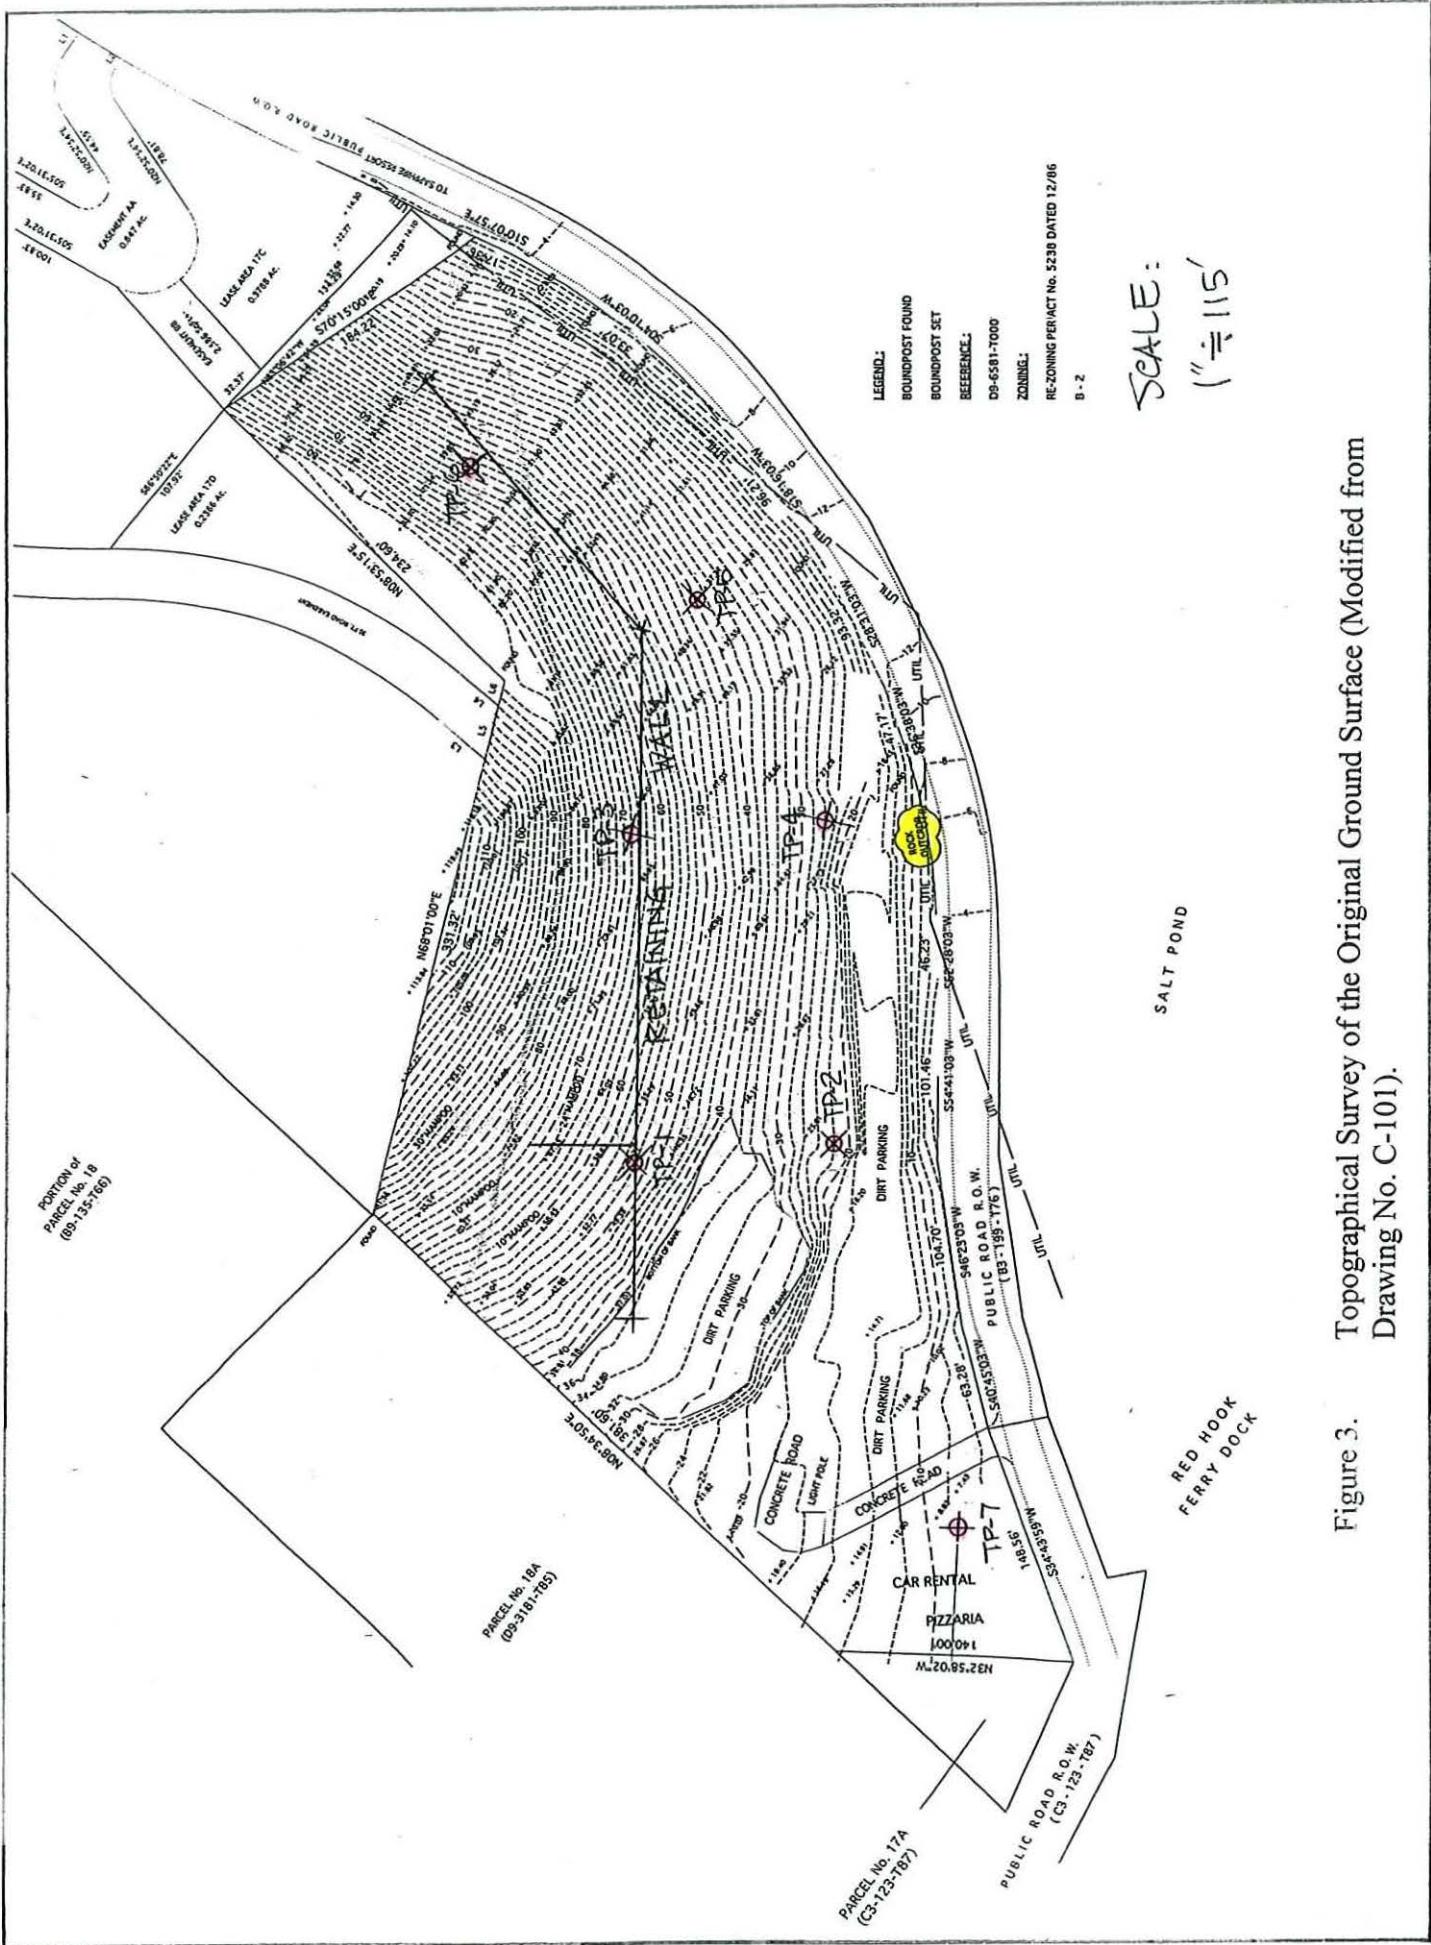
Figure 3. Topographical Survey of the Original Ground Surface (Modified from Drawing No. C-101).

Based on the soil maps, the project site is within the **SrF** soil unit. **SrF** stands for Southgate-Rock, located on the side slope of a volcanic mountain. The outcrop complex has a 40 to 60 percent slope and a 40 percent rock outcrop area. However, based on Figure 3, the slope of the original ground surface at the project site is estimated to be 40 to 45 percent and the rock outcrop is estimated to be less than 1 percent. Thus, the depth of weathering at the project site is much deeper than the soil map indicates.

Based on the original topography of the site before the excavation (Figure 3) and the corresponding configuration after the collapse (Figure 4), six cross sections around the collapsed area were developed. The location of the sections is shown in Figure 4. The first two sections (Figures 7 and 8) were to the north of the collapsed area. From these two figures, the following information was identified:

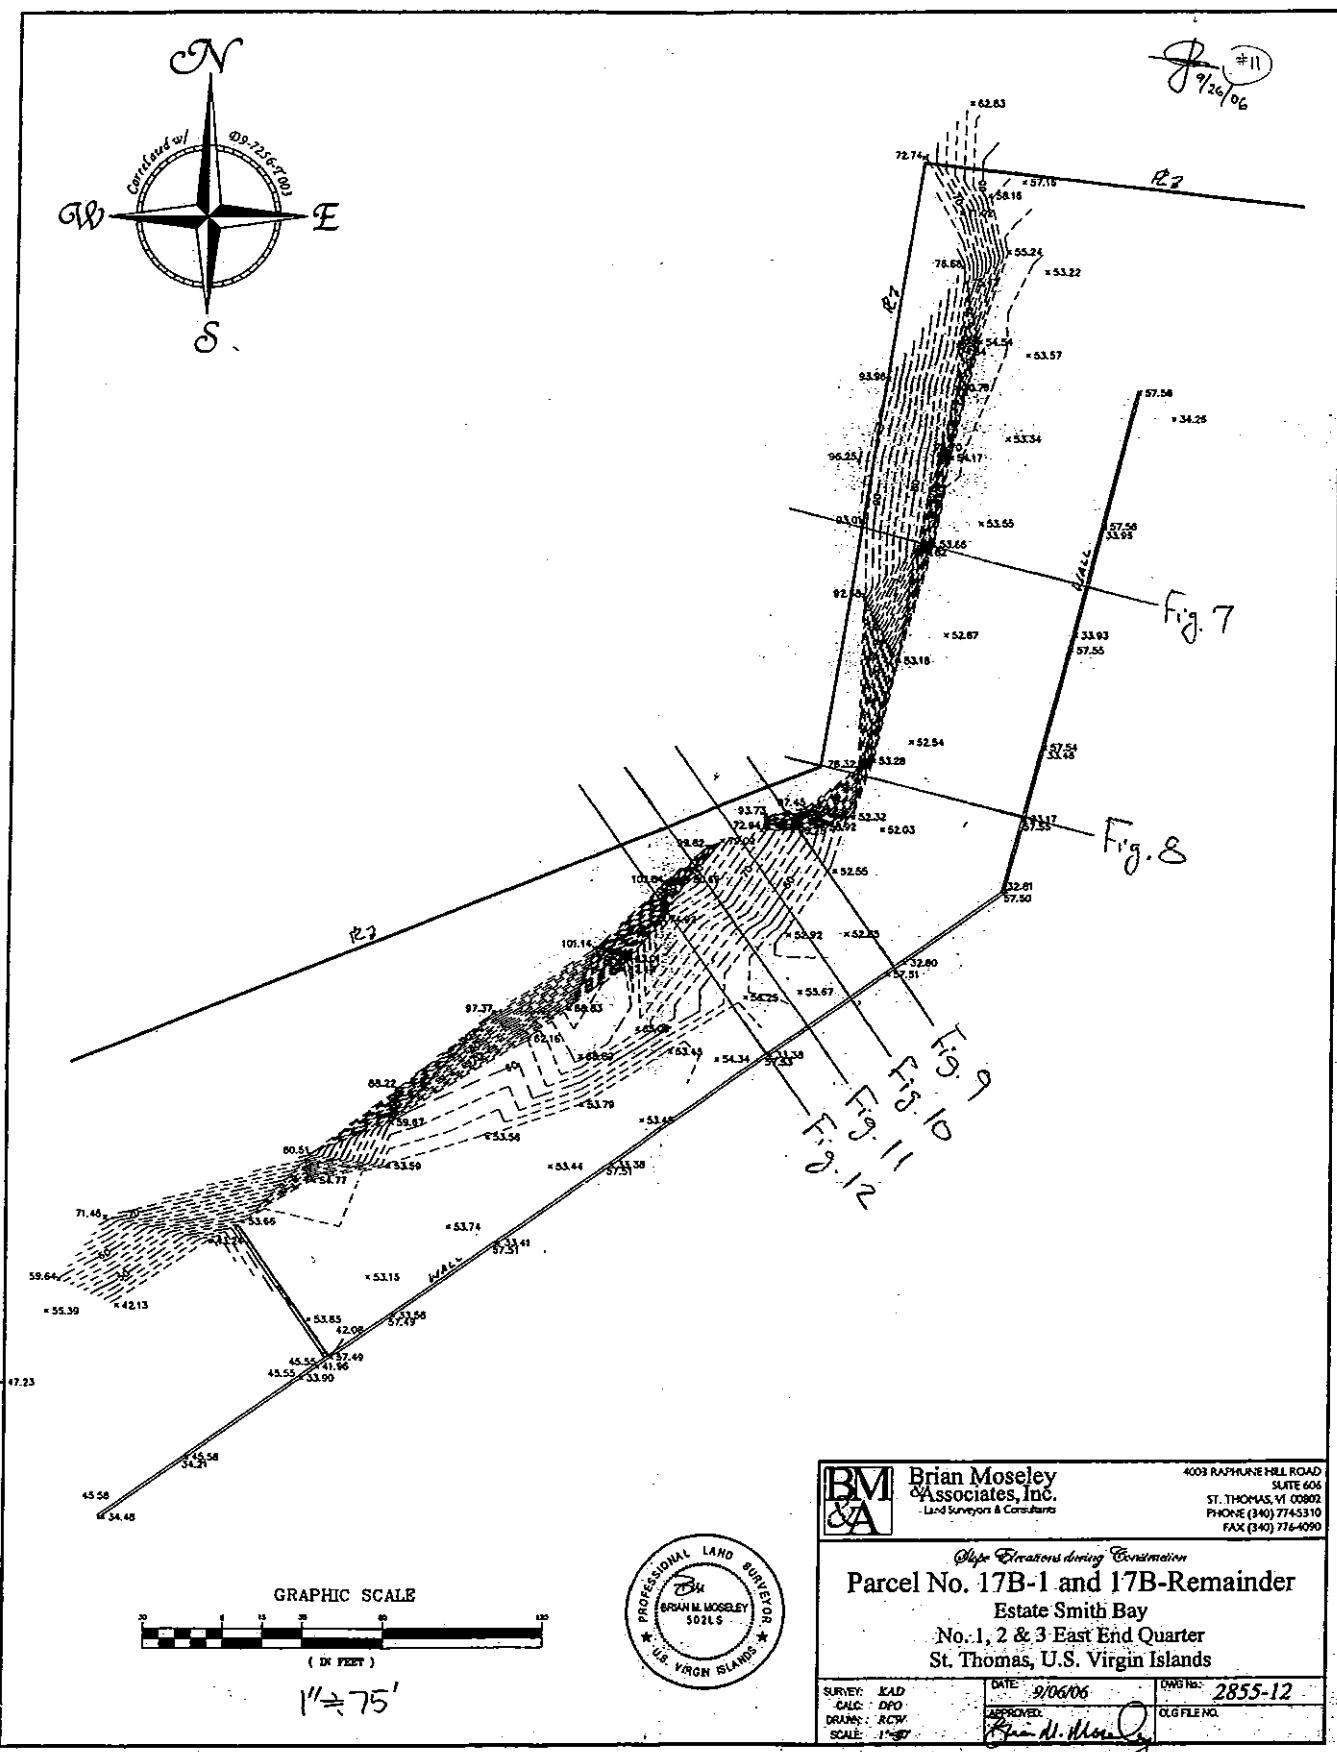
Figure 4. Topographical Survey of the Ground Surface after the Collapse (Provided by GEC, LLC.)

The project was in the first phase of construction, i.e., excavation and site stabilization, when the incident occurred. At that time, the excavation of the parking areas into the mountain slope was almost completed. The retaining wall between the upper and lower levels of the parking area, near the middle of the project site, had been constructed as shown in Figure 4.

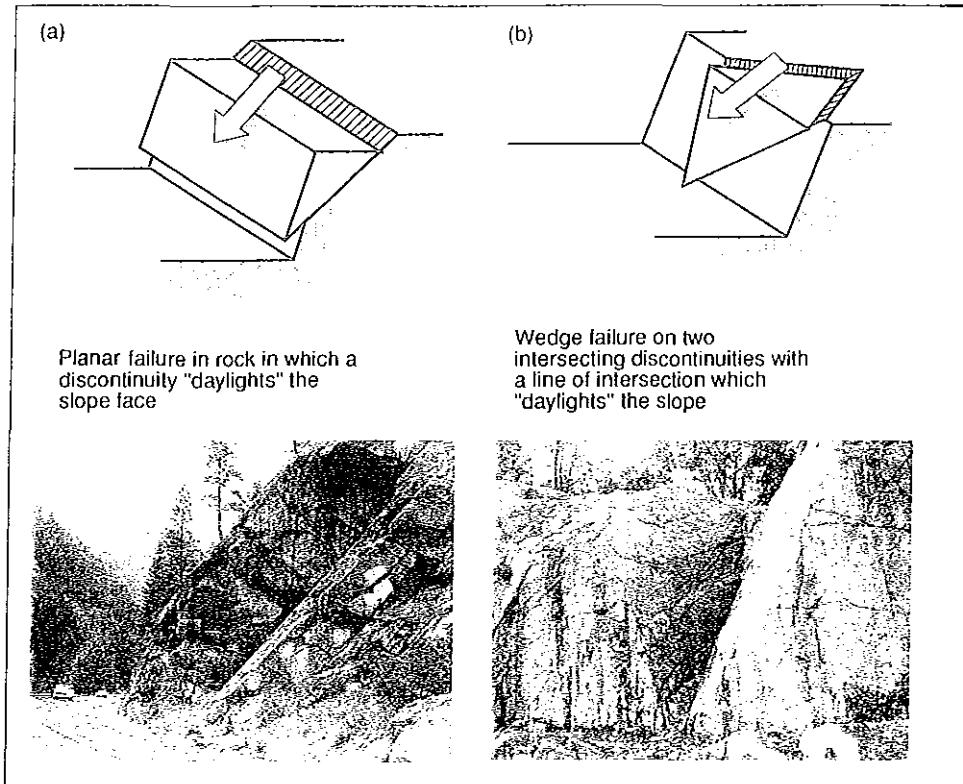
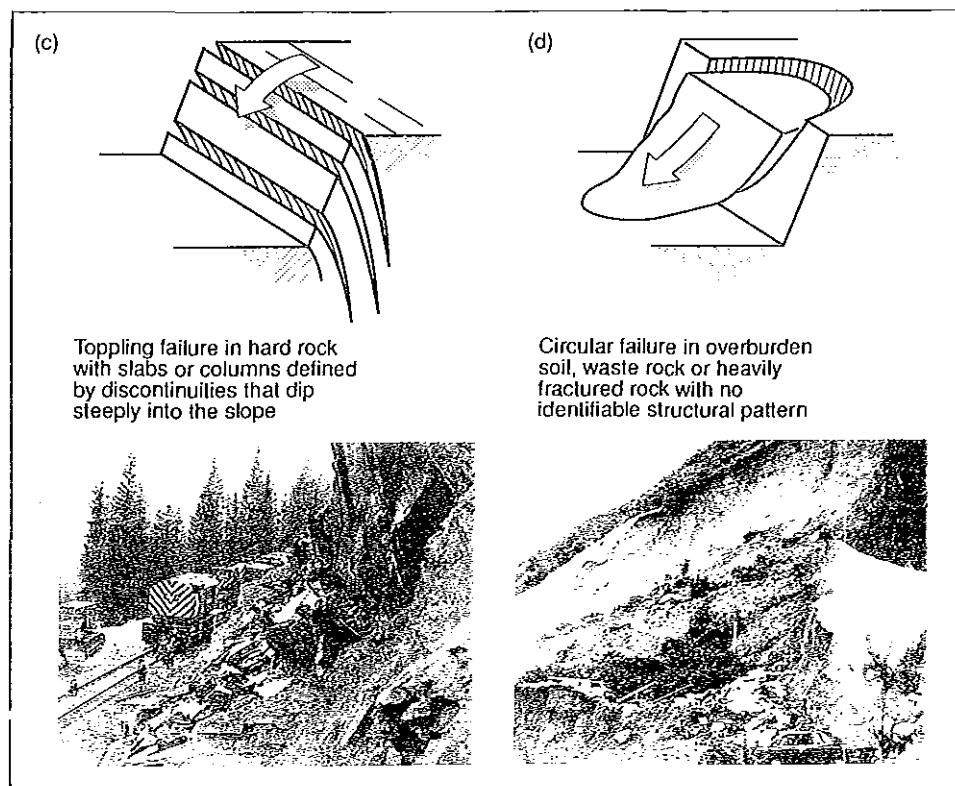
Figure 23. Types of Rock Slope Failures (Modified from Hoek and Bray, 1981 and Tuner and Schuster, 1996).

The figure on the cover of this report presents the overall shape of the collapse. As shown, the collapse was in a near circular or spoon shape. Based on references presented in Figures 23 and 24, a collapse of this shape would mostly occur in overburden soil, weathered rock, waste rock or heavily fractured rock. Therefore, the earth deposits in the collapsed area could only be residual soil, weathered rock or heavily fractured rock. They were more soil-like than rock-like deposits.
