Investigation of the June 14, 2007, Incident at U.S. Highway 90 across St. Louis Bay, Pass Christian, MS

U.S. Department of Labor
Occupational Safety and Health Administration
Directorate of Construction

December 2007

Report Prepared by
Mohammad Ayub, PE

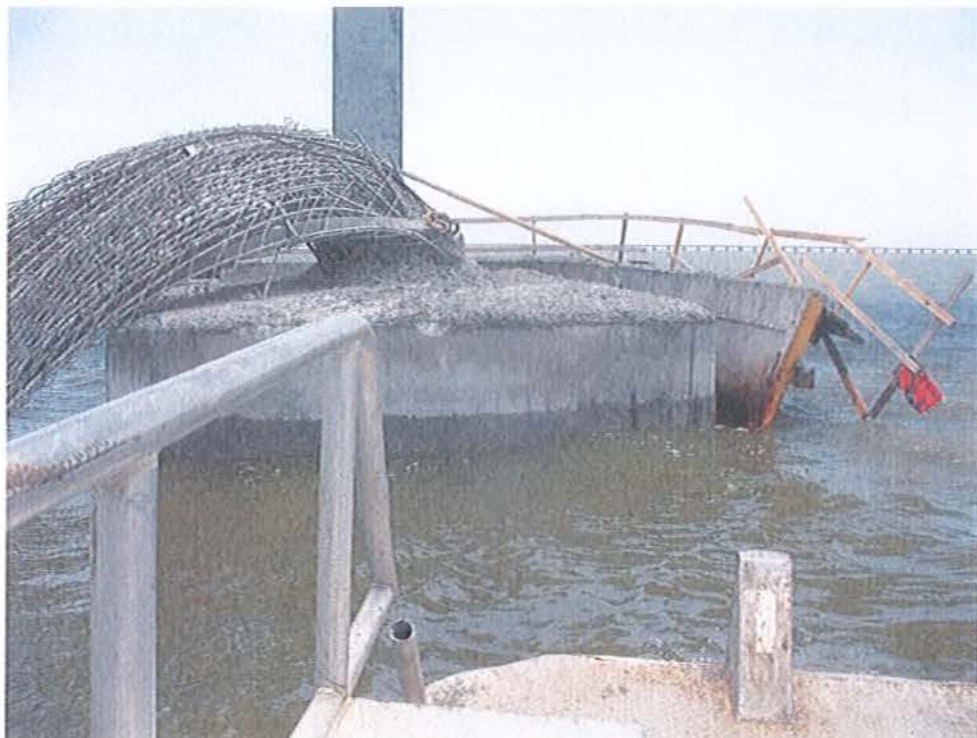
FIGURE 8

The column fell in a north-easterly direction with the reinforcing cage arching in the same direction. There was very little concrete adhering to the reinforcing bars, indicating the highly fluid state of concrete up to the time of the failure, see figures 8 thru 13. Almost all the concrete fell into the bay. The lower piece of the column form approximately 39' high fell in one piece with the bottom 9' of the north side folding approximately 180 degrees. The bottom seam of the column form at the south-west, north-east and north-west were torn apart for an approximately distance of 9'. The seam at south-east remained intact. The upper piece of the form approximately 7' high supporting the platform fell in to the bay in one piece, see figure 7.
