INVESTIGATION OF THE FEBRUARY 14, 2011 PARTIAL COLLAPSE OF A PARKING STRUCTURE UNDER CONSTRUCTION IN SAN ANTONIO, TX

U. S. Department of Labor Occupational Safety and Health Administration Directorate of Construction

August 2011

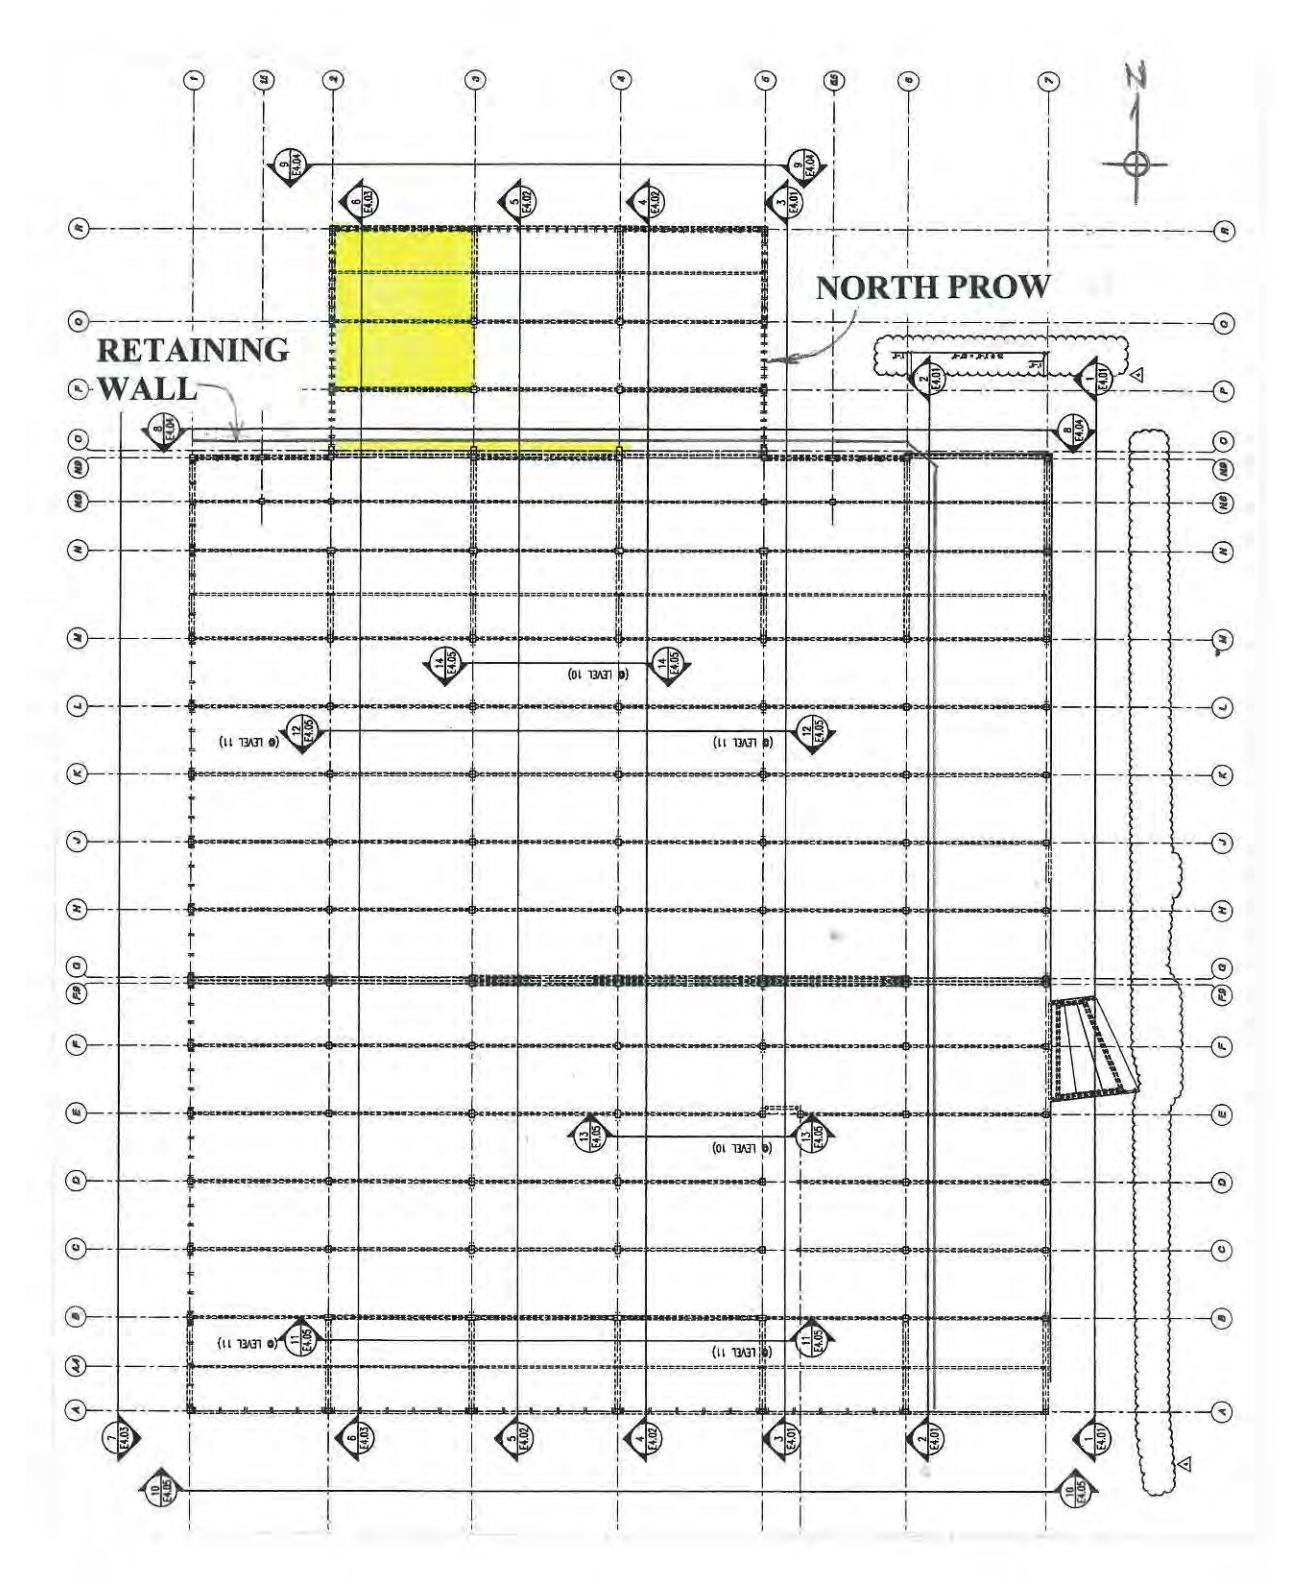
Figure 2. Project Site Plan (Modified from the Precast Erection Drawing Sheet No. E1.00). Note that the collapsed areas are highlighted.

and P, the portion of the garage south of Grid Line O extended down to Level 1 (See Figure 2). All erected precast members in the North Prow area collapsed (See highlighted area in Figure 2); it included an approximately 65' long, 56' wide and 80' high two-bay frame (At Grids P/2 through R/3) and an approximately 114' long and 113' high line frame (At Grids O/2 through O/4).

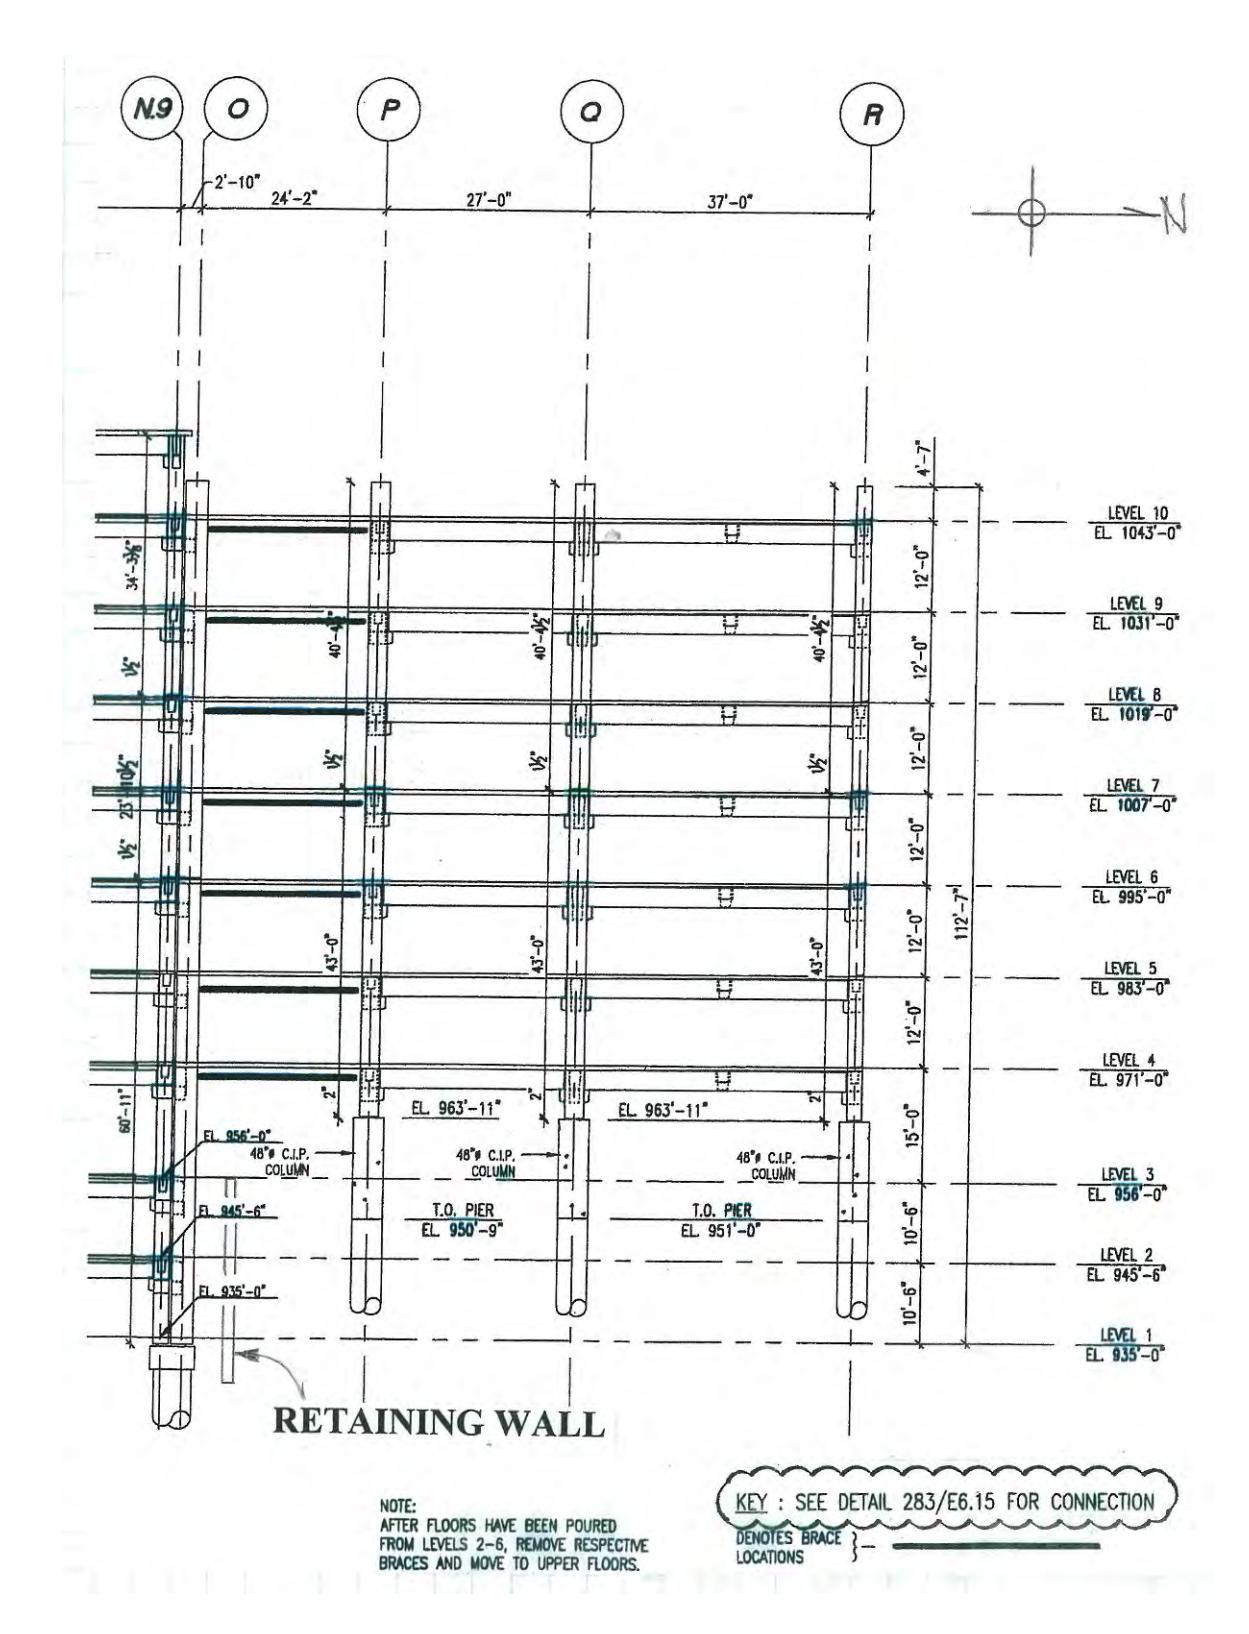
Figure 3. Elevation View of the Parking Structure at the North Prow Area (Modified from the Precast Erection Drawing Sheet No. E4.01B).

Sheet No. E4.01B of the precast erection drawings specified that seven levels of horizontal bracings were to be installed at the columns between Gridlines O and P (See Figure 3). Sheet No. E6.15, Detail 283 also specified that the type of the bracings were to be adjustable in length and 6" in diameter pipe braces (B-5).

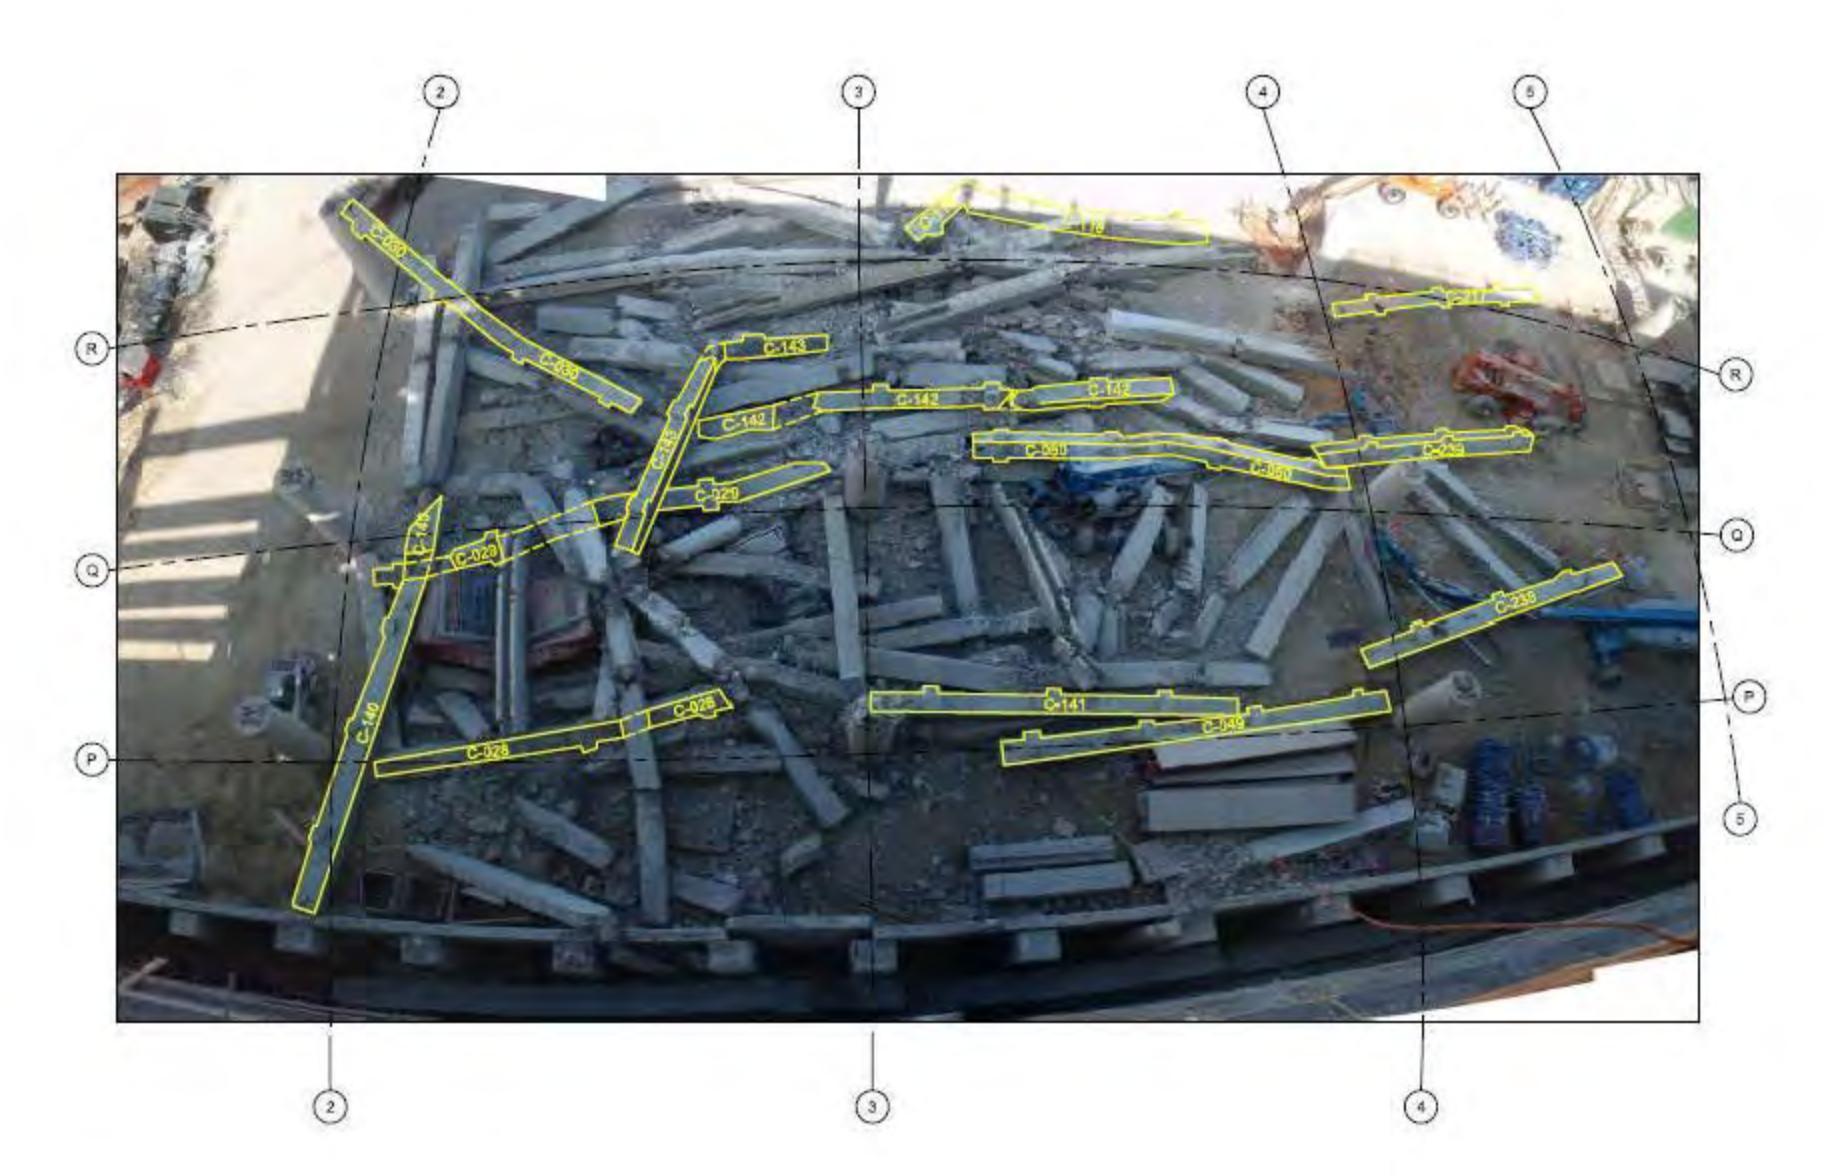
Figure 4. Landing Location of Precast Columns [Modified from WJE Preliminary Report (Reference 10)].

The lower and upper precast columns had already been erected before the collapse at the top of the six piers at Grids P/2 through R/3. A total of 12 columns fell at the time of the collapse. Each column had a specific identification on its base plate. The location where the collapsed columns landed is shown in Figure 4. It was therefore determined that 11 out of the 12 columns fell toward the east. Column C-143, the upper column at Grid R/2, was the only exception as it fell toward the south. Column C-140 was the upper column at Grid O/2 on the south side of the retaining wall as it fell toward the north. Thus, the general direction of the collapse was toward the east.

Based on the horizontal fall distance from the base of the lower column to its supporting piers in Figure 4, it appeared that Grid Line 2 columns fell near their supporting piers. In fact, the bottom of the lower column at Grid R/2 was still attached to its supporting pier. However, Grid Line 3 columns fell farther east from their supporting piers. Thus, we believe the three columns on Grid Line 3 led the collapse and the three columns on Grid Line 2 were pulled by the Grid Line 3 columns to collapse.

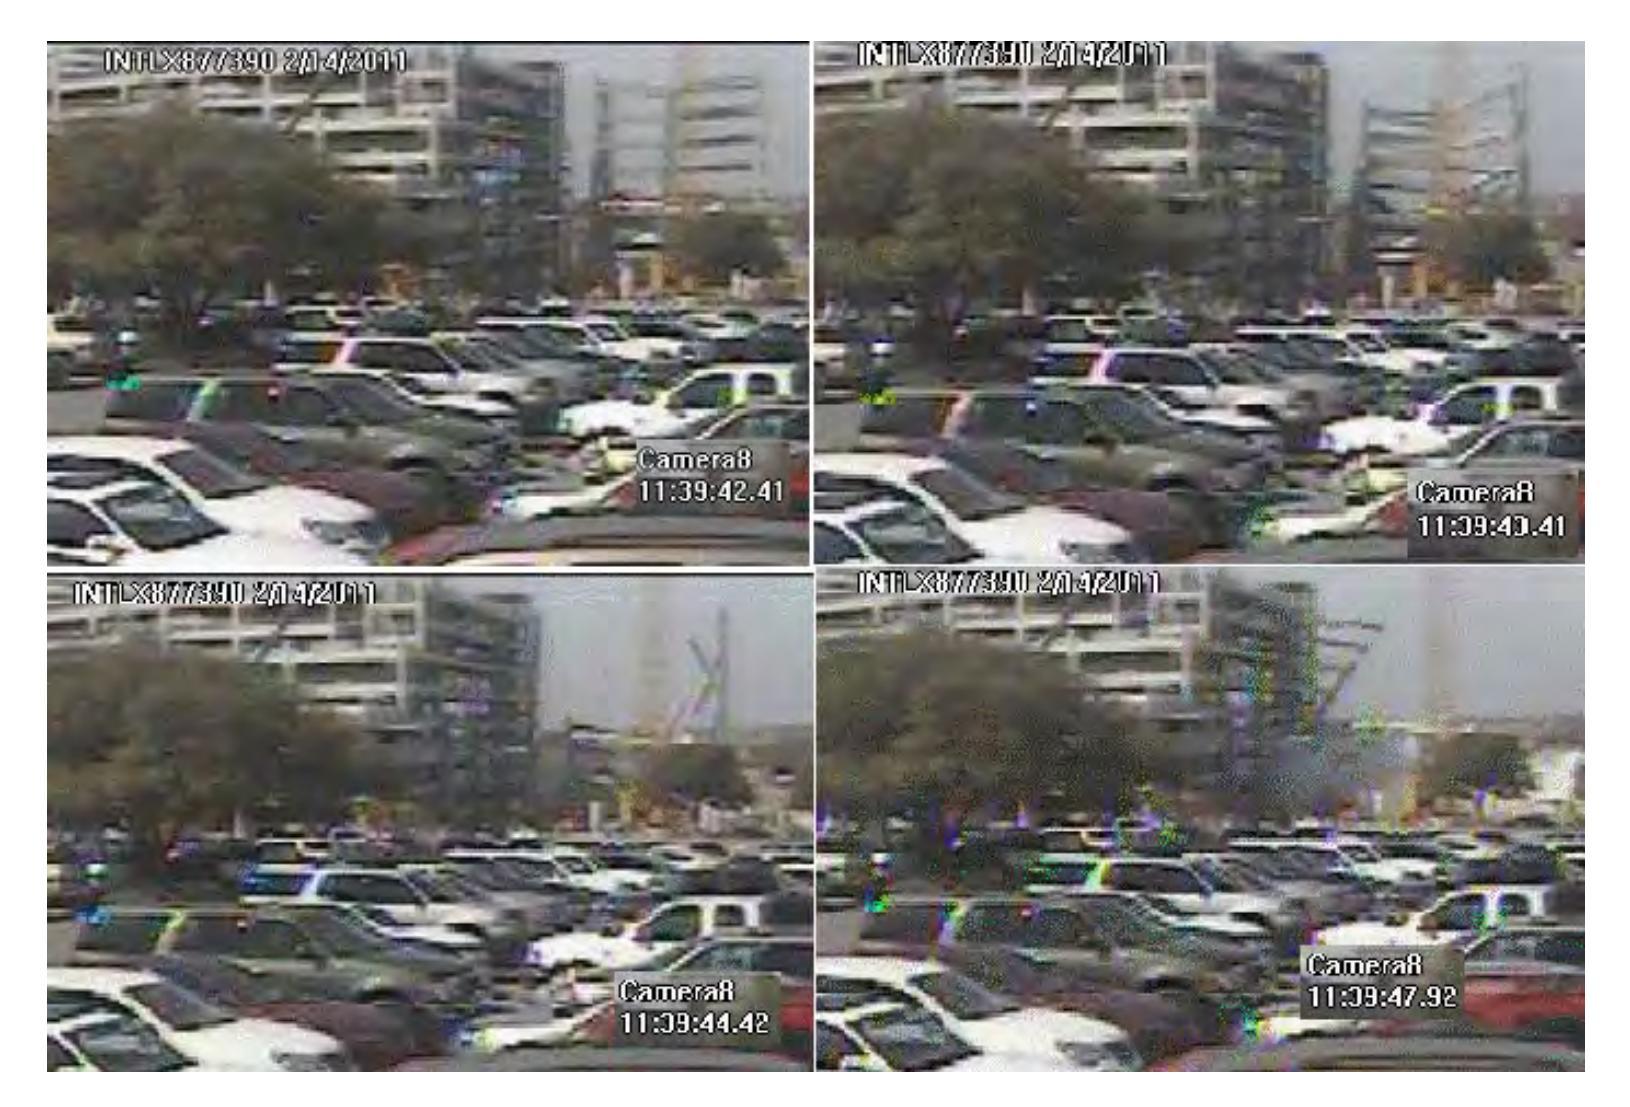
Figure 5. Still Photographs from the Video Record (Modified from Project Security Camera, February 14, 2011). Note that A is the upper left photo, B is the upper right, C is the lower left photo and D is the lower right photo.

We also reviewed the surveillance video from a security camera located at the northeast corner of the garage. It captured the collapse of the precast frames from a distance. Four still photographs taken from the video are presented in Figure 5. We made the following observations:

- Initial movement of the frame appeared to occur on Grid Lines P and Q with the Q Line slightly ahead of the P Line (Figure 5 A and B).
- The precast members at Grid R/2 appeared to fall after those on Grid Lines Q and P, and Grid R/3 (Figure 5 C).
- It appeared that each of the six columns fell as an individual unit, i.e., the connection between the lower and upper columns remained intact during the fall (Figure 5 – A, B and C).
- The columns and beams along Grid Line 0 appeared to fall a few seconds after the collapse of the frame at Grids P/2 through R/3 (Figure 5 D).

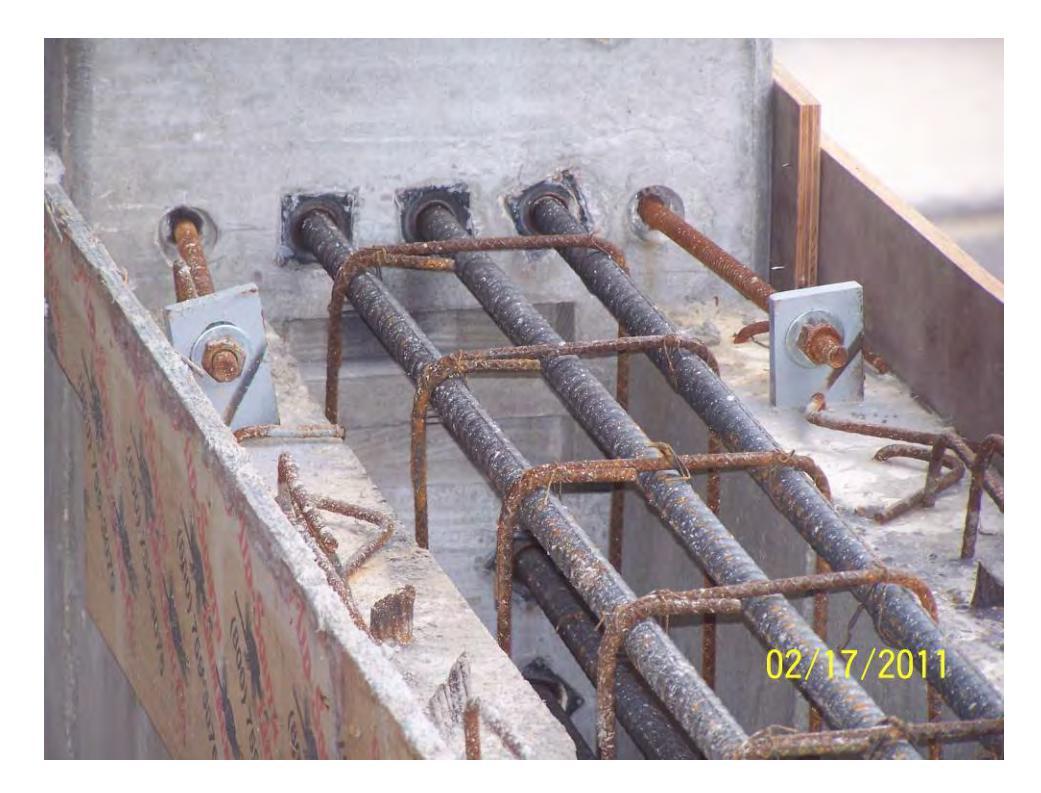
Figure 19.Typical Column to Beam Connection.
Note that this photograph was taken at a connection away from the collapse.

During erection, the temporary column-beam connection consisted of a coil bolt assembly from the side of a column connected to a steel plate projected out from the top face of the beam (See Figure 19). Figure 20 presented the failure condition of this connection. We made the following field measurements:

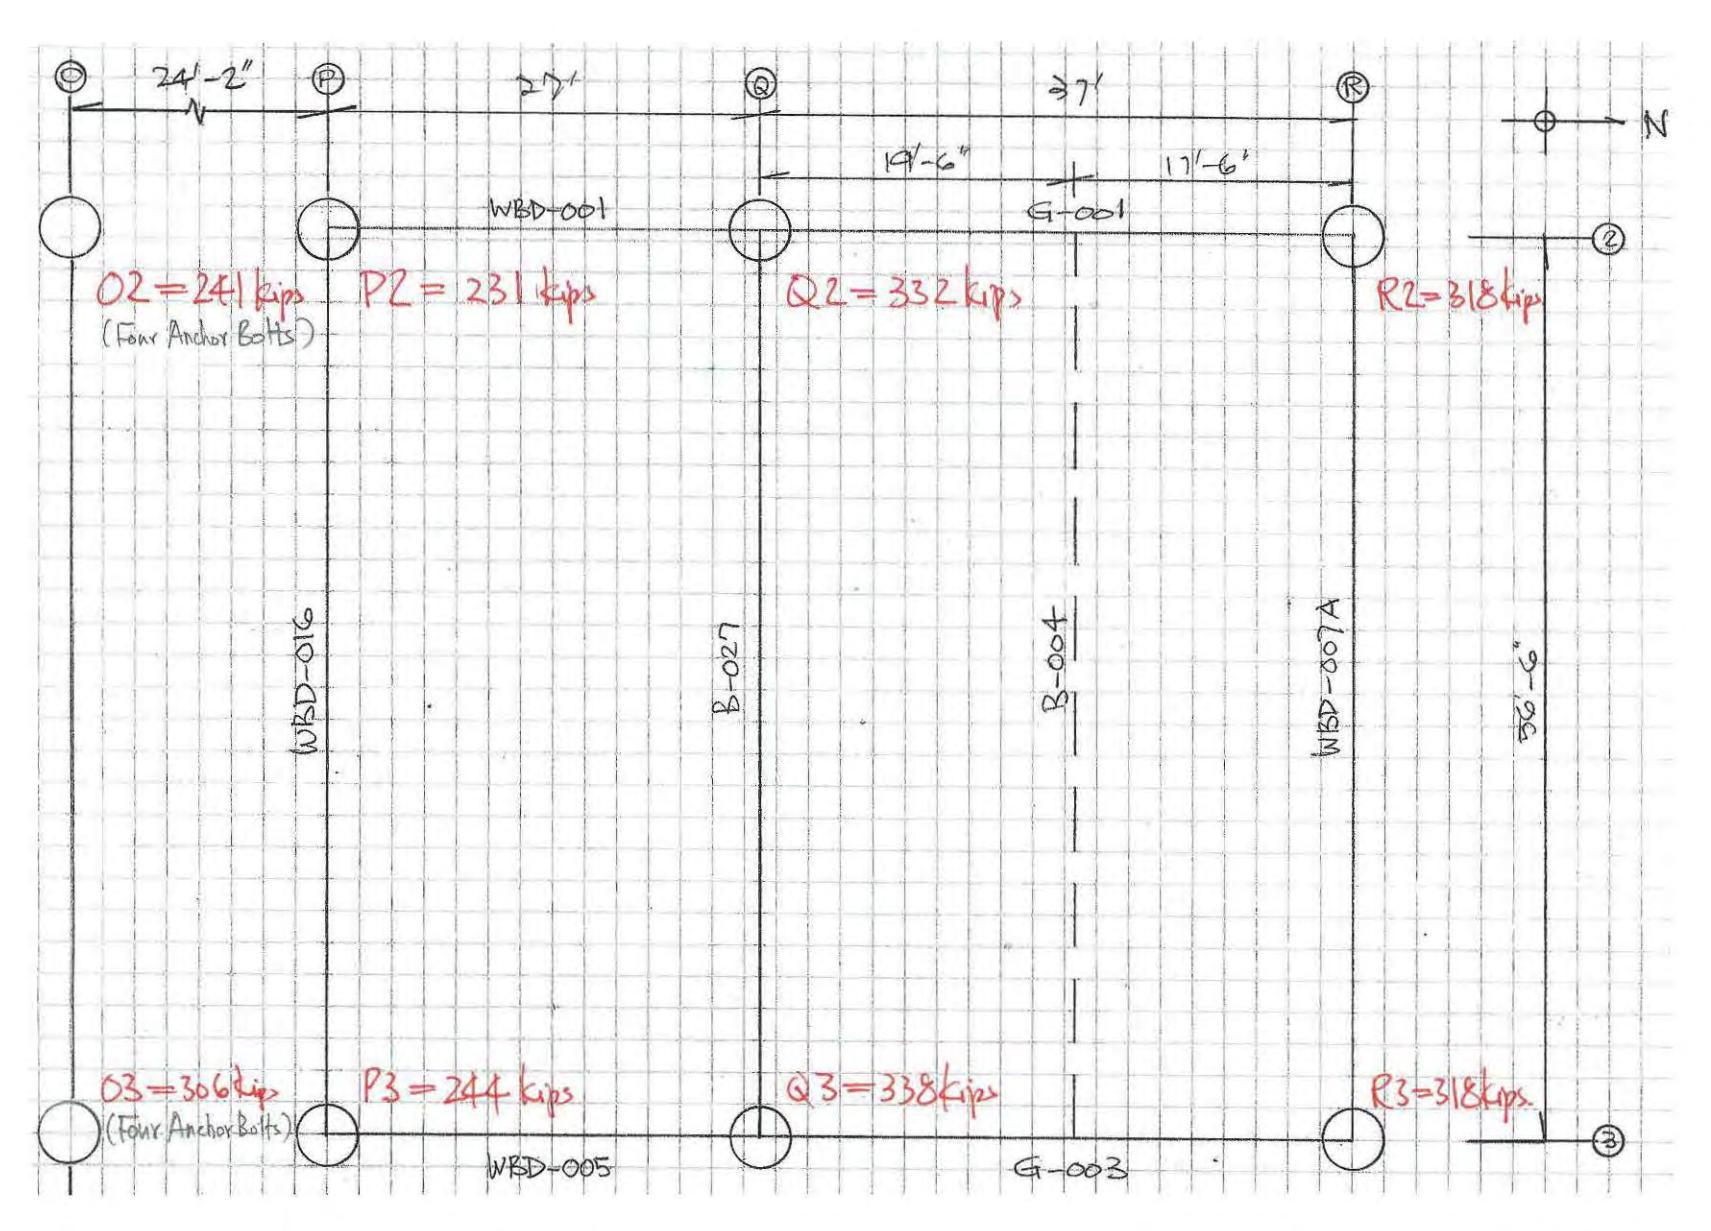
Figure 22. Estimation of the Column Loads at the Time of the Collapse.

precast members was taken directly from the fabrication drawings. The total column load on each column is listed in Figure 22 for the following discussion.

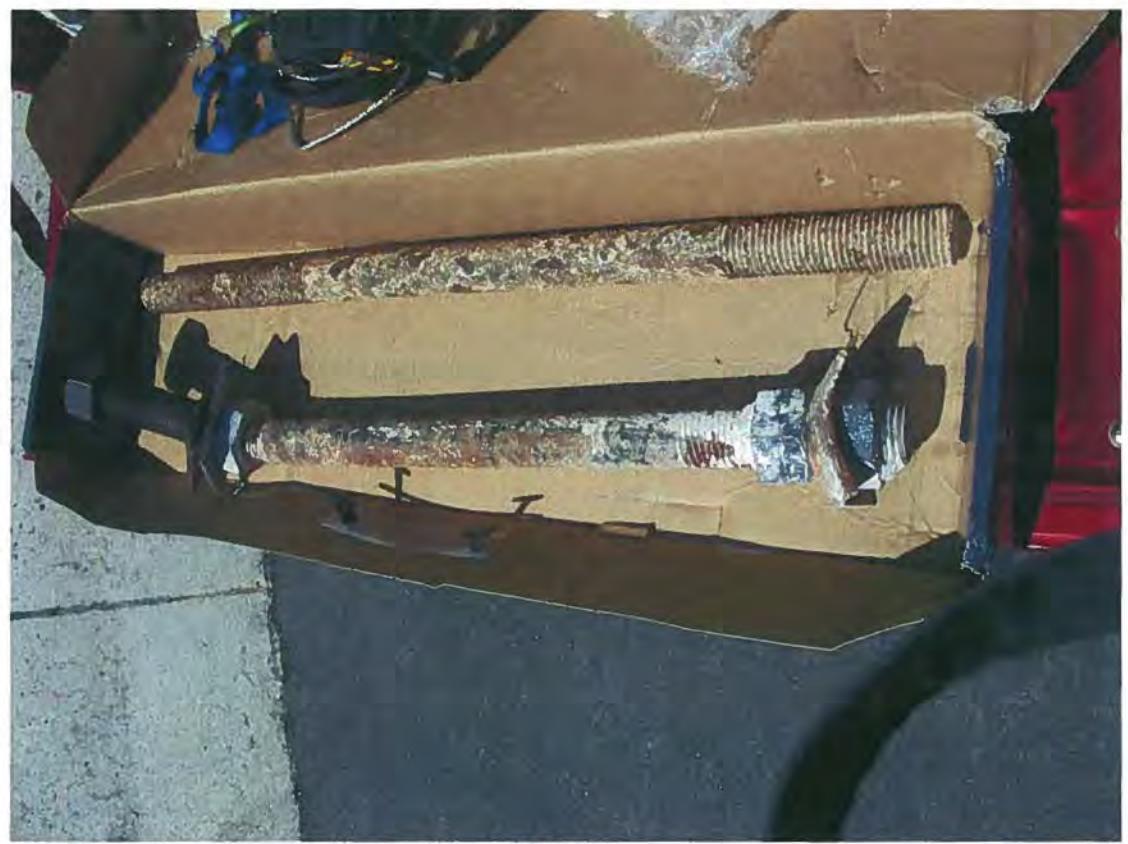
Photo 1: Anchor bolts and fittings as received at SLTC

Two lengths of 1 $\frac{1}{2}$ inch diameter steel threaded anchor bolt, four large nuts and three square washers were submitted for directed analysis to the Salt Lake Technical Center (SLTC). It was requested that we determine compliance with a submitted specification supplied in a mechanical drawing denoted AB001¹. These were received as follows: one anchor bolt with no nuts or washers attached and one anchor bolt with all four nuts and all three washers attached. This is as shown in Photo #1. The case was assigned the laboratory tracking number L01065.

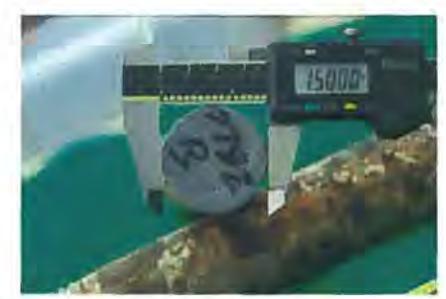
Photo 2: Example of bolt diameter measurement

Length estimated at 28" Diameter measured at 1.502" Short thread length 5.750" Long thread length 8.375" Both threads UNS6 Tensile strength 139,000 psi TS is consistent with F1554 Grade 105

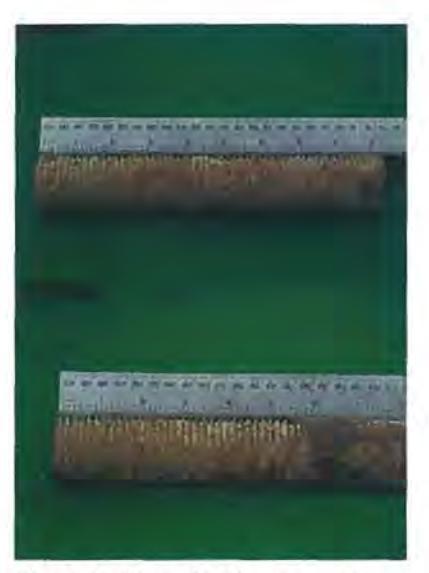
Photo 3: Example of measurement of the thread length

Length estimated at 28" Diameter measured at 1.498" Short thread length 5.424" Long thread length 8.500" Both threads UNS6 Tensile strength 152,000 psi TS is consistent with F1554 Grade 105 No color or grade marks were seen on the rod. No visible elongation of the threads was

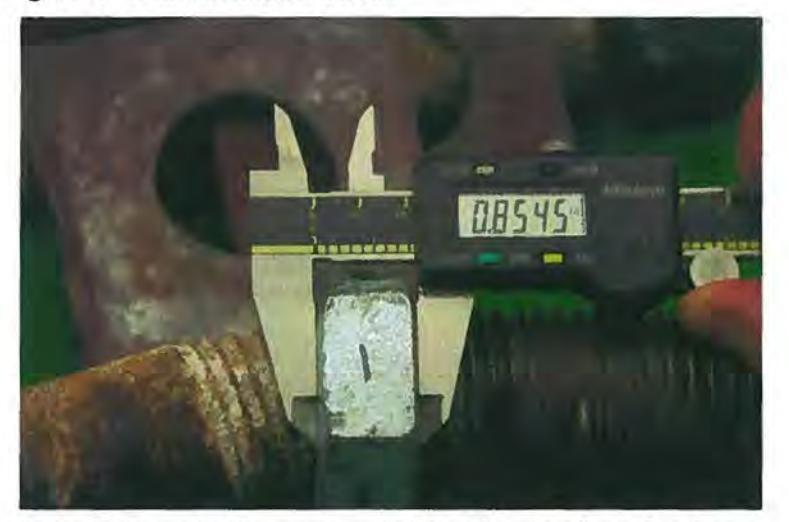
Photo 5: Example of measurement of the thickness of nut #3 at face #1

Thickness measureme	ents for Nut #3
Face	Thickness (inches)
1	0.8545
2	0.8585
3	0.8535
4	0.8560
5	0.8515
6	0.8420
Verage	0.8527
STDEV	0.0075

A 563 gives no specifications for a 1-inch thick nut. Nut # 2 was a 1 $\frac{1}{2}$ inch nut, but with a Rockwell hardness below any specification in A 563. None of the nuts had any markings which would be required for high-strength Hex nuts. Grade A nuts may have a strength of 90 ksi or 68 ksi if Zn-coated. However, none of the nuts met the hardness criterion for Type A.

The specification for nut #4 was for a high-strength nut. This constitutes a deviation from the specification. All of the hex nuts except hex nut #2 met the standard for ASTM A563 Grade O.

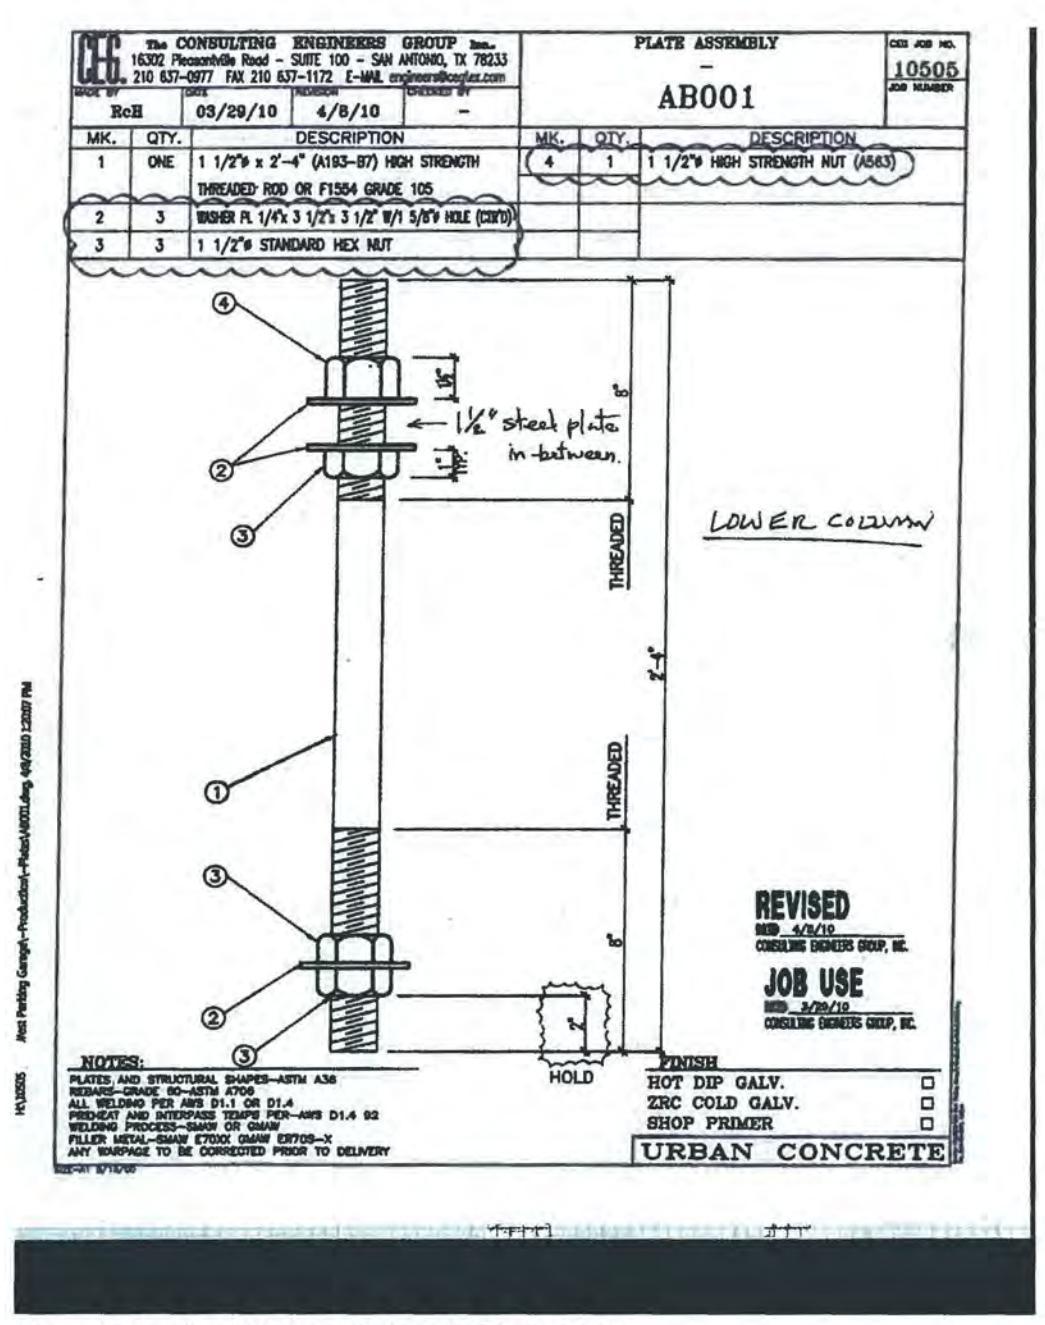
Figure 5: Drawing AB001 provided to SLTC by Scott Jin

Figure 1: Identification of Nuts and washers on a figure extracted from mechanical drawing AB001 supplied to SLTC by Scott Jin. Note that this is the mechanical drawing. The assembly differed from this in that the threaded end on the left was 5.75 inches on anchor bolt #1 and 5.424 inches on anchor bolt #2. Also, Nut #4 on anchor bolt #2 was 1.276 inches thick and not 1.500 as indicated in AB001.
