INVESTIGATION OF THE SEPTEMBER 7, 2011 COLLAPSE OF A MOBILE CRANE AT THE NATIONAL CATHEDRAL SITE IN NORTHWEST WASHINGTON, DC

U. S. Department of Labor
Occupational Safety and Health Administration
Directorate of Construction

March 2012

This report was prepared by
Scott Jin, Ph.D., P.E.
Mohammad Ayub, P.E., S.E.
Directorate of Construction
Occupational Safety and Health Administration

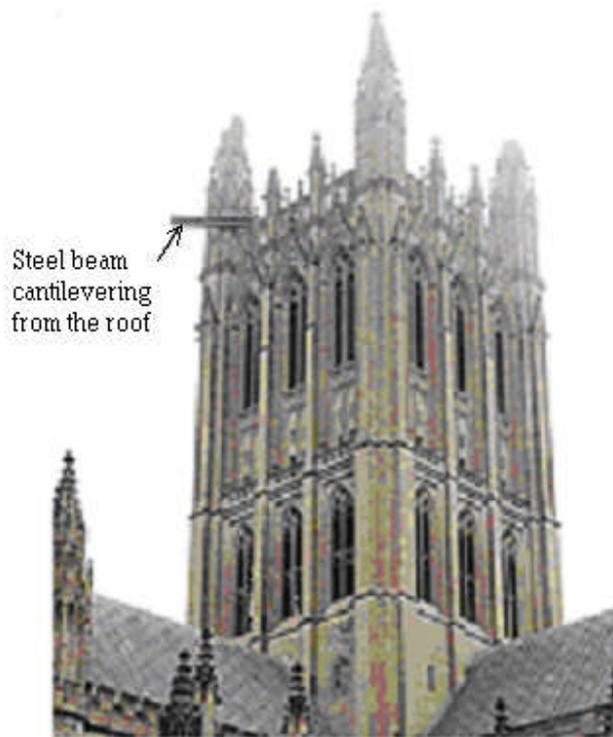
Figure 3. Center Tower of the Cathedral Building (Taken from Architecture Week). Note that a large steel beam cantilevering from the roof of the center tower was the last load delivered by the crane.

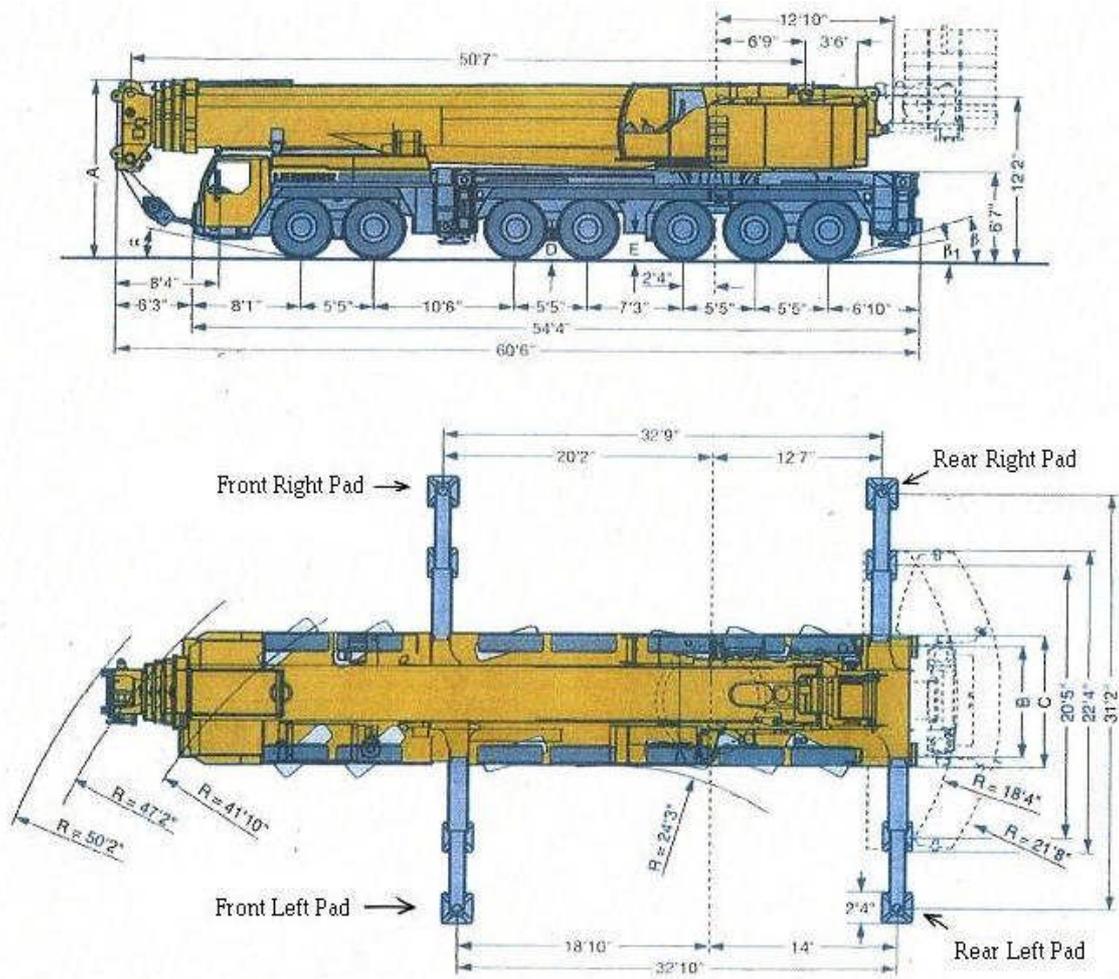
Figure 15. The Basic Dimensions of the Carrier and the Outriggers, and the Location of the Center of the Turntable (Taken from Liebherr Mobile Crane Technical Data, Page 33).

The basic dimensions of the carrier and the outriggers were taken from the Liebherr manual and verified in the field (See Figure 15). The weights and center of gravity of the carrier, various components of the superstructure, and counterweights are indicated in Figure 16.

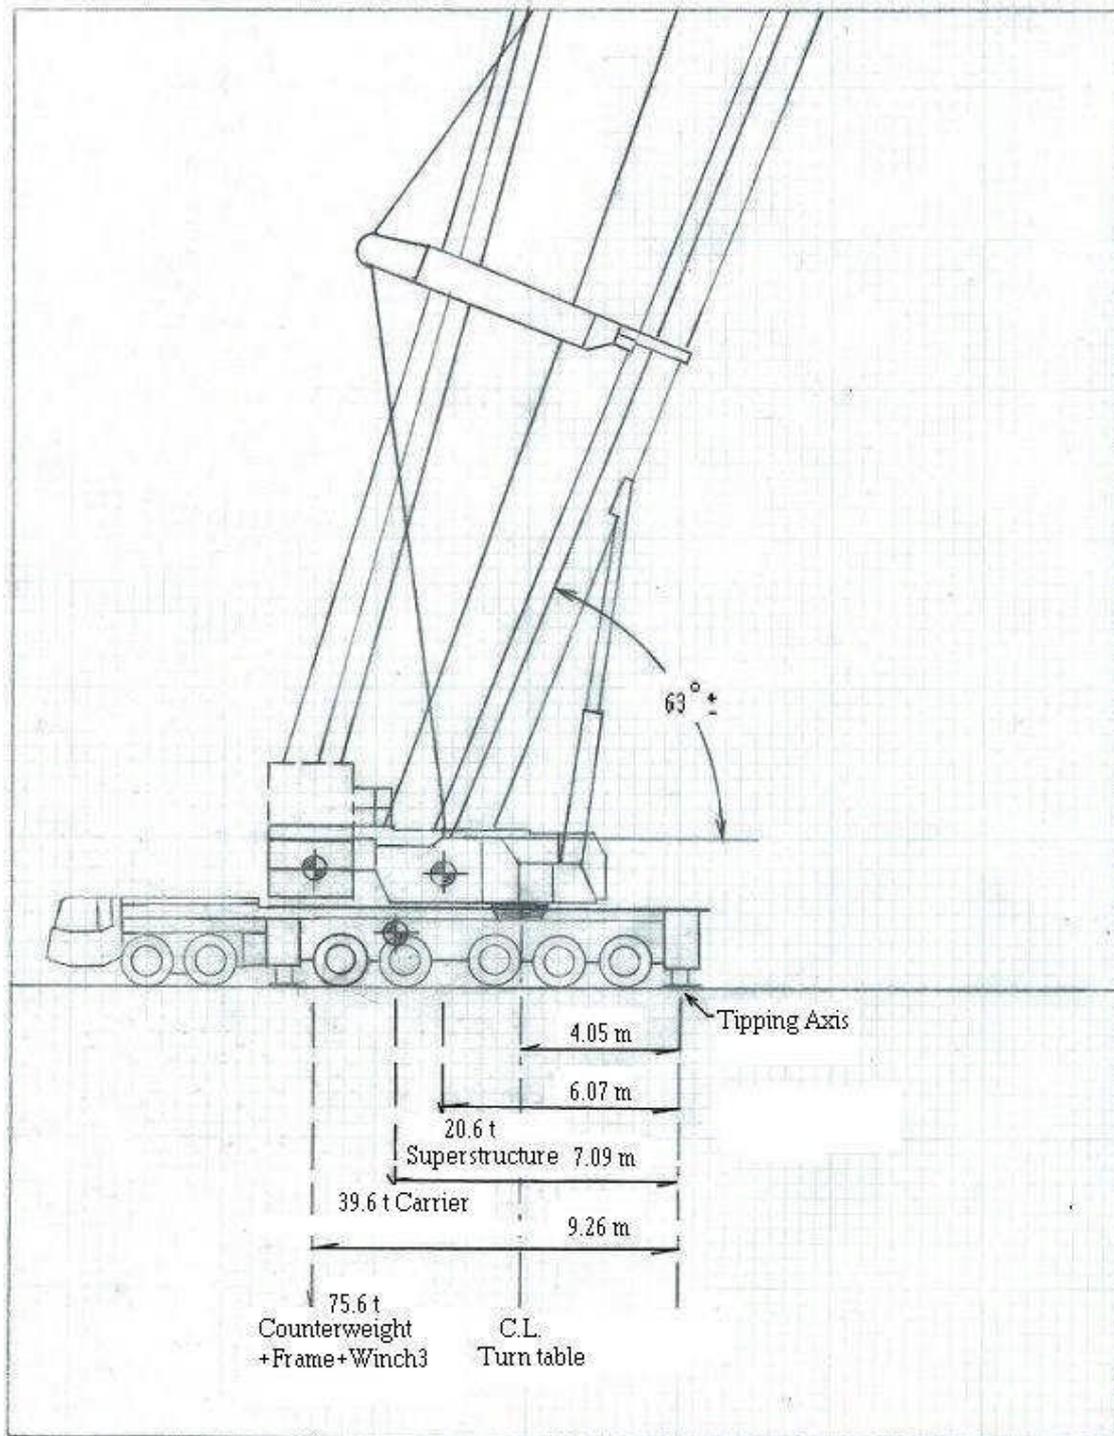
Figure 16. The Weight and Centroid of the Carrier, the Superstructure and the Counterweights in the Direction of the Collapse (Weight and Centroid Were Provided by Liebherr-Werk Ehingen GmbH).

Crane Member	Individual Element	Individual Weight	Total Weight	Centroid to Tipping Axis *
Carrier	---	---	87,100 lbs.	-23.3 ft.
Superstructure	---	---	45,300 lbs.	-19.9 ft.
Counterweight + Frame + Winch 3	Base Plate	15 tons	166,000 lbs. (75.6 tons)	-30.4 ft.
	Center Plate	5 tons		
	10 Tons Wt. x 4	40 tons		
	5 Tons Wt. x 2	10 tons		
	Frame + Winch 3	5.6 tons		
Telescopic Boom Assembly	Base Section	6.6 tons	97,500 lbs. (44.3 tons)	7.8 ft.
	Section 1	5.3 tons		
	Section 2	4.7 tons		
	Section 3	4.1 tons		
	Section 4	3.5 tons		
	Tele. Cylinder	3.4 tons		
	½ Luff. Cylinder	1.9 tons		
	TY Guying	12.2 tons		
	TN/TF Adapter	1.9 tons		
	TN Adapter	0.7 tons		
Lattice Jib Assembly	G9	7.4 tons	41,800 lbs. (19.0 tons)	154.5 ft.
	G3	1.04 tons		
	2 x G4	2 x 1.86 tons		
	G5	0.45 tons		
	G6	1.00 tons		
	G7	1.95 tons		
	2 x G6	2 x 1.00 tons		
	G8	1.42 tons		
Load Block Assembly	Headache ball + Web Sling + Nylon Ropes	---	1,760 lbs. (0.7 tons)	330.3 ft.

It was determined that when the telescopic boom reached an angle of 63 degrees to the horizontal, and when the jib was nearly horizontal, the overturning moment was 8,000,000 ft-pounds. The stabilizing moment at this position of the crane was computed to be 7,980,000 ft-pounds, and hence the failure. At the time of the collapse, the crane had a working radius of 344 feet which was well beyond the allowable radius provided in the load chart, discussed later.

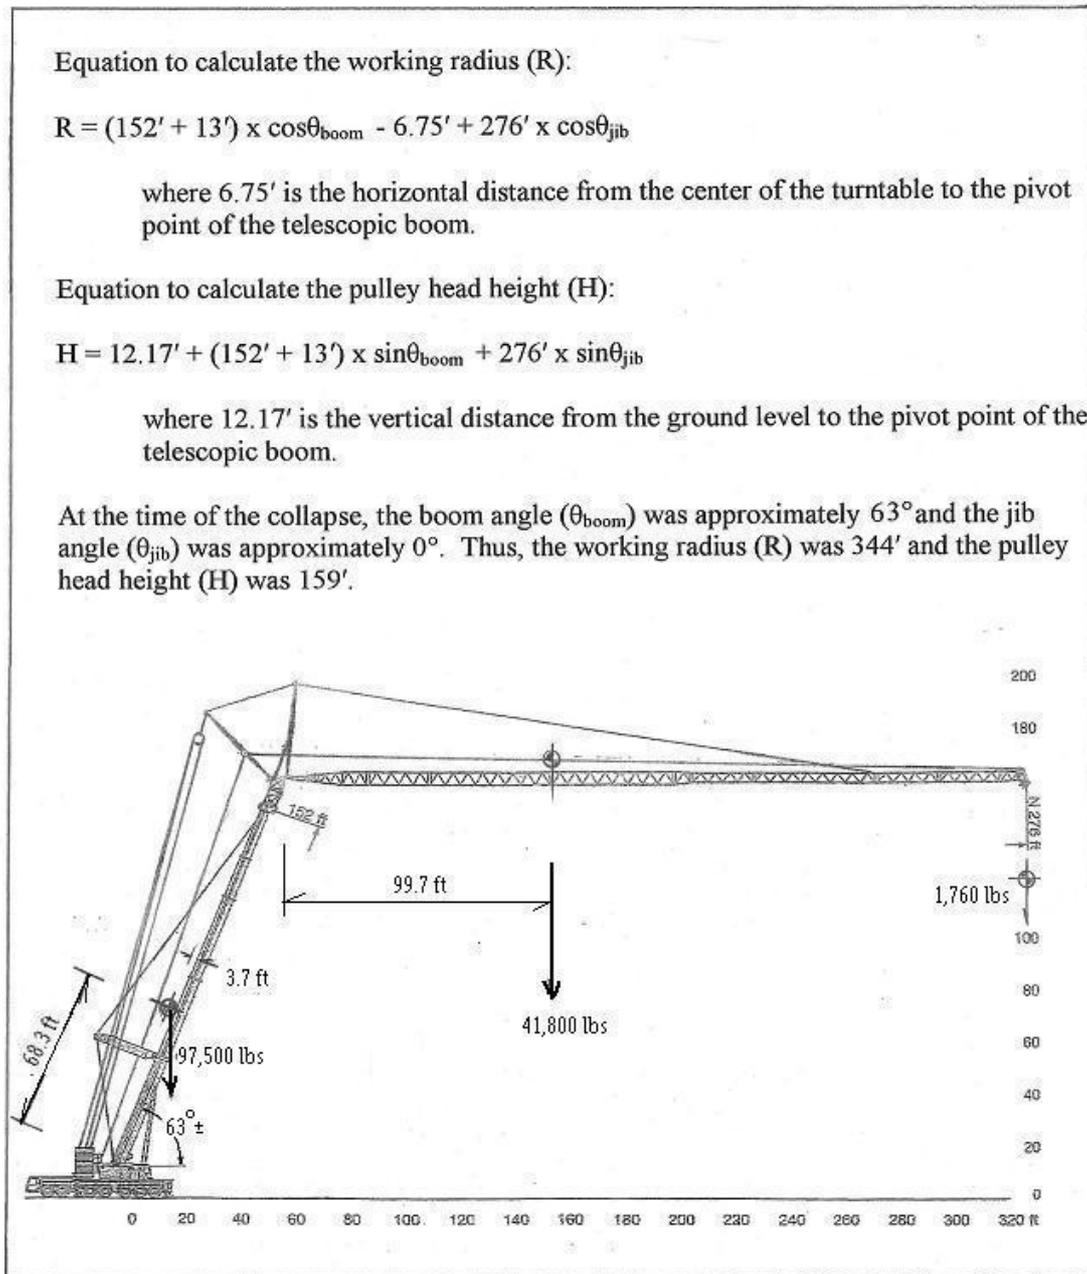
Figure 17. The Weight and Centroid of the Telescopic Boom, Lattice Jib and Load Block in the Direction and at the Time of the Collapse.

The weights of some of the above items were taken from the operating instructions for the crane (See Figure 17).

At the time of the collapse, the entire crane including all elements mentioned above weighed approximately 200 tons. This weight compared very closely to the total weight of 203 tons derived from the shipping packing lists prepared by Liebherr.
