Investigation of the April 18, 2013 Partial Collapse of a Masonry Wall during construction of the Goodwill Retail Store in Hendersonville, TN

U.S. Department of Labor
Occupational Safety and Health Administration
Directorate of Construction

July 2013

Report Prepared by
Mohammad Ayub, P.E., S.E.
Dinesh Shah, P.E.
Office of Engineering Services
Directorate of Construction

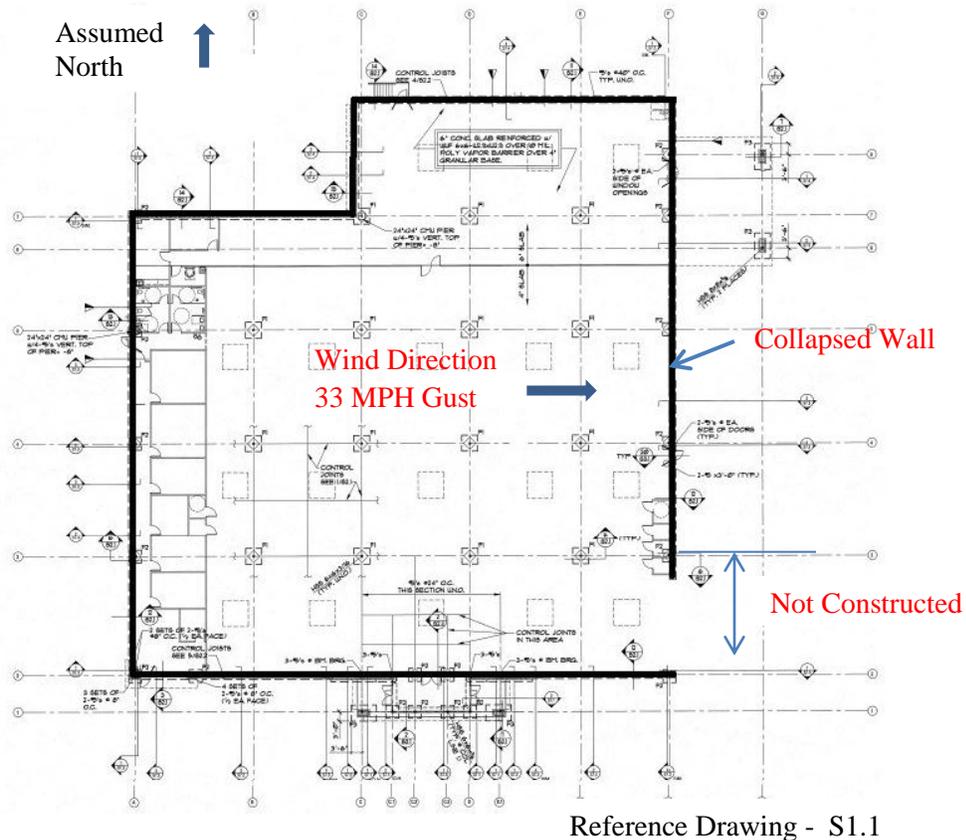
Figure 1 – CMU wall Plan

The project consisted of construction of a one-story Goodwill Retail Store, approximately 170' wide x 180' long (see figure 1).

For the purpose of this report, the wall that fell is identified as the east wall by the field personnel, although contract drawings identify it as the north wall. The exterior non-load bearing walls consisted of 8" thick partially grouted Concrete Masonry Units (CMU) supported on 2' wide x 1' deep concrete footing (see Figures 1 to 3).

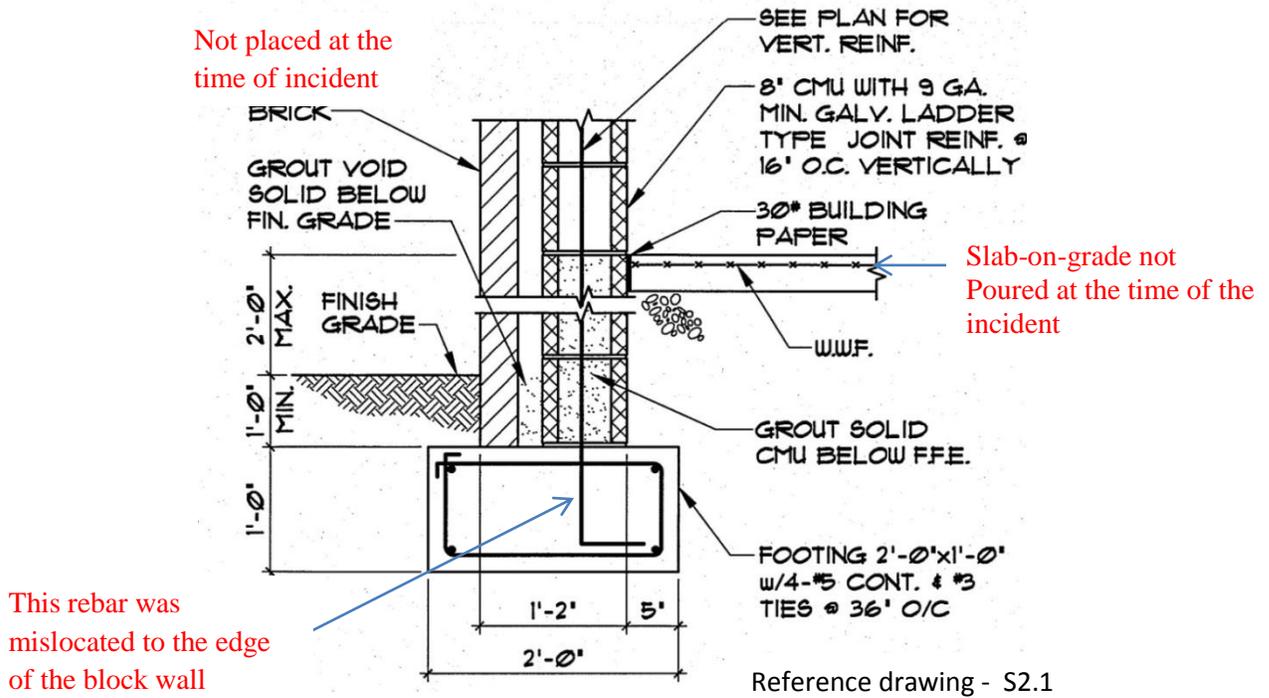
Figure 4 – Exterior Wall Section

The CMU walls consisted of hollow concrete blocks and were partially grouted using a low lift grouting method. The wall was reinforced with #5 rebar at 40” on center (see Figure 4).

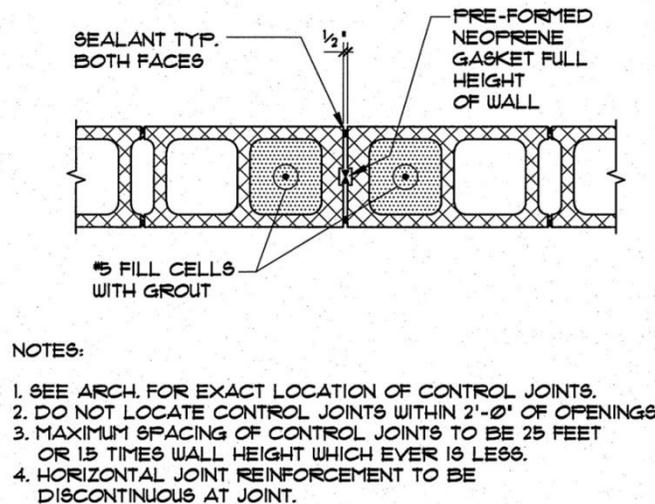
Figure 5 – Control Joint detail

The architect specified the maximum spacing of the control joints to be at 25' on center in the horizontal direction (see Figure 5).

5. Based on architectural drawings, vertical control joint at the east wall was considered at 25'-0" on center (see Figure 5).
6. Three interior bracings and one exterior bracing at the east wall were considered to resist the wind loads. For calculation purposes, the top of the brace was considered to be 9'-0" above the top of the footing, and the bottom of the brace was assumed to be supported at the ground

The masonry contractor provided too few braces between the control joints of the 150'-long masonry wall that fell. In this project, the control joints in the masonry wall were designed and detailed as a complete separation (see Figure 5) similar to an expansion joint which necessitated a minimum of two braces for the masonry walls between the control joints (see Figure 11). Only three interior and three exterior braces for the entire wall were provided instead of the twelve specified in the industry standard, "Standard practice for Bracing Masonry Walls under construction" developed by the

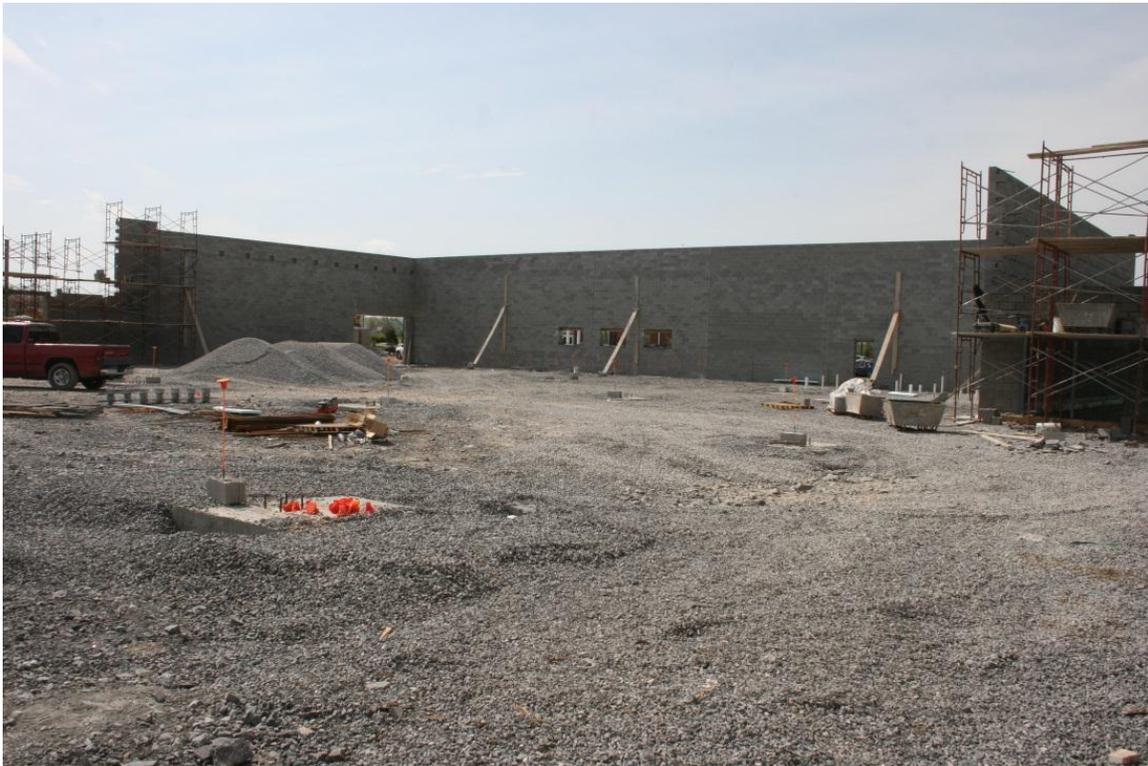
Figure 6 – Typical interior bracing detail

beams at the top of the masonry wall were reported to be discontinuous at the control joints. The ground floor slab, also known as the first floor slab, was not poured at the time of the incident. During construction, the masonry contractor had provided six bracings against wind for the entire length of each wall. Three braces were located at the interior (similar to Figure 6) and three on the exterior faces of each wall.
