Investigation of the May 28, 2013 failure of gin pole rigging at a cell tower in Georgetown, MS

U.S. Department of Labor Occupational Safety and Health Administration Directorate of Construction

October 2013

Report Prepared by Mohammad Ayub, P.E., S.E. Office of Engineering Services Directorate of Construction

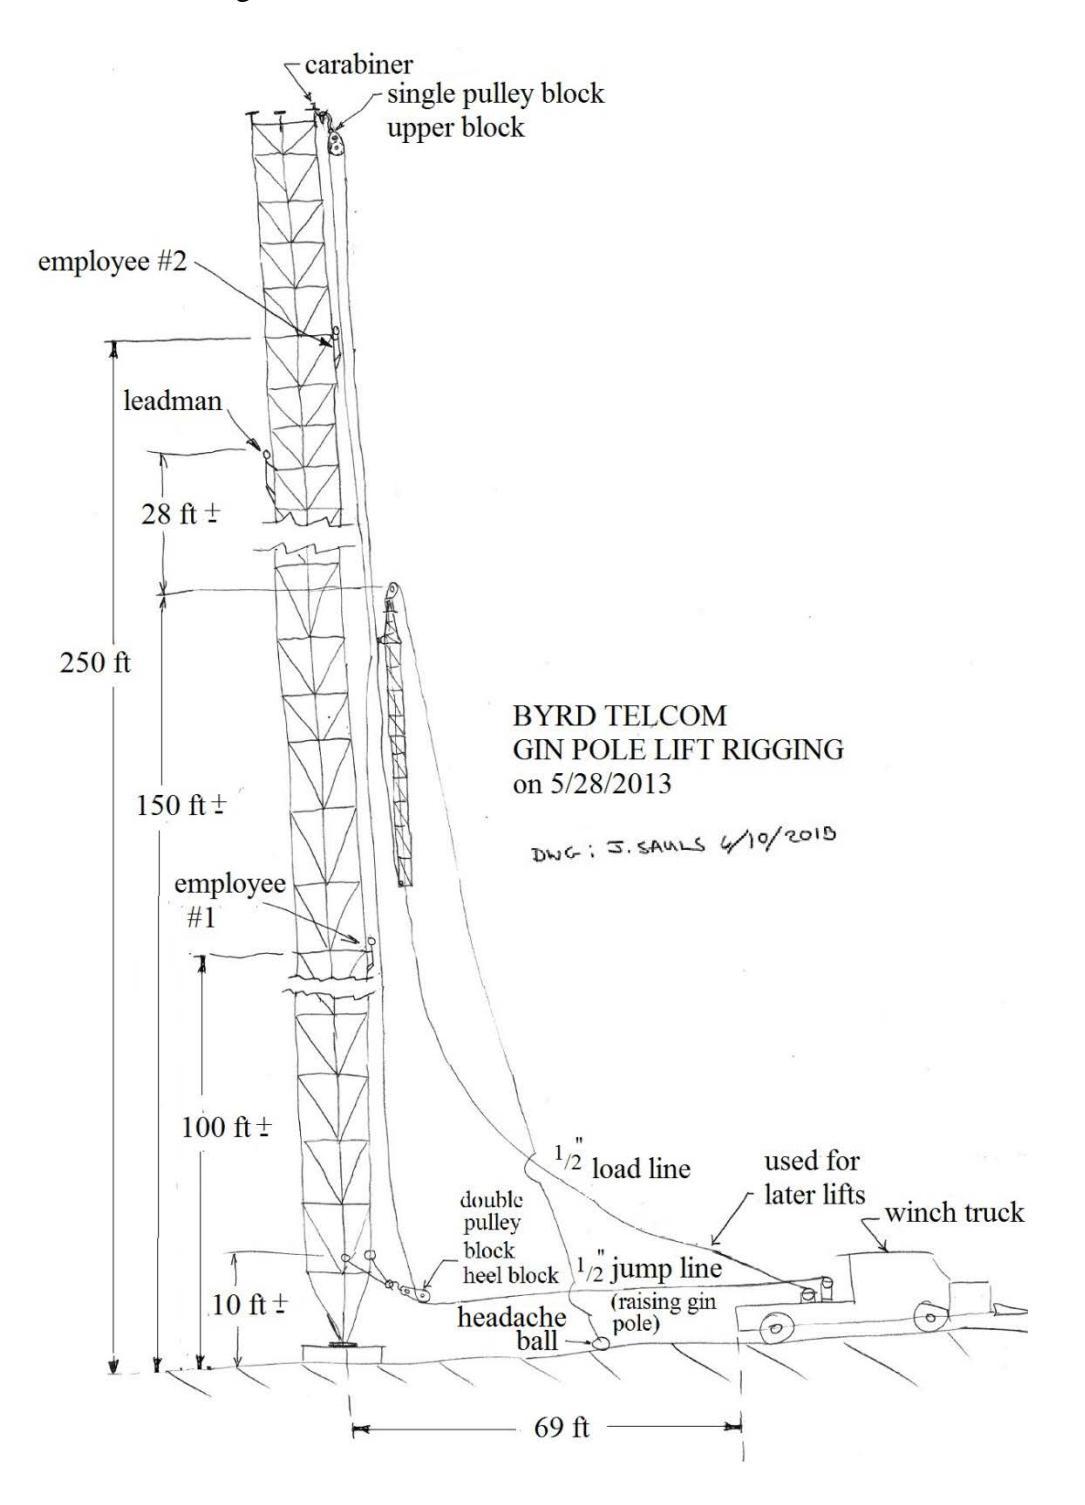
Fig. 1 – Rigging elevation

John Davidson and Johnny Martone climbed up the tower and hooked a carabiner in one of the holes of the tower leg's topmost plate. These plates are used to connect the lower and upper segments of the tower together, and are provided with four holes. The carabiner was placed in a manner so that the narrower part was pointing downwards to where the hook was placed. The hook was attached to a block where a synthetic rope was placed to pull the jump line wire rope. This is based on the testimony of John Davidson who rigged the carabiner and the block along with Johnny Martone. John testified that there was plenty of free movement of the hook, and there was no bind.

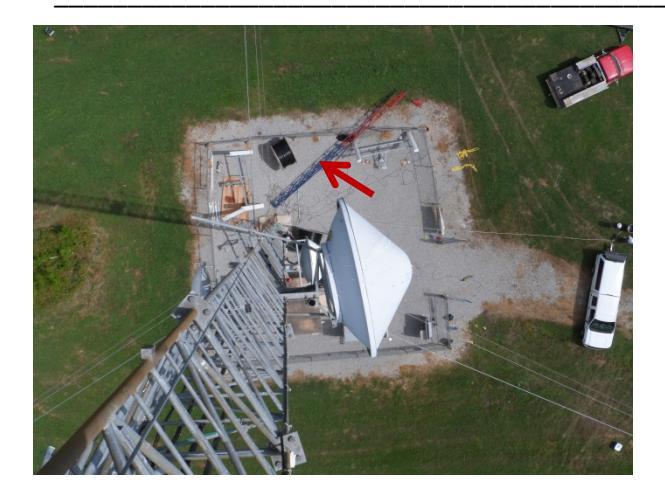
Fig. 5 - A view of the gin pole from the top of the tower

Michael was fatally struck with the falling gin pole. Both were thrown on to the ground. The gin pole came down in one piece at the foot of the tower, see fig. 4, 5 and 6. The time of the incident was 2:10 P.M..

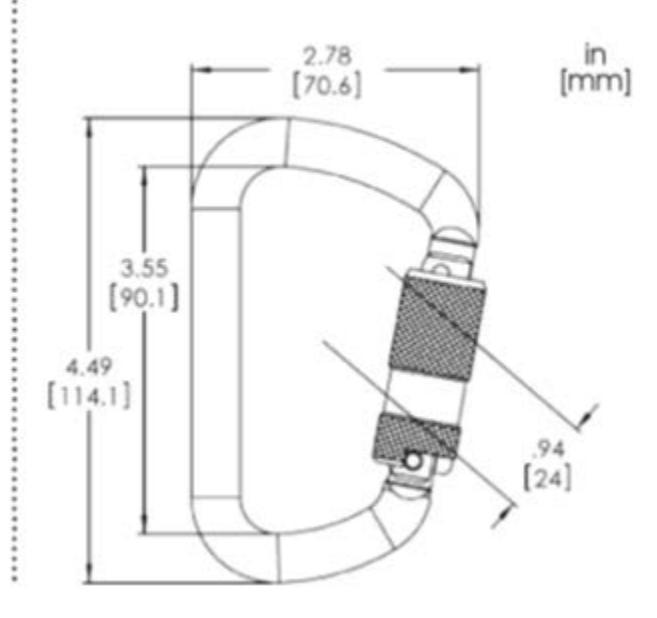
Fig. 15 - Carabiner manufacturer's specifications

It is believed that the carabiner used at the site was manufactured by PenSafe Inc. of Canada; model Number C 775, see fig. 15. The carabiner has been load-tested by the manufacturer to support a tensile load of 3,600 pounds, and a side load of 3,600 pounds. Using a factor of safety of 2.75, the failure load would be approximately 10,000 pounds. A couple of days after the incident, several photographs were taken of the failed carabiner stuck in the hole of the pad plate, see fig. 16, 17 and 18. The carabiner was taken out and examined, see fig. 19.

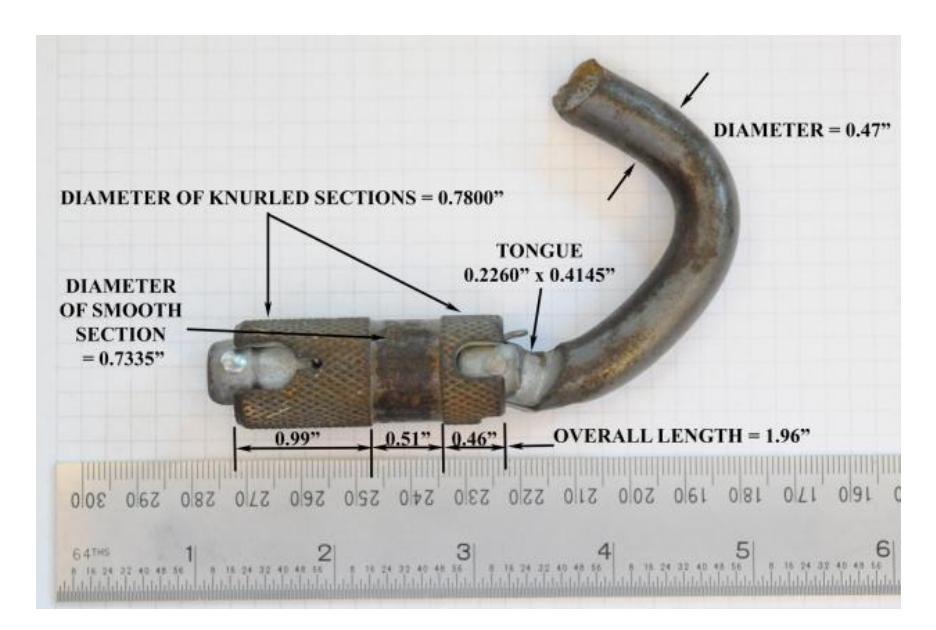
Fig. 23 - SLTC Photo of carabiner remnant showing dimensional measurements

Third, we examined how high or low the carabiner could be placed in the 13/16" hole, and whether it could freely move up and down, and move horizontally over the diagonal edge of the plate. It was determined that the carabiner could move freely if the hole in the steel plate was smooth, as it was supposed to be. There was testimony from John Davidson who said that the carabiner went in smoothly, and that the movements were without any bind or hitch. The person who climbed up the tower and took the failed carabiner out of the hole also said in a telephone interview with OSHA that she took out the carabiner without any special effort or without using any tool. The hole in the plate was 13/16" (0.8125"), and the maximum diameter of the carabiner was 0.78" providing some room for movement, see fig. 23 and 24, for the measurements taken by OSHA's Salt Lake City Laboratory (SLTC). For the hook to be placed in the lower part of the carabiner, the minimum space required below the steel plate was required to be 1 7/8 to 2". The available space was 2 ½". By the force of gravity, the carabiner would eventually be located, see fig. 25 and 26, giving ample space for the hook to be placed, see discussion later on the new carabiner.

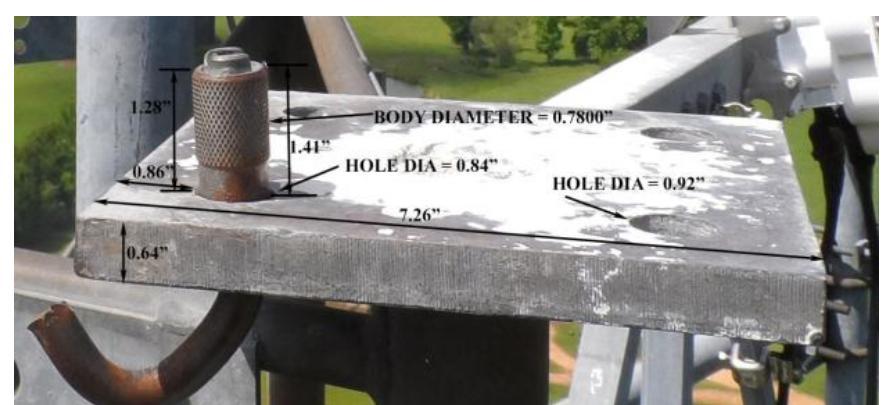
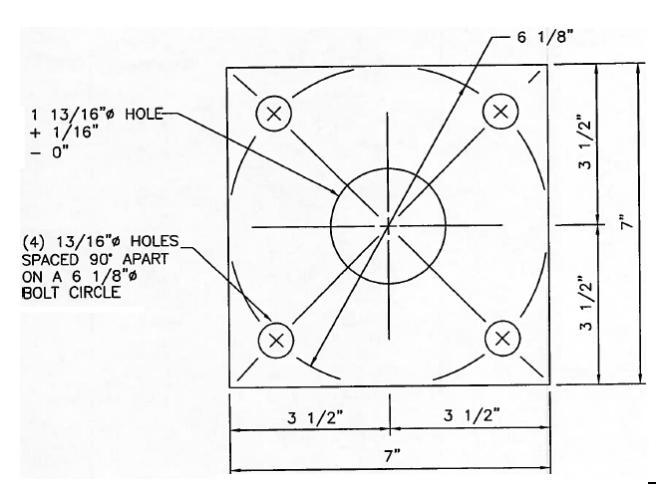
Fig. 24 – SLTC Photo of carabiner remnant showing dimensional measurements

The body diameter of the Kwiklock hasp was measured directly and used as the calibration for this photo. The plate diameter measurement was made at the location of the front holes, but is offset in this photo for clarity. The hasp extends 1.28" out on the left and 1.41" on the right as shown in the photo

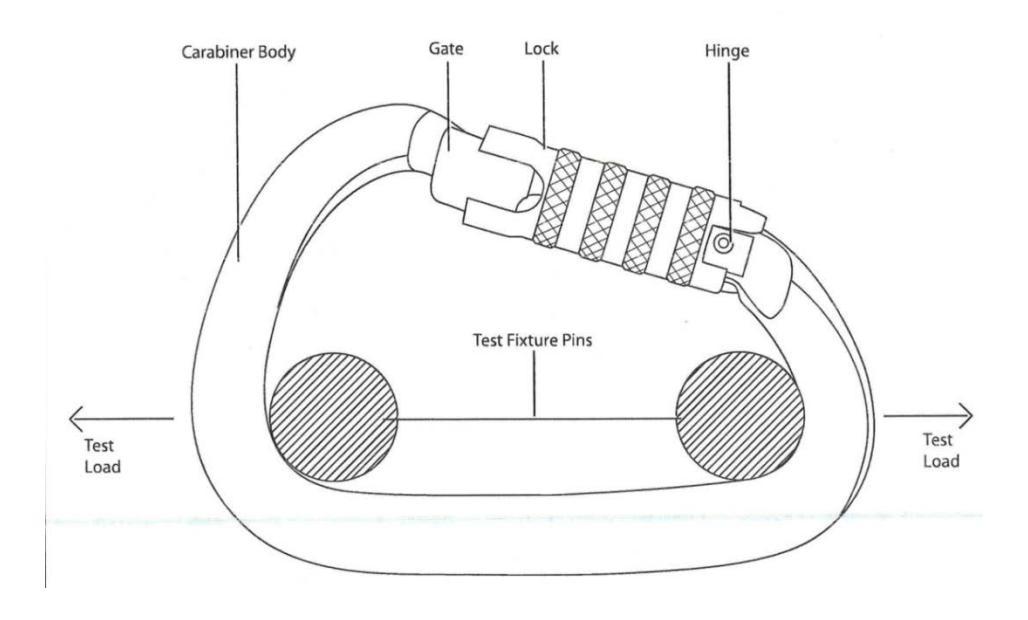
Fig. 27 – Tensile testing of carabiner

<u>Fourth</u>, we examined how the carabiner would support the load of the gin pole, wire rope, etc. It was estimated that the carabiner would be subjected to a direct tensile load of approximately 3,600 pounds, well within the failure load of the carabiner, if used properly. Carabiners are always used in a configuration where the line of application of the load coincide with the line of support of the carabiner, subjecting the carabiner to direct tension, and preventing any flexural moment of the carabiner's body, see fig. 27 below of the manner in which carabiners are tested longitudinally. However, in this instance, the line of application of the load was at the center of the hook, but the support was where the carabiner touched the steel plate either in the 13/16" hole or the top part of the plate. If the support is not concentric to the application of the load, the

carabiner will be subject to flexural loads, for which the carabiner is not designed. When the workers placed the carabiner in the plate hole, they did not realize that it was a misuse of the carabiner. They only considered the tensile load capacity which is much greater than the load placed on the block, but they failed to take into account that the support was a few inches away from the hook and the block.

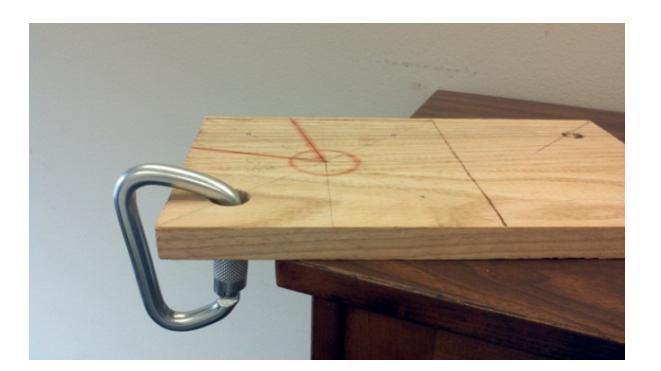
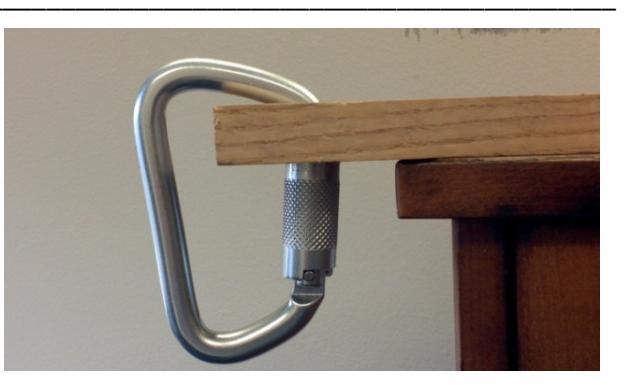
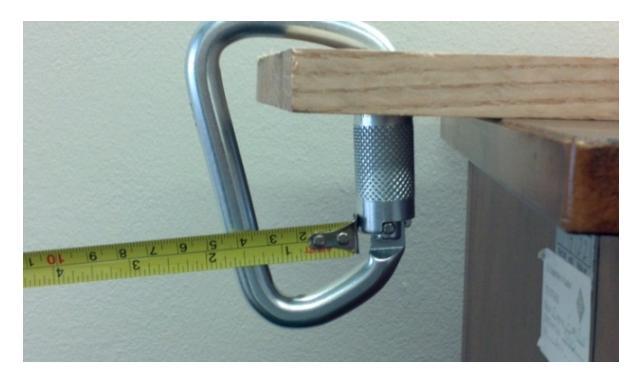
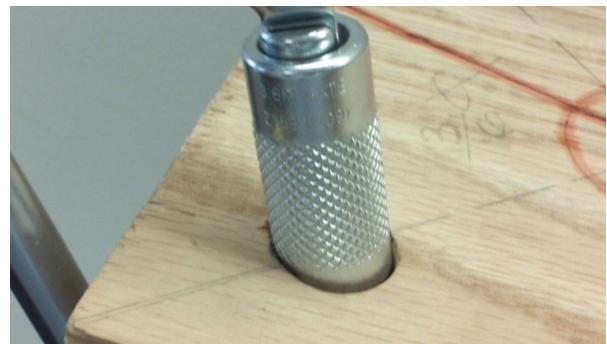
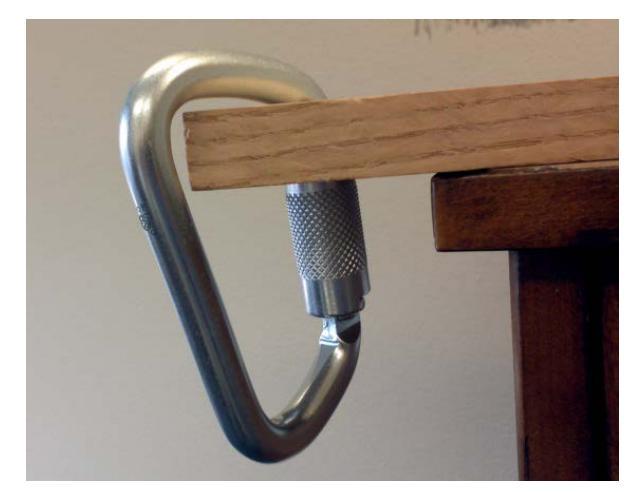
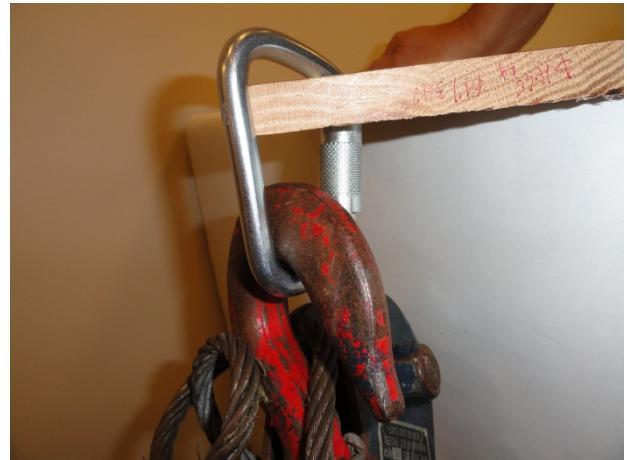
For our investigation, DOC purchased a carabiner model No. C775 (ANSI/ASSE Z359.12-09) from the manufacturer in Canada. This model was almost identical to the carabiner (ANSI/ASSE Z359.1-07) used in the incident. The C775 was placed in a 13/16" hole drilled in a 5/8" wood piece to simulate the actual site conditions. The hole was drilled to the dimensions indicated in the drawing provided by the tower manufacturer, including edge distances. The C775 went into the hole with little difficulty, and it soon became apparent that the narrower part of the carabiner would have to be placed below the steel plate for the hook to be placed inside the carabiner. Also, the wider part of the carabiner allowed the carabiner to move freely in a horizontal angular direction. This validated the testimony given by John Davidson. See fig. 28 through 35.
