# Investigation of the November 2, 2013 collapse of concrete beams at Fort Lauderdale-Hollywood Airport runway project

U.S. Department of Labor  
Occupational Safety and Health Administration  
Directorate of Construction

April 2014

Report Prepared by  
Mohammad Ayub, P.E., S.E.  
Office of Engineering Services  
Directorate of Construction

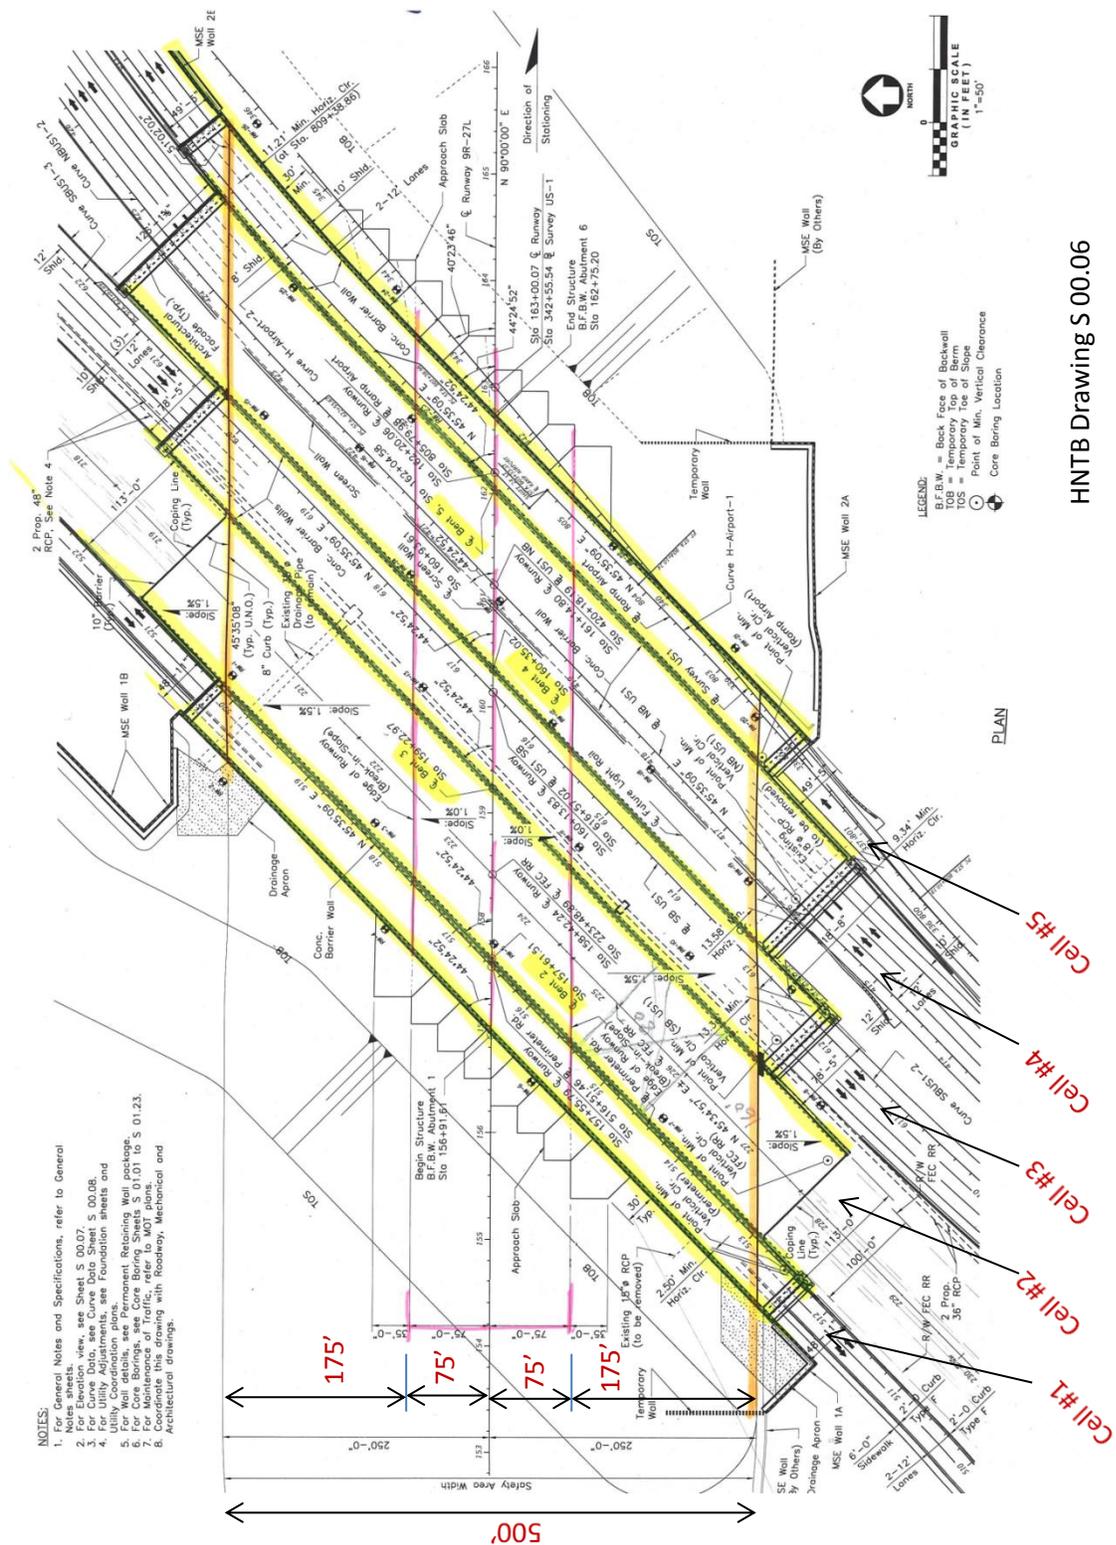
Fig. 1 Plan showing Cells #1 thru 5 and runway expansion

The actual runway was 150 ft. wide plus 175 ft. of safety width on either side, making a total width of 500 ft. of concrete construction, see Fig. 1.

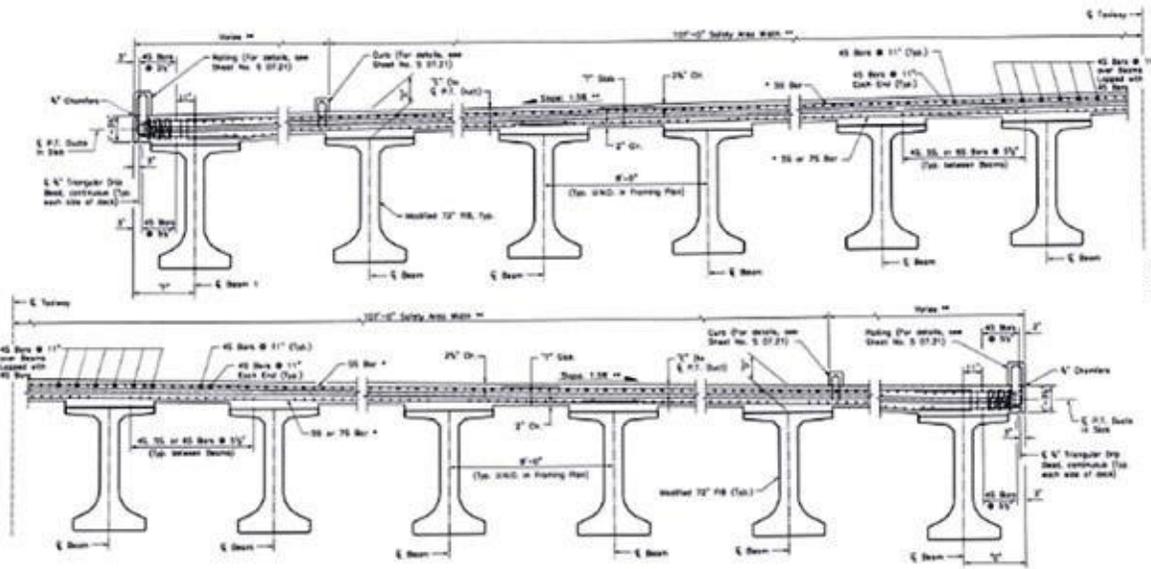
**Fig. 2** Transverse cross section of the structure

The runway expansion was not on grade but rather on a structural slab framed over concrete abutments and concrete bents similar to a bridge construction. For the purpose of this report, we will identify the structure as a runway bridge. The deck slab to be poured later was to consist of poured in place post-tensioned 15" thick slab over pre-stressed concrete girders generally spaced at 8 ft. on centers, see Fig. 2.

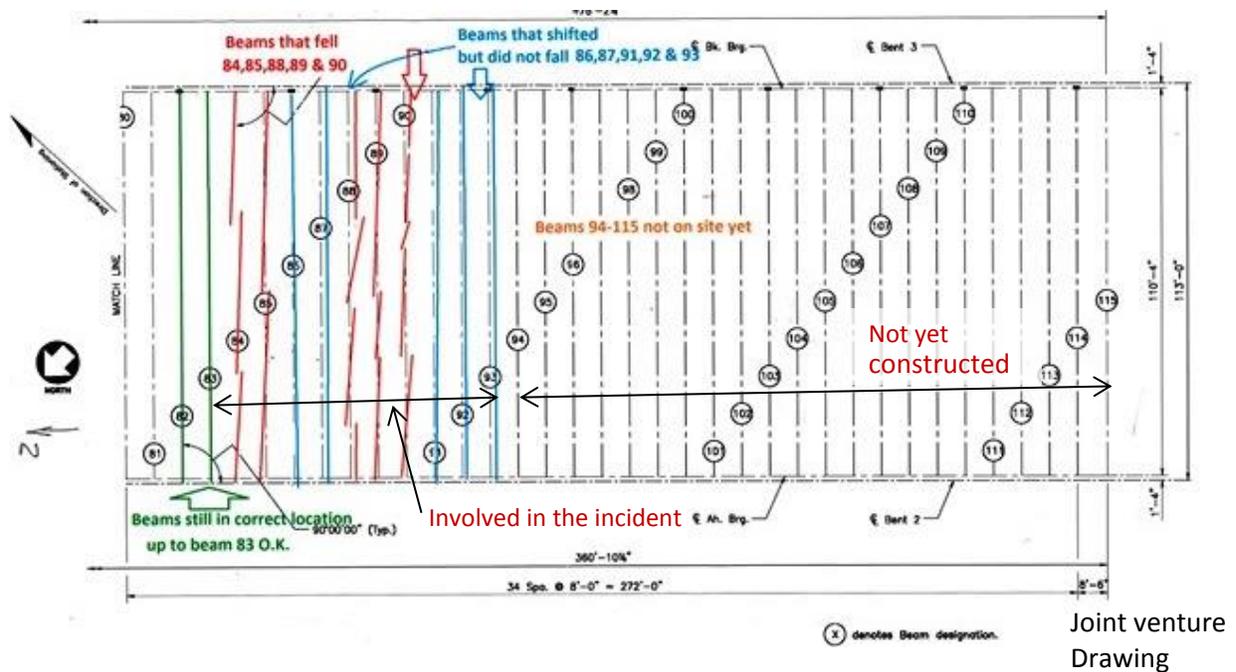
Fig. 6 Cell #2 Plan showing concrete beams involved in the incident

The first beam on the north end was marked as 1 and the last was marked as 93. Twenty-two (22) additional beams remained to be placed. It takes approximately 20 to 30 minutes to hoist a beam and place it at its final location, but due to railroad traffic in Cell # 2, it took longer due to the need to suspend work during train passage.

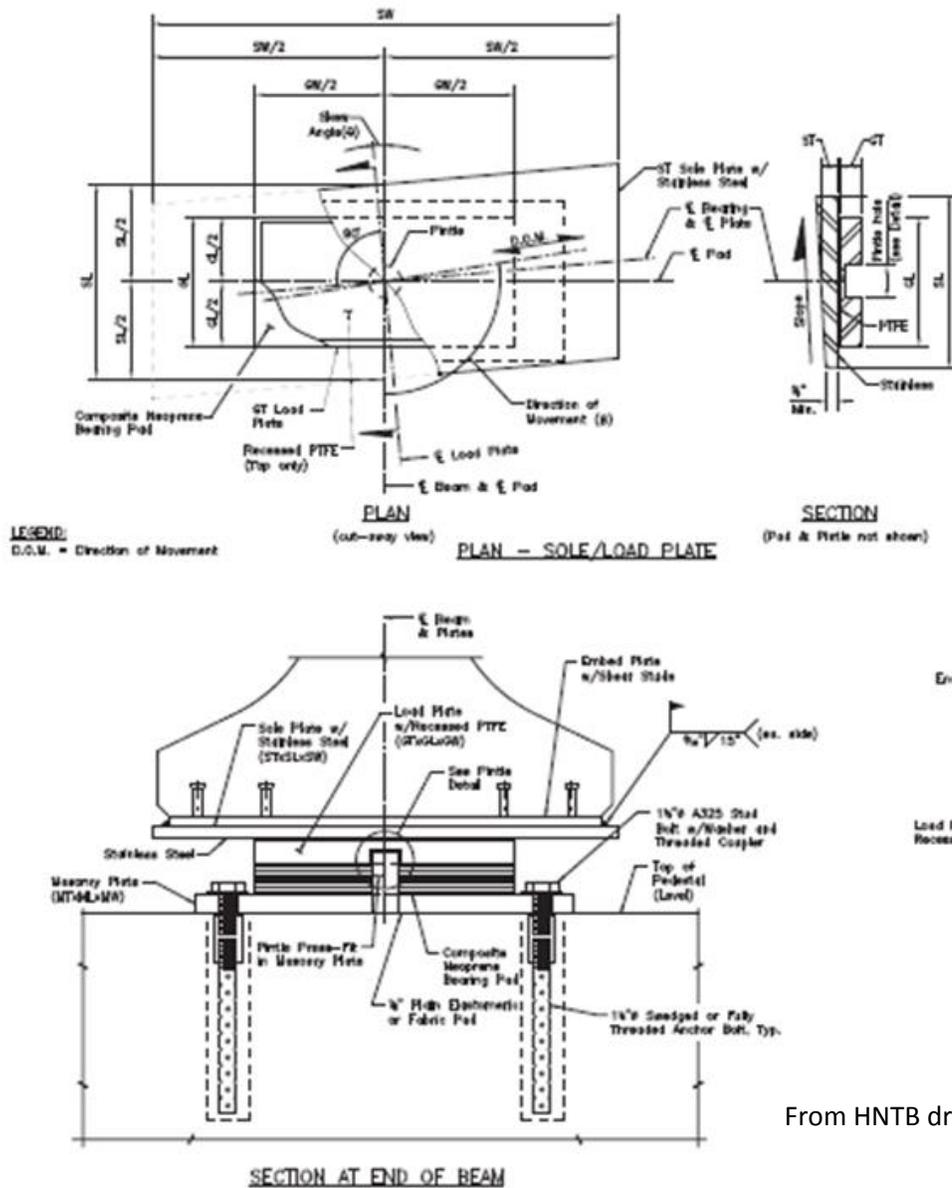
Fig. 23 Typical detail of bearing type IV

For beams No. 84 thru 93, there were two types of bearings, identified as Type III and Type IV. All beams bearing on Bent 2 had Type IV bearings. Beams bearing on Bent 3 were also Type IV except for beams 85, 89 and 93. Type IV bearings permitted both transverse and longitudinal movements of the beams, whereas Type III bearings prevented longitudinal movements but permitted transverse movements. Both bearings were of similar construction except for the guide plates of Type III to prevent longitudinal movements. Typical details for Type III and IV are provided below (see Figs. 22 and 23).

There were five parts of the bearing, i.e., masonry plate, composite neoprene bearing pad, load plate with recessed polytetrafluoroethylene (PTFE), sole plate with stainless steel backing having #8 mirror finish, and steel plates embedded in the precast beams. Masonry plates were anchored to the bents by anchors embedded in the concrete walls of the bents. On the center of the masonry plates were composite neoprene pads 12" x 24", approximately 3" thick consisting of five layers of neoprene. The pads were secured to

the masonry plates with two pintles. On top of the neoprene pads were the steel load plates bonded with recessed PTFE at the top with silicone grease. On the top of the PTFE was the sole plate with a stainless steel mirror finish at the bottom to mate with the PTFE for ease of sliding with a coefficient of friction no higher than 4%. The sole plate was welded to the embedded plate which is cast in the concrete beams.

Type IV bearings provide movement in multiple directions. Type III bearings are restricted to transverse movements only. The longitudinal movements are contained by welding guide bars to the sole plate, see Fig. 22 above.

The use of PTFE and a mating stainless steel with a mirror finish are well recognized and accepted in bridge construction where longitudinal or transverse movements are desired. All bearings were manufactured by D S Brown Company of Ohio, and were individually shipped with all five pieces of the bearings bundled together. The bearings were not opened until they were placed when the sole plate was ready to be welded to the embedded plate of the concrete beams, see Fig. 24.
