Investigation of the March 23, 2015 Mast Climbing Scaffold Collapse during Dismantling at Raleigh, NC

U.S. Department of Labor
Occupational Safety and Health Administration
Directorate of Construction

August 2015

Report Prepared by
Mohammad Ayub, P.E., S.E.
Office of Engineering Services
Directorate of Construction

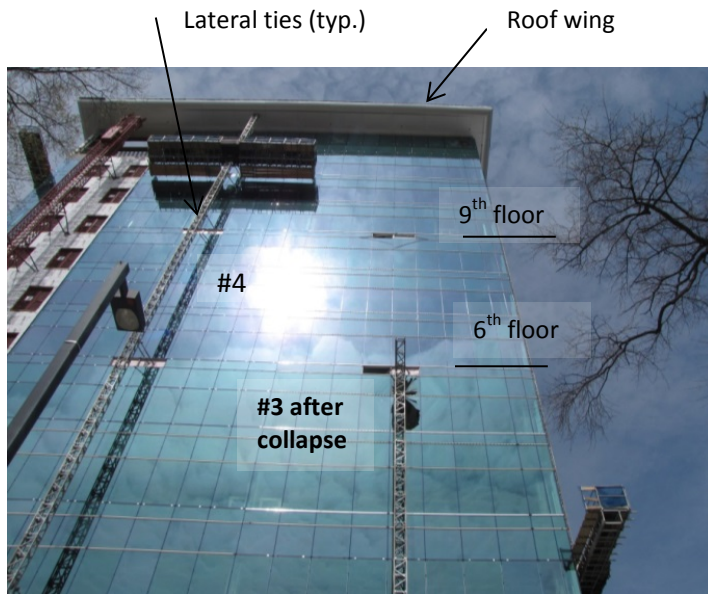
Fig. 8 – Location of mast-climbers #3 and #4 (south side)

Associated erected six mast-climbers; Tower Nos. 1 & 2 on the east face, Nos. 3 & 4 on the south face and Nos. 5 & 6 on the west face of the building under construction, see Fig. 8, 9 and 10. No mast-climber was erected on the north face as there was no “roof wing” on the north face. After the mast climbers were erected by Associated at the construction site, the mast climbers were then leased to Choate, who was assigned the job of operating them during the construction period. Associated provided training to the employees of Choate and another contractor, Jannawall, Inc., to operate the mast climber. Jannawall was erecting the glass panels for the curtain walls of the building under construction. After the erection of the mast climber was completed, and training provided to the employees who would operate them, Associated left the construction site. Associated was responsible for assembling and disassembling the tower, but not to operate the platform during construction. Associated would later be called upon by Choate to disassemble them. Tower No. 3 was the first to be disassembled by Associated. This tower failed during its disassembly process. This report will confine itself to Tower No. 3. The rest of the towers were to be disassembled by Associated, and they were standing upright in their

original configuration at the time of the failure of Tower No. 3. The failure of Tower No. 3 did not impact any other tower.

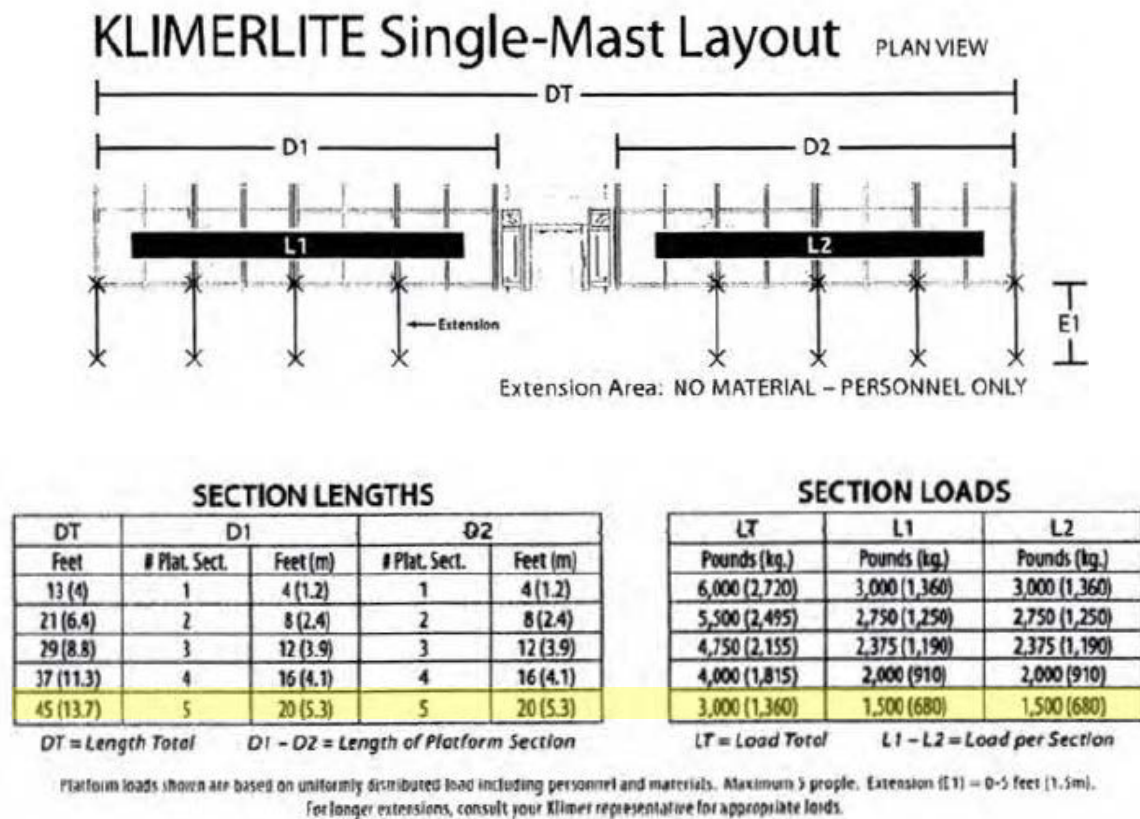
Fig. 24 – Load Chart for Single-Mast layout from manual

According to Klimer, the allowable load on the Klimerlite single-mast for a free-standing height of 40 ft. with a 45 ft. long platform without upper rear extension was 3,000 pounds which included the weight of employees. The 3,000 lbs. had to be evenly distributed on each side of the main platform with a maximum of 1,500 pounds per side, see Fig. 24 and 25, load chart. The

3000 pounds allowable load is valid only for standard configuration for a 45 ft. long platform with extensions up to 5 feet on the wall side (lower platform) and no rear extension.

The load chart states “**IMPORTANT!** Study operator's manual before use. Do not load above recommended safe working loads. No materials at any time to be placed on platform extensions. For configurations not shown above, consult your local Kilmer dealer or operator's manual. This product must be used in conformity with safe practice and applicable statutes, regulations, codes and ordinances. Specifications of products and equipment shown herein are subject to change without notice.”

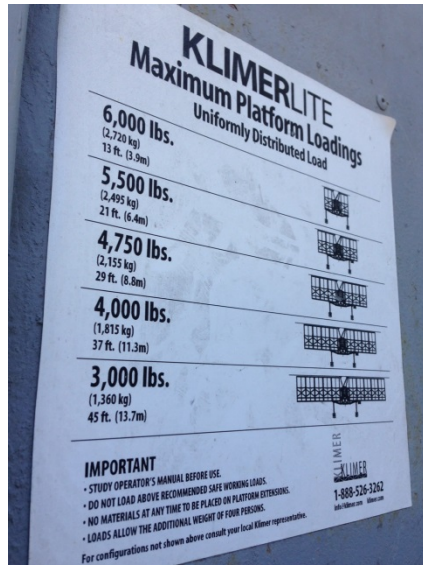
Fig. 25 – Load Chart displayed on a Mast

Klimer, during OSHA's interview, confirmed that the uniformly distributed load of 3,000 pounds was valid for both operating and dismantling the mast climbing platform with a maximum height of 40 ft.

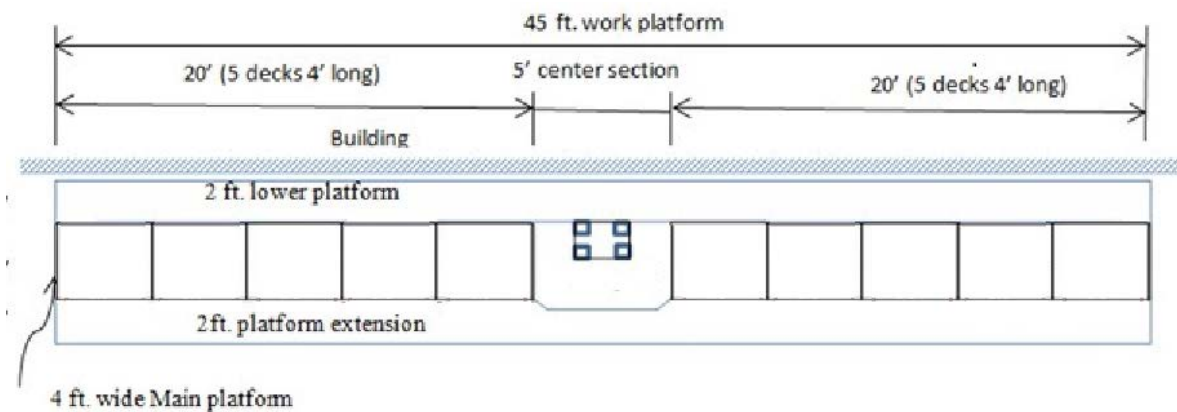
Fig. 28 – Mast scaffold platform plan

The failed mast climbing scaffold had a front lower extension of 24" and a rear upper extension of 24", see Fig. 26, 27 and 28. The dead weight of the rear extension (extension steel tubes and deck) itself is approximately 500 lbs. The deck with an upper extension is not a standard configuration and is not commonly used in the industry. All manufacturers generally do not provide the safe capacity of the deck configuration with the upper rear deck, and ask that the user contact them to determine the safe load capacity. In this instance, the manufacturer was not contacted to determine the safe load carrying capacity of the deck configured with an upper rear deck. The safe load carrying capacity will be lower than 3,000 pounds and if the load is placed on the rear extension, the allowable load capacity will be further reduced due to the greater eccentricity of the loading. It is not known whether the contractor was using the rear extension as a part of the main platform during dismantling and whether the dis-assembled mast sections were actually placed on the rear extension area.

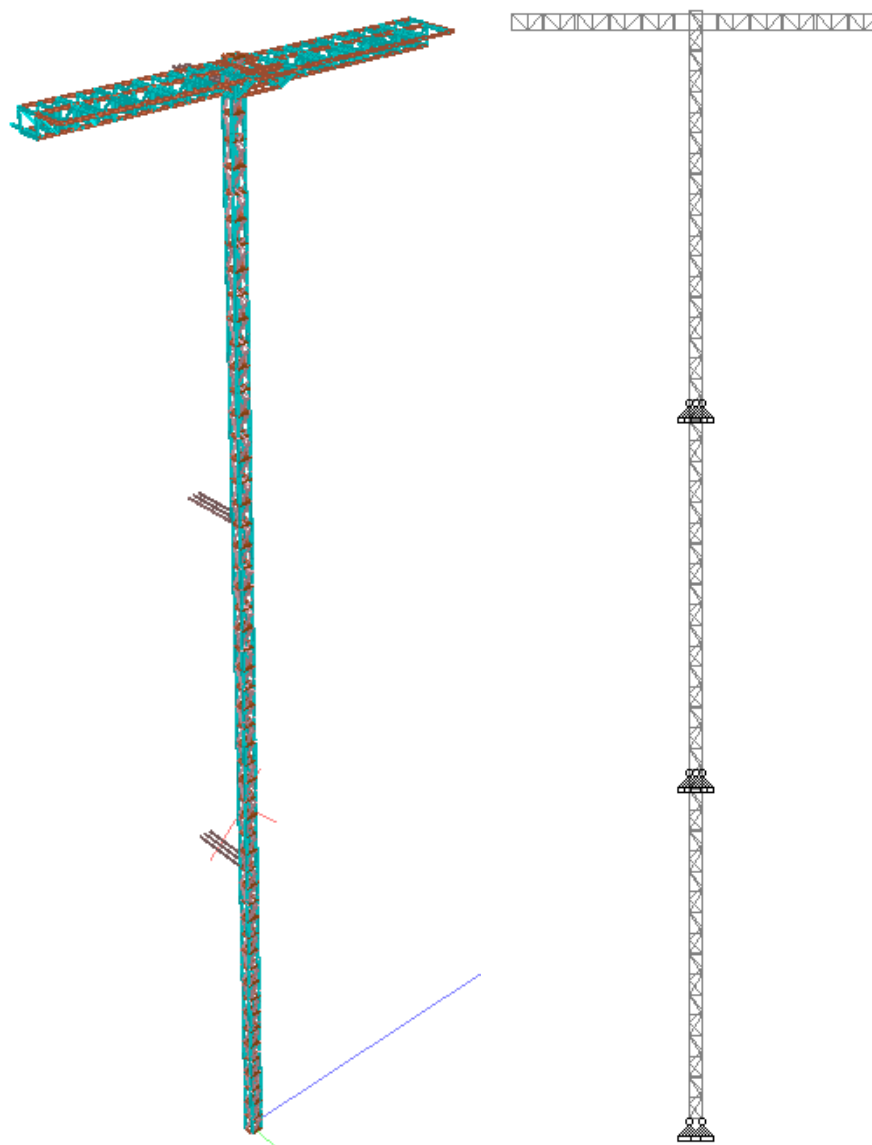
Fig. 29 – STAAD model for analysis

STAAD.Pro program was used to create a 3-D model of the mast along with the platform for the analysis, see Fig. 29. Since the incident occurred during dismantling, analysis was performed for the dismantling condition only. In the STAAD analysis, the bolts were assumed to be at the center line of the mast legs. The roller mechanism on the mast was not included in the model.

Four cases were considered and a P-delta analysis was performed. Wind was not considered in the computation.

For Case I, for a free-standing height of 40 ft. and with a load of 3000 lbs., uniformly distributed over the entire deck, the two bolts on the side of the building near the 6th floor were subjected to a tension of approximately 5 kips, which can be increased by 17% to adjust for the actual location of the bolts in the N-S direction. With consideration of pre-tension in the bolt, and adjusting for the actual spacing between the bolts, the net tension in the bolt was approximately 18 kips. With P-delta effect and the pre-tension, the tension was increased to approximately 20 kips below the failure load of 22 kips. Hence, the mast could safely support 3,000 pounds when uniformly distributed for a cantilevered height of 40 ft. However the capacity of the bolt did not comply with OSHA’s regulations, mentioned above. OSHA regulations 29 CFR 1926.451(a)(1) was not satisfied regardless of whether the safe capacity of the deck was taken as 3,000 or 2,000 pounds.

For Case III, for a cantilevered height of 47 ft. with a load of 4,260 lbs. uniformly distributed, the tension in the bolts on the side of the building near the 6th floor level increased only slightly to 5.8 kips. Considering the P-delta effect, the reduced spacing between the bolts and the pre-tension, the tension in the bolts was approximately 22 kips, close to the failure load. It must be mentioned here that the loading and the height of the free-standing height of Case III exceeded the permissible limit set by the manufacturer.

For Case IV, which was identical to Case III except for the fact that the superimposed load on the platform was not uniformly distributed, but as shown in Fig. 30, the tension in the bolts significantly increased to 8 kips. Again with due consideration of the P-delta effect, and the reduced spacing between the bolts and pre-tension in the bolts, the tension in the bolts was 26 kips, well above the failure load, and this caused the failure.

We highly recommend that the design of the mast climbing platform be brought into compliance with the above stated OSHA regulations 1926.451(a)(1). Reducing the distance between the lateral ties to 20 ft. from the present 40 ft. should be examined to determine if it could result in compliance with the OSHA regulations.
