# Investigation of the February 5, 2016 Crane Collapse at 40 Worth Street, New York, NY

U.S. Department of Labor  
Occupational Safety and Health Administration  
Directorate of Construction

July 2016

Report Prepared by  
Mohammad Ayub, P.E., S.E.  
Office of Engineering Services  
Directorate of Construction

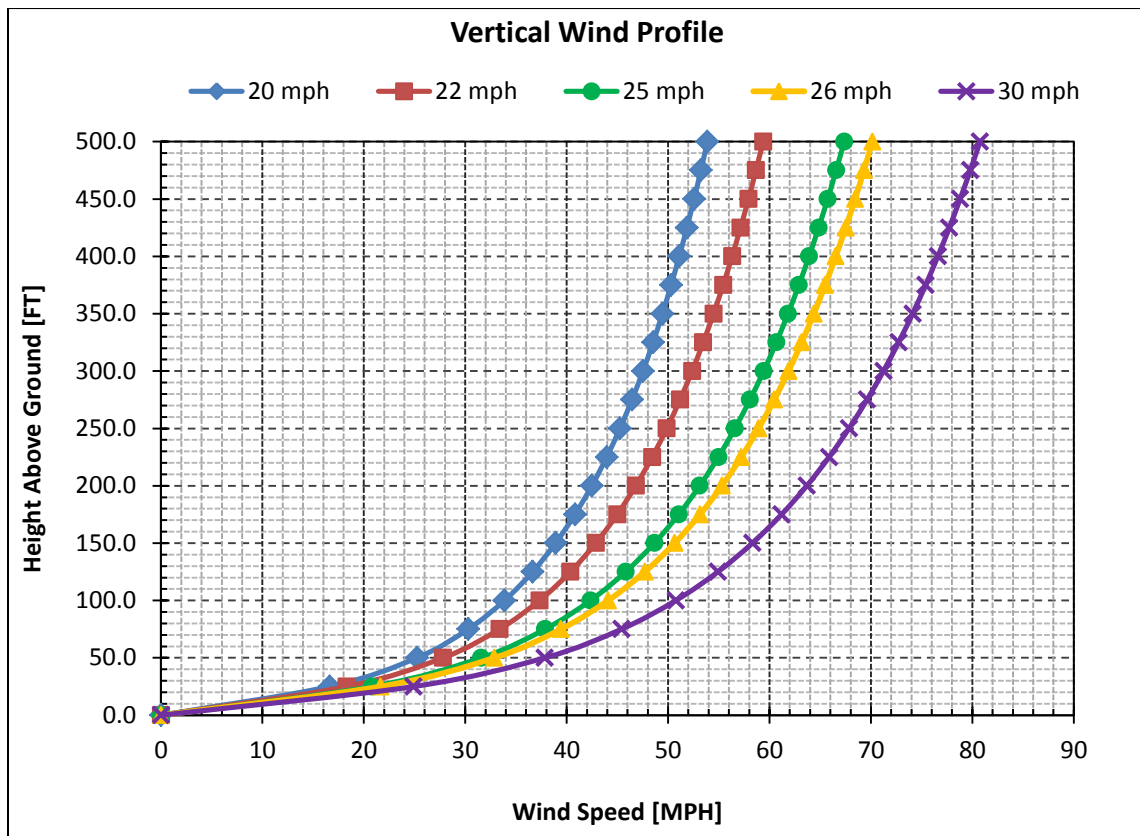
**Figure 14** Wind speed profile

given below, using the logarithmic wind speed profile for the reference wind speed of 20, 22, 25, 26 and 30 mph at the reference elevation of 33 ft. Other methods also yielded similar results.

Wind pressure on crane components increases with the increasing wind speed and increasing height in the ratio of the square of the wind speeds. Compared to the 20 mph wind speed, the wind pressure on the crane jib and boom increases by 65% and 119% at 25 and 30 mph wind speeds, respectively. All five speeds were considered in the analysis.

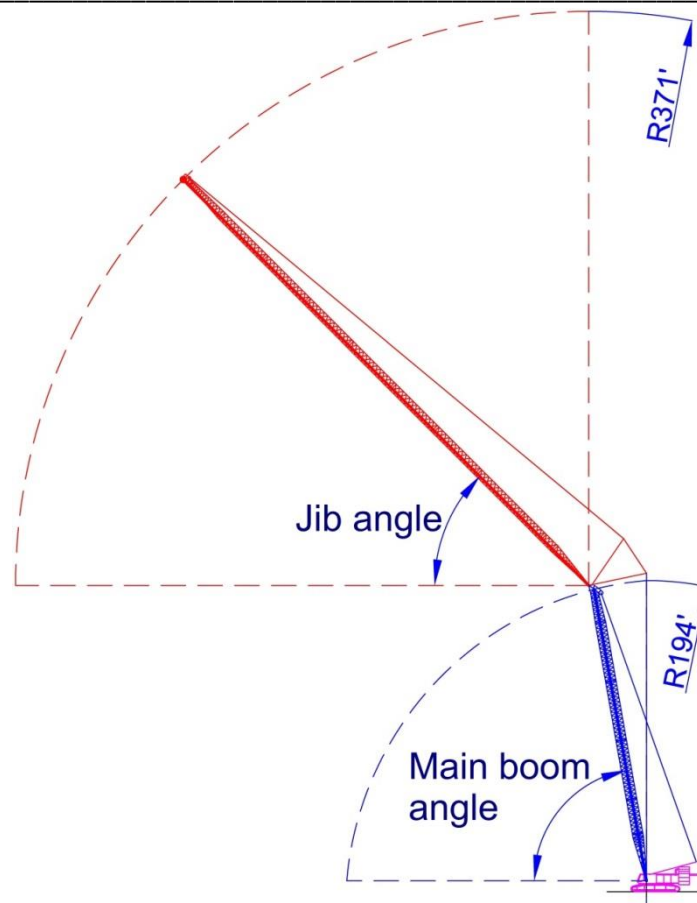
**Figure 15** Crane vertical profile

A line diagram of the vertical profile of the crane is shown below, see Fig. 15.

Wind loads were computed by the formula  $p = 0.00256 V^2$  where  $p$  is the wind pressure in pounds per square foot and  $V$  is the wind speed in miles per hour. Other than pendants, the majority of the structural members of the boom and jib were round shapes to minimize the effects of wind. A shape factor of 0.5 was used to arrive at the wind loads on round members.
