April 15, 2016 Double Tee Collapse at the Miami-Dade College West Campus Parking Garage, Doral, FL

U.S. Department of Labor
Occupational Safety and Health Administration
Directorate of Construction

August 2016

Report prepared by:
Mohammad Ayub, P.E., S.E.
Office of Engineering Services
Directorate of Construction

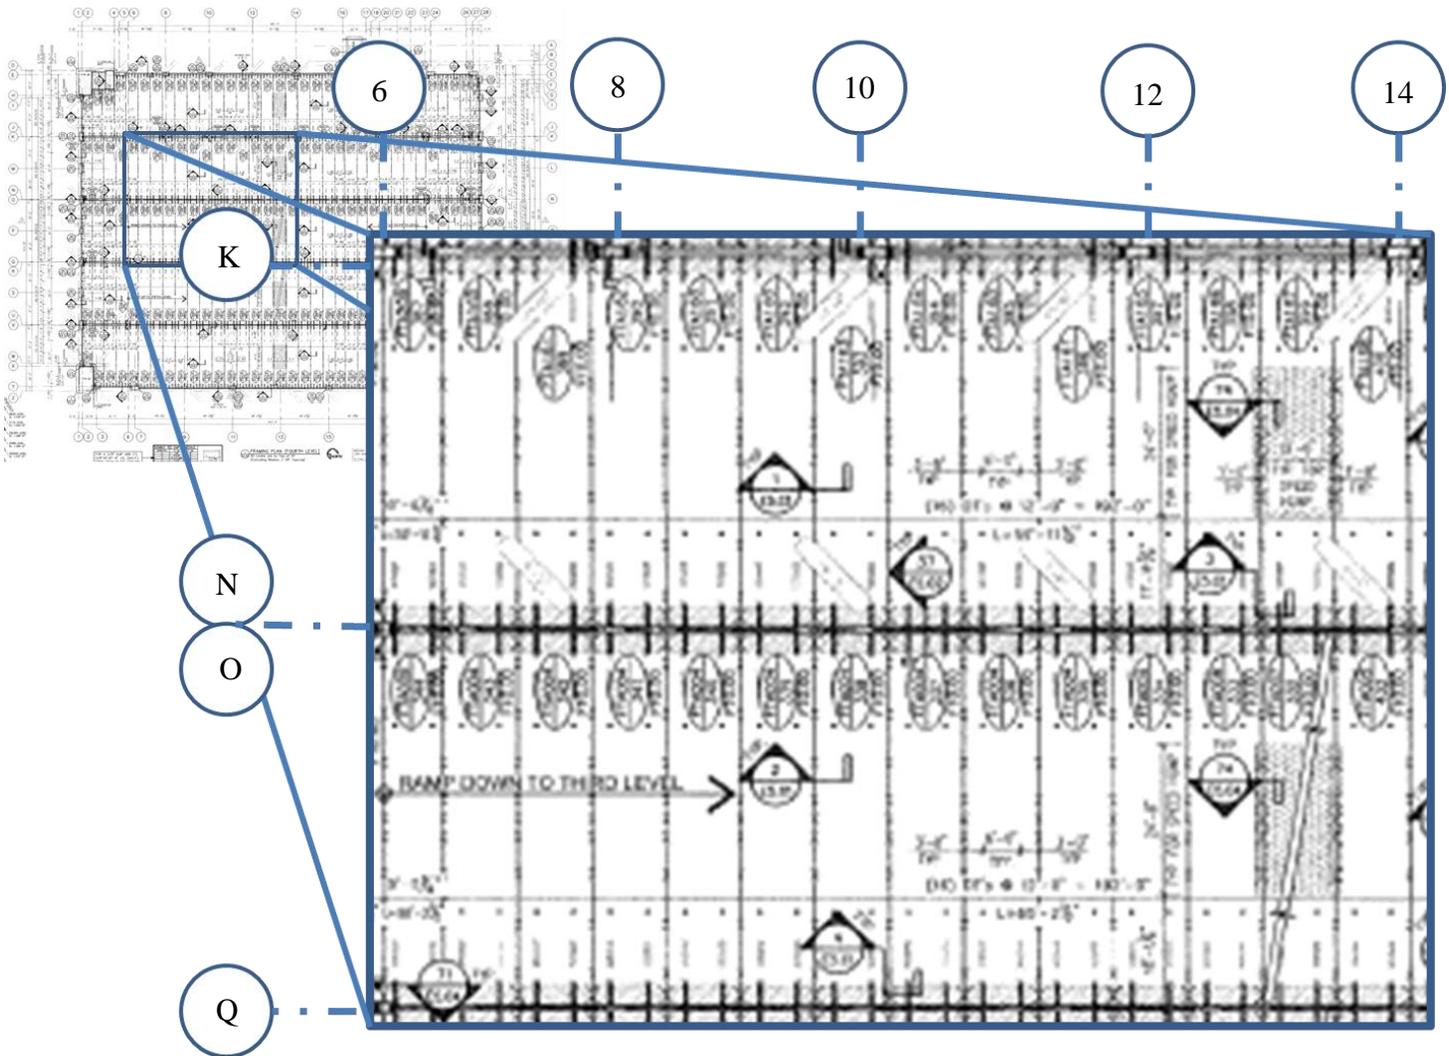
Figure 4. Fourth Level Floor Plan

At the onset of the project, discussions were held between Metomont, Pre-Con, and Haskell regarding the erection sequence for the parking garage. It was decided that initially only two bays, K-N and N-Q, would be erected between the column lines 6 through 14. This area is shown in Figure 4. Accordingly, wall panels were erected along column lines Q and N after which precast double tees were placed at the second through the sixth level. The double tees rested on wall panels at both the north and south ends. At a few locations, it was discovered that the tee flanges were misaligned due to fabrication and erection tolerances; therefore, the flanges of some tee members were not level with the adjacent tee flange and proper welds between the tee flanges could not be made. Although it is a common practice to shim beams to facilitate adjustment, fabrication issues required an unusually high number of adjustments. Shims were placed under the stems of the affected double tees. The shims were placed by jacking up the stems of the tees from the lower level.

After all the precast tees were placed between bays K and N from column lines 6 through 14 from the second to the fourth floor, erection moved to the adjoining bay of N-Q. First, precast columns were erected on column line Q. Second, inverted tee beams along column line Q were placed followed by the placement of double tees on the second and third floors. As was the case between bays K and N, adjustments were needed to align the flanges of the tees. All adjustments of the tee elevations were made by placing shims under the stems of the affected tees. The stems of the tees, however, were not jacked up from the lower level as was the case in the previous bay between lines K and N, but by raising the tees with a crane.
