Investigation of the September 27, 2017, Gin Pole Collapse at an Antenna Tower in Miami Gardens, Florida.

U.S. Department of Labor
Occupational Safety and Health Administration
Directorate of Construction

February 2018

Report Prepared by
Mohammad Ayub, P.E., S.E.
Bryan D. Ewing, Ph.D., P.E.
Office of Engineering Services
Directorate of Construction

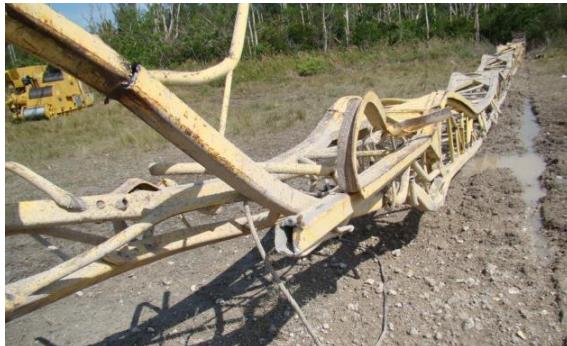
Figure 10 – Lower Sections of Gin Pole

Items within the debris field on the ground included two sections of the gin pole (see Figure 10 through Figure 15), three-drum hoist (see Figure 16 and Figure 17), dummy pole (see Figure 18), dummy pole pedestal (see Figure 19), fork lift (see Figure 20 and Figure 21),

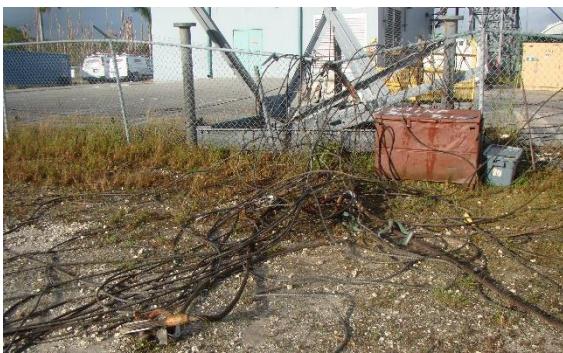
Figure 22 – Jump, Tag and Load Lines

hundreds of feet of wire rope (jump, tag and load lines – see Figure 22) and their associated blocks and assemblies. The fractured basket sling is shown in Figure 23. To the extent possible, these items were stored in a secure, fenced-in area for specimen preservation and for further testing and examination as needed.

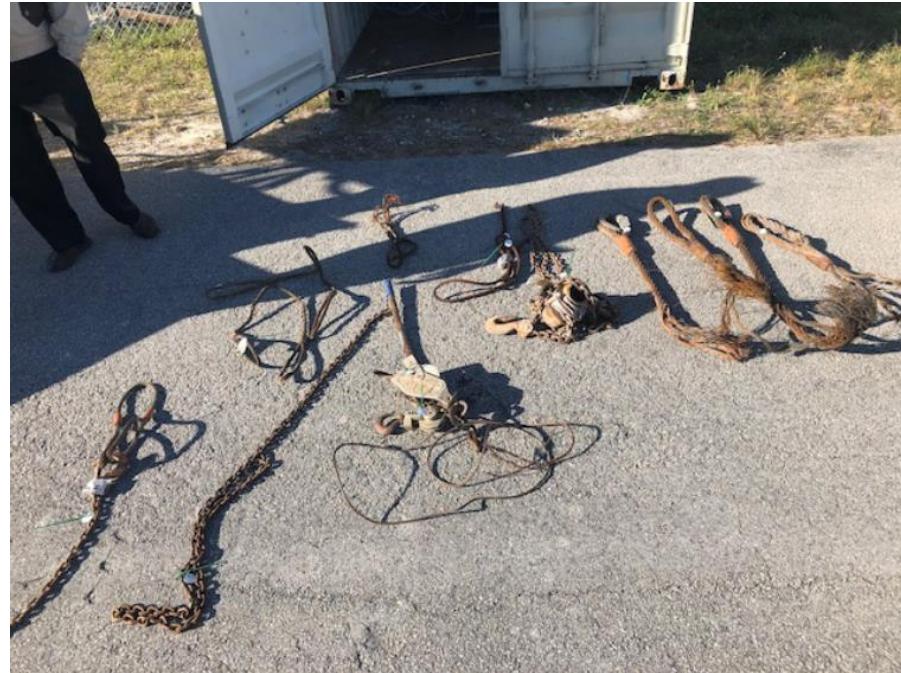
Figure 29 – Materials Collected by QC Met for Examination

The bridle connection materials being examined by QC Met are shown in Figure 29. At the time of this report, QC Met had not provided a report of their findings.
