# Investigation of the April 19, 2018, Communication Tower Collapse in Fordland, Missouri.

U.S. Department of Labor Occupational Safety and Health Administration Directorate of Construction

October 2018

Report Prepared by Bryan D. Ewing, Ph.D., P.E. Mohammad Ayub, P.E., S.E. Office of Engineering Services Directorate of Construction

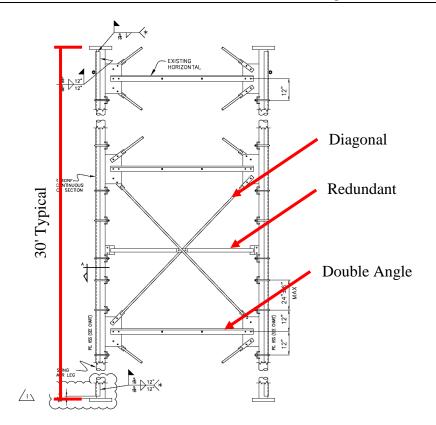
Figure 2. Typical Bracing Elevation of Tower Legs

The 1,891-foot-tall guyed communication tower is constructed of 10-foot wide triangular sections. The legs of the tower consisted of 63 sections of solid round steel ranging in diameter from  $4\frac{1}{2}$ " to  $3\frac{1}{4}$ " that were approximately 30 feet long. The lower 34 leg sections were constructed from high strength alloy steel with a design yield strength of 95 ksi. The design yield strength of the remaining leg sections was 47 ksi. The legs are connected by numerous angle struts, solid rod diagonals and horizontal redundants as shown in Figure 2. Although Figure 2 only shows one side, all three sides of the tower are similar. The angle struts consisted of double back-to-back A36 grade steel angles. The sizes of the angles vary and were either  $L3x2x^{1/4}$  or  $L2^{1/2}x2x^{1/4}$ . The solid rod diagonals were fabricated from A36 grade steel and vary in diameter from <sup>3</sup>/<sub>4</sub>" to 1<sup>1</sup>/<sub>4</sub>". The horizontal redundants were 1<sup>3</sup>/<sub>4</sub>" diameter solid A36 steel rods. The horizontal redundants were narrowed at its mid-span to accommodate the splice plates of the crossing diagonals. Both diagonals and the redundant were secured to each other with two through bolts. Note that Figure 2 shows the recommended split pipe reinforcement of the tower legs, but these split pipe reinforcements were not in place at the time of the incident. The 30-foot tower leg sections were field spliced together with six A325 bolts through factory fabricated flange plates at each end of the leg. The tower was stabilized by nine levels of guy wires. Each level had three guy lines (1 for each of the principal triangular directions of the tower). The diameter of the guy lines varied from 1-1/16" to 1-9/16" with a range of initial tensile forces between  $\pm 15$  kips to  $\pm 33$  kips depending on the temperature. A typical cross section of the tower and tower elevation are shown in Figures 3 and 4, respectively.

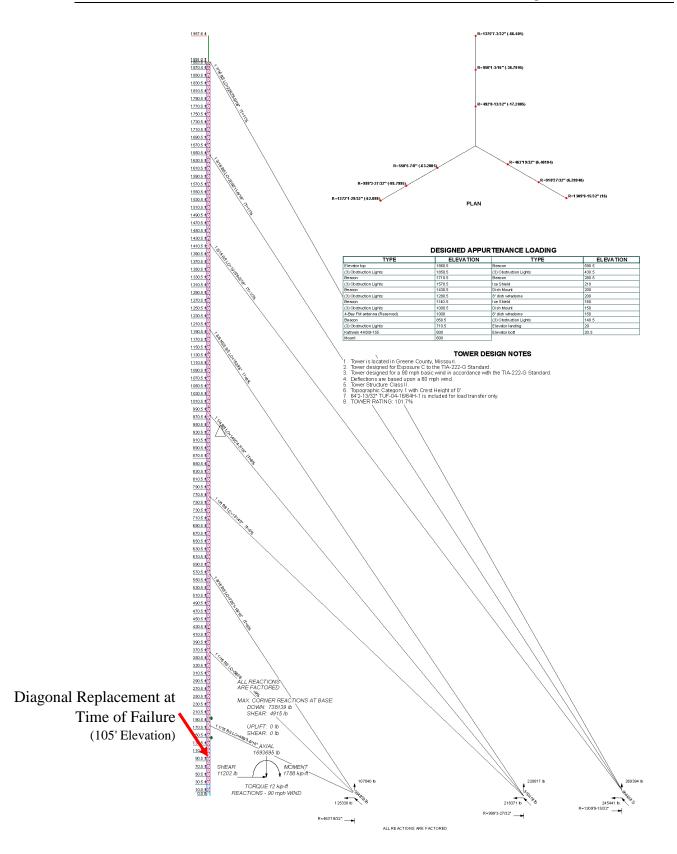
Figure 4. Tower Elevation (TCI Structural Analysis Report Appendix E-1)

TCI's May 19, 2017 structural analysis of the communication tower concluded that structural modifications were necessary for the tower to comply with the wind and ice loading requirements of ANSI/TIA-222-G. TCI recommended to replace one level of guy wires, reinforce 34 tower leg sections, replace 25 bays of diagonals and reinforce one level of horizontal struts. Lemay was contracted to perform the recommended structural modifications.
