Investigation of August 14, 1990 Collapse of Precast Concrete Beams At Airside Building, Midfield Terminal Project, Greater Pittsburgh International Airport, Allegheny County, Pennsylvania

U.S. Department of Labor Occupational Safety and Health Administration

December 1990

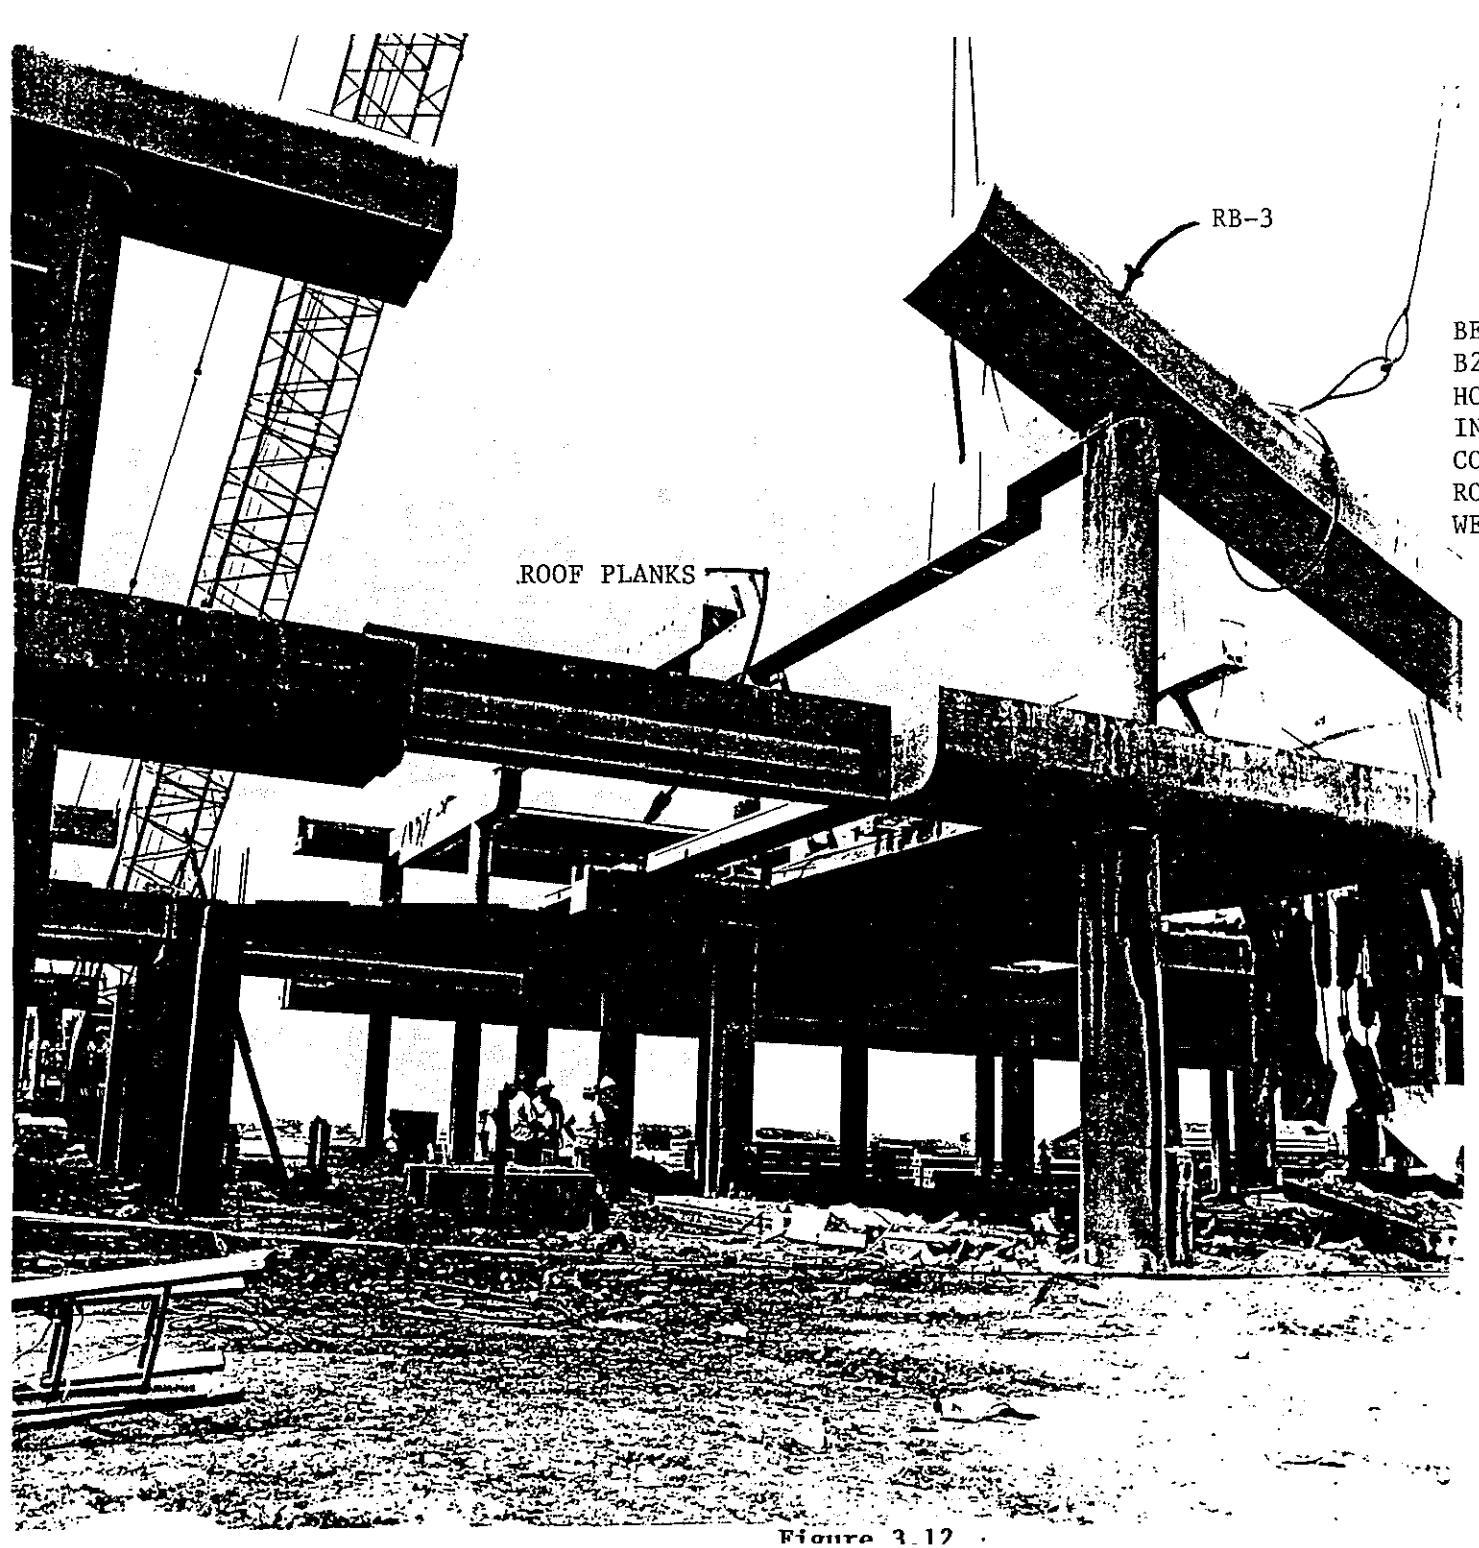
BETWEEN COL. LINES B20-B22, SHOWING HOLLOW PLANKS WERE INSTALLED BETWEEM COL. B20-B21 AT THE ROOF LEVEL OF THE WEST EXTERIOR BAY.

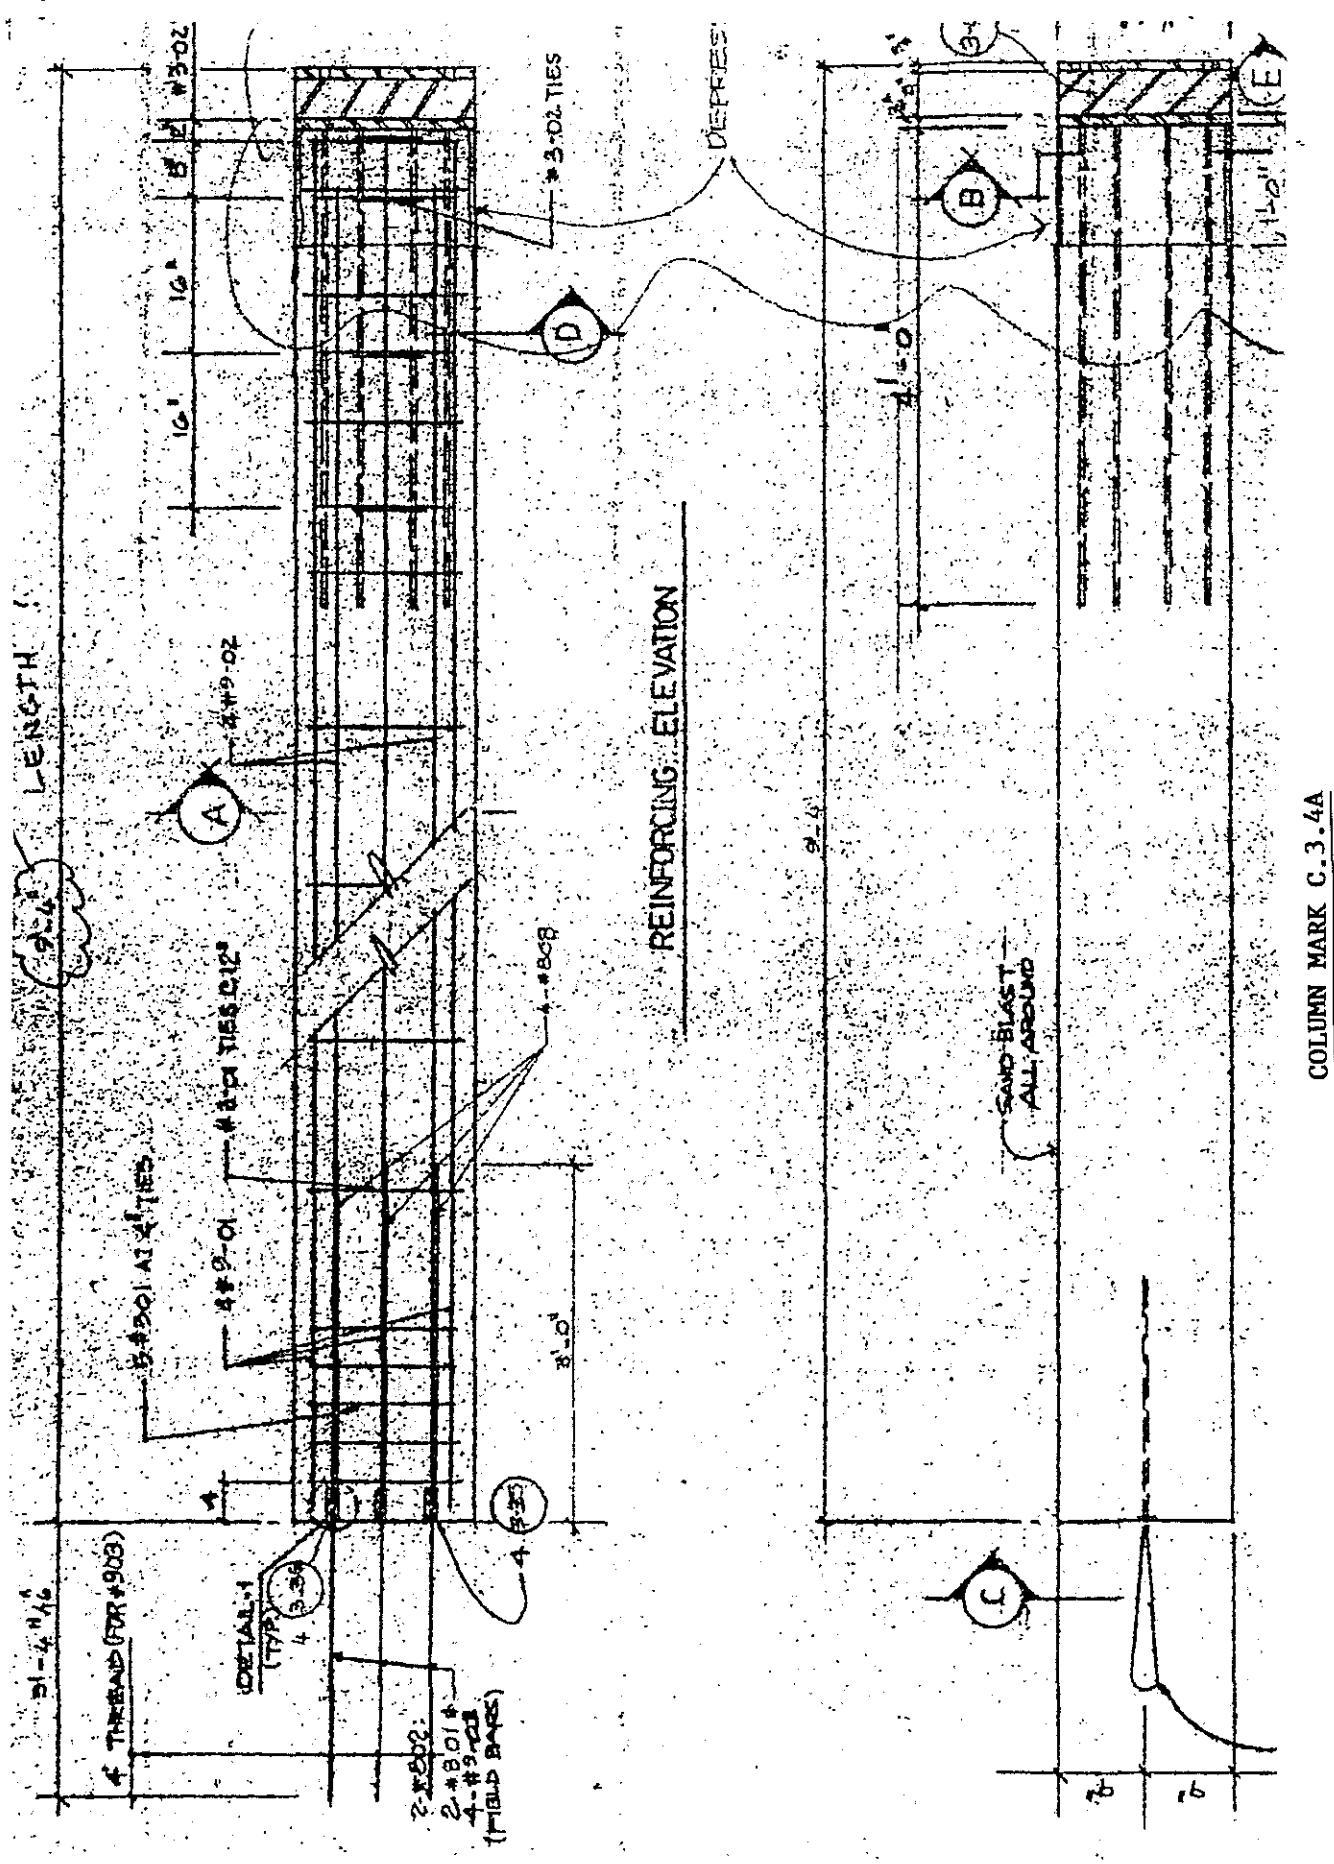
Figure 3.23

Column marked C3.4A which was supporting the interior end of beam RB-35 failed at the top and bottom ends. There were eight rebars extending from the top of the column into the 11" x 11" opening in beam RB-35. See figure 3.23 for the reinforcement. As a result of the collapse, the column remained attached to beam RB-35 with its eight rebars bent and skewed as shown in figure 3.22. The base of the column, prior to the collapse, was resting on the concourse level beam marked B-2. The steel base plate of the column had four oversize holes through which four threaded rebars were to be fastened with washers and nuts. It is not known if the nuts and washers were placed and tightened. The base of the column was rotated and separated. See figures 3.22, 3.24 and 3.25 for the configuration of the column and beam RB-35 after the collapse. With the exception of some spalling and cracks at the top edge of the column, deformations were not observed along the length of the column. At the base of the column, concrete had spalled as a result of the column rotation.

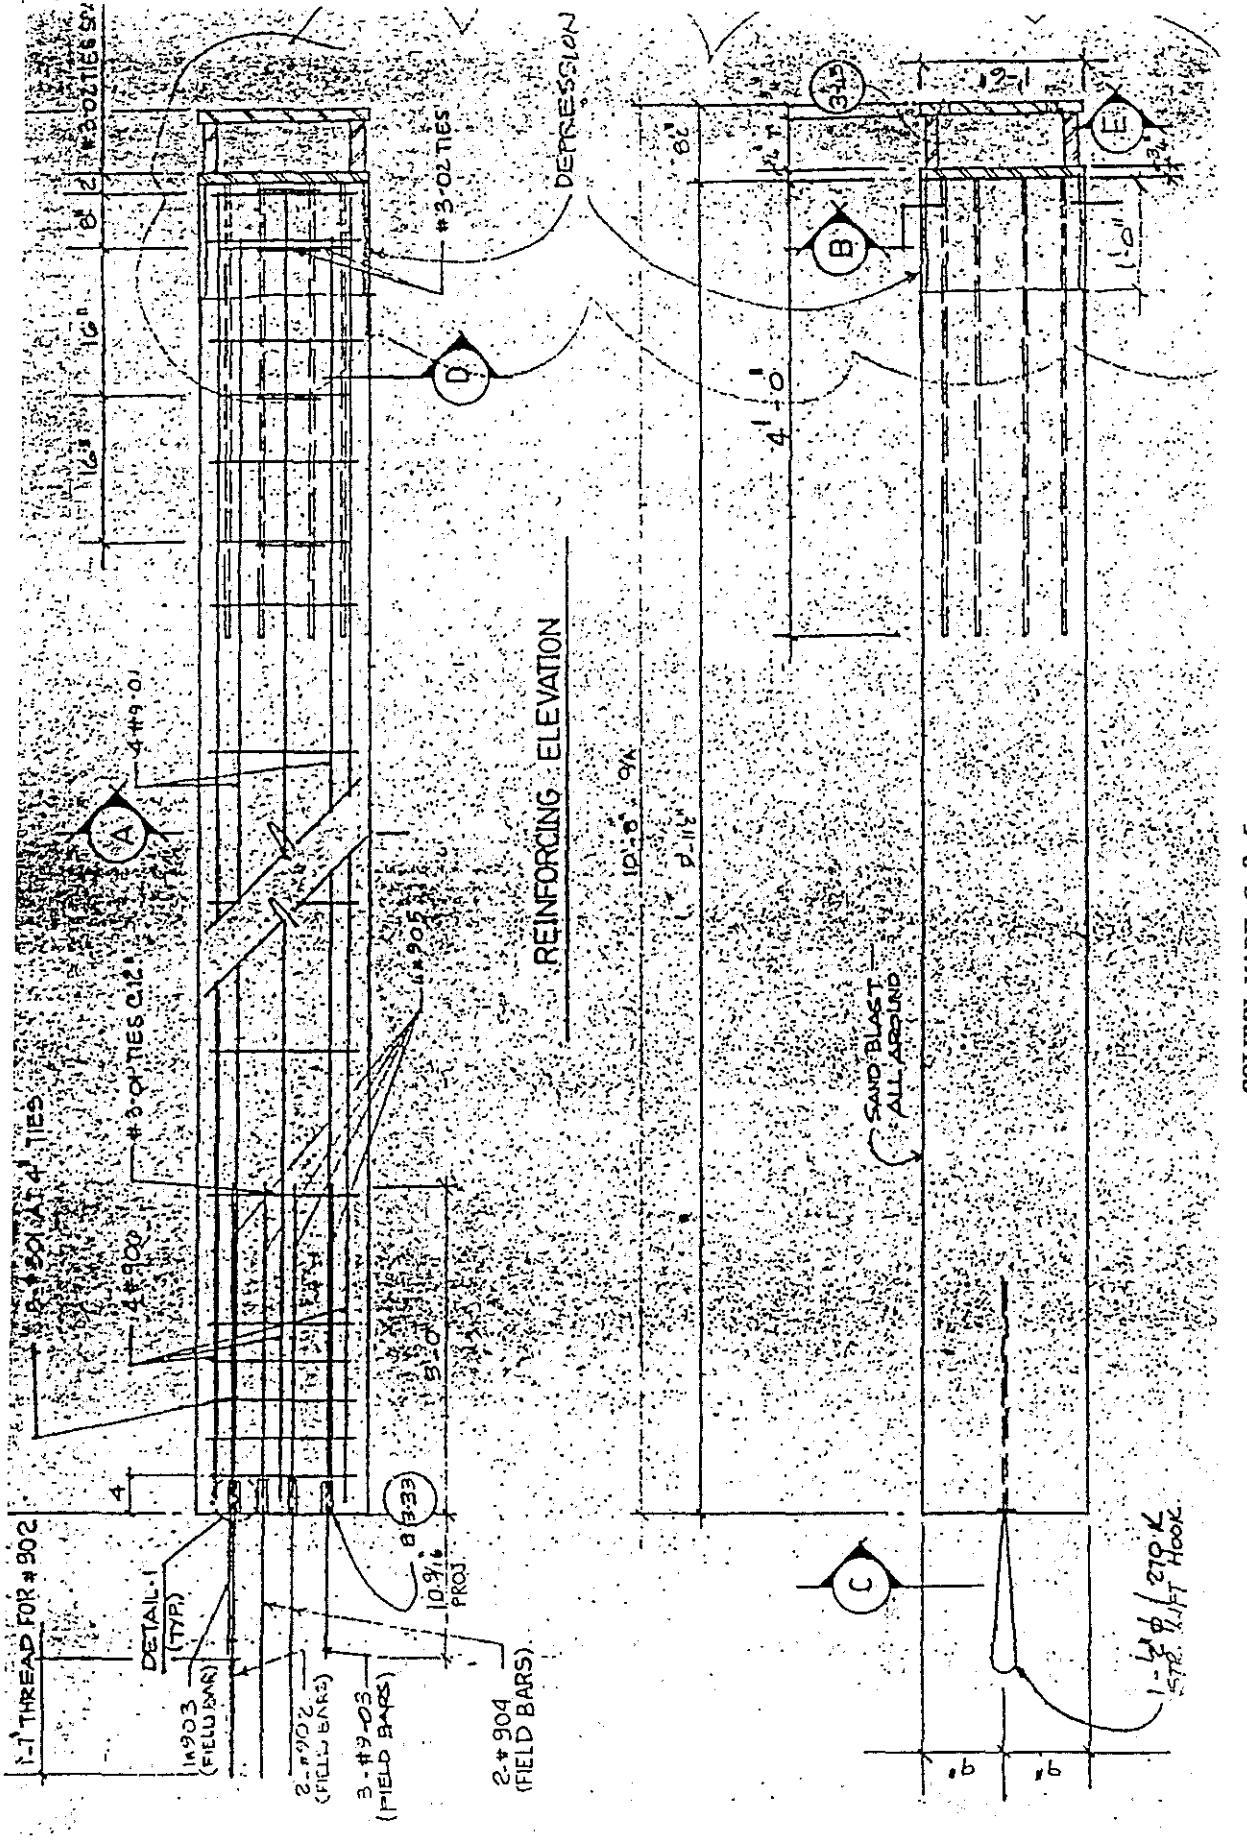
Figure 4.05

Figures 4.05 and 4.06 are copies of the approved shop drawings showing the top and bottom ends of the precast column C3.5. Figure 4.07 is a photograph taken after the accident. All eight #9 top bars extending above the beam bearing elevation were present. No deformations were noticed in those bars. The 11" x 11" grout had some minor spalling and some rebar did not seem to have desired cover. At beam RB-35

COLUMN MARK C.3.5

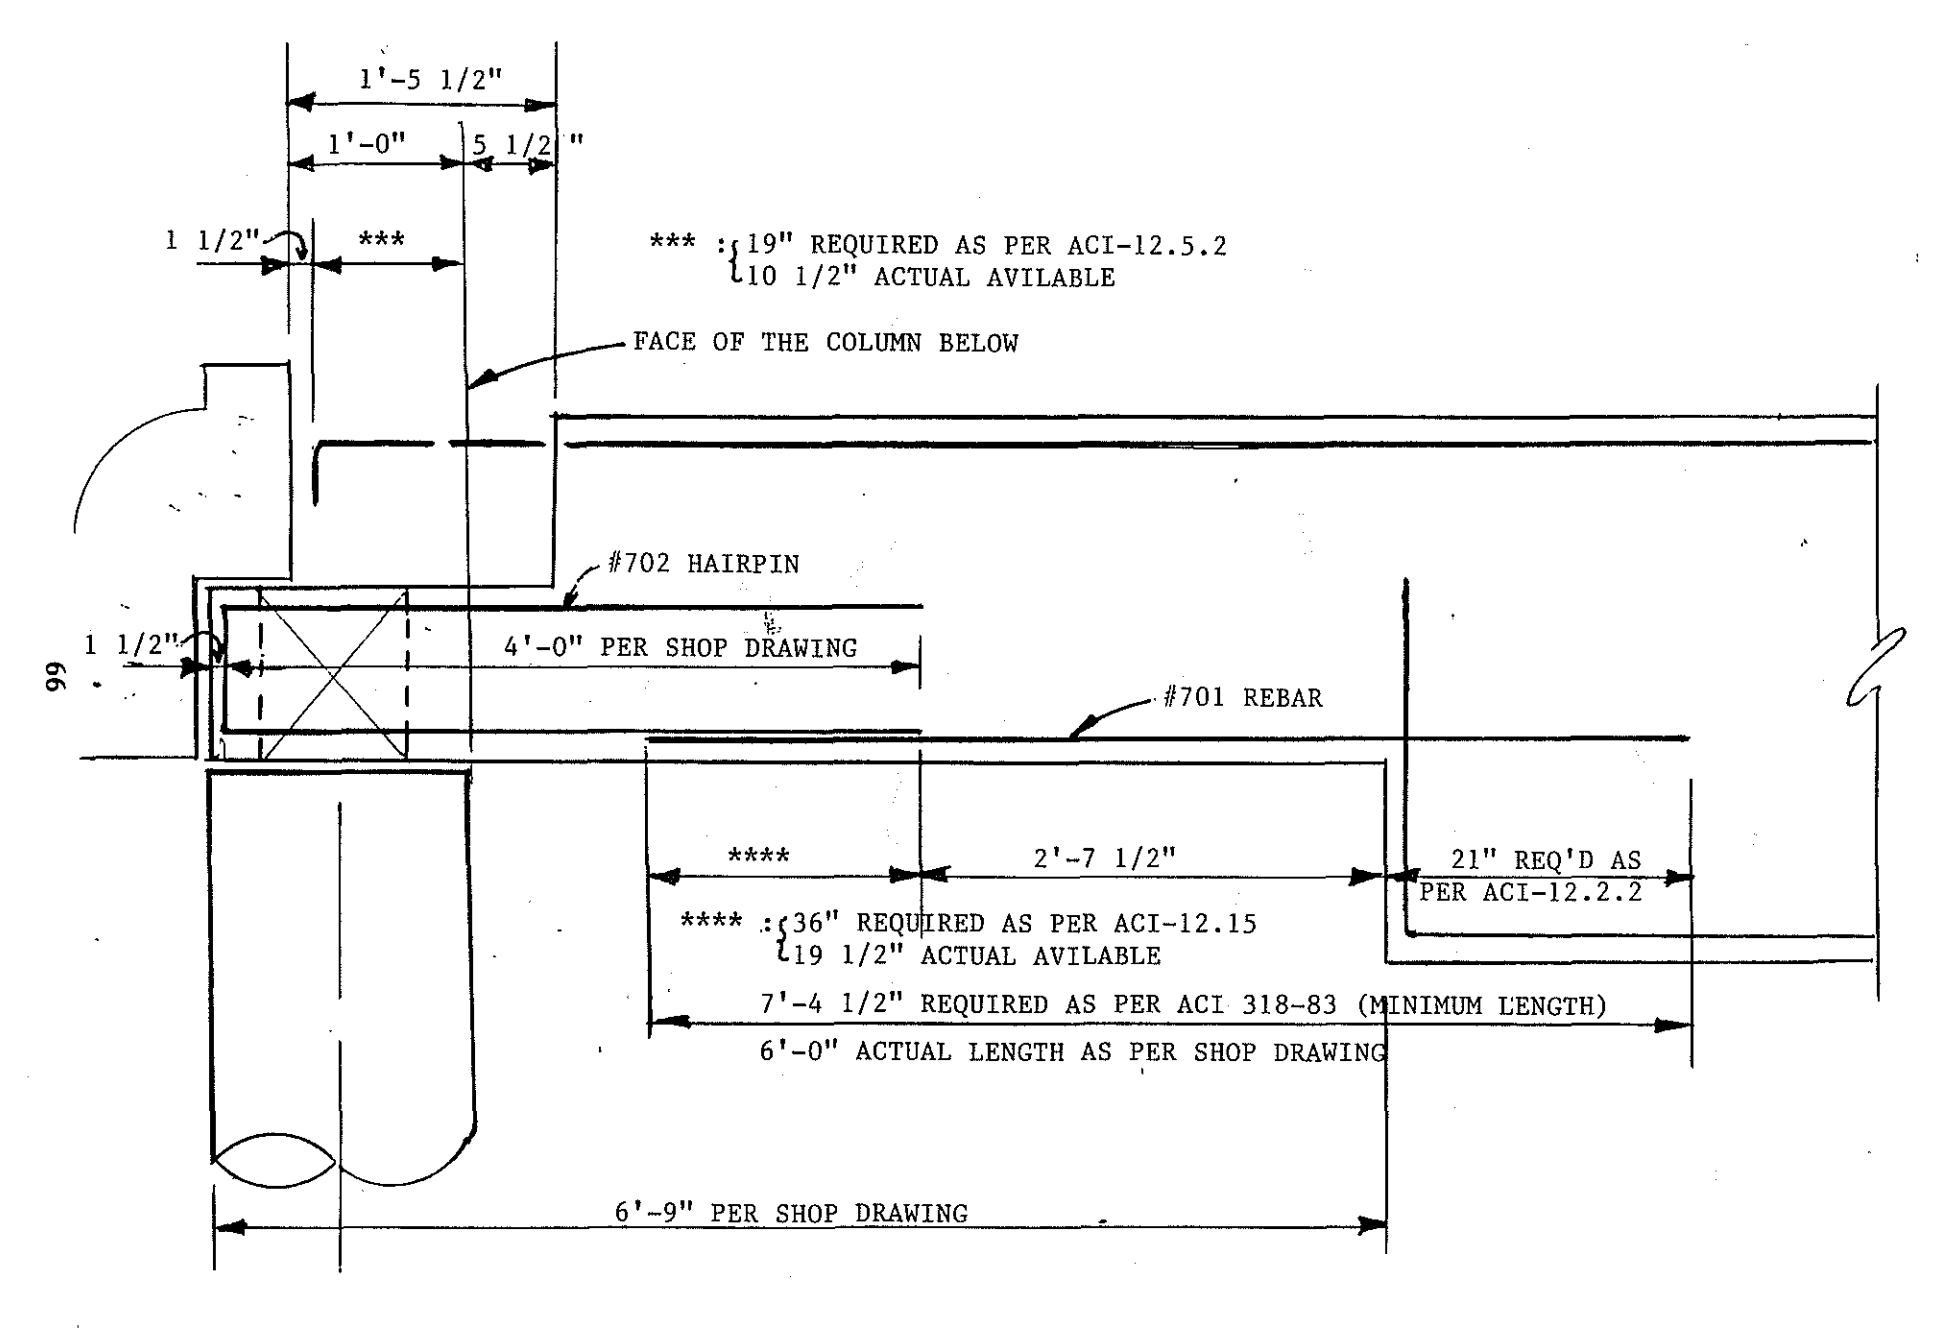
It must be mentioned here that the placement of the bar marked #701 had impacted the beam in two ways. One end of the bar provided the development length needed for the full flexural capacity at section c-c, and the other end provided the lap splice length between bars marked #701 and #702 which affected the flexural capacity of section b-b. The precast designer stated in his interview that if the bars were placed at the dimension line shown on the plan, a development length of 25" would be available, sufficient to develop the full flexural capacity of beam RB-35. However, the lap splice length on the other end would then be reduced to 15-1/2". A lap splice length of 15-1/2" is less than the required Class C splice length of 36", as per ACI 318-83. Correct splice lengths were critical to develop the full flexural strength at section b-b. However, the actual provided splice length of bar #701 was 32" due to the shortened development length of other end. Figure 7.01 illustrates the reinforcement requirements as per ACI 318-83.

REINFORCEMENT REQUIREMENT AS PER ACI 318-83

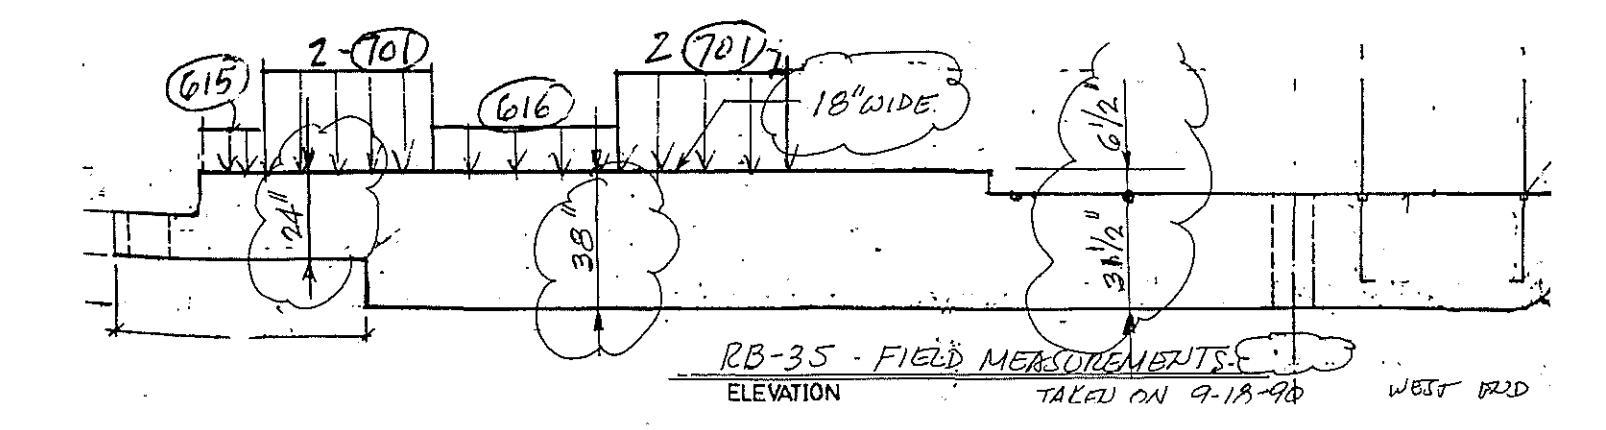
DEAD WEIGHT OF THE SLAB ON RB-35 @ COLLAPSE

1 PLANK SLAB = 58#/sq. ft. X [(30'-0")-(0'-8")]X ½ =851 #/'

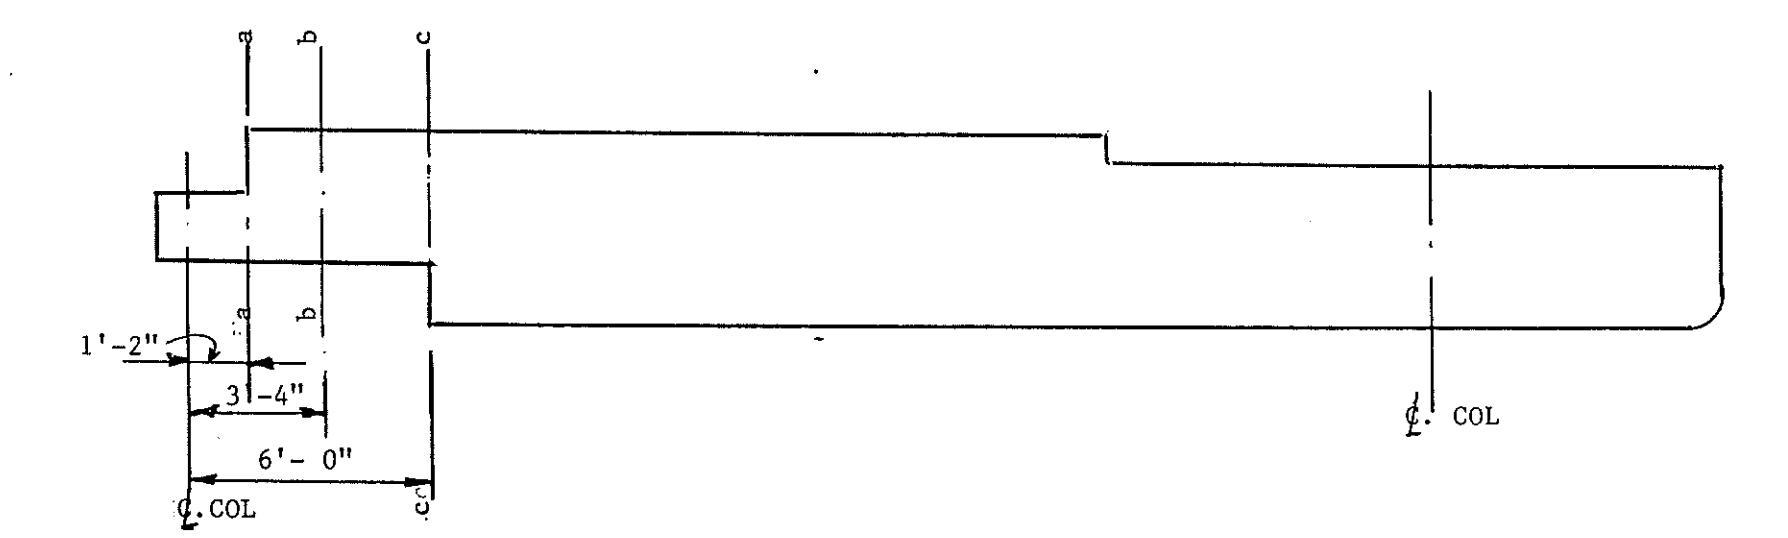
CRITIAL SECTION	- SECTION a-a		SECTION b-b		SECTION c-c	
BENDING MOMENT (KIP-FT) LOADING CONDITION	M. D	1.4°M _D	MD	1.4 M _D	MD	1.4 M _D
LOAD CASE 1: SELFWEIGHT OF BEAM RB-35, REACTION FROM BEAM RB-22, AND REACTION FROM SPANDEL RB-13	0.33	0.5	11.67	16.34	22.70	31.8
LOAD CASE 1a: SAME AS ABOVE,BUT <u>WITHOUT</u> REACTION FROM SPANDEL RB-13	6.44	9.07	17.30	24.2	27.71	38.8

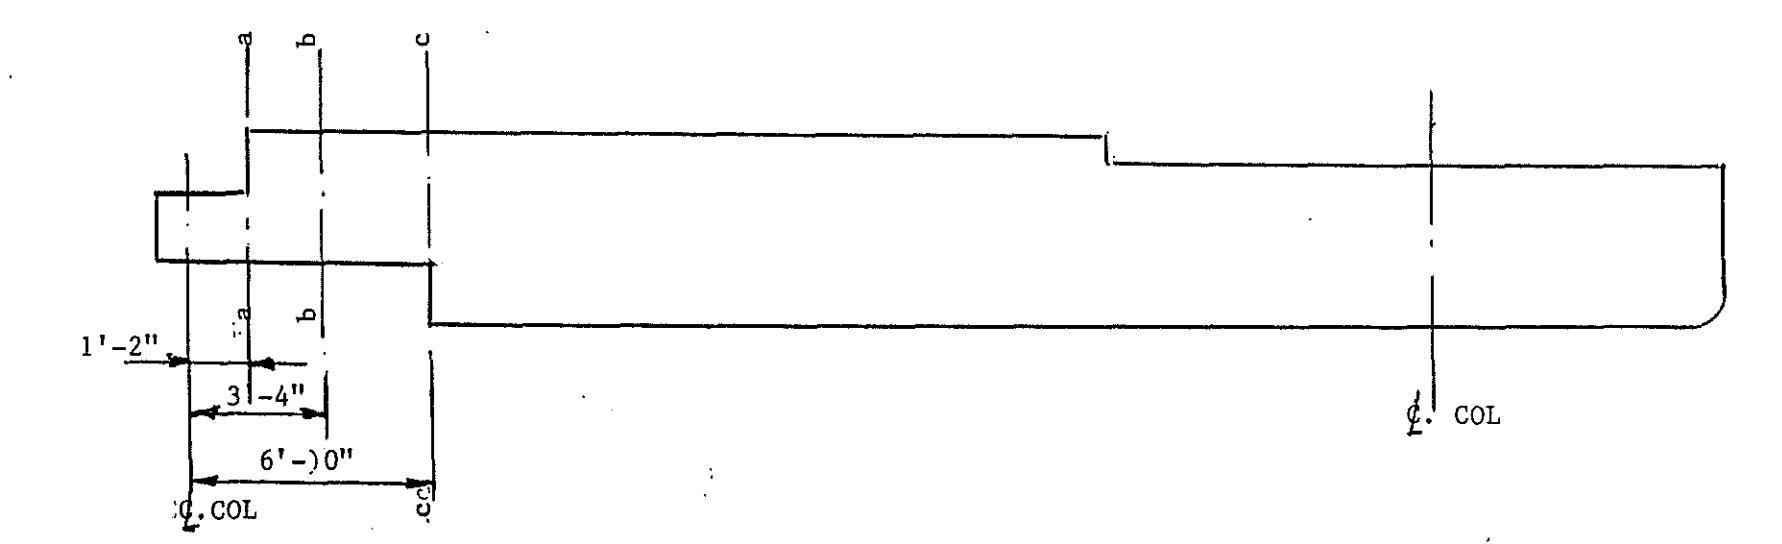
The unfactored bending moments at section c-c due to the load case #2 (the loading condition at the time of collapse) was 87.4 ft.-kips if the end of RB-35 at column C3.5 was assumed hinged. If it was assumed fixed, the unfactored bending moment was 70.3 ft.-kips. These two values represent upper and lower bounds. In reality, the actual moment would lie in between the two.

Structural analysis and field observations indicated that section c-c of beam RB-35 was deficient as it failed to develop the required flexural strength due to insufficient embedment length of the bottom bars marked #701. As the placement of roof planks progressed, section c-c was subject to increasing positive bending moment which exceeded its capacity and, hence, failure occurred. Due to the dead load of the planks, an unfactored positive bending moment of 70.3 ft.-kips or 87.4 ft.-kips was computed at section c-c depending upon whether the support condition of beam RB-35 at column C3.5 was assumed fixed or hinged. The flexural limit strength of the beam RB-35 without employing any capacity reduction factor, at section c-c was computed as 122 ft.-kips, provided the flexural bars were able to develop their full strength.

CRITIAL SECTION	SECTION a-a		SECTION b-b		SECTION c-c	
BENDING MOMENT ((KIP-FT)	M. D	1.4°M _D	M _D	1.4 M _D	M _D	1.4 M _D
LOAD CASE 2: SELFWEIGHT OF BEAM RB-35, REACTION FROM RB-22, REACTION FROM RB-13, AND WEIGHT OF THE 6 PLANKS	14.27 (14.28)	19.98	51.25 (51.29)	71.75	87.37 (87.43)	122.32 **
LOAD CASE 2a: , , SAME AS ABOVE: HINGED AT BOTTOM BOTH ENDS OF COL ASSUMED FIXED	(-2.73)		(34.23)		(70.30)

LOADING CONDITION AT THE TIME OF THE ACCIDENT (LOAD CASE 2))
