# Investigation of November 19, 1990 Excavation Collapse at 14th and H Streets, N.W. Washington, D.C.

U.S. Department of Labor  
Occupational Safety and Health Administration

May 1991

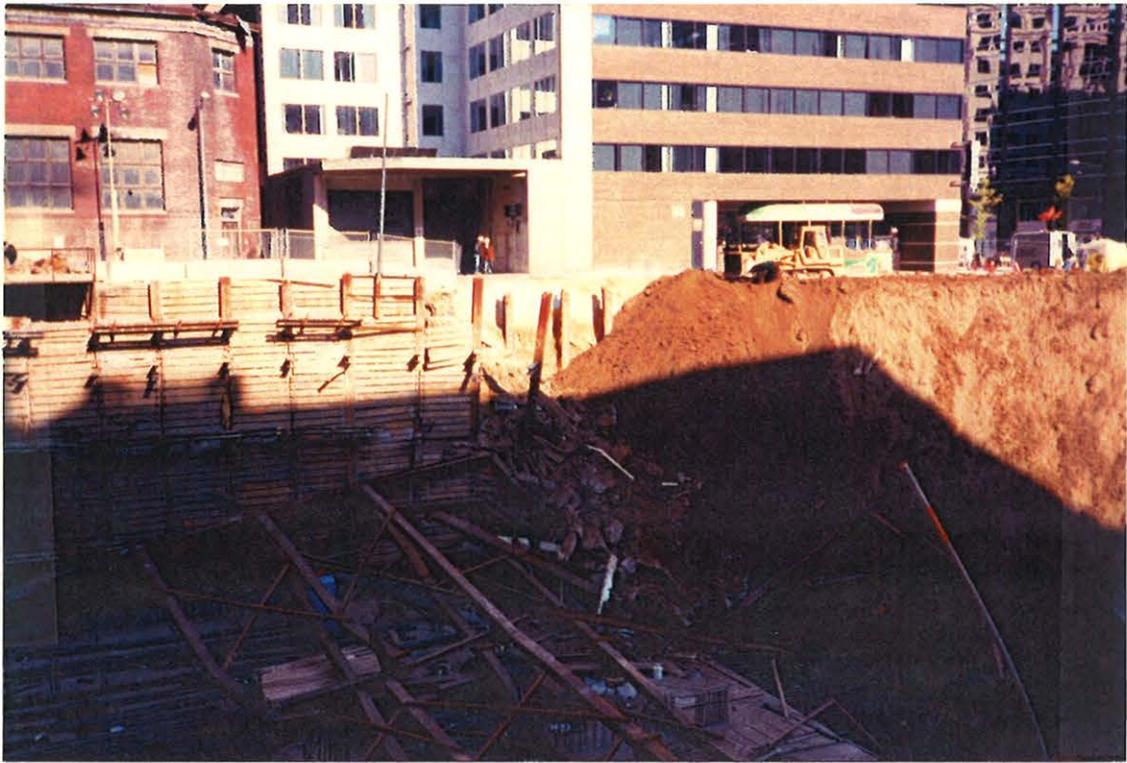
November 19, 1990 collapse, sent the north top and middle wales about 37 feet and 20 feet westward, respectively, and both fell about 24 feet and 12 feet, respectively, as indicated in Figure 3.3. Similar sliding and falling also happened along the south wall, the south top and middle wales slid about 37 feet and 25 feet westward, respectively, and fell about 22 feet and 10 feet, respectively as indicated in Figure 3.4. Due to this westward sliding, the west end of the top tier north wale hit the lagging of the west wall before it broke away as indicated in Figure 3.5. The top tier south wale was sheared off at its sloped location between soldier beams 63 and 64. This is probably due to a very high westward force from the east wall during the collapse. As a result, the remainder of the top tier south wale, between soldier beams 64 to 71, was still attached on the south wall as indicated in Figure 3.4.

Figure 3.3 Sliding and Falling of North Wall Wales (Looking Toward North).

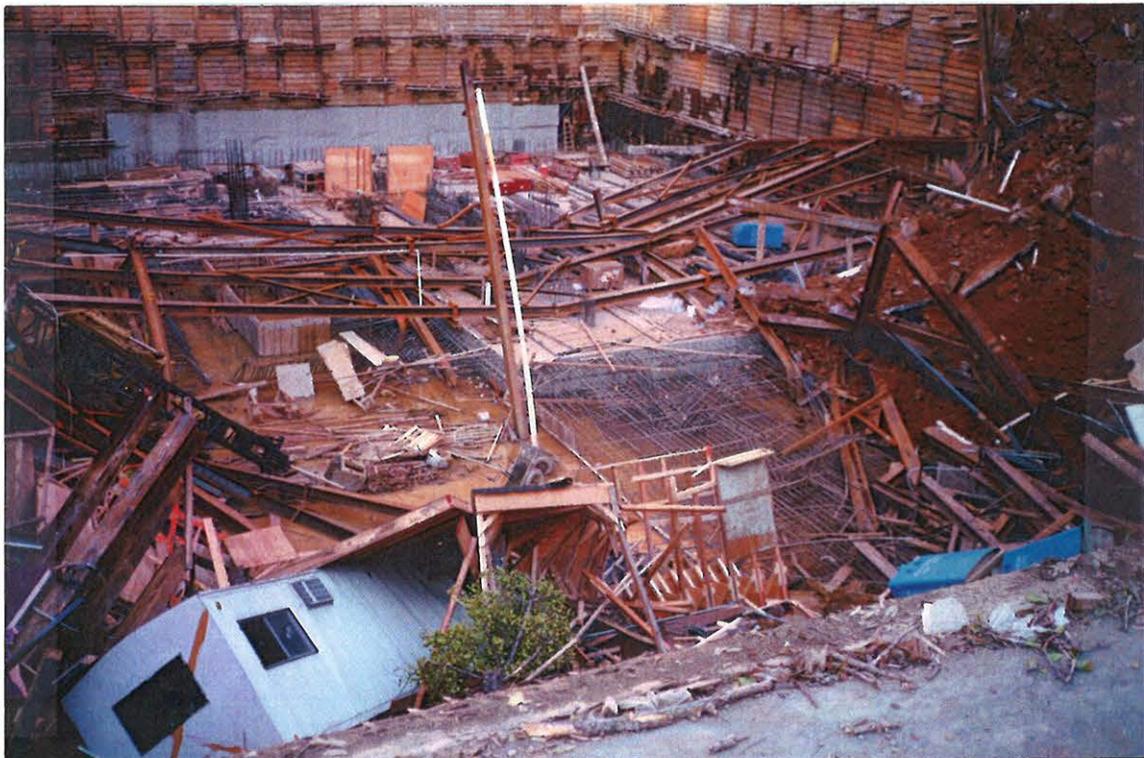
As indicated in both Figure 3.5 and Figure 3.6, the soldier beams of both the north and south walls were bent westward and inward, the westward movement was probably due to the pulling force from the wales, while the inward movement was due to the earth pressure from the back. Based on the uncovered top of the east wall soldier beams, they were simply bent inward, that is westward, due to the earth pressure from the back. Although a portion of the top wales with a diagonal in the northeast corner was bent upward after the westward travel, this probably was due to secondary effects after the initial collapse.

Figure 3.6 Three lines of Struts Traveled with Wales (Looking Toward Northwest).

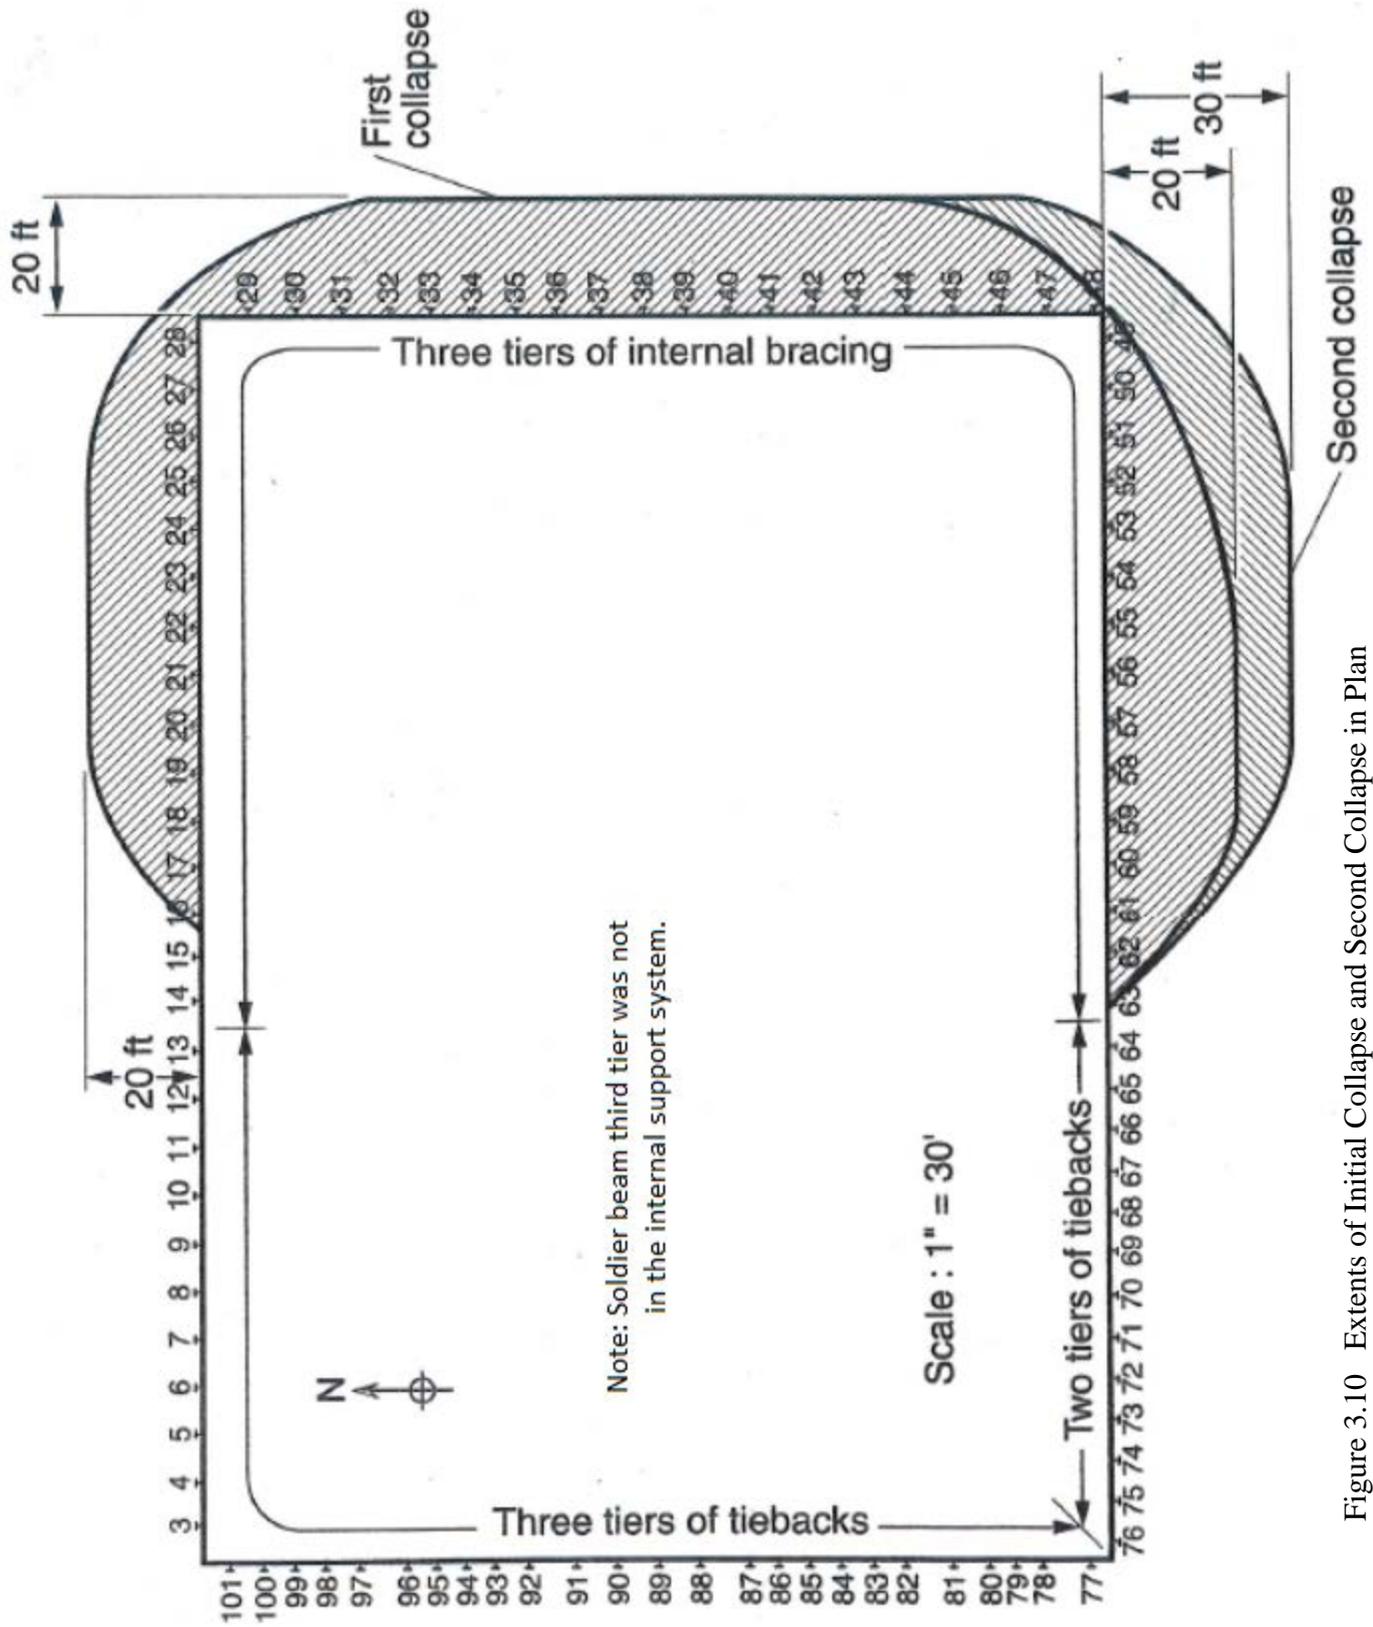
Figure 3.10 Extents of Initial Collapse and Second Collapse in Plan

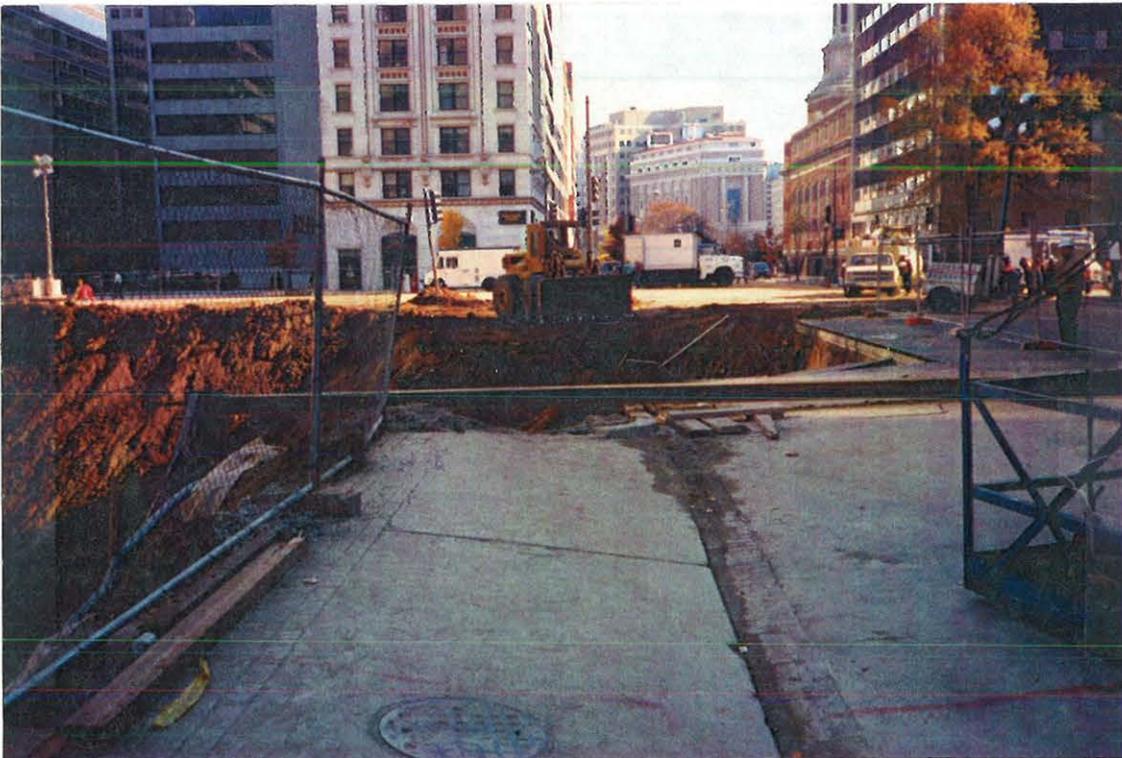
Figure 3.14 An Anchored Horizontal Beam Securing the Top Portion of Soldier Beam 63 (Looking Toward East).

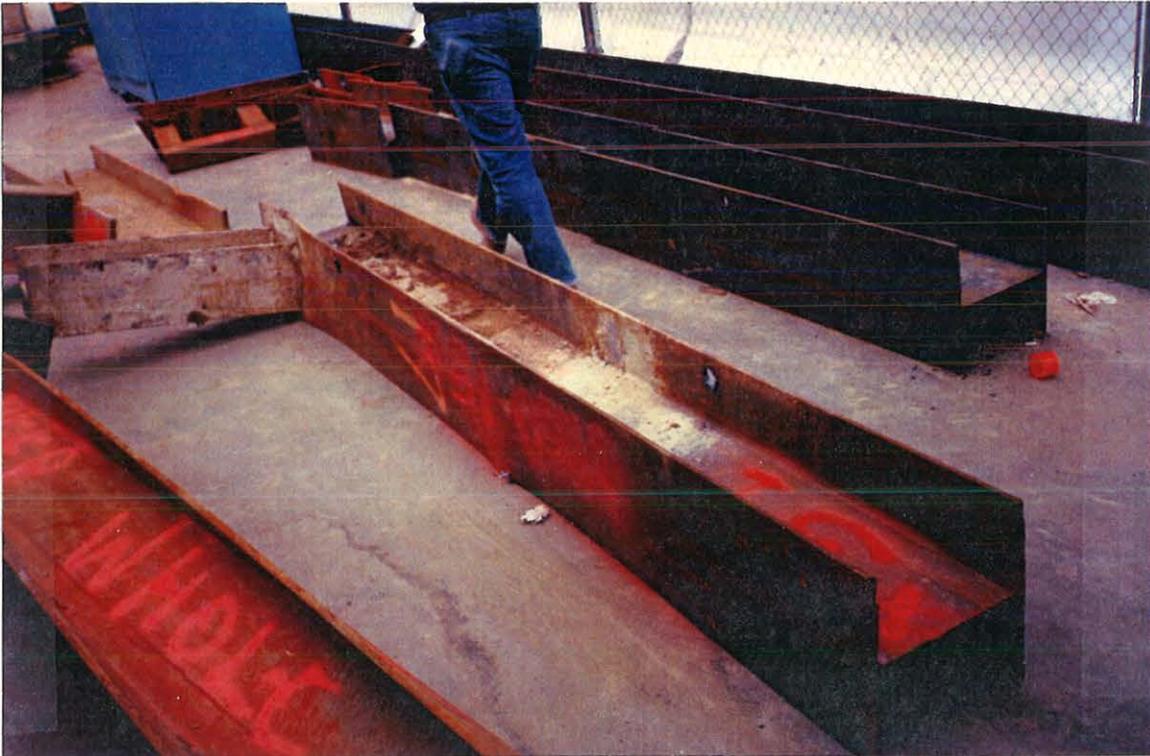
**Figure 3.17** Outlooker of Soldier Beam 17 Top Tier Showed a Westward Deformation (Looking Toward the Bottom of the Soldier Beam).

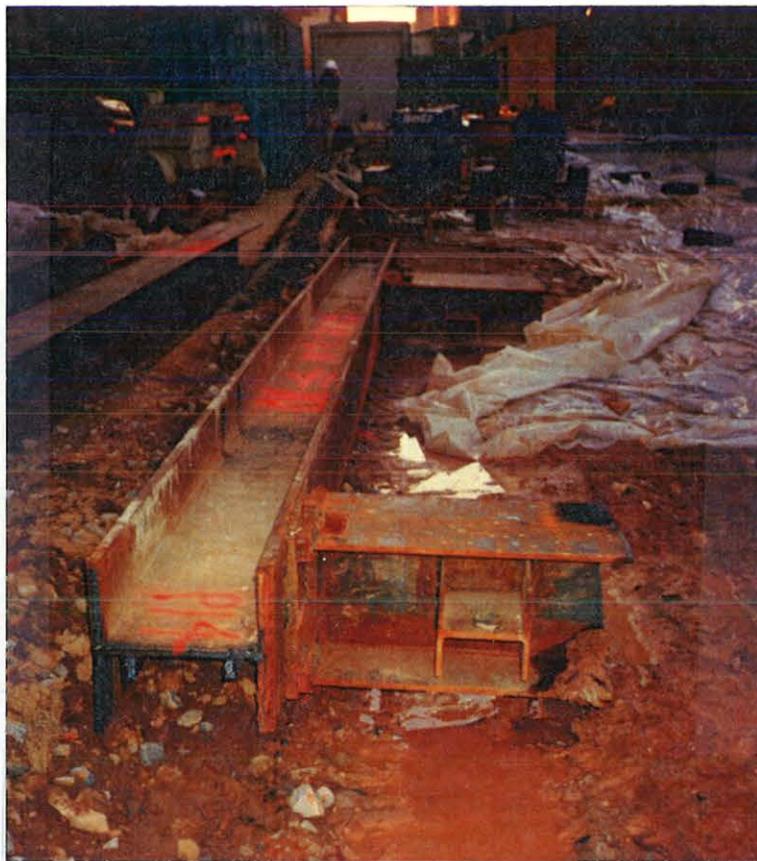
Figure 3.21 Intact Top Wale-Strut Connections with Preloading Plates and Shimming Plates, Wale Between Soldier Beams 14 to 16.

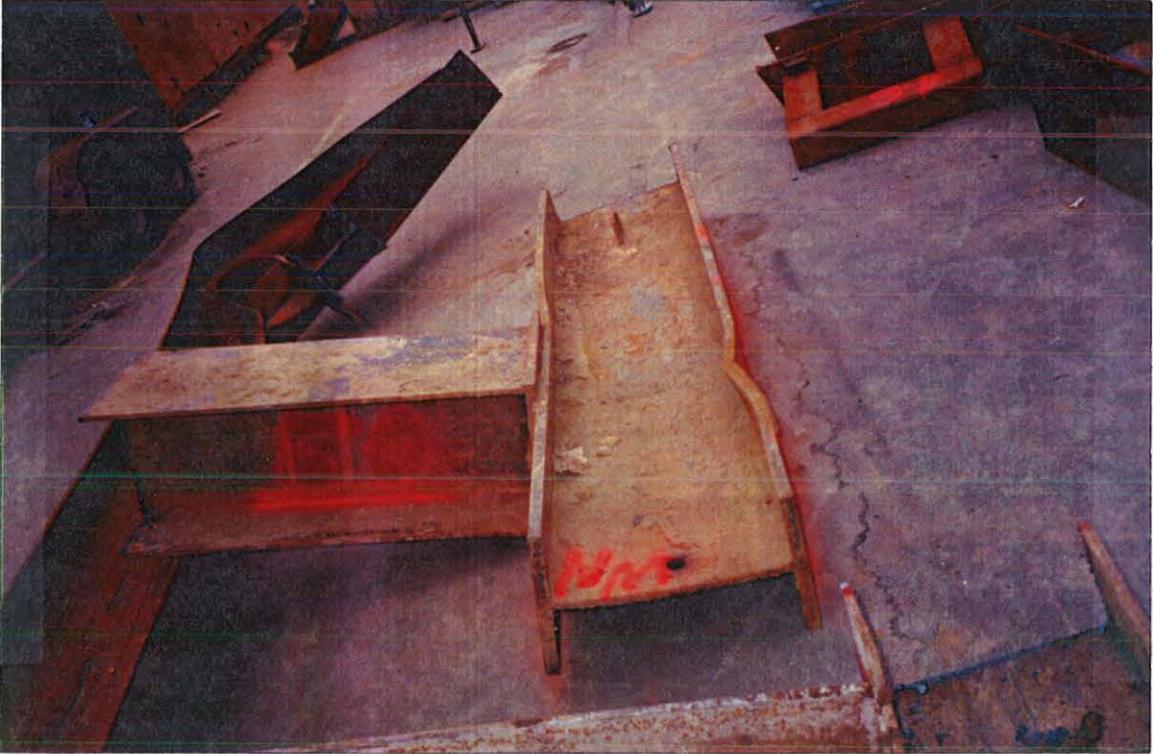
Figure 3.25 Middle Wale-Strut Connection at Soldier Beam 63.

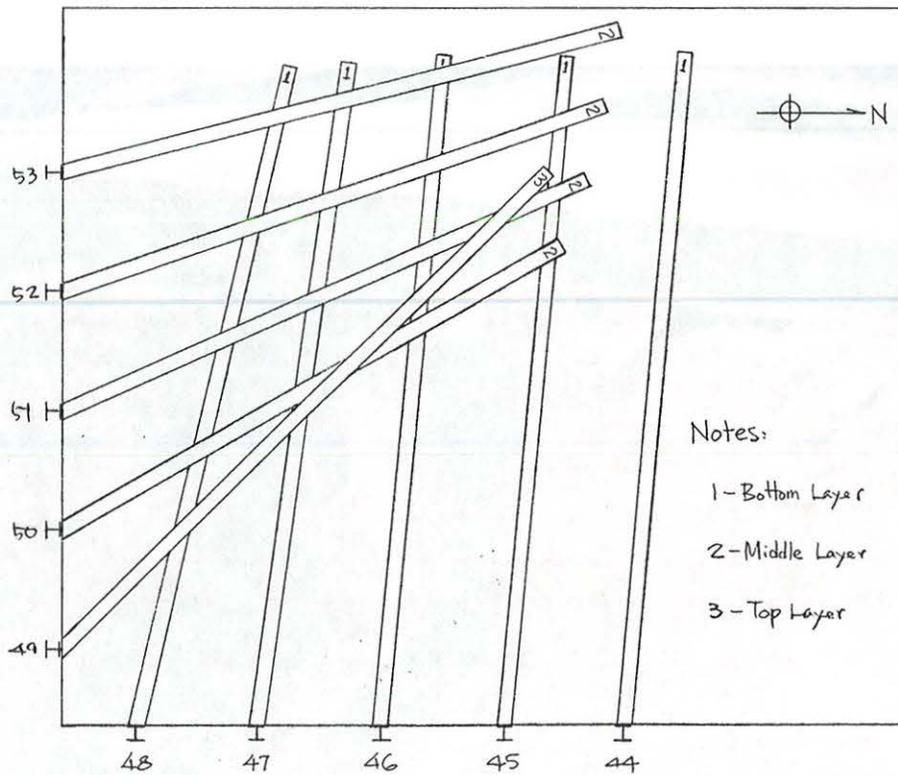
Figure 3.42 Approximate Falling Pattern of Soldier Beams in the Southeast Corner of the Excavation in Plan.

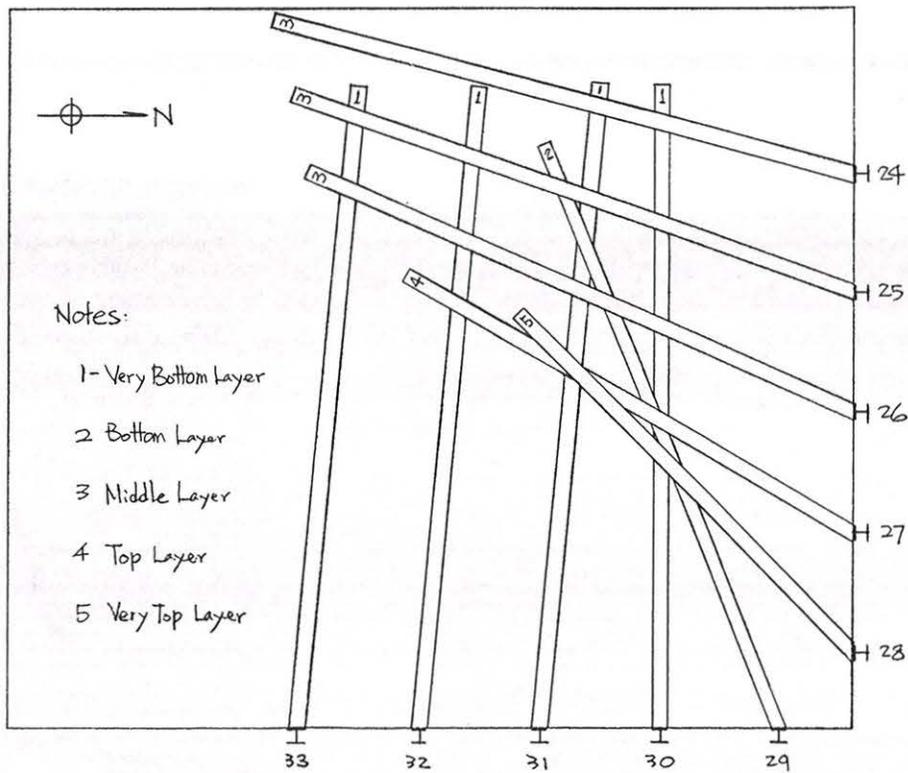
Figure 3.44 Approximate Falling Pattern of Soldier Beams in the Northeast Corner of the Excavation in Plan.

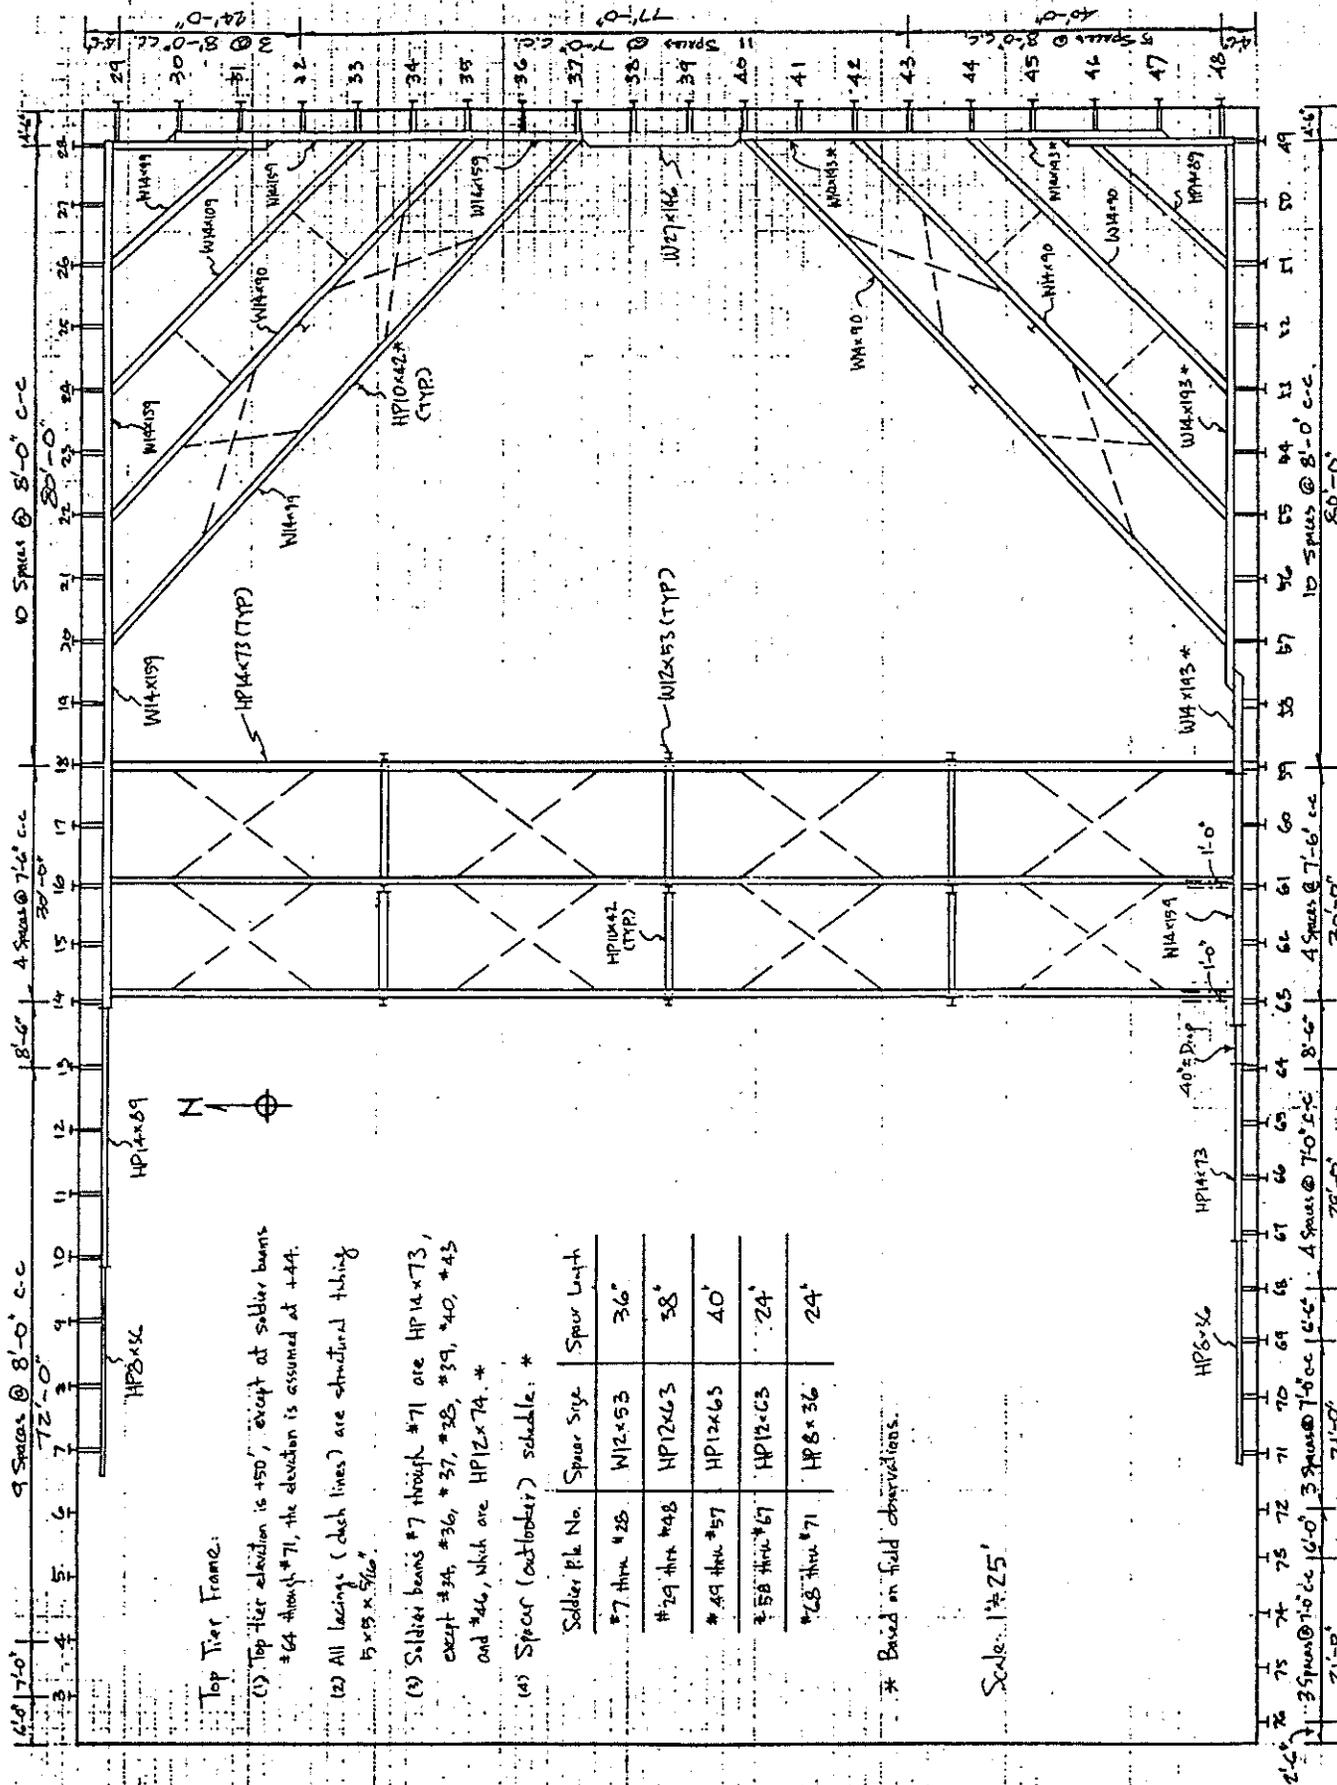
- Based on the field measurements, the size of wale between soldier beams Nos. 37 and 40, for all three tiers, had been modified from the designed W24x146 or W24x162 to W27x146. The size of the first tier wale between soldier beams Nos. 40 and 59 was increased from the design W14x159 to W14x193. The size of the second tier wale between soldier beams Nos. 14 and 21 was increased from the designed W18x106 to W14x159. The size of the pinpiles Nos. 9 through 13 was increased from the designed HP8x36 to HP10x42. The size of soldier beams Nos. 34, 36, 37, 38, 39, 40, 43 and 46 was modified from the designed HP14x73 to HP12x74.

Figure 3.45 As-built Condition of the Top Tier Internal Support System.

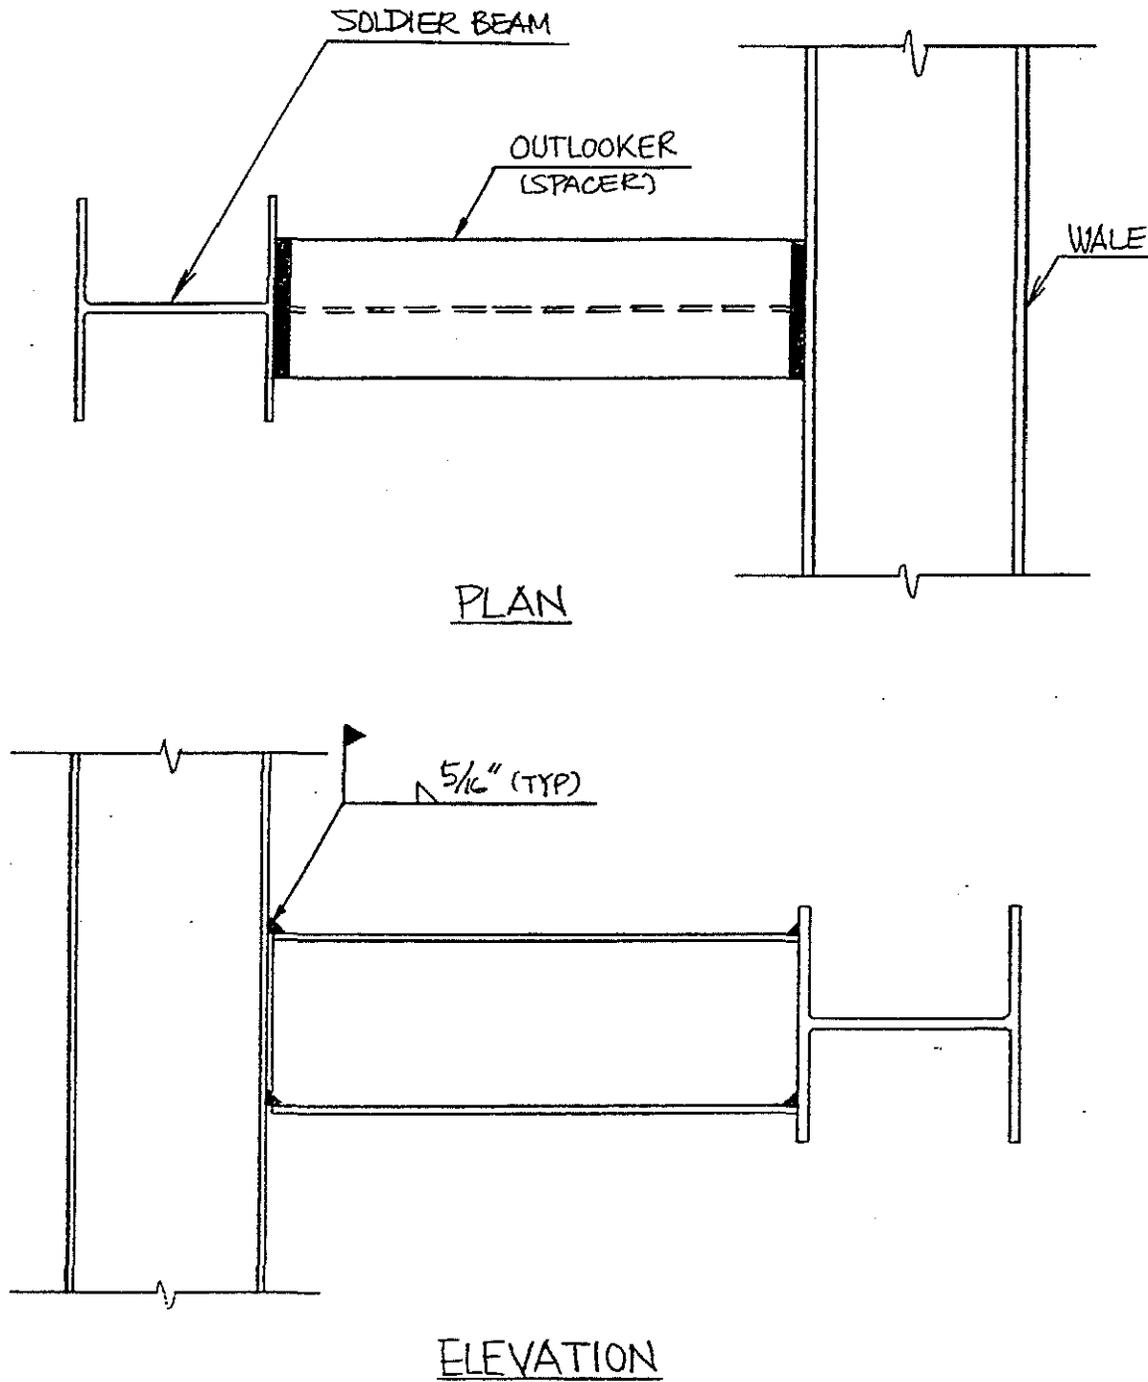
FIGURE 4.1

The typical welding detail of the outlooker to the soldier beam and wale is shown in Figure 4.1, as per the information obtained from the field observation. Overhead welding was avoided and the top surface of the top and bottom flanges were connected with a 5/16" fillet weld. The web of the outlooker was not welded except for the outlookers comprising of built-up sections. As per information obtained from the field, welding electrodes having an ultimate tensile strength of 70 ksi were used. In the calculations in this report, therefore, the capacity of the welds was evaluated based on 70 ksi strength.

**OUTLOOKER TO SOLDIER BEAM AND WALE  
WELDED CONNECTION DETAILS, AS-BUILT CONDITION**

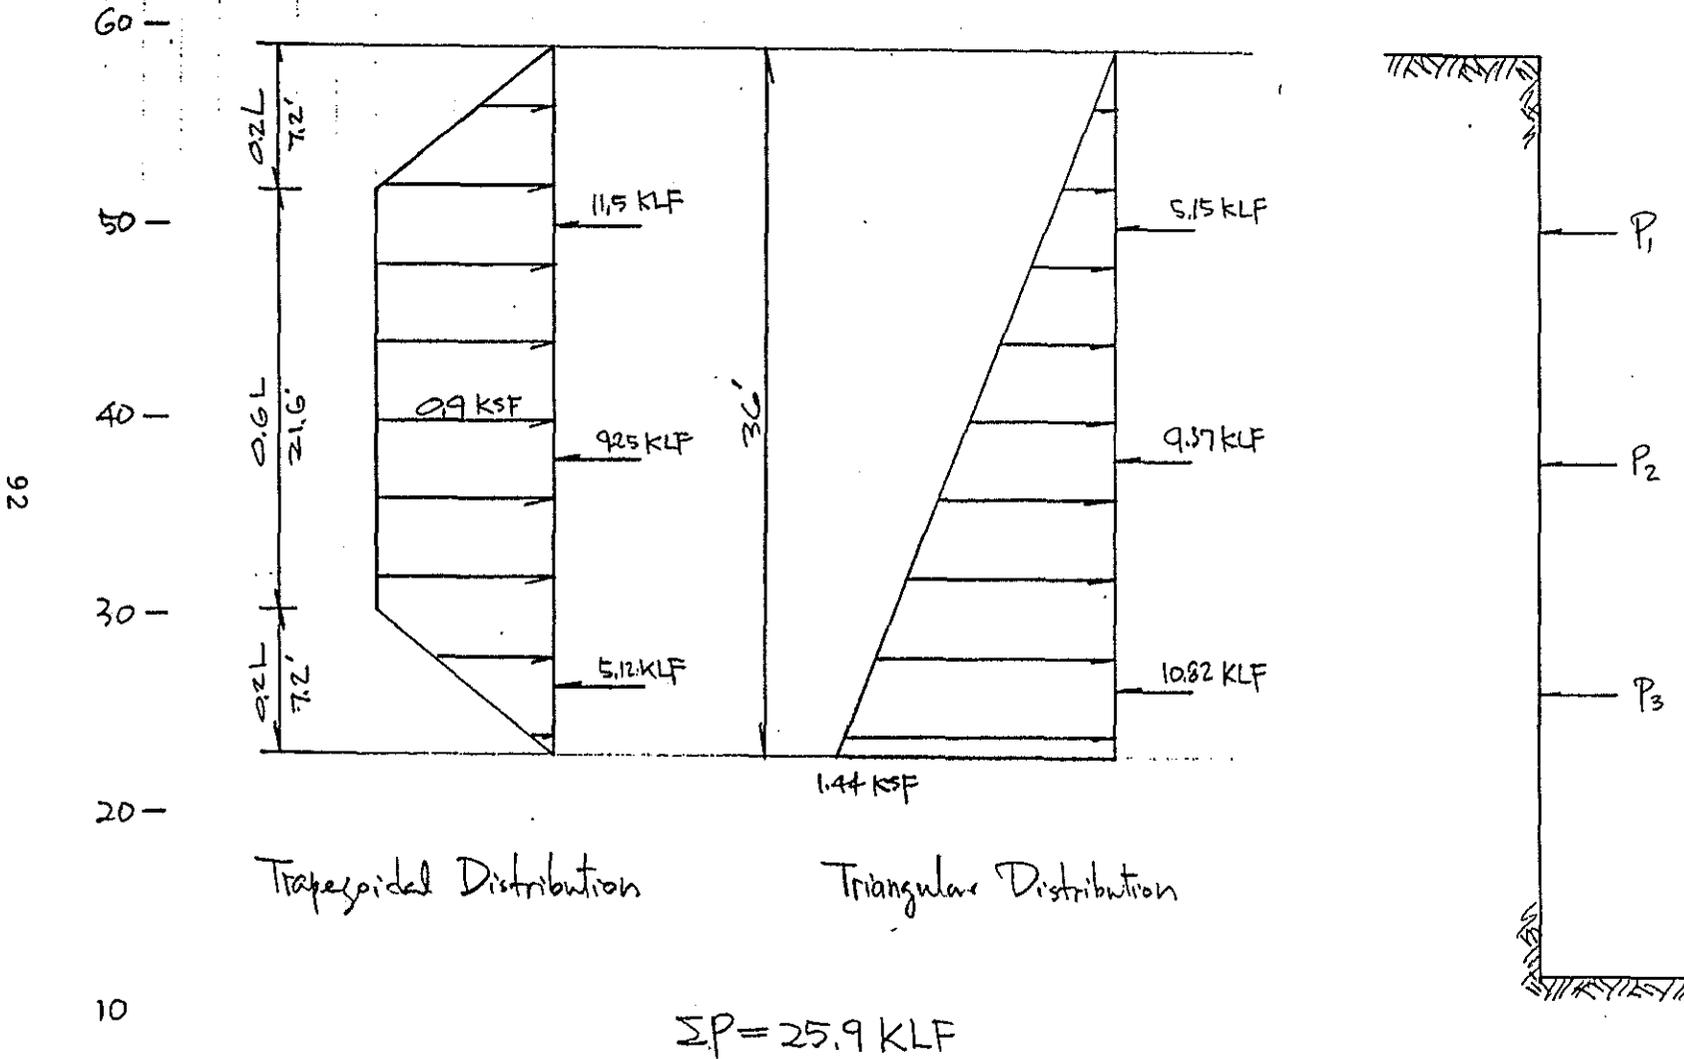
FIGURE 4.26

Note: For soldier beams 14 through 23, earth pressure starts at El. 60.

SOIL PRESSURE IMMEDIATELY PRIOR TO THE COLLAPSE
