**COLLAPSE OF A MAST CLIMBING WORK  
PLATFORM (SCAFFOLD) IN MIAMI, FLORIDA  
MARCH 4, 1995**

U.S. Department of Labor  
Occupational Safety and Health Administration

June 1995

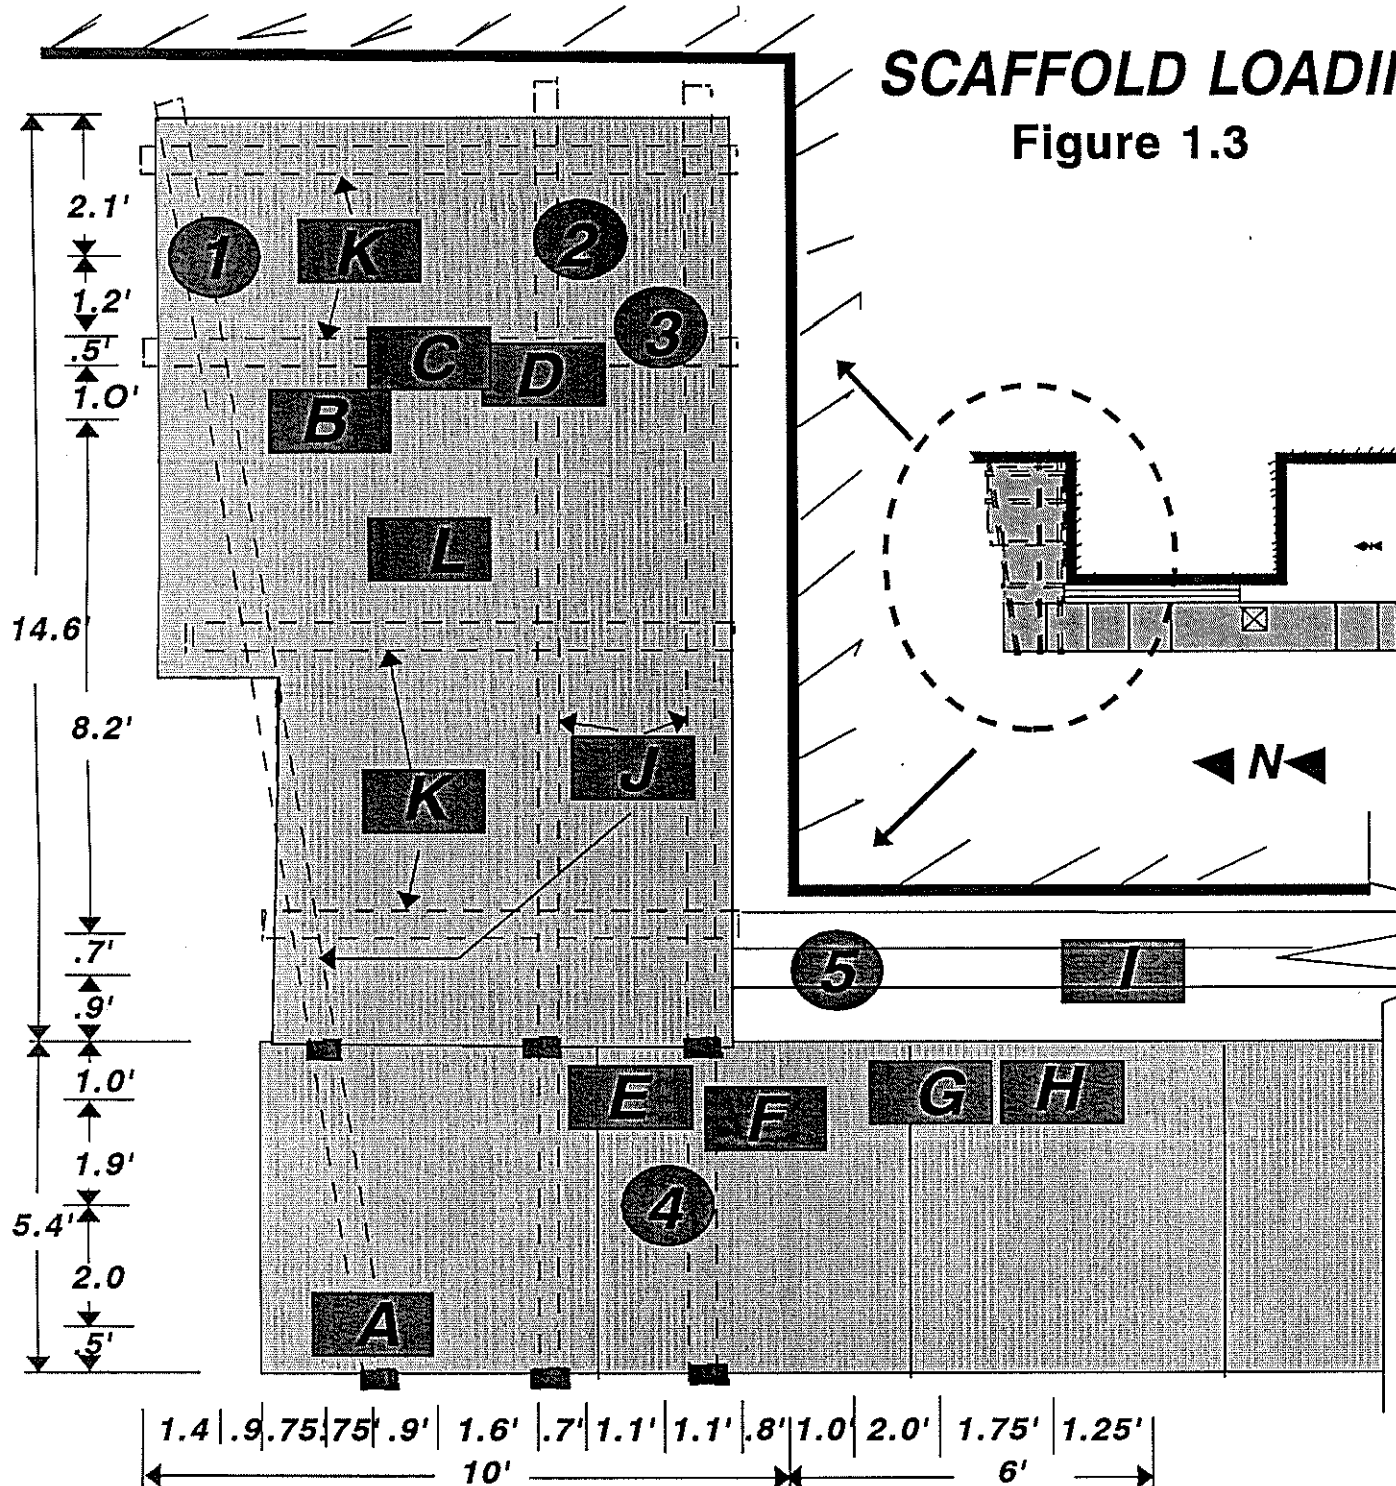
Figure 1.3

# SCAFFOLD LOADING PRIOR TO EVENT

1. Employee - 250 lbs.
2. Employee - 180 lbs.
3. Employee - 160 lbs.
4. Employee - 190 lbs.
5. Employee - 150 lbs.
- A. 2 small coolers - 20 lbs. & Tool Bag
- B. 5 Gallon Bucket - 1/2 full of Stucco
- C. Mud Board w/1 Bucket Stucco
- D. Same as B.
- E. Mud Board w/1 Bucket Stucco
- F. Same as B.
- G. Same as B.
- H. Same as B.
- I. 8 - 16' (2"x10") Scaffold Planks
- J. 3 - 21' Alumina Beams
- K. 6 - 4x6 Wood Timbers
- L. 12 - (4'x8'x3/4") plywood sheets

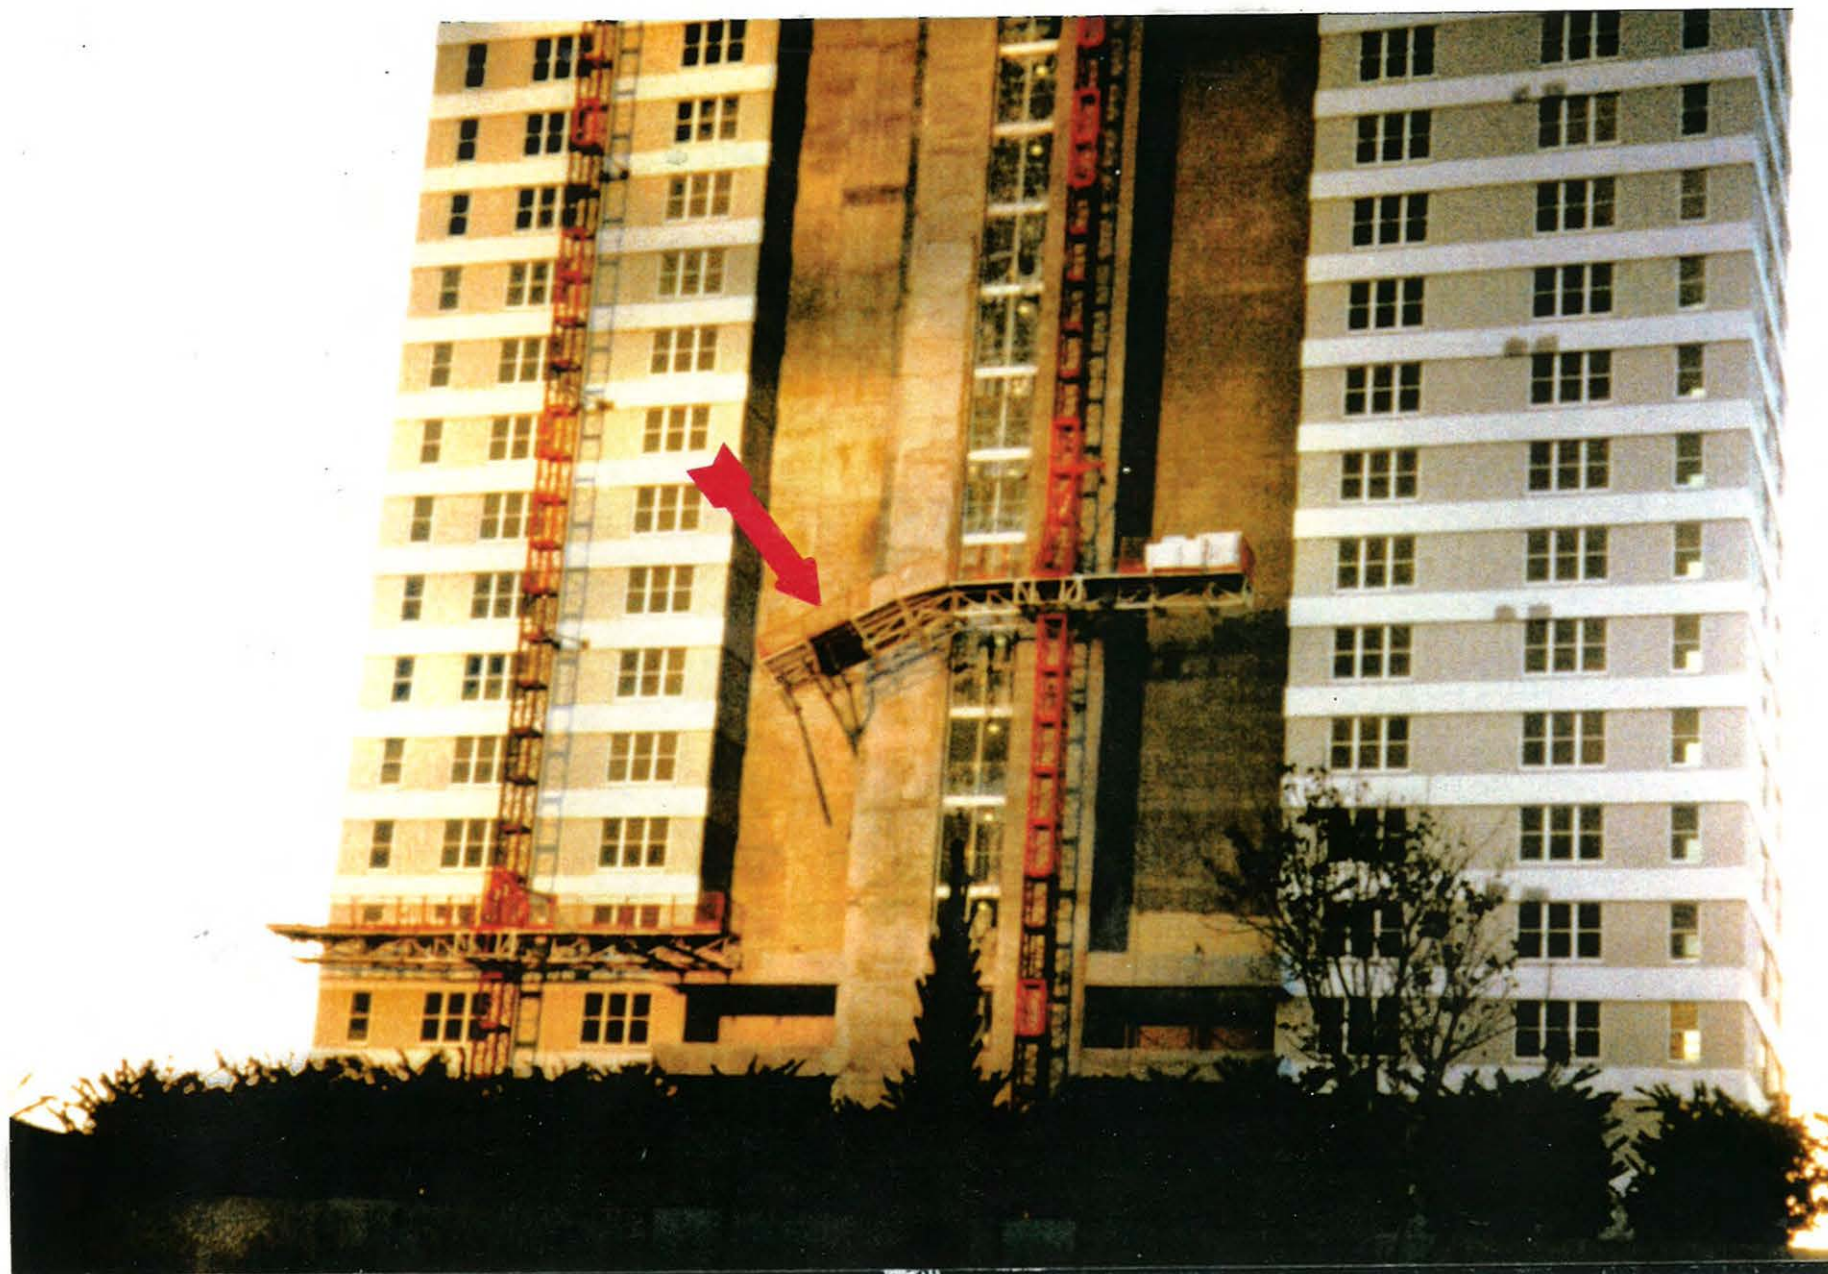
Figure 1.4

Two Mast Climbing Elevated Work Platforms on West Face of Building  
Arrow shows the Failed Scaffold (Looking East)

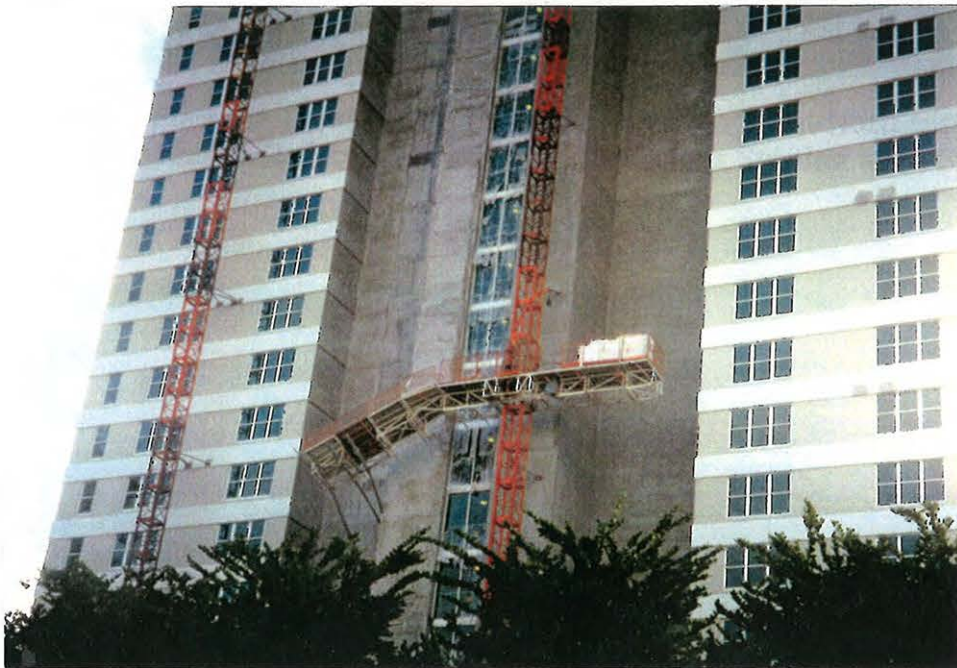
**Figure 1.5**

**Failed ACCESS Satellite Scaffold - Unit #78 (Looking East)**

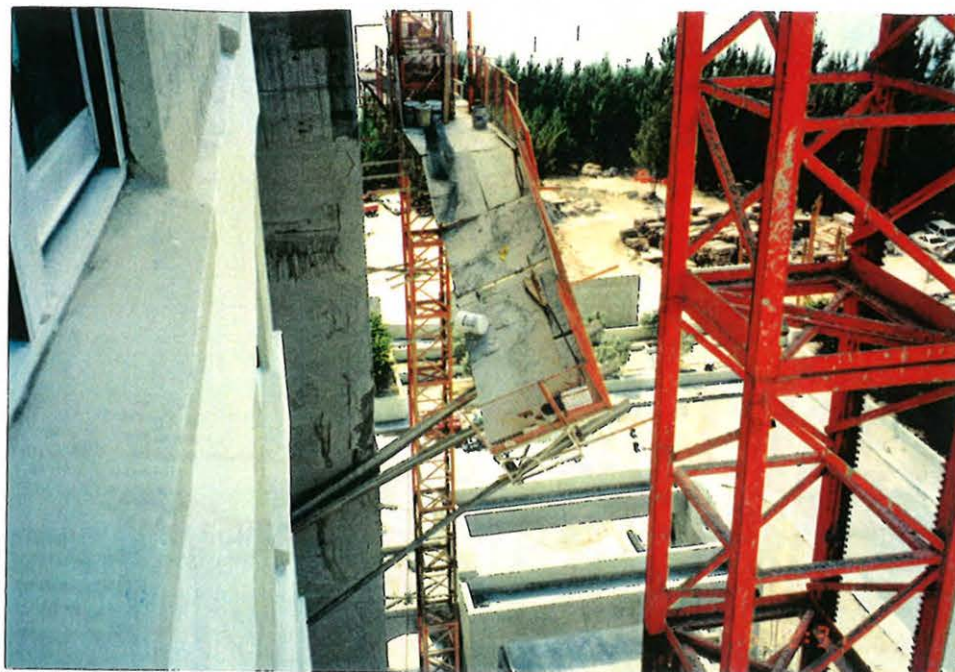
**Figure 1.10**

**Aluminum Outriggers Relative to the Platform and Building (Looking South)**

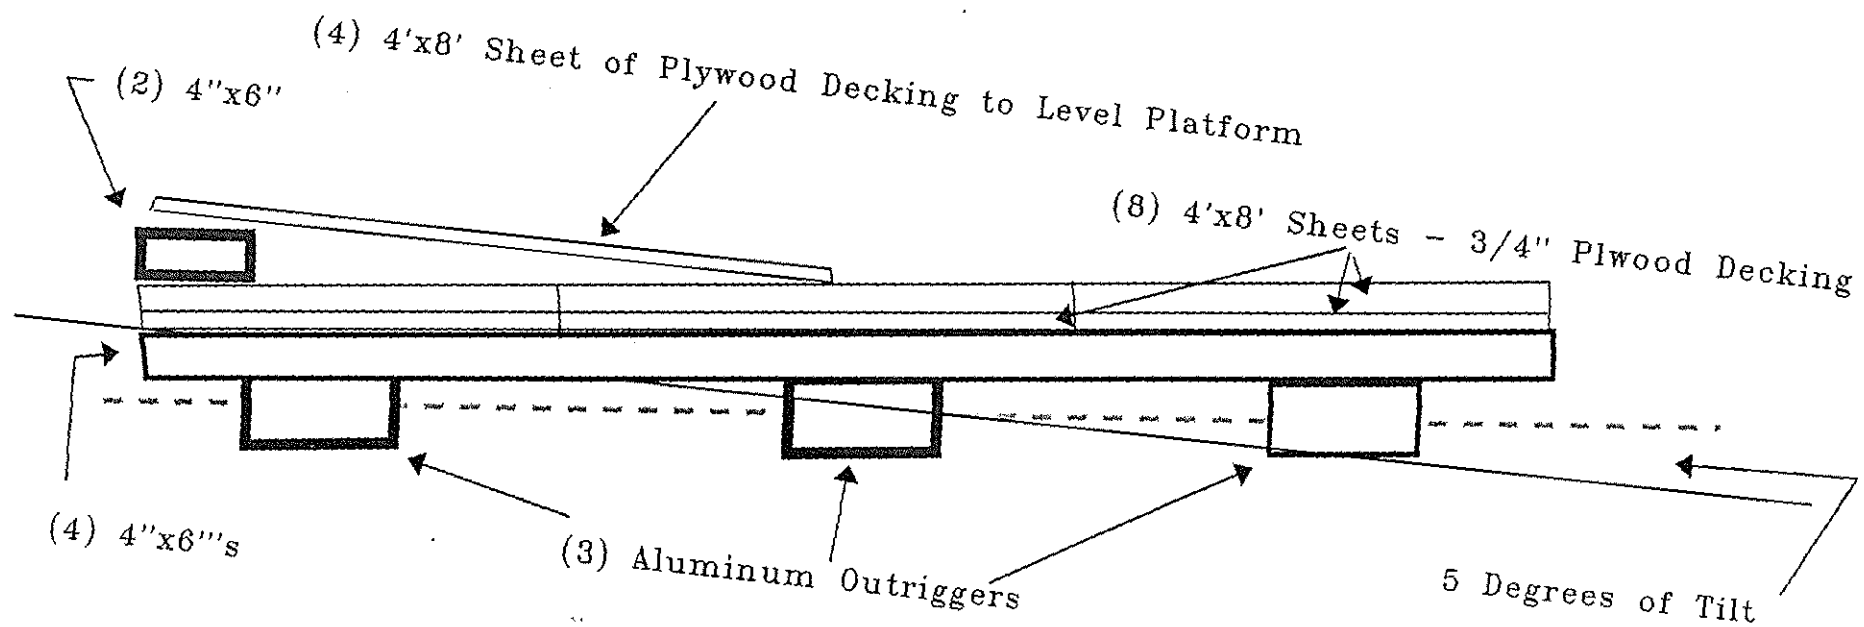
Figure 1.13

# ELEVATION VIEW OF OUTRIGGER SECTION OF PLATFORM PRIOR TO COLLAPSE

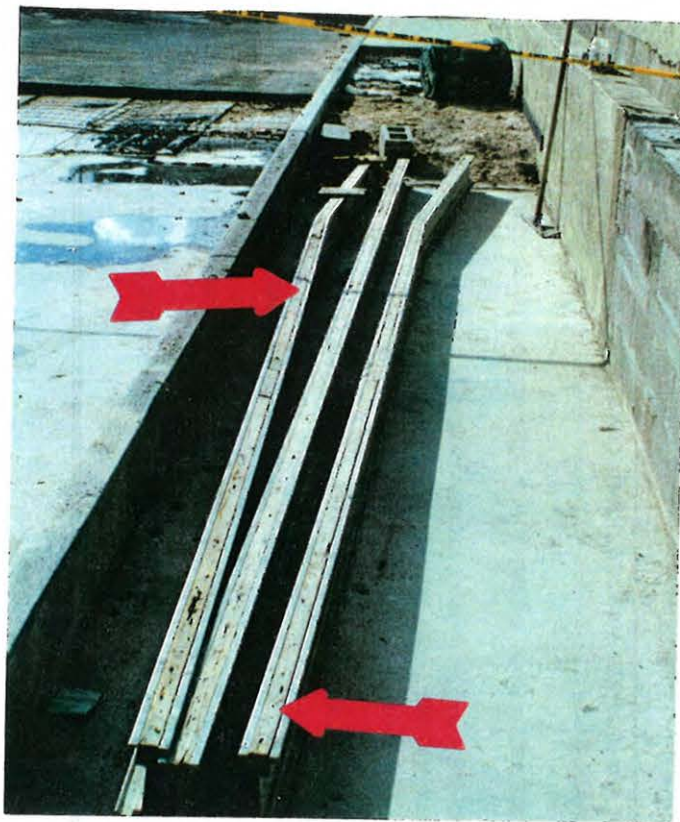
**Figure 1.20**

**3 Outriggers From the Failed Scaffold**  
**Near Arrow Shows South Outrigger, Far Arrow Shows North Outrigger**

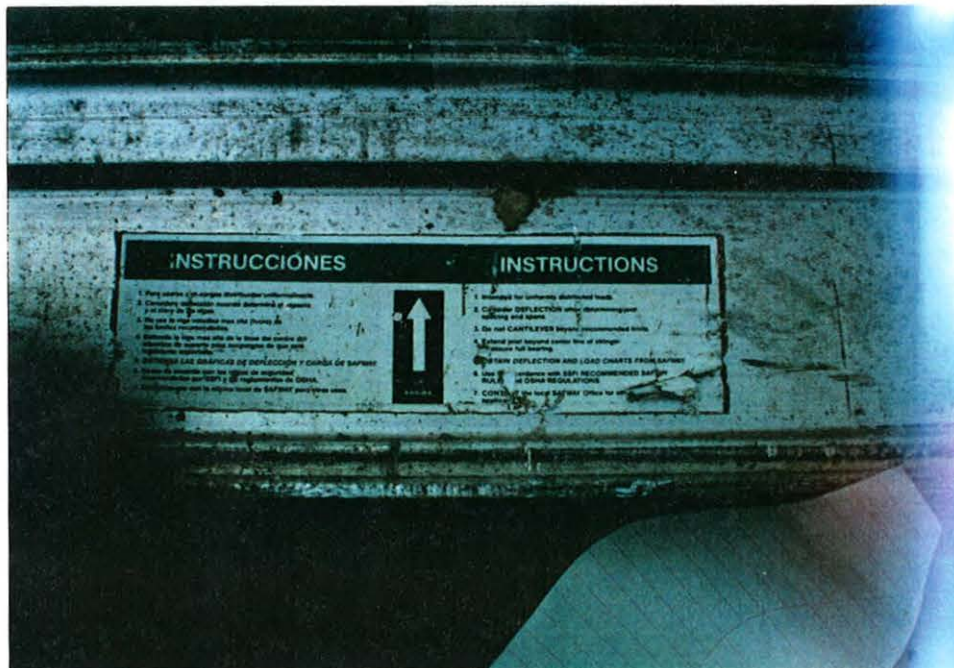
**Figure 1.21**

**Label/Instructions on 1 of Outrigger Beams**

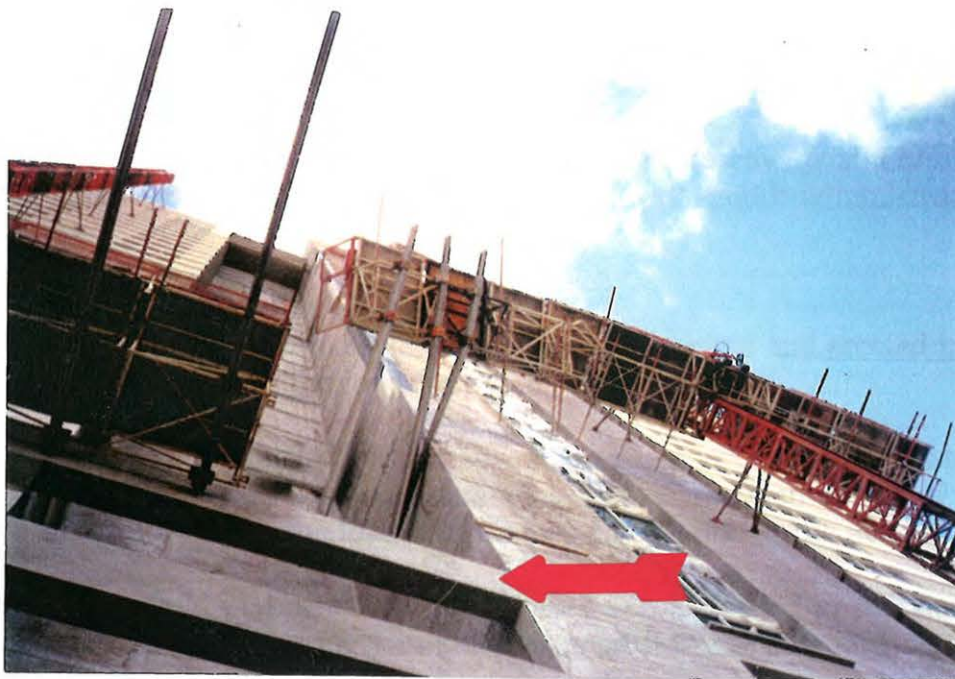
Figure 5.1

North Inset on the West Face of Building (Looking Up)  
Arrows Show Concrete Beams Which are on Face of Building

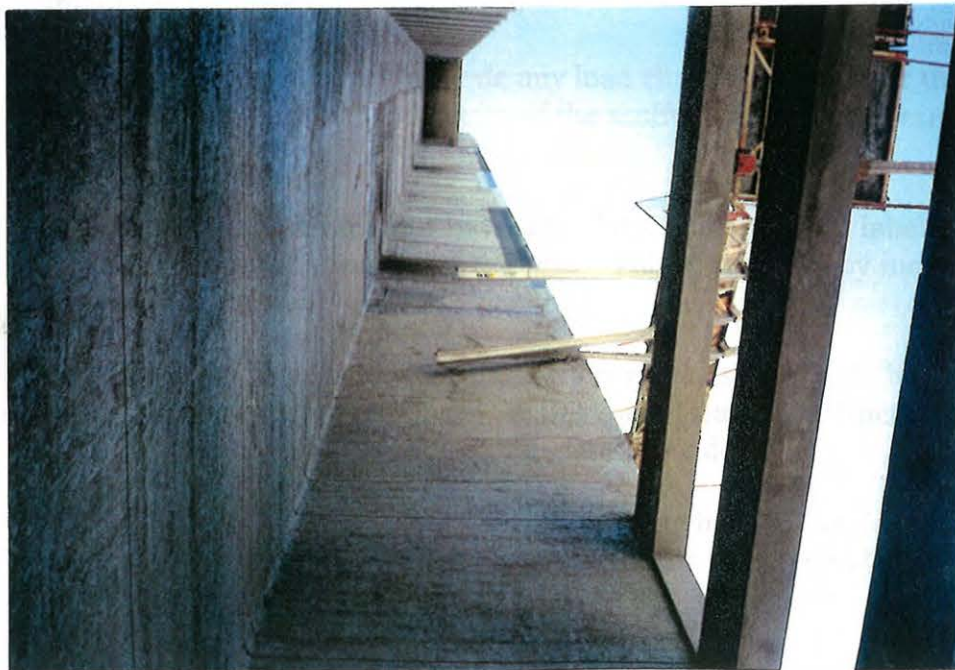
Figure 5.2

Concrete Beams Which Prohibit Setting Mast Climber Directly in Inset
