Guardrail System for Tunnel Form Stripping Platform

Safety and Health Information Bulletin

SHIB 08-08-2006

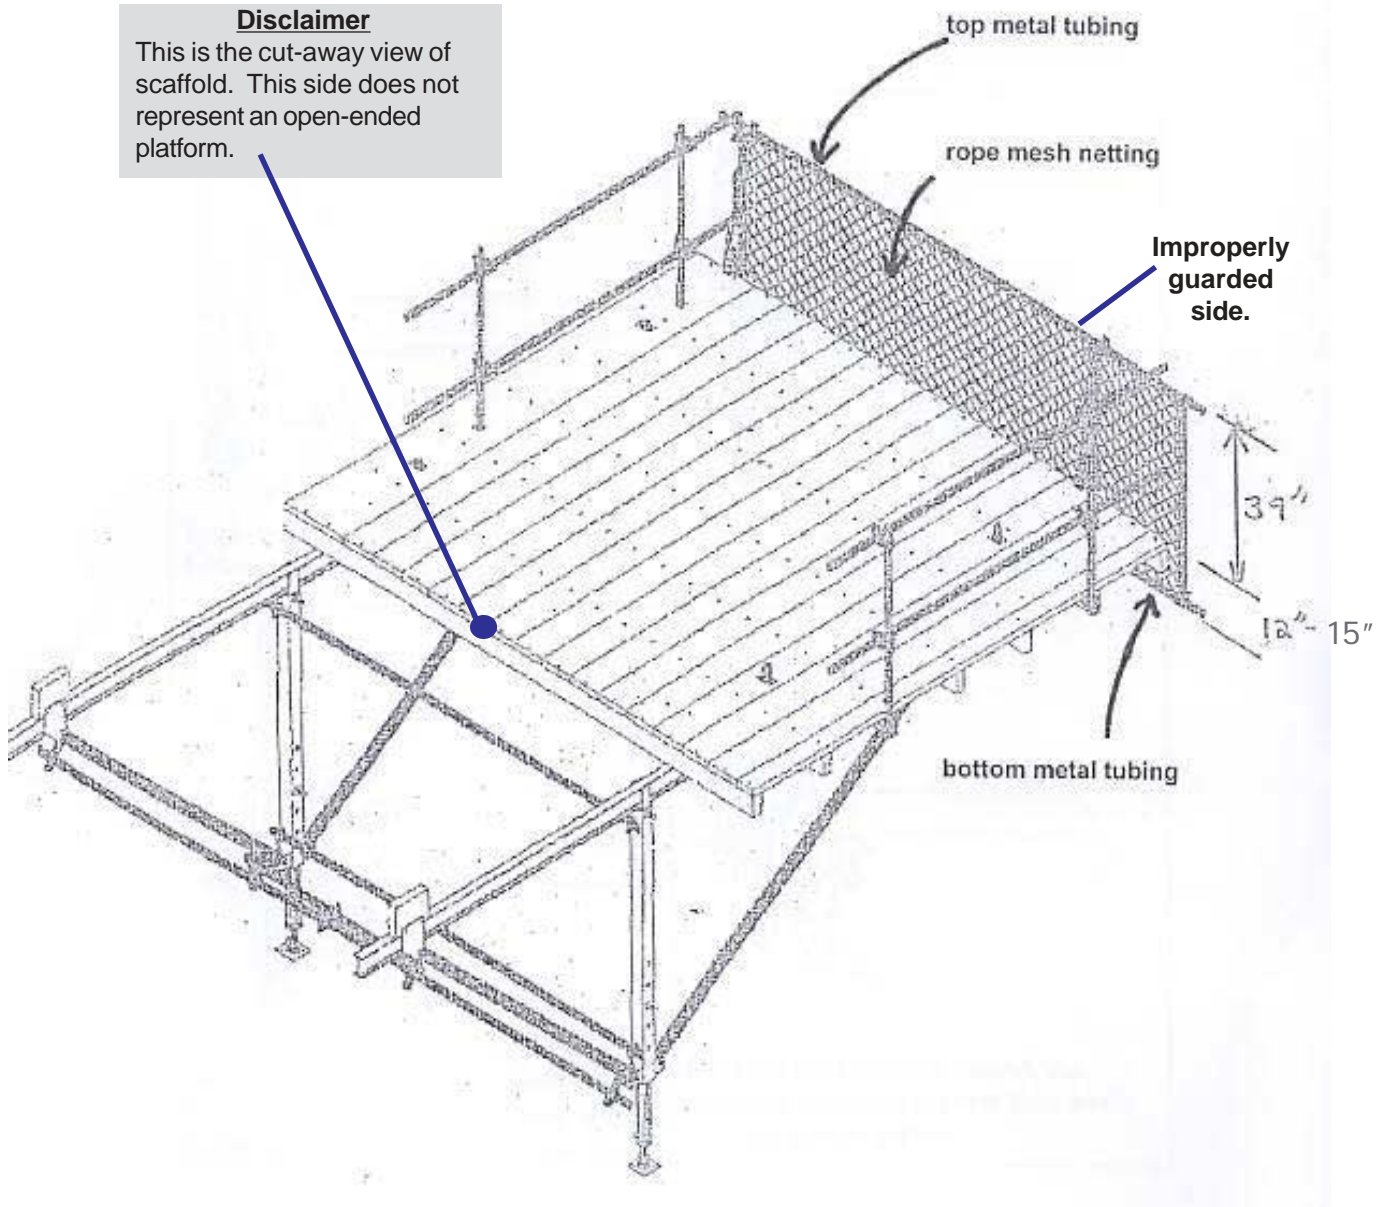
Figure 1

Recently, an OSHA Area Office inspected a construction site where the high-rise structure was being built using “tunnel forms.” Figure No. 1 is an illustration of the perimeter “netted” guardrail system which the Compliance Officer observed. It consists of mesh rope netting attached to top, bottom, and vertical metal tubing. The guardrail system attaches to the stripping platform, and extends 39 inches above and 12 to 15 inches below the platform

edge. There was, however, a horizontal opening of 7 inches measured from the edge of the platform to the netting. When a tape measure was used to push the netting away from the platform edge, it created an opening of at least 19 inches.

Cut-Away View of “Stripping Platform” (drawing not to scale)

Specifically, when midrails, screens, mesh and intermediate vertical members, solid panels, or equivalent structural members are used, they must be installed between the top edge of the guardrail system and the scaffold platform. Upon initial observation by the Compliance Officer, the “netted” guardrail system appeared to be securely fastened to the platform and adjoining side guardrails. However, upon closer examination it became apparent that the design of the “netted” guardrail could easily have allowed an employee to fall between the netting and the platform to the next lower level.

The netting and its framing could not support a downward or horizontal force as specified in (g)(4)(ix). Although the top edge and side edges of the “netted” guardrail was securely fastened, the bottom edge was not properly secured along the

length of the scaffold platform and along the entire opening between the side supports as required by 29 CFR 1926.451(g)(4)(2).

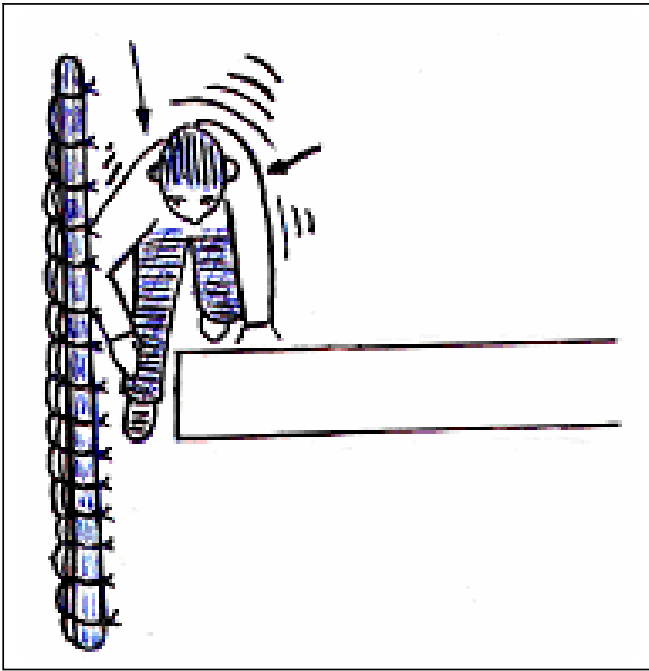
Figure 2-1. Description of the potential to fall - Employee steps into opening

As a result of the inspection, citations were issued. The opening between the platform edge and the netting could expand to more than 19 inches, and allow an average-sized worker to fall through the opening [Figures No.2-1 - 2-4]. Thus, the fall prevention system did not eliminate all fall hazards.

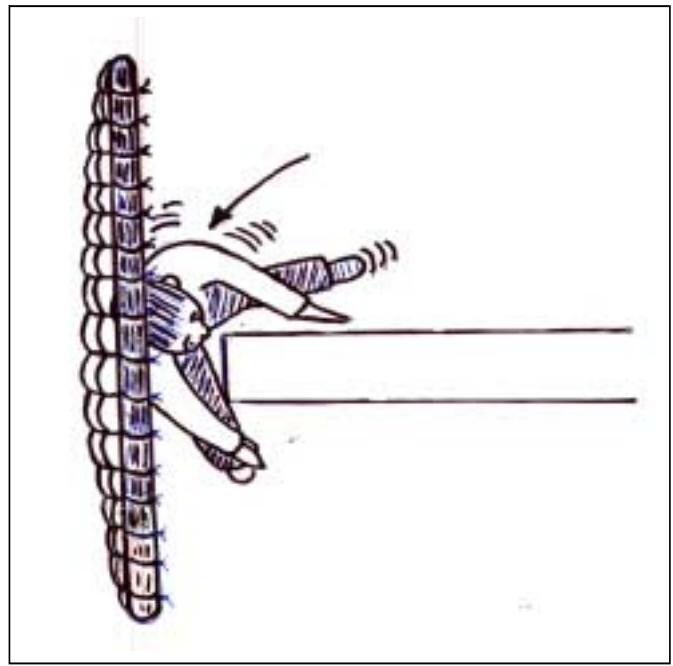
Figure 2-2. Employee loses balance and begins to fall into netting system

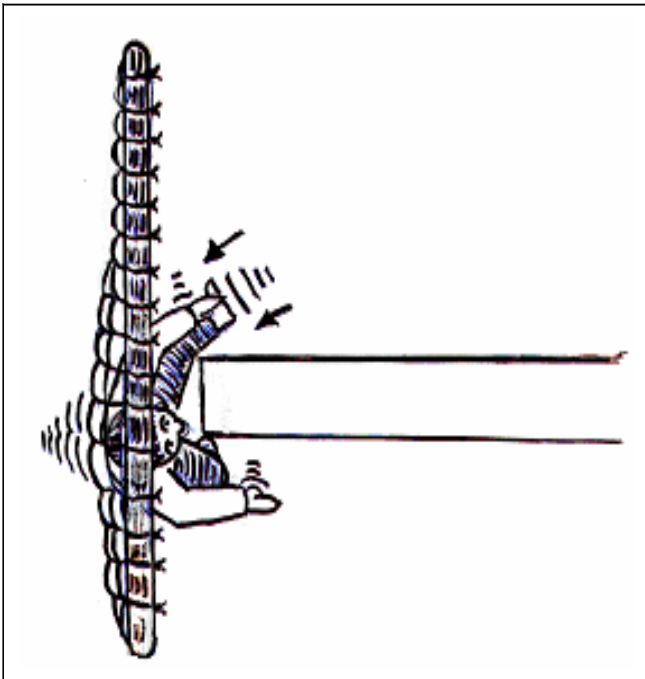
Figure 2-3. Momentum carries employee downward

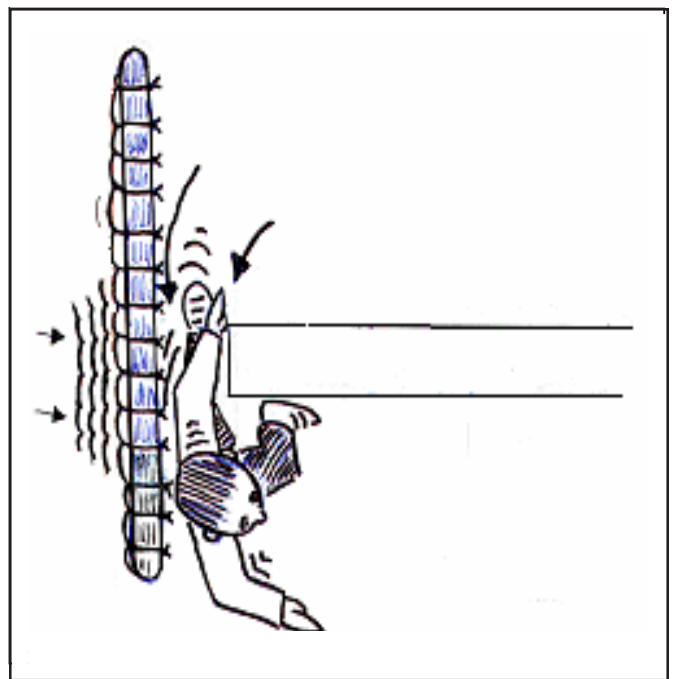
Figure 2-4. Employee clears floor edge and when the net tightens near the bottom rail it would have the tendency to push the employee out of the net

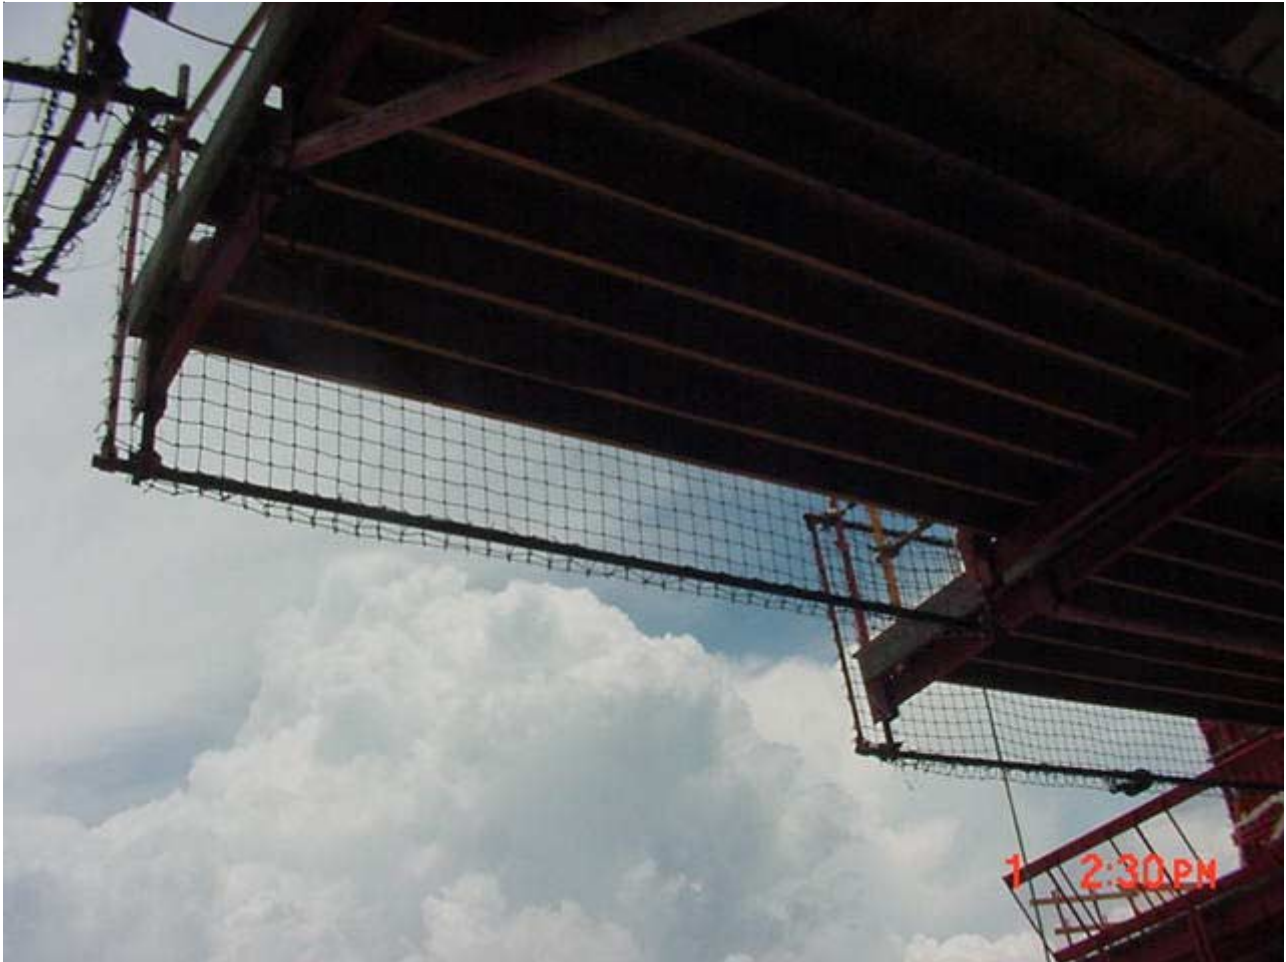
Underside of Stripping Platform showing mesh guarding.
