## Module 2, Scenario 4

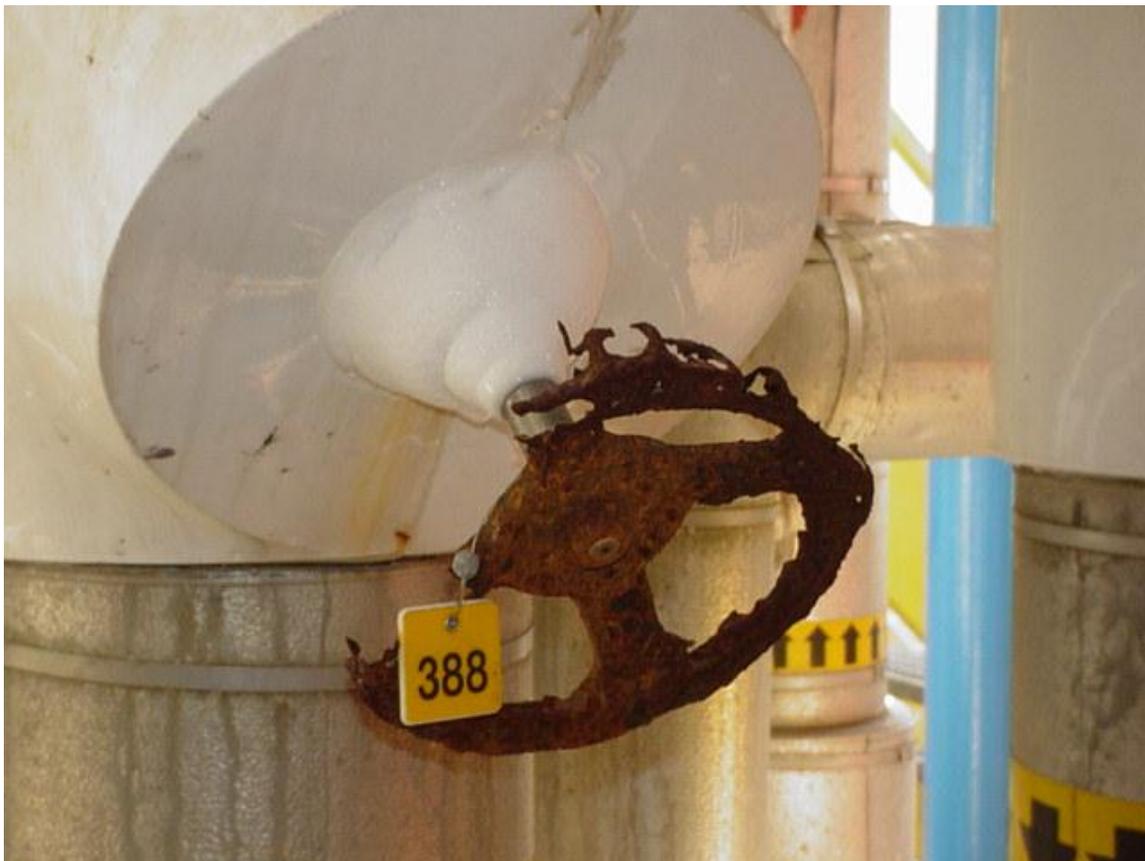
Employee #1, an ammonia refrigeration systems maintenance worker, was torquing a stuck valve on an ice-making machine. He over-torqued the valve and the lower windows of the site gauge ruptured, spraying ammonia out on Employee #1. He sustained chemical burns on his face, chest, and legs. The valve had become stuck because it had not been cycled, inspected, and maintained on a regular basis. Employee #1 was not wearing appropriate PPE for the job.
