# Investigation of the March 15, 2008 Fatal Tower Crane Collapse at 303 East 51<sup>st</sup> Street, New York, NY

U.S. Department of Labor  
Occupational Safety and Health Administration  
Directorate of Construction

September 2008

Report Prepared by  
Mohammad Ayub, PE  
Directorate of Construction, OSHA  
Washington, DC

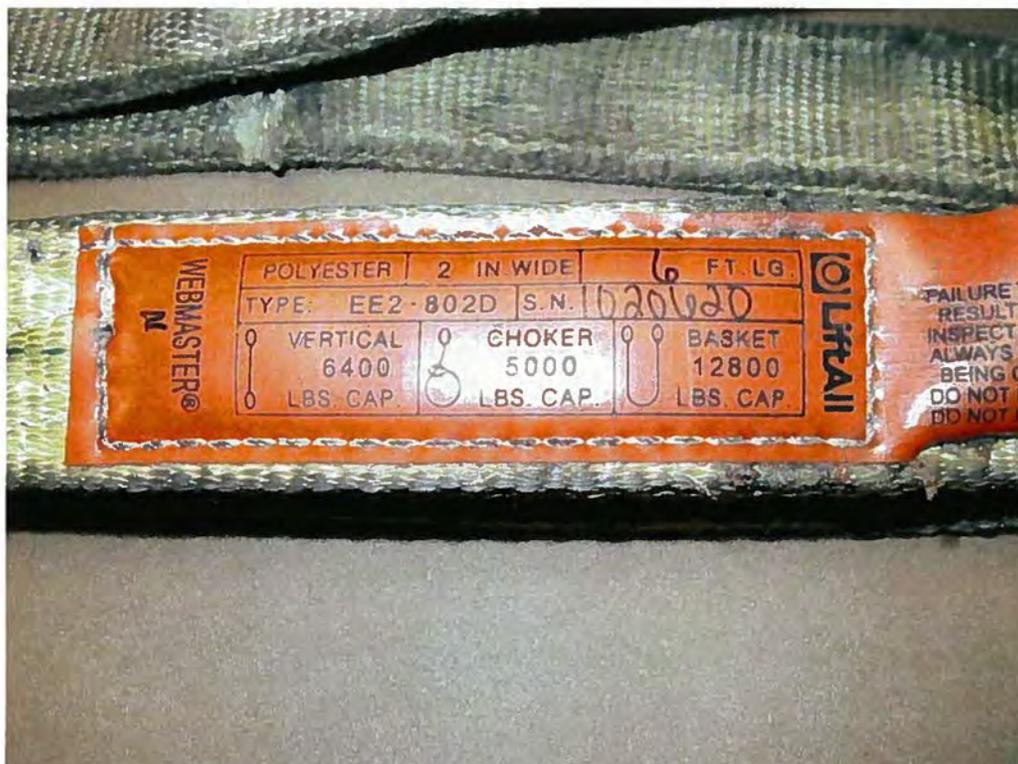
FIGURE 24

There were four slings used to support the collar. All were 2" wide polyester slings, 6 ft. long. Three were manufactured by LiftAll Company, and one was manufactured by Metro Wire Rope. Post-collapse examination of the slings revealed that the Metro sling was used at the southwest corner of the collar, and had a rated capacity of 6,400 pounds, 5,100 pounds and 12,800 pounds under vertical, choker and V basket configurations, respectively, see Fig. 23. The Metro sling bore a serial # Sample-028. The Liftall slings had a similar rated capacity i.e., 6,400 pounds, 5,000 pounds and 12,800 pounds under vertical, choker and basket configurations, respectively, see Fig. 24. Two LiftAll slings, type EE2-802D, bore serial numbers 1049068. The other

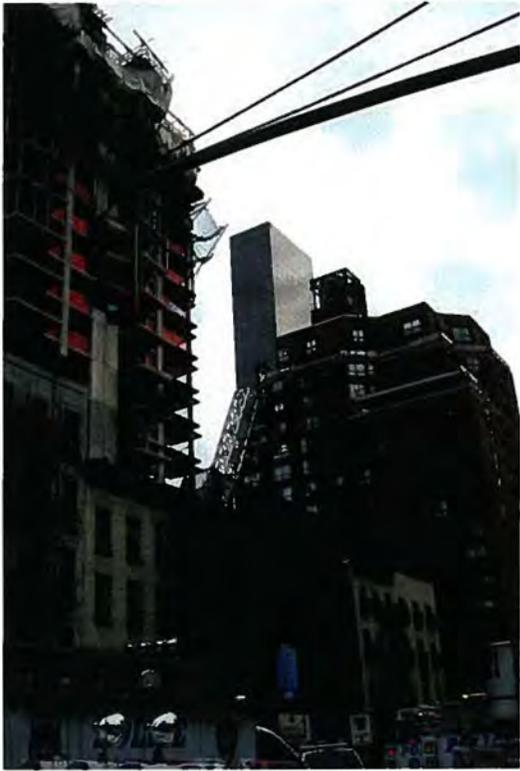
**FIGURE 29**

The lack of lateral ties transformed the crane mast into a free-standing structure with no lateral support above the 3<sup>rd</sup> floor. The crane mast leaned a little towards the north and then fell towards the south, pivoting near the base of the mast, see Fig. 29 & 30. The crane boom was facing towards the north and the counterweights were towards the south. The crane fell in one

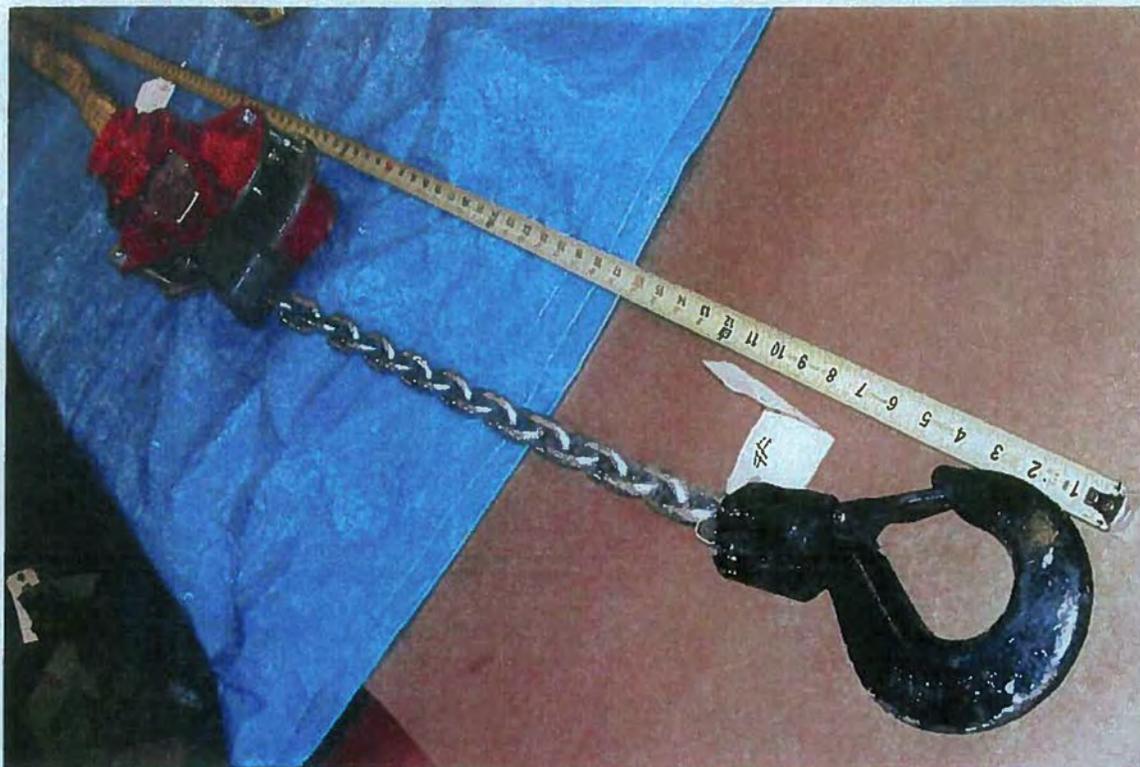
PHOTOGRAPH #1  
INSPECTION AT NEW YORK OSHA OFFICE

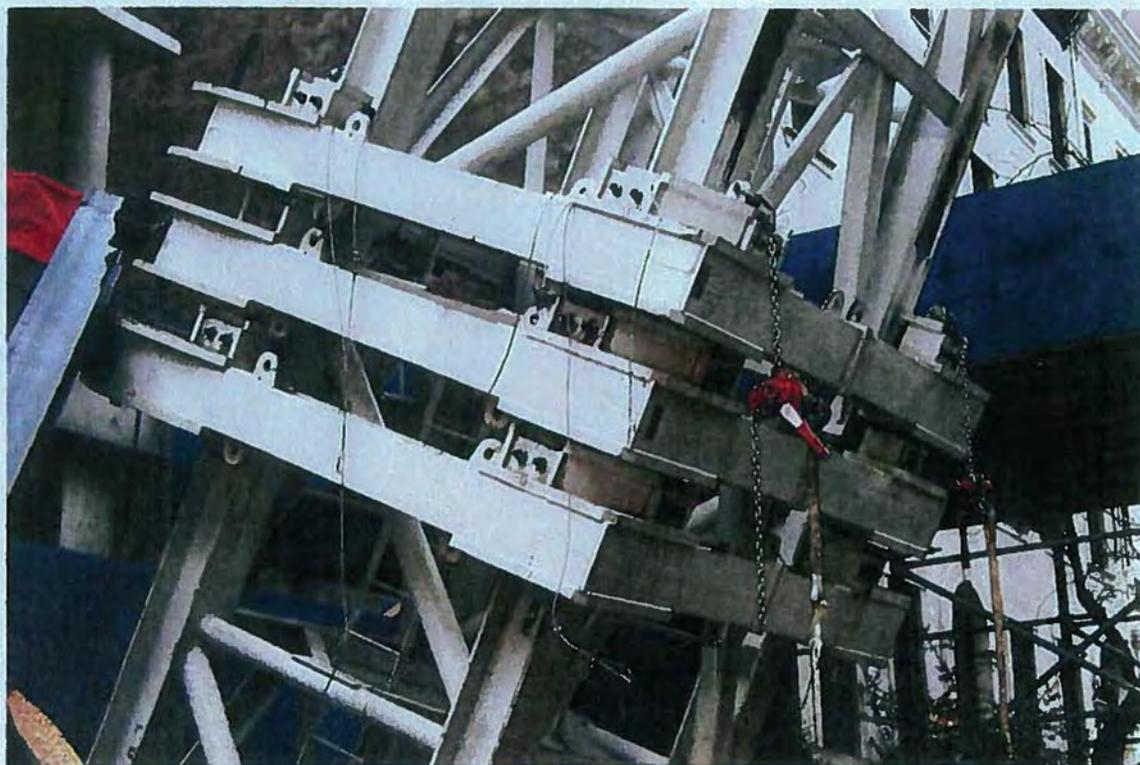
**PHOTOGRAPH #8  
SLING ASSEMBLIES ON COLLAR FOLLOWING ACCIDENT**

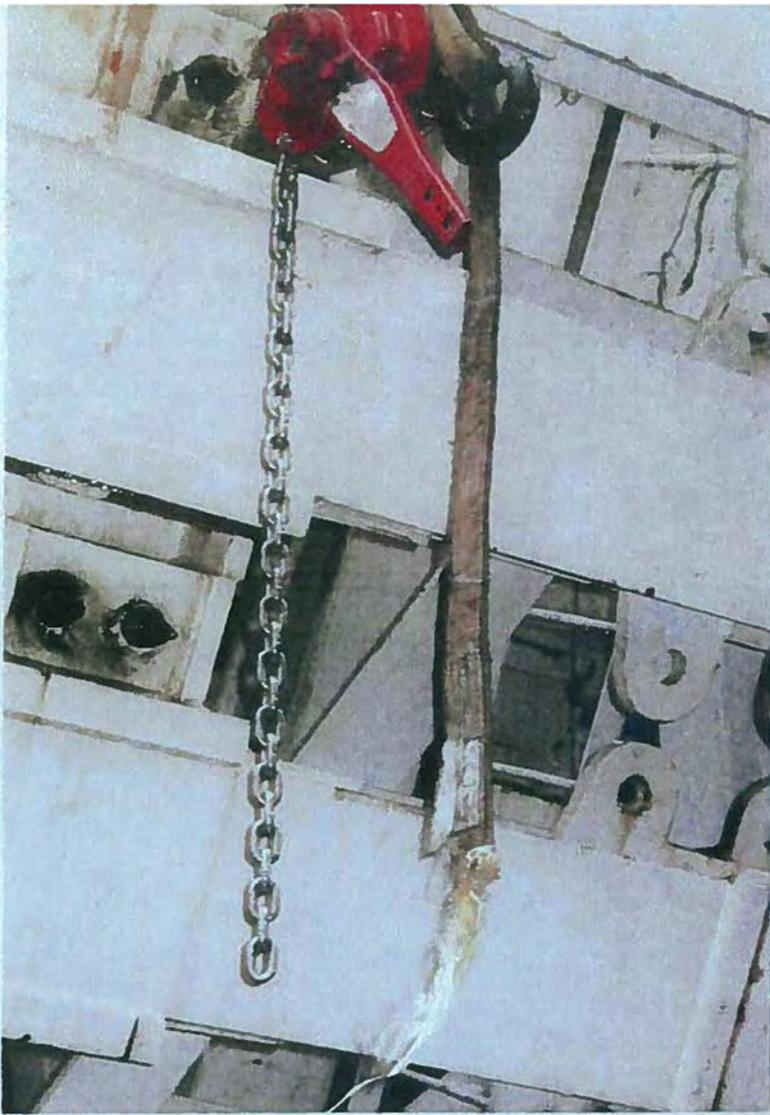
**PHOTOGRAPH #9  
METRO SLING STILL  
ATTACHED TO FALLEN  
COLLAR**

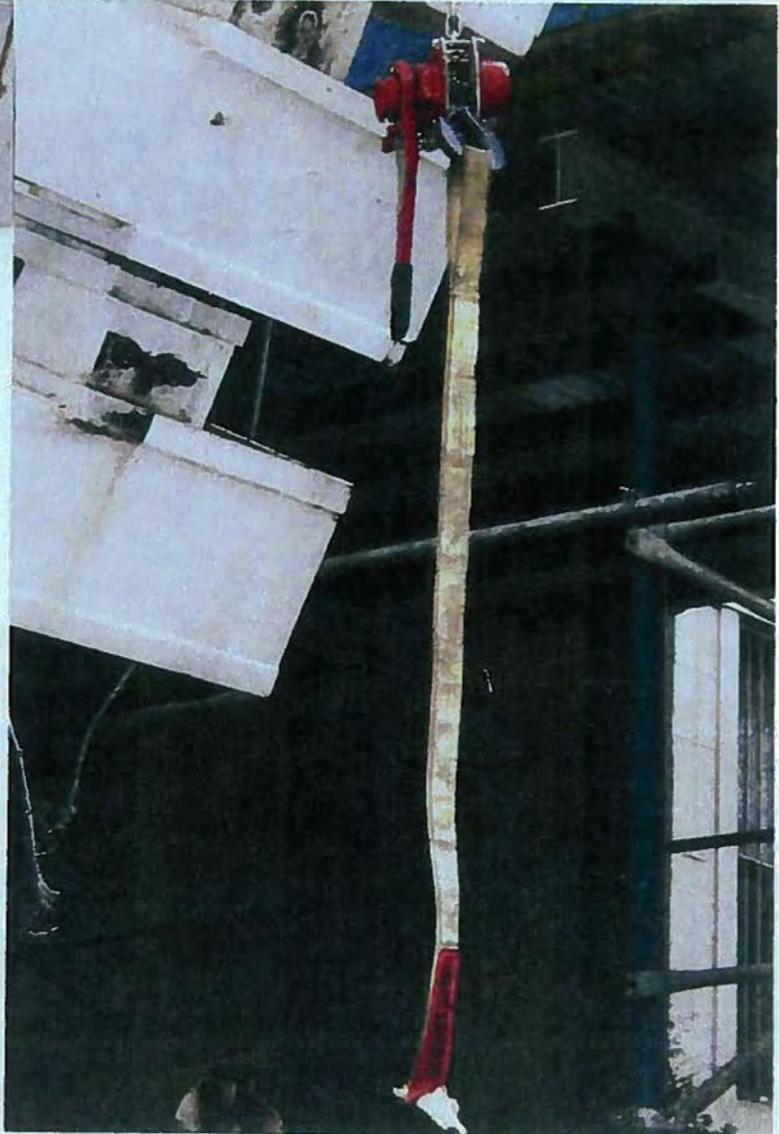
**PHOTOGRAPH #10  
LIFTALL SLING STILL  
ATTACHED TO FALLEN  
COLLAR**

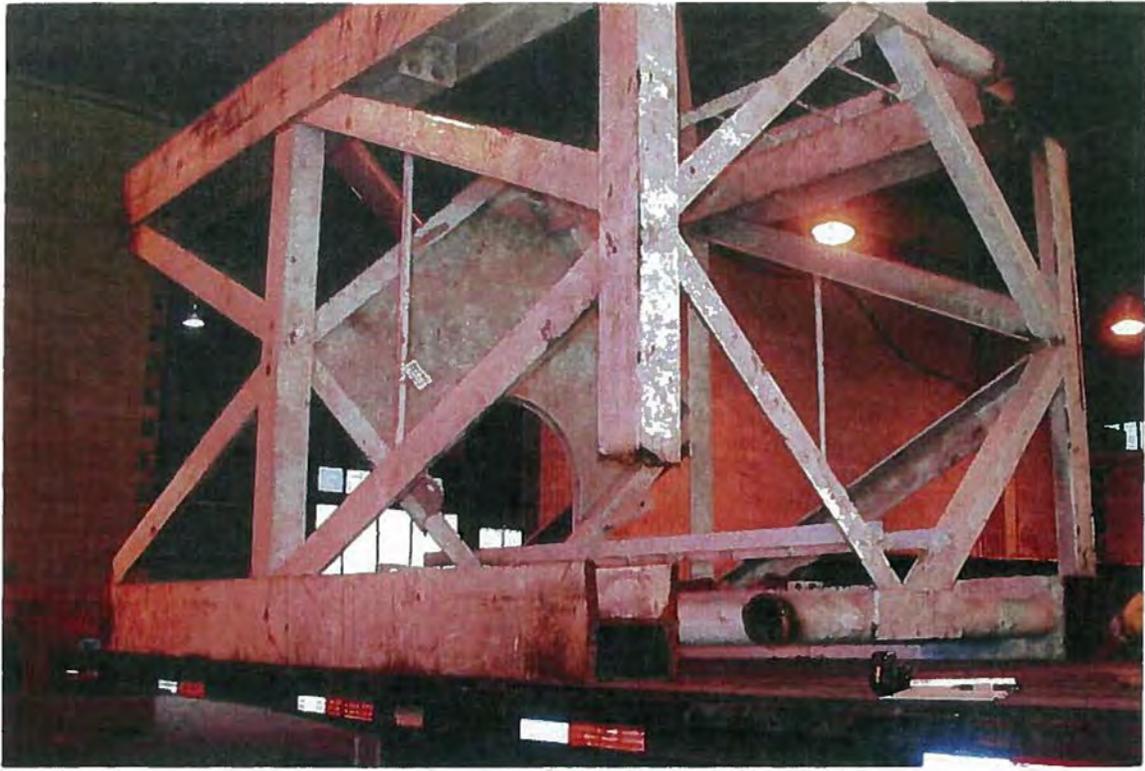
**PHOTOGRAPH #11  
CRANE SECTION IN STORAGE AT WAREHOUSE**

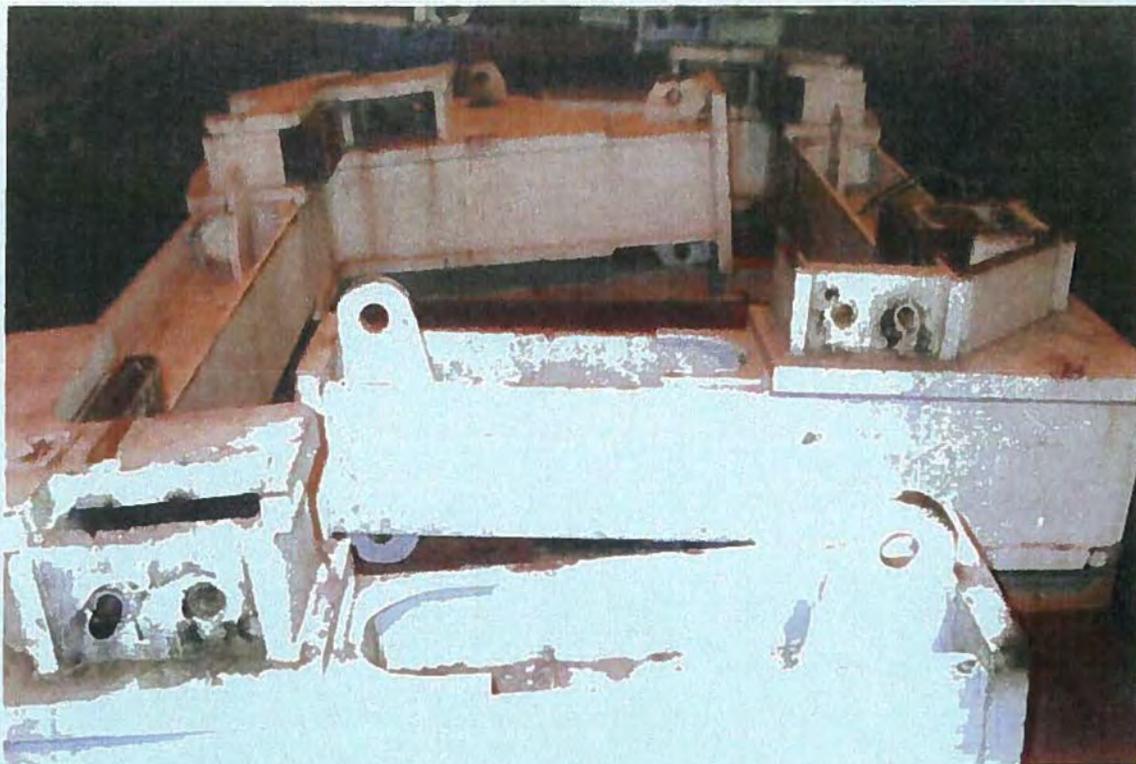
**PHOTOGRAPH #13  
BOTH HALVES OF COLLAR IN STORAGE WAREHOUSE**

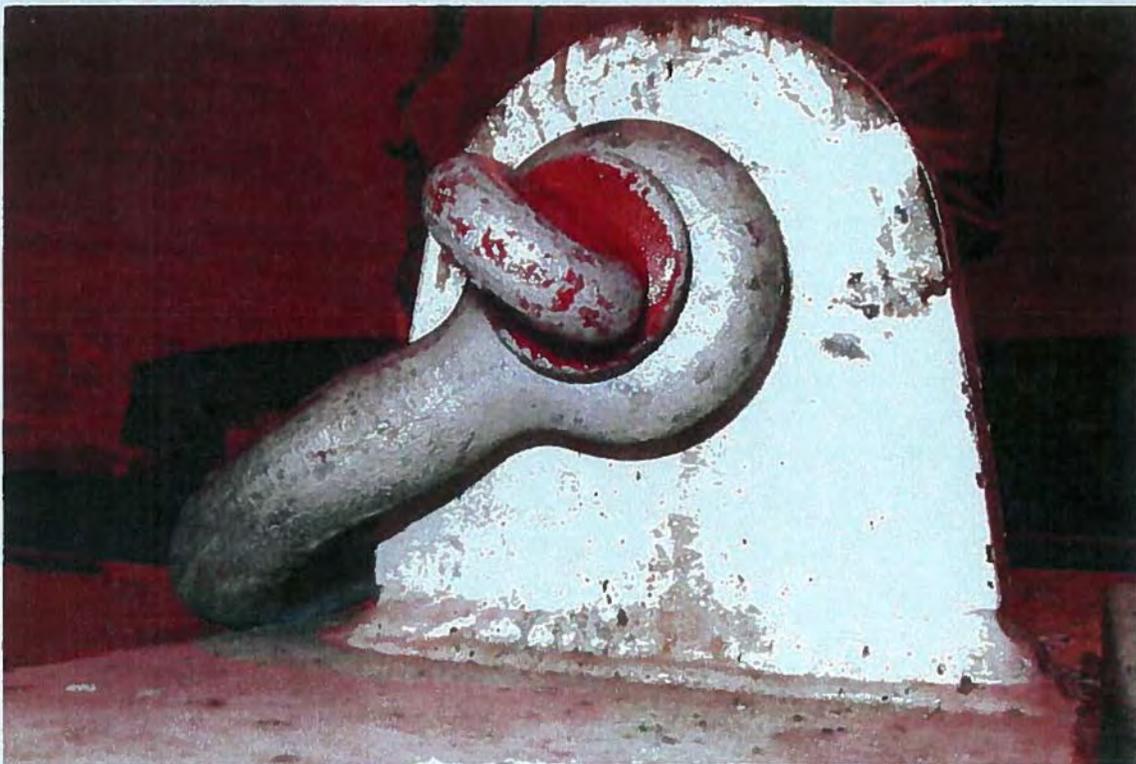
**PHOTOGRAPH #14  
WELDED PAD EYE ON COLLAR**

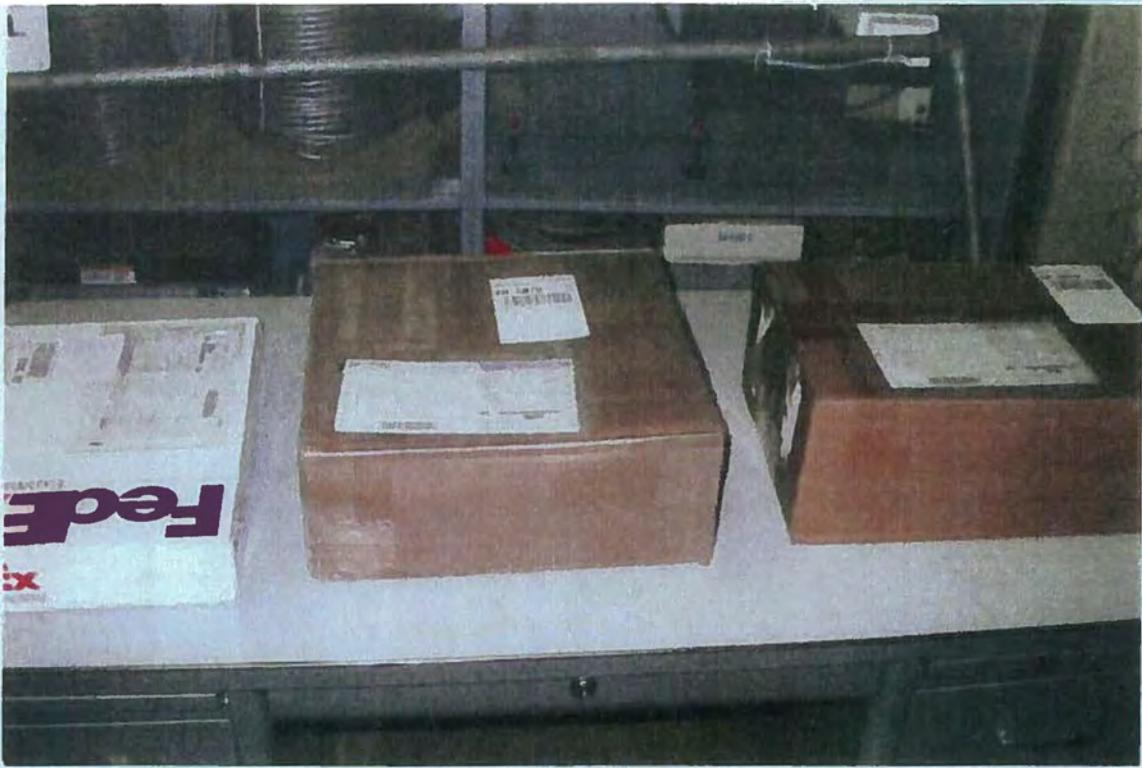
PHOTOGRAPH #15  
THREE BOXES OF EVIDENCE AS RECEIVED AT SWRI

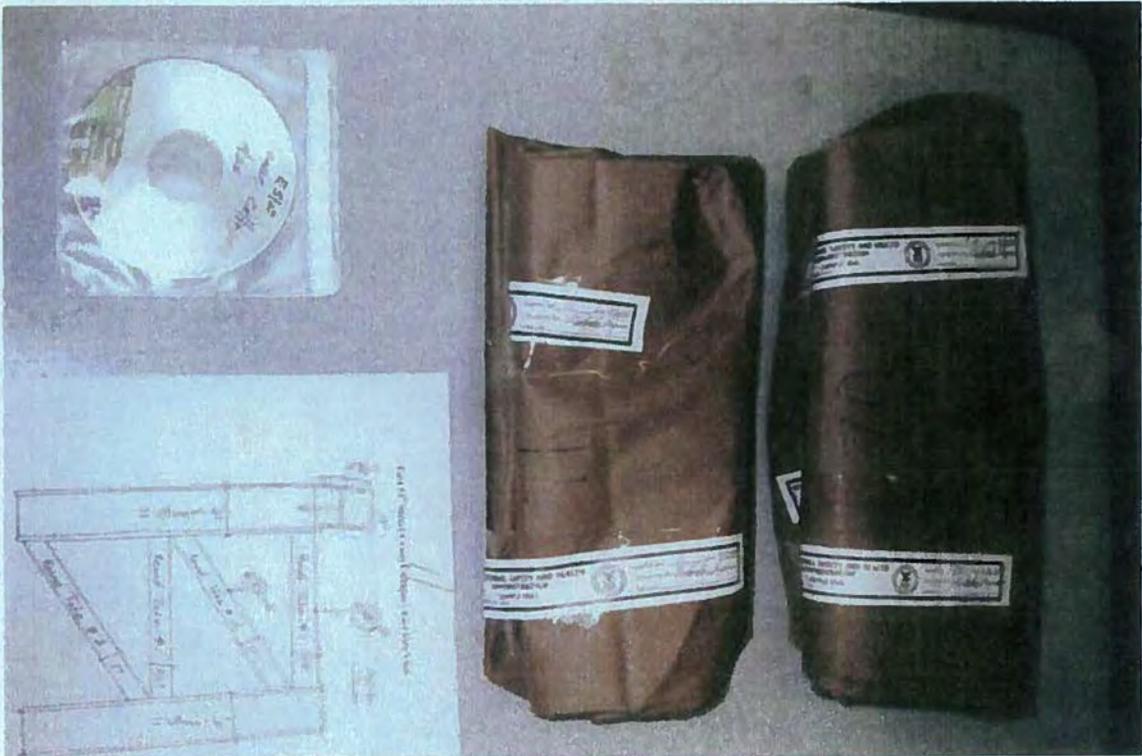
PHOTOGRAPH #16  
CONTENTS OF BOX #1

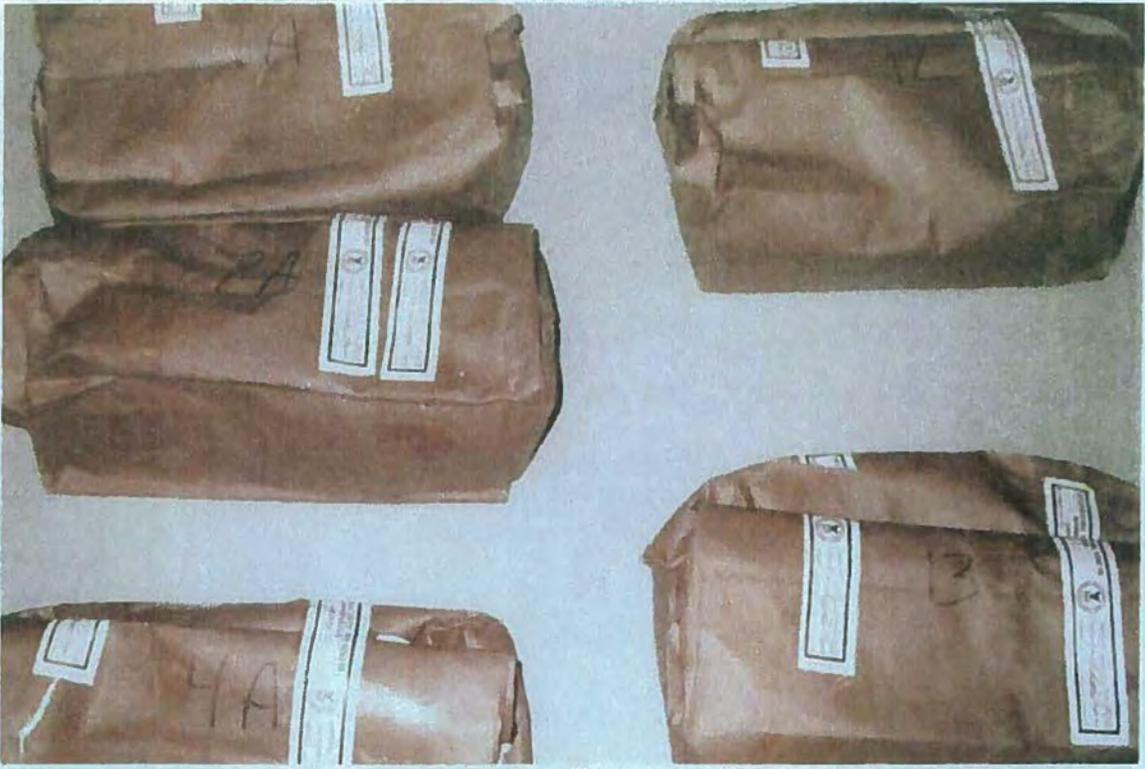
**PHOTOGRAPH #17  
CONTENTS OF BOX #2**

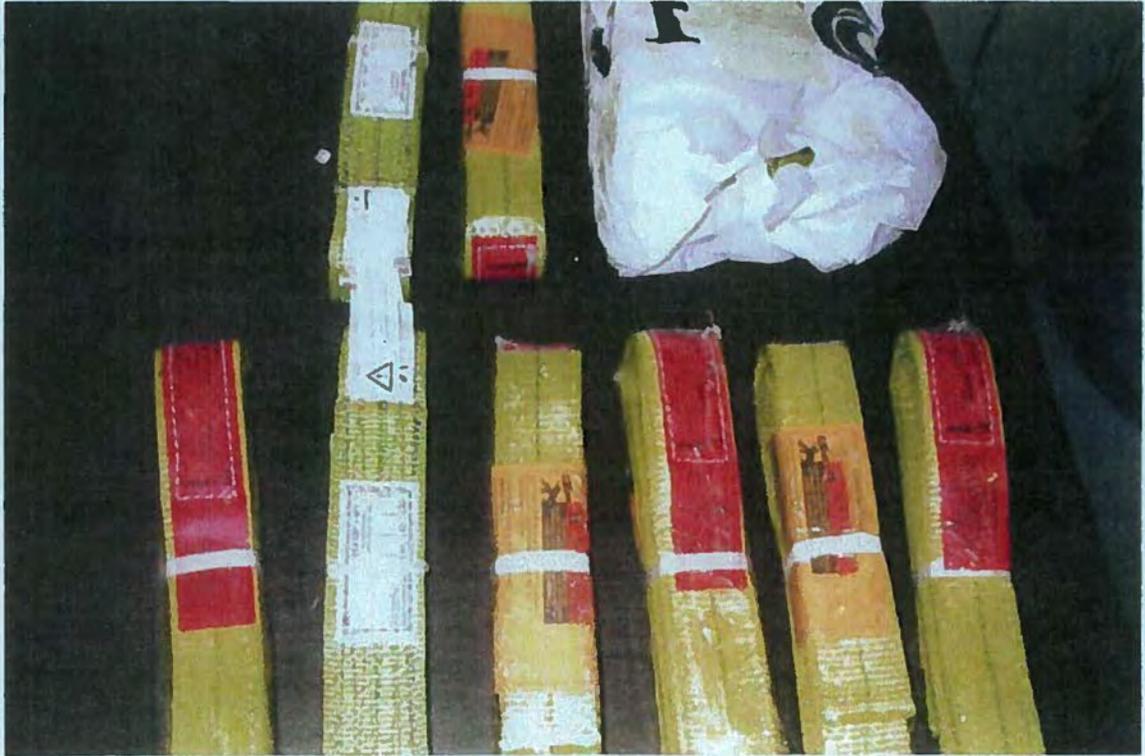
**PHOTOGRAPH #18  
CONTENTS OF BOX #3**

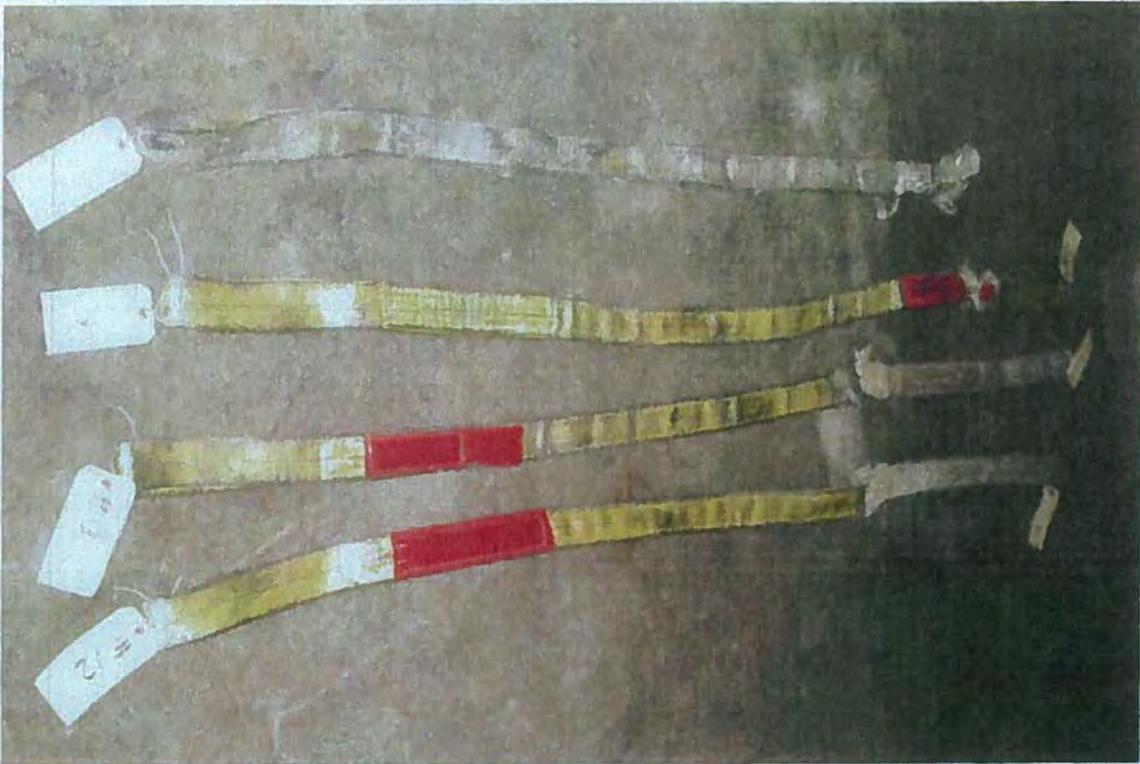
**PHOTOGRAPH #19  
MATCHED SLING REMNANTS**

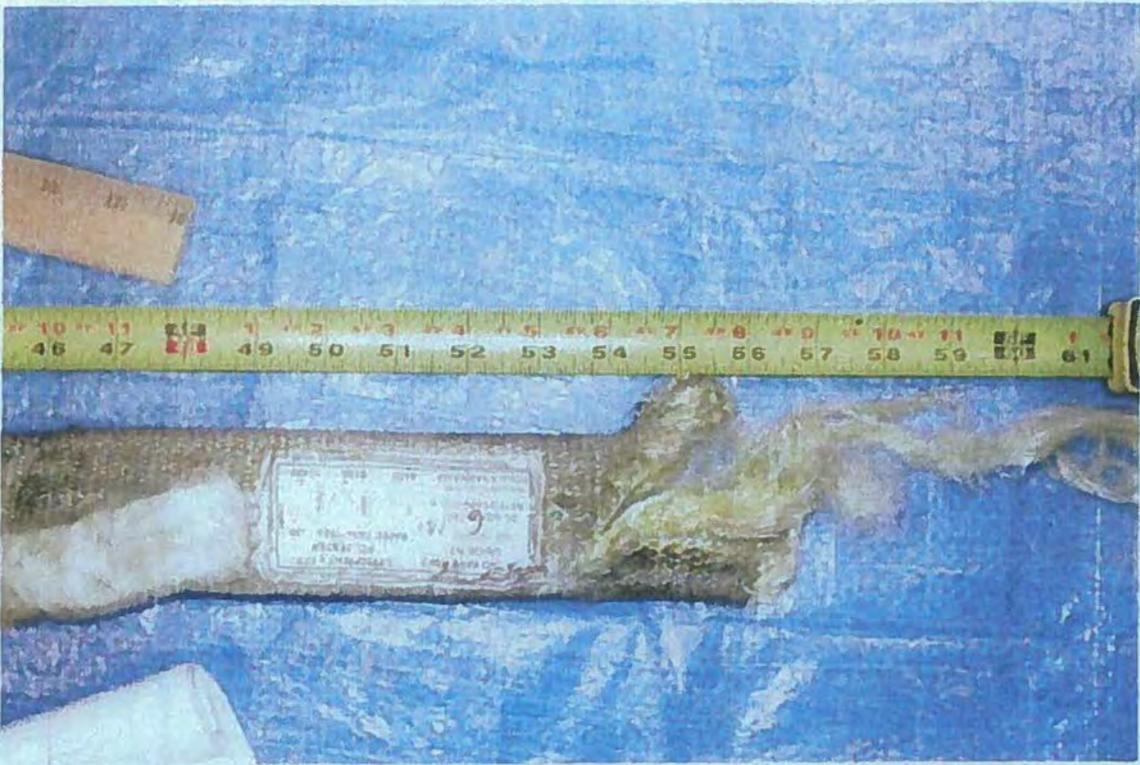
Inspection of this sample #1A shows the angular cut across and down the body of the sling (Photograph #21). Closer inspection reveals the depth and length of the cut, and the final elongated polyester fibers which parted last in tensile (Photograph #22). This protrusion and separation of the small bundle of cut fibers at the edge of the sling in the upper section of the photograph also suggests that the sling was "bunched" in the crease at the intersection of the I-beam and the diagonal bracing. More evidence of this "bunching" is depicted in the position of this sling in Photograph #12. At even a higher magnification, it is discovered that some of the outer fiber surfaces have experienced ultraviolet degradation, a usual byproduct of exposure to the sunlight (Photograph #23). This is evidenced by the lighter, bleached color on the outside of the sling. The most magnified view of the cut of the fibers at the failure location reveals the sliced edge of the sling, the melting and fusing of the cut fiber ends, and the existence of some bleached outer fibers from ultraviolet degradation (Photograph #24).

PHOTOGRAPH #21  
FAILURE END OF METRO SLING - SAMPLE 1A

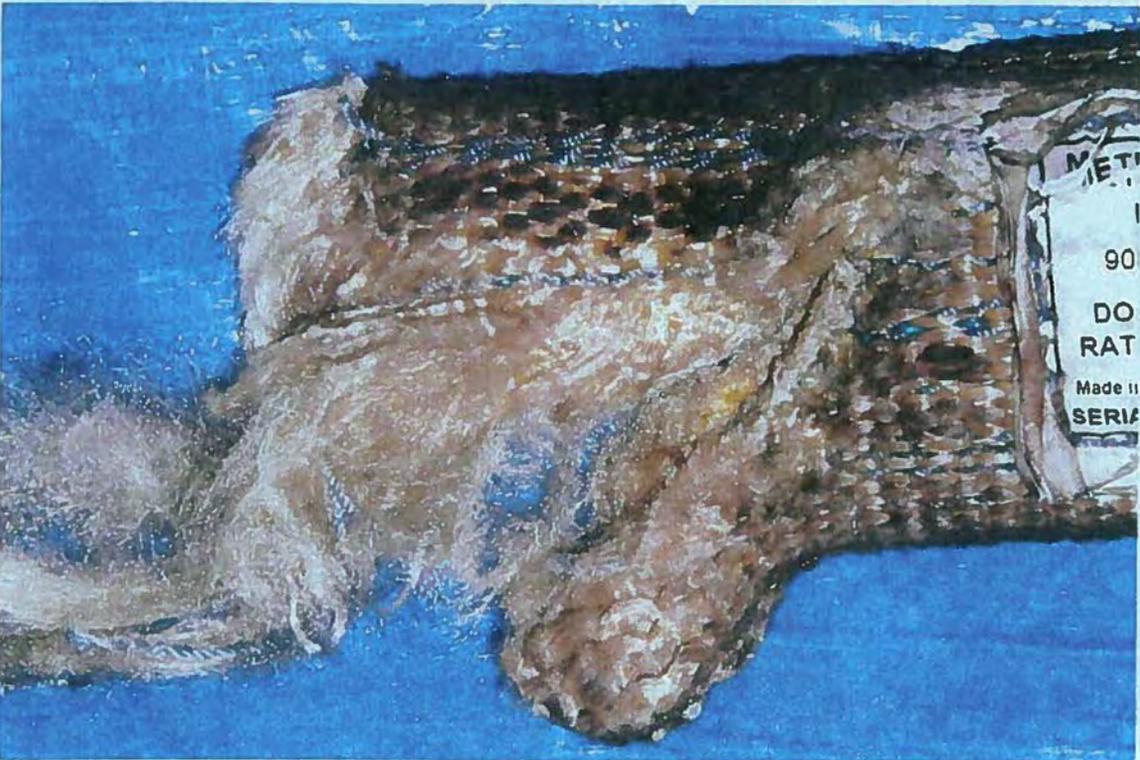
PHOTOGRAPH #22  
CLOSE UP OF FAILURE END OF METRO SLING - SAMPLE 1A

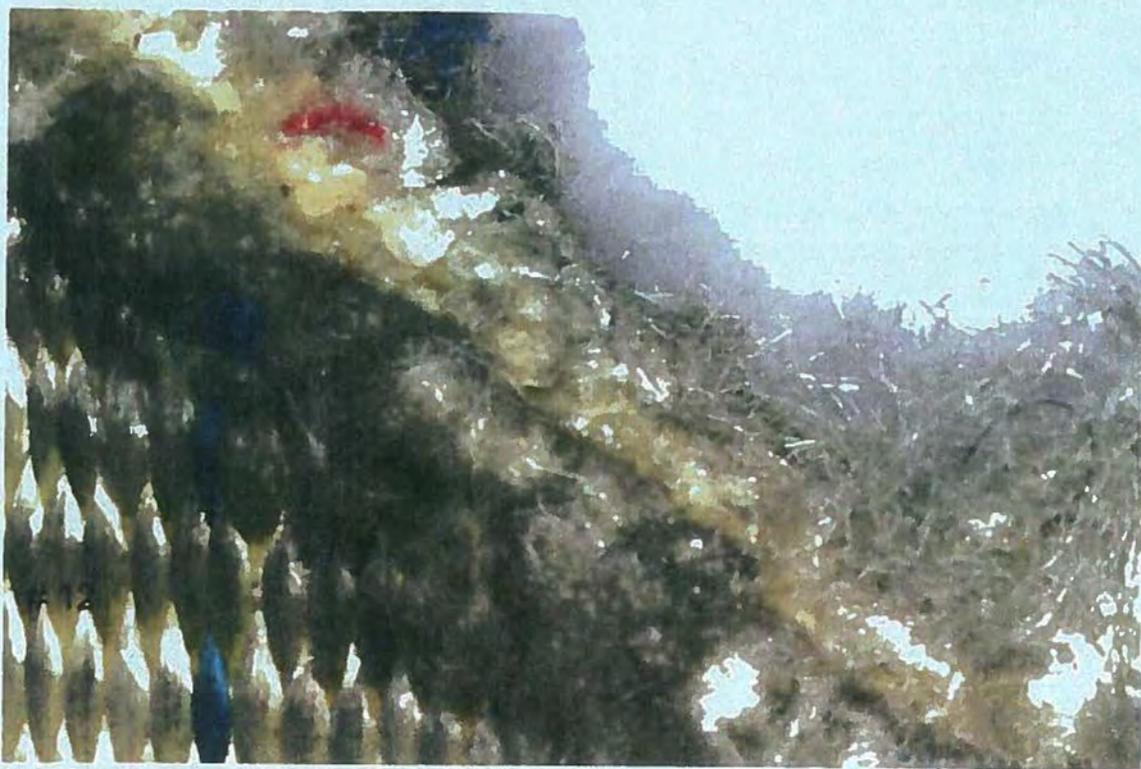
Photograph #34 depicts the ends of the break with samples 4A and 12. This angular cut has extended across almost the entire width of the sling body. The straight line cut is depicted on the left side of Photograph #35, while the elongated fibers on the right side show the last fibers to pull apart in tensile. A magnified view of the cut on sample #12 is shown in Photograph #36, which also reveals the melting and fusing of the fibers along the cut edge from the heat developed during the movement and rupture of the sling against a the edge of hard surface.

**PHOTOGRAPH #36  
HIGHLY MAGNIFIED VIEW OF FAILURE END OF LIFTALL SLING – SAMPLE 12**

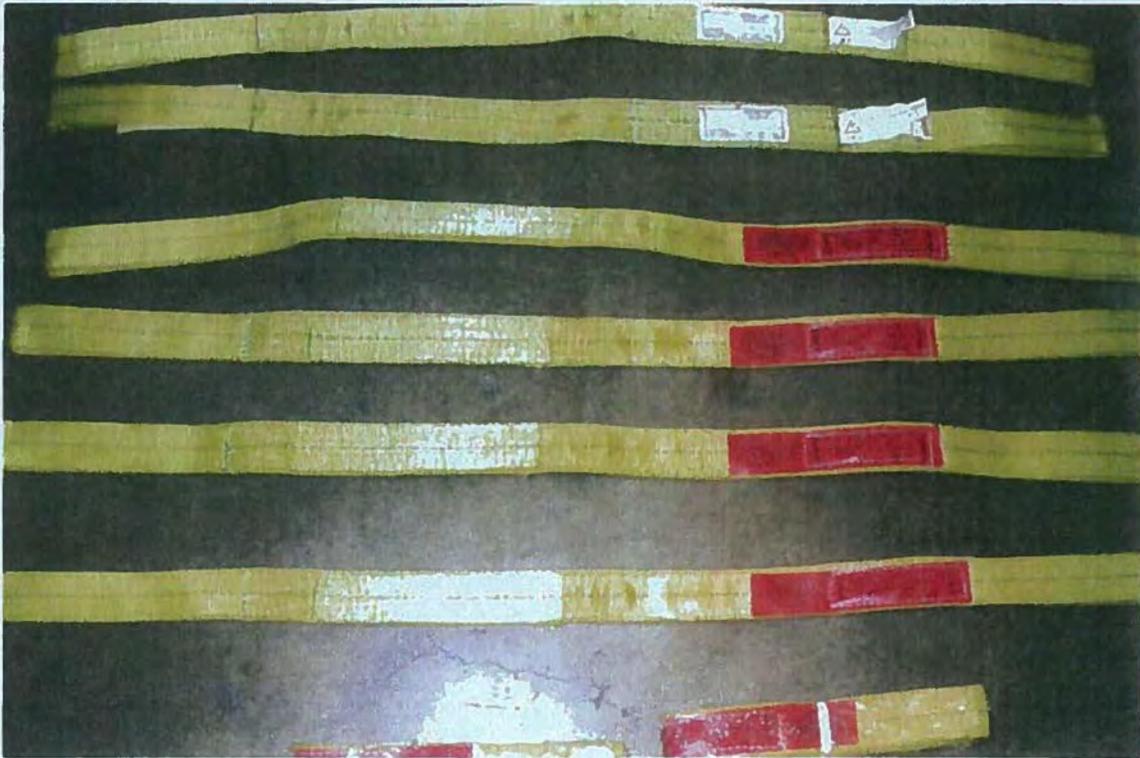
The six slings tested are shown in Photograph #40. Four of these slings are from LiftAll and two are from Metro Wire Rope. However, the sling tags containing the lifting capacities are similar to the tag on the Metro sling which ruptured on the tower crane. The ultimate strength tests were conducted at SWRI on a 400,000 # Tinius Olsen tensile testing machine. The configuration of testing consists of placing one eye of a sling around a 1 3/4" diameter pin at the top dead end, and choking the other end around the live end (Photograph #41). This machine was last calibrated on February 4, 2008 by the Tinius Olsen Company (photograph #42).

**PHOTOGRAPH #40  
SIX SLINGS TESTED AT SWRI**

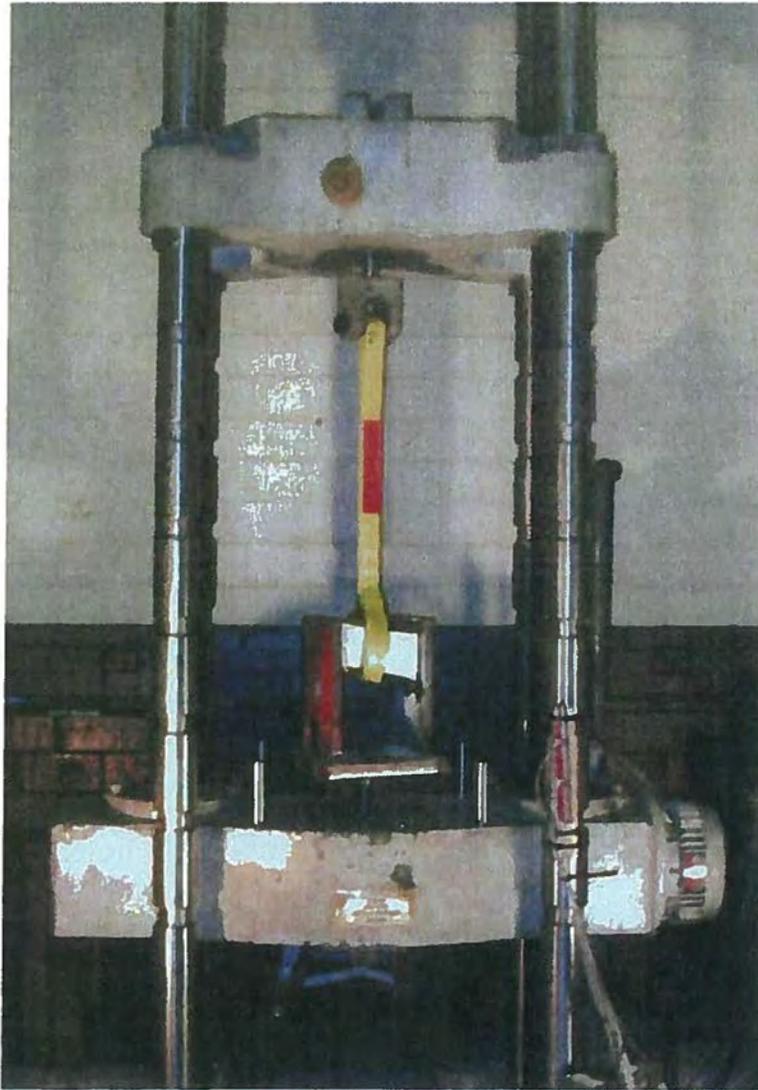
PHOTOGRAPH #41  
SETUP OF TESTING ON TINIUS OLSEN  
TENSILE MACHINE

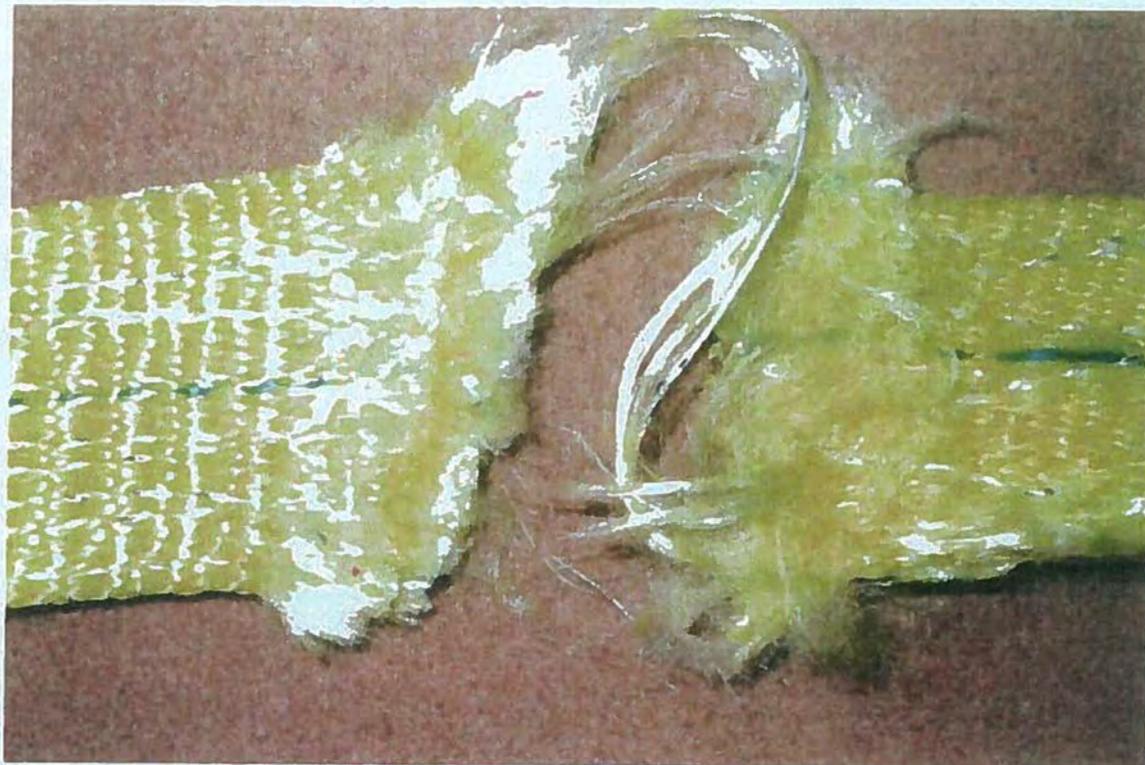
The first series of SWRI tests positions the lower sling eye choked around the angular I-beam (Photograph #43). The edges of the I-beam closely duplicate the edges of the I-beam chords of the tower crane, and the angle will induce some limited movement of the sling along the I-beam during testing (Photograph #44). The first test, involving a LiftAll sling, broke at 15,275 # at the lower edge of the beam closest to the choked eye (Photograph #45). A close up view of the break shows the cutting of the sling along the edge of the beam, and reveals that the fibers have fused along this cut from movement of the sling against the edge of the I-beam (Photograph #46). After removal of the sling from the test frame, the side view of the sling break reveals that the break occurred at the angle of the beam in relation to the sling body and that the cut fibers extend across most of the sling body width (photograph # 47).

**PHOTOGRAPH #47  
MATCHED FAILED ENDS OF SLING TESTED AROUND I-BEAM**

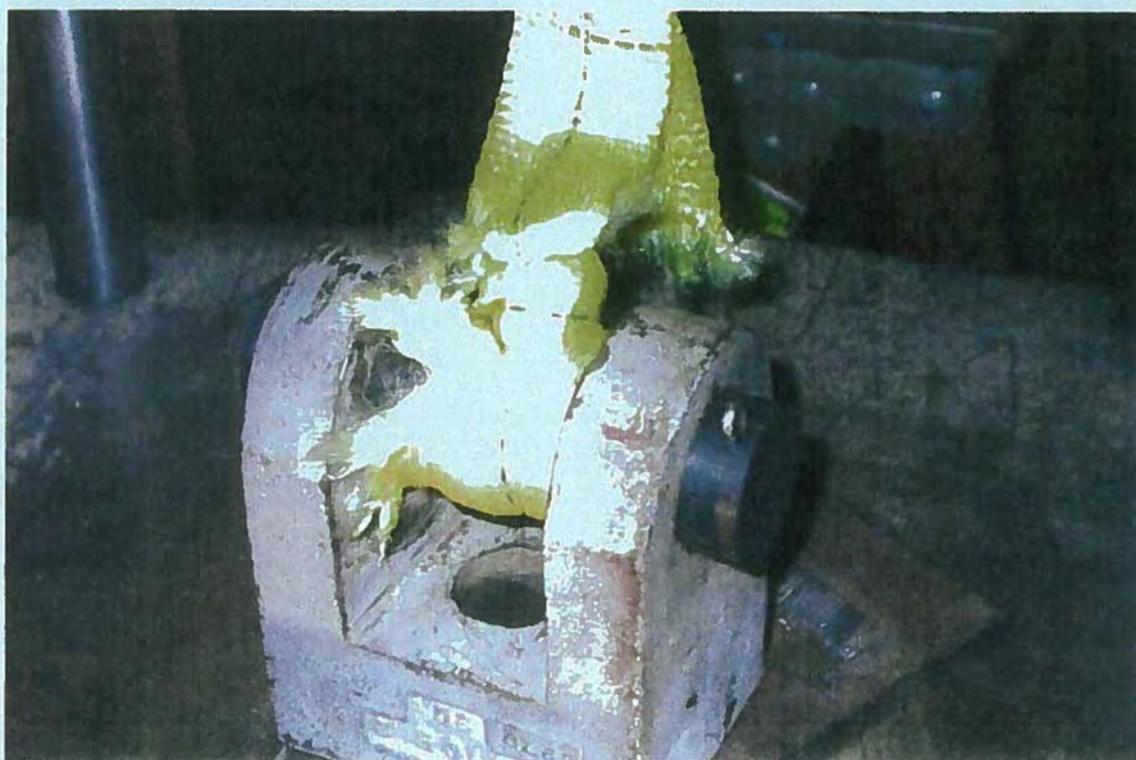
The second series of tests consists of choking the lower eyes around a 1 3/4" diameter pin (Photograph #49). As expected, the slings failed at the choked location on the pin. The LiftAll sling broke at 21,410 # and the unidentified sling broke at 20,102 # (Photograph #50). After removal from the pin, the sling break show that the fibers have parted in a tensile and shearing (Photograph #51) and there is no sign of cut fibers.

**PHOTOGRAPH #50  
FAILURE OF SLING BEING CHOKED AROUND A PIN**

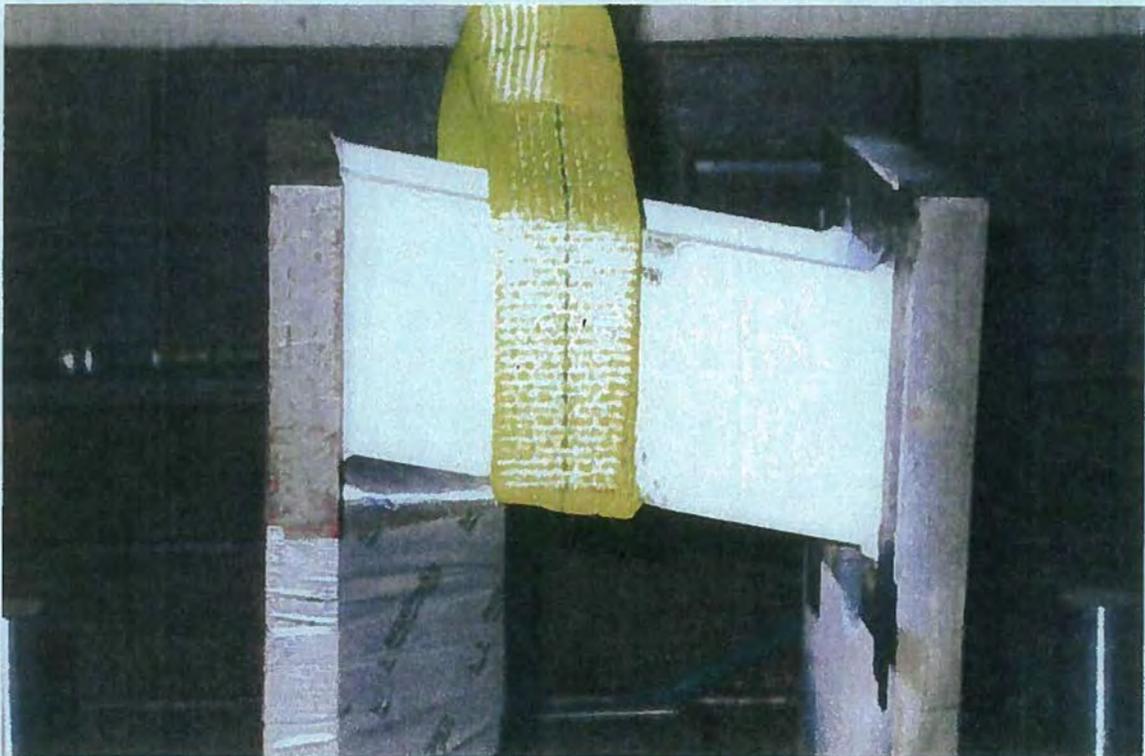
The fifth test involves placing a side restraint against the side of the sling as it is choked around the I-Beam (Photograph #52). It was the intent to possibly introduce a sideward shearing force and bunching, but this small angle resulted in only preventing the sling from sliding along the I-beam. This test sample broke at 16,576 #.

**PHOTOGRAPH #52  
SETUP OF TEST WITH SIDE RESTRAINT ON I-BEAM**

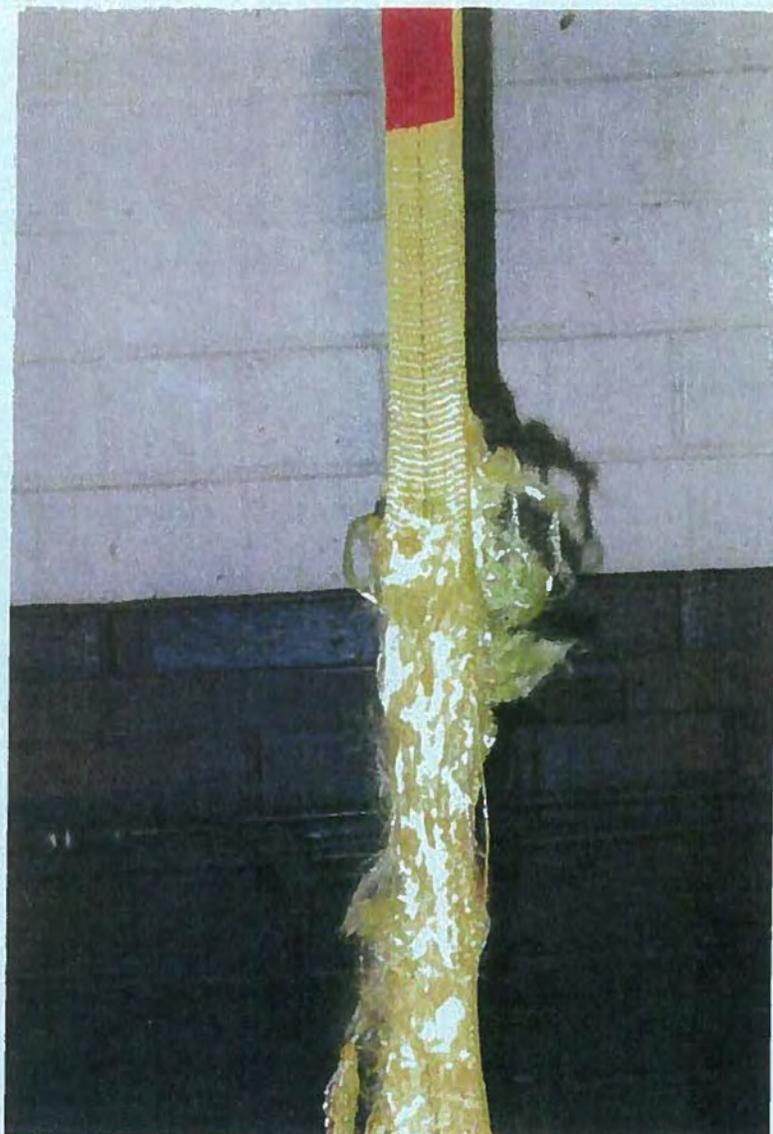
The last test involves testing a sling with both eyes around 1 3/4" pins. This is expected to produce the highest breaking strength of all tests. The sling began parting at 32,767 # with all fibers elongating and pulling apart in a tensile mode (Photograph #53). There is no cutting, and the elongation and stretching of the fibers are identical in appearance to the last fibers in the incident slings which pulled apart in tensile after cutting occurred.

**PHOTOGRAPH #53  
FIBERS OF WEB SLING FAILING IN TENSILE TEST  
BOTH EYES ON PINS**
