Investigation of a Tower Crane Collapse in San Francisco, California-November 28, 1989

U.S. Department of Labor Occupational Safety and Health Administration

May 1990

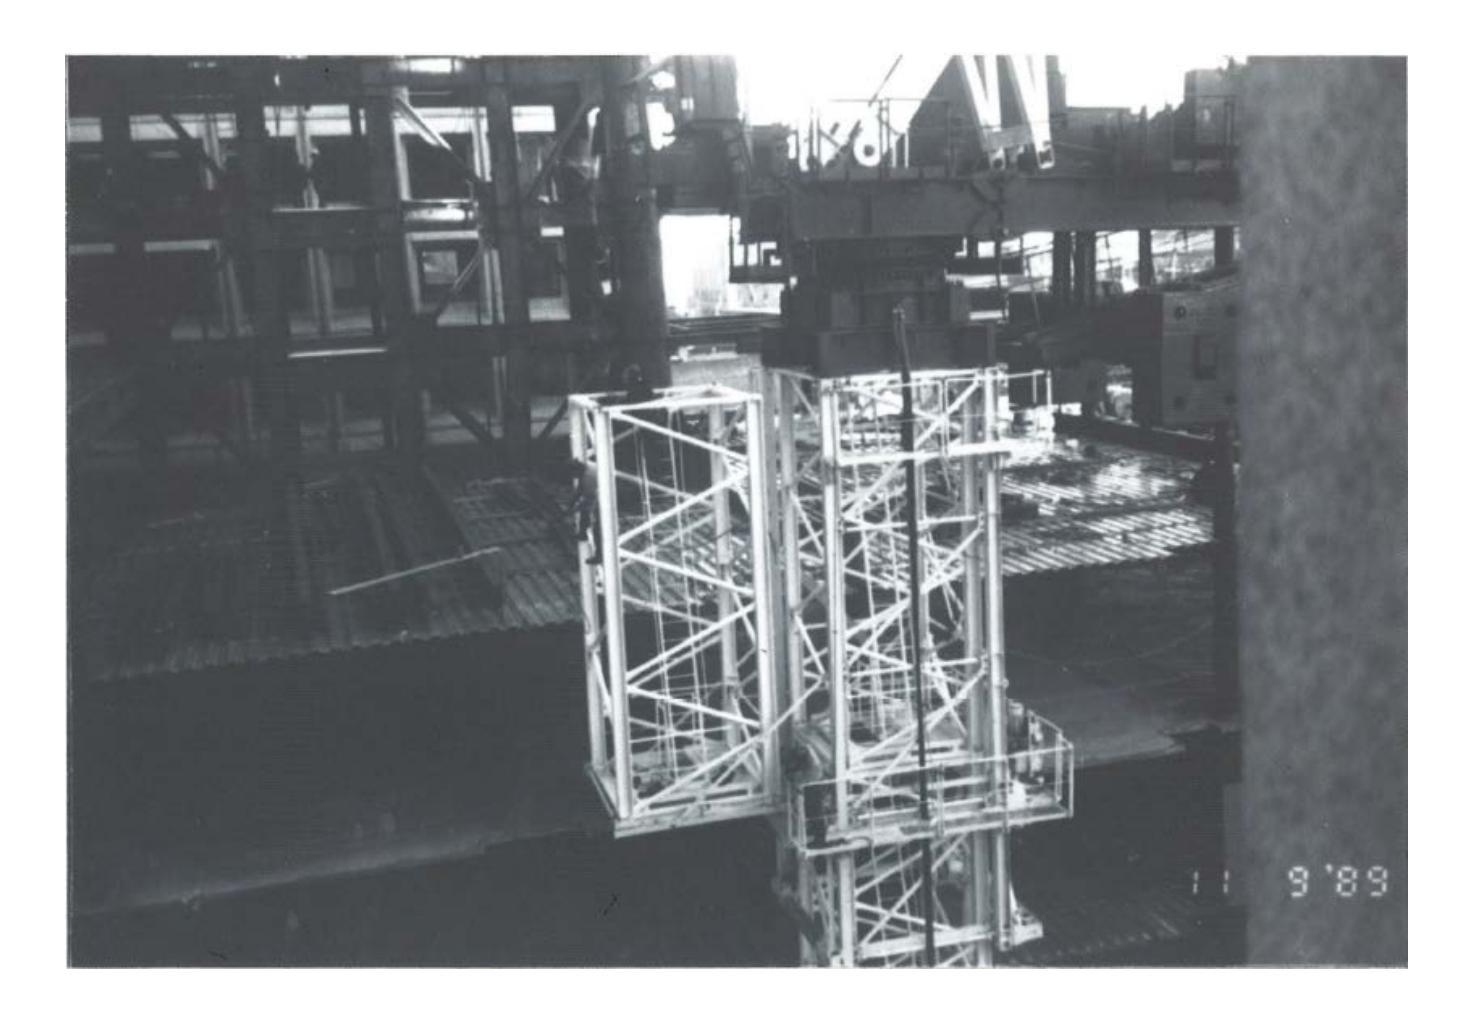
Figure 1.1.3

Climbing operation on 11-9-89. Turntable on top of climbing section, new section on platform at left.

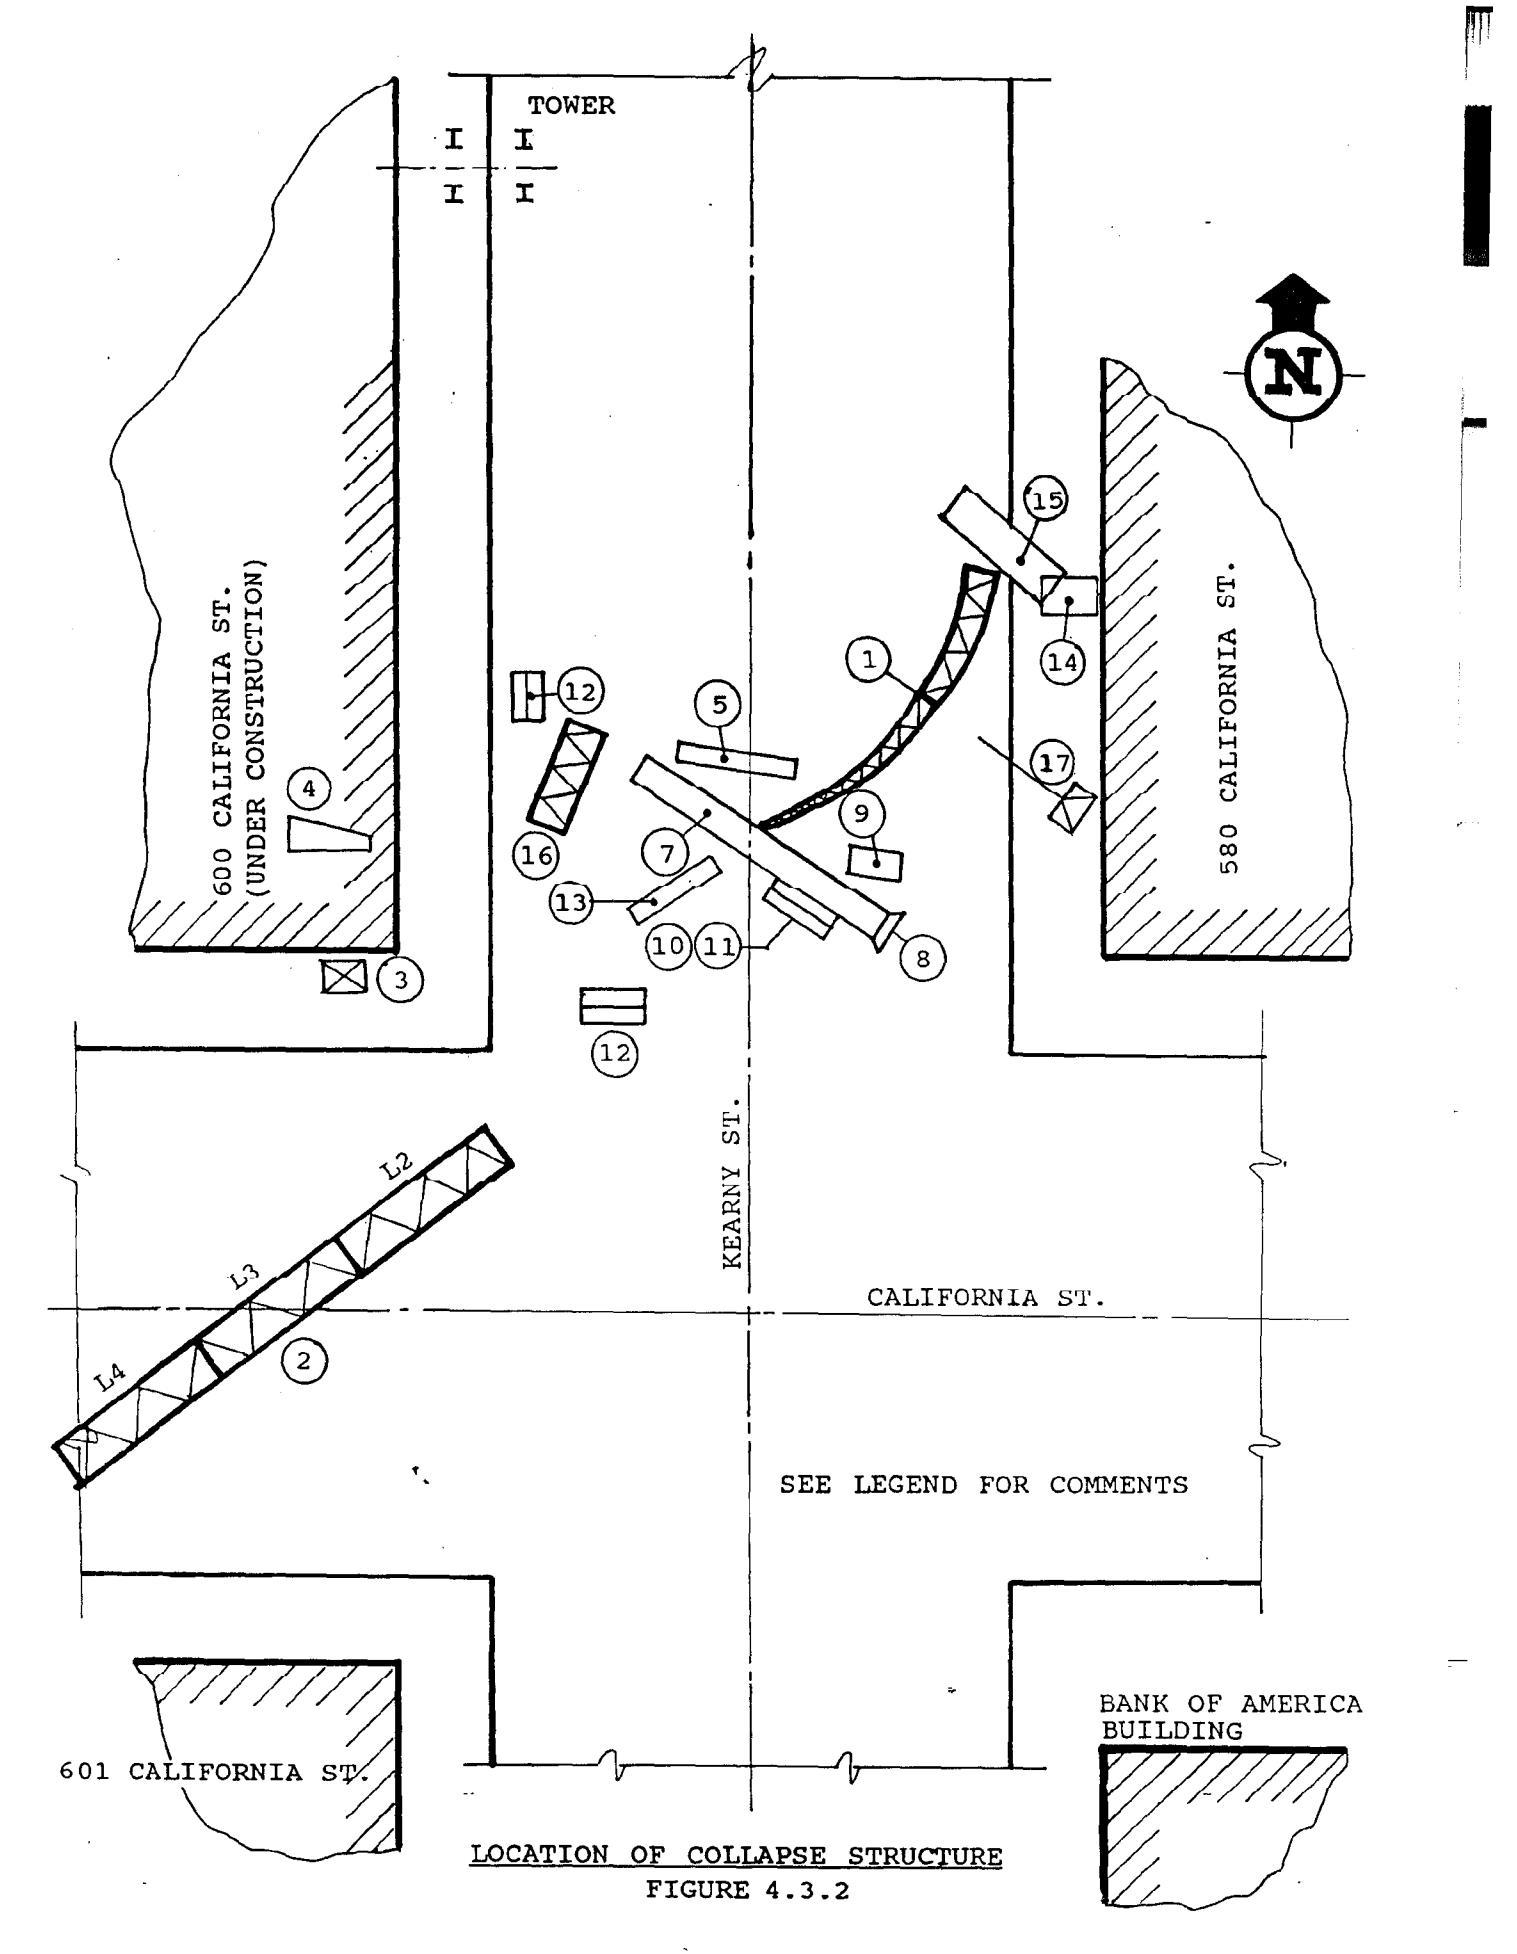
Location of Collapsed Crane Parts

#14 Climbing Frame	Hit the face of the 580 California St. building on Kearny St. and then landed on the sidewalk leaning against 580 California St. Upright condition. West face leaning against the bldg. North face towards California St.	Leaning against the 580 California Street on Kearny Street side.
#15 Tower Section 15	Partially underneath the climbing frame. West face up. South face towards California St. SE leg sheared, SW leg sheared, NE leg sheared, NW leg partially fractured.	Kearny Street
#16 Tower Section 16	South face up. Top towards north	Kearny Street
#17 Climbing Traverse	Hydraulic ram pointing to NW	Kearny Street

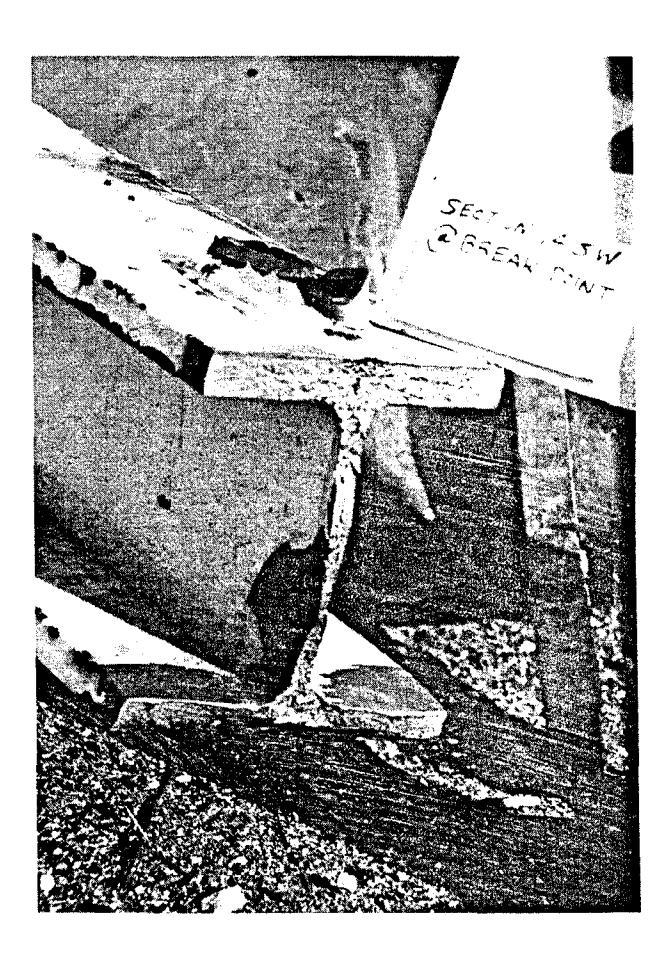
Failure of Section 14 SE leg viewed toward bottom of the section.

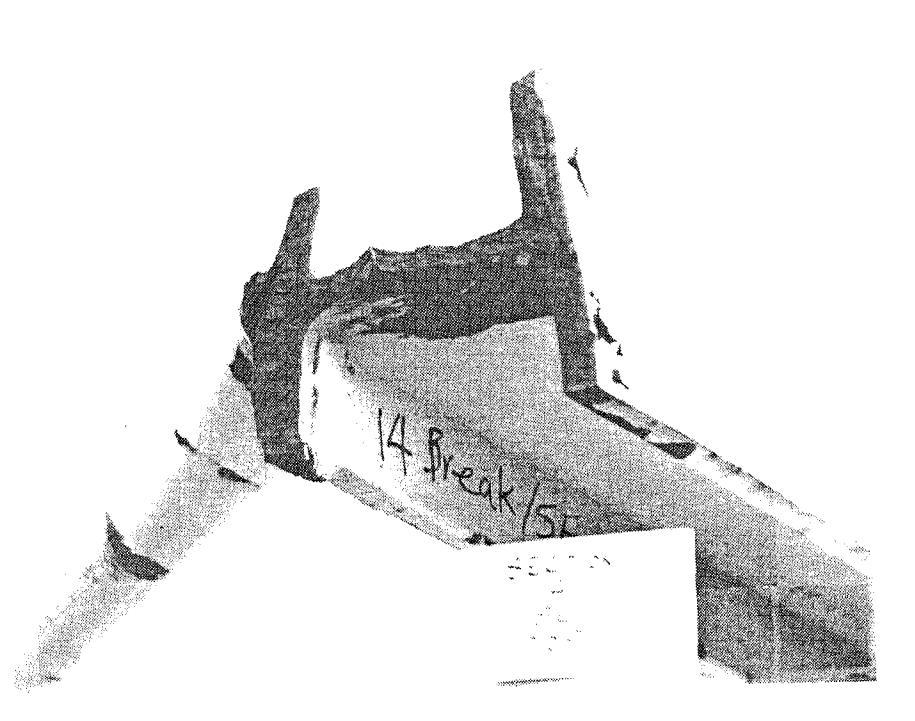
Failure of Section 14 NE leg -- at top of section.

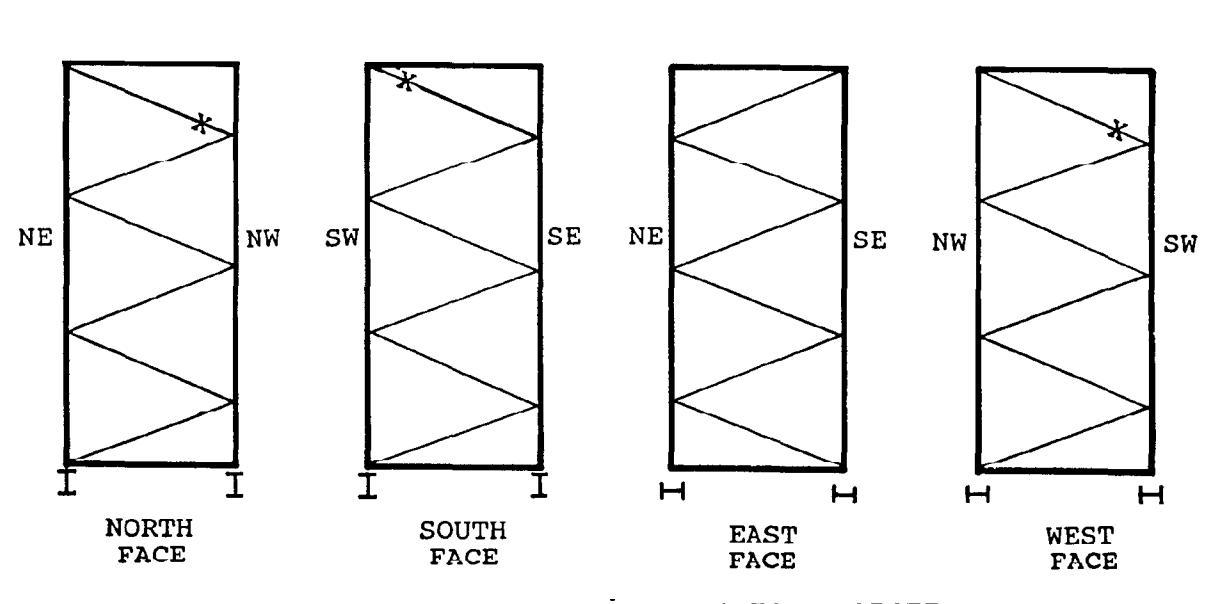
ELEVATION OF FRACTURED DIAGONALS OF TOWER SECTION 15 AFTER COLLAPSE

- X LOCATION OF FRACTURE THRU ENTIRE SECTION
- P = LOCATION OF PARTIAL FRACTURE

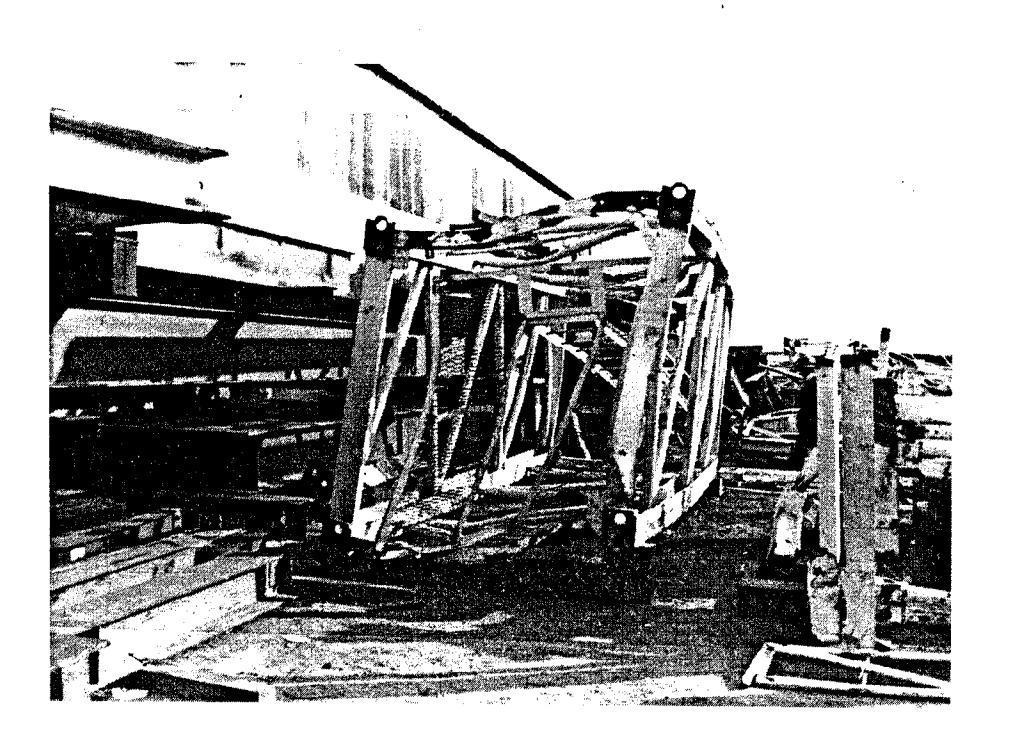
Tower Section 16 — viewed from the bottom — the West face is on the ground.

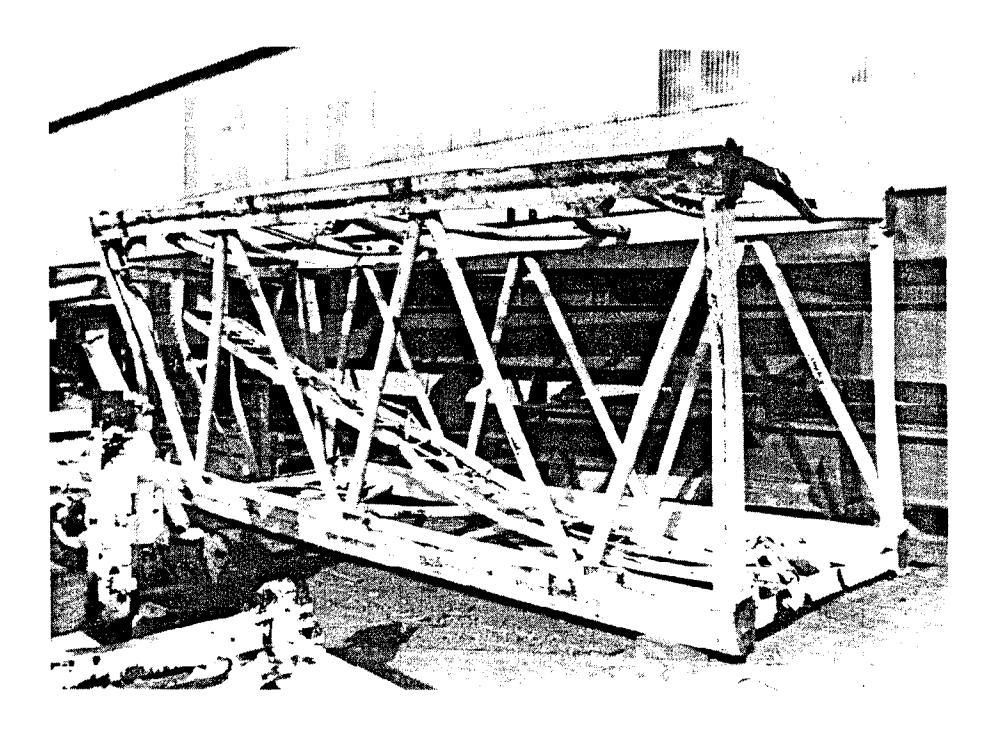
Figure 4.3.11

Tower Section 16 - view of North face.

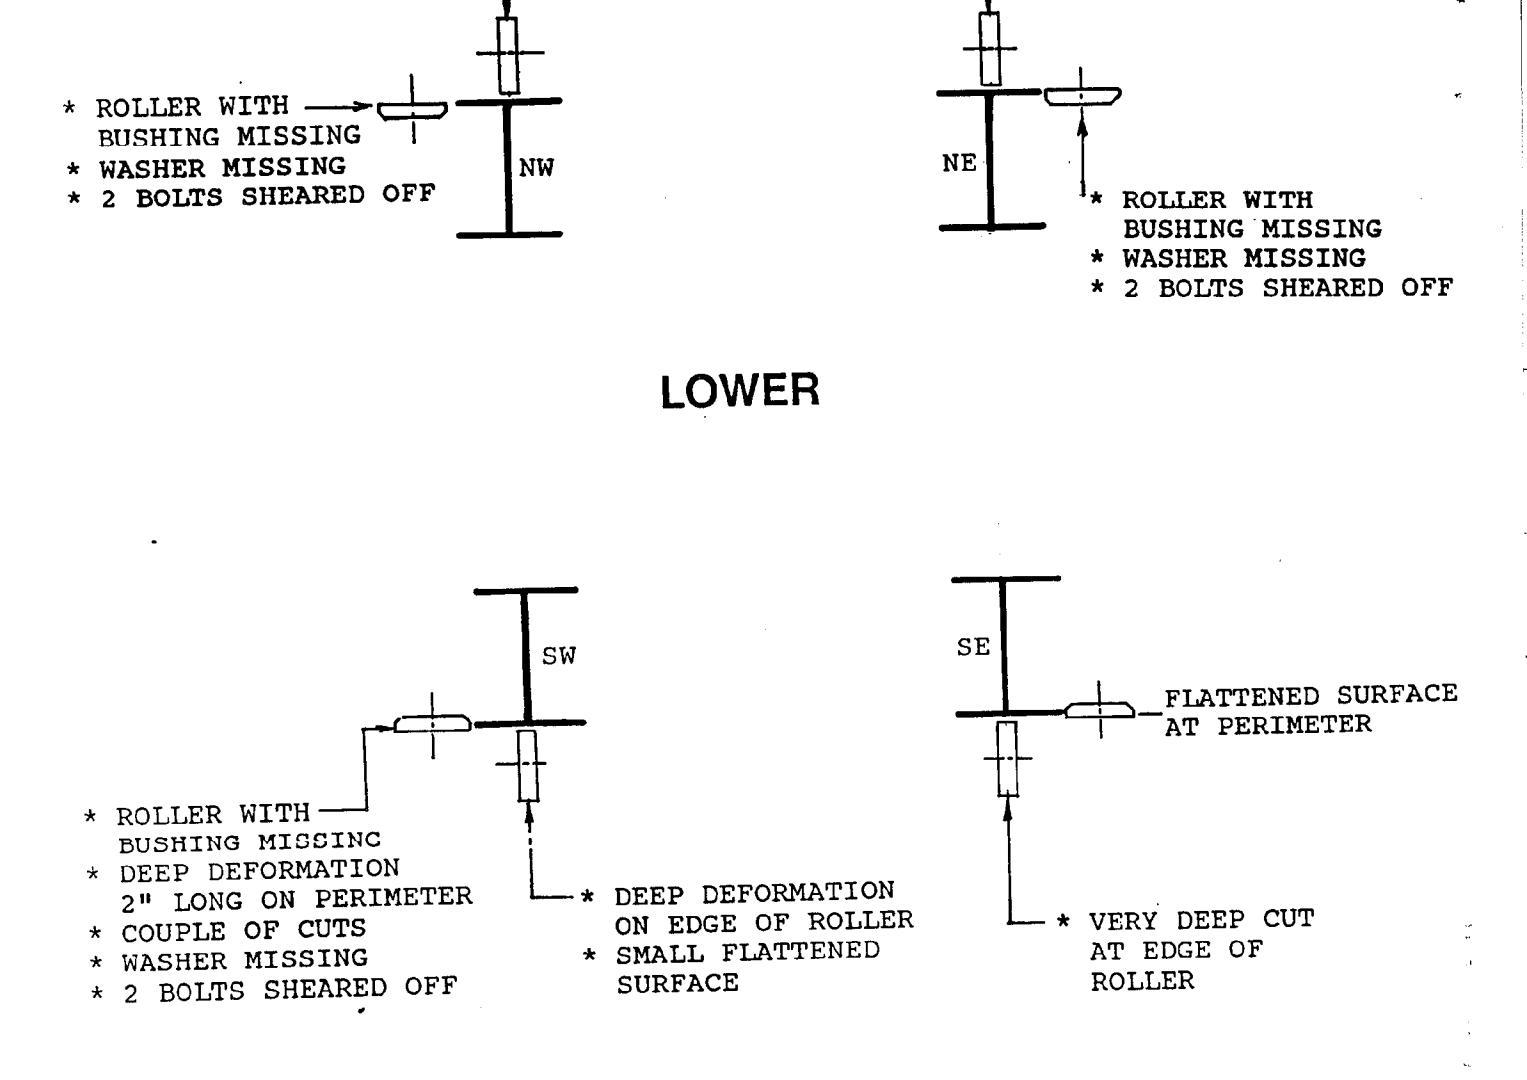
SLIGHT DENT AND

FLATTENING OF ROLLER

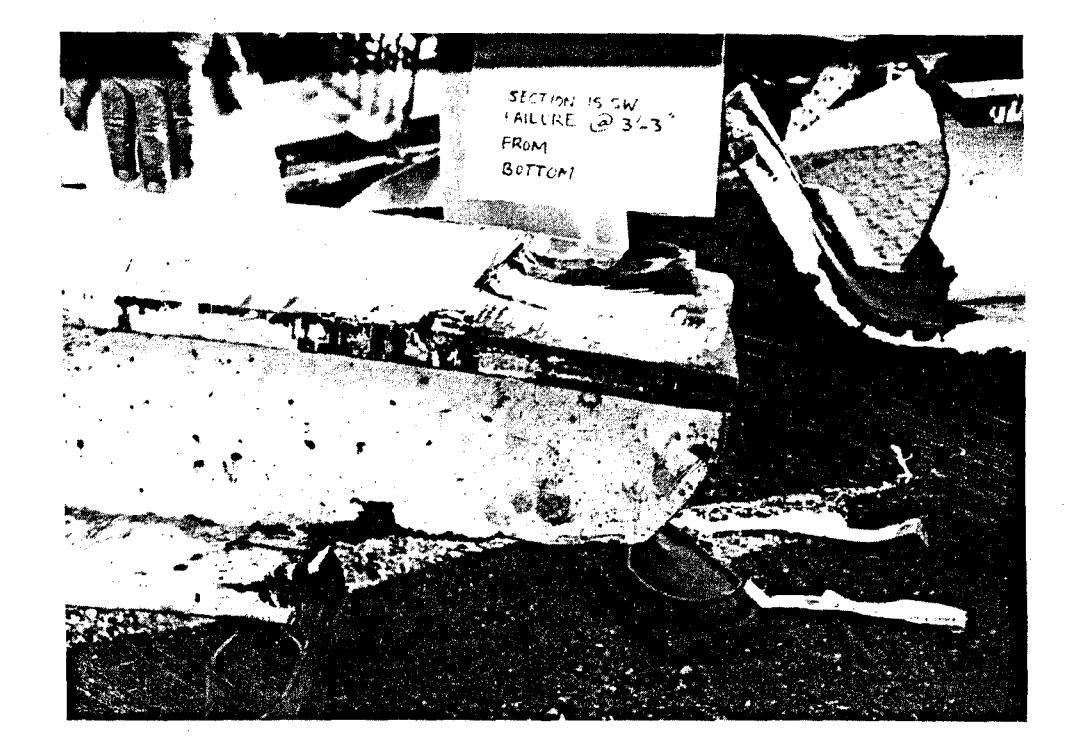
Failure of Section 15 SW leg — at 3'-4'' from bottom of member.

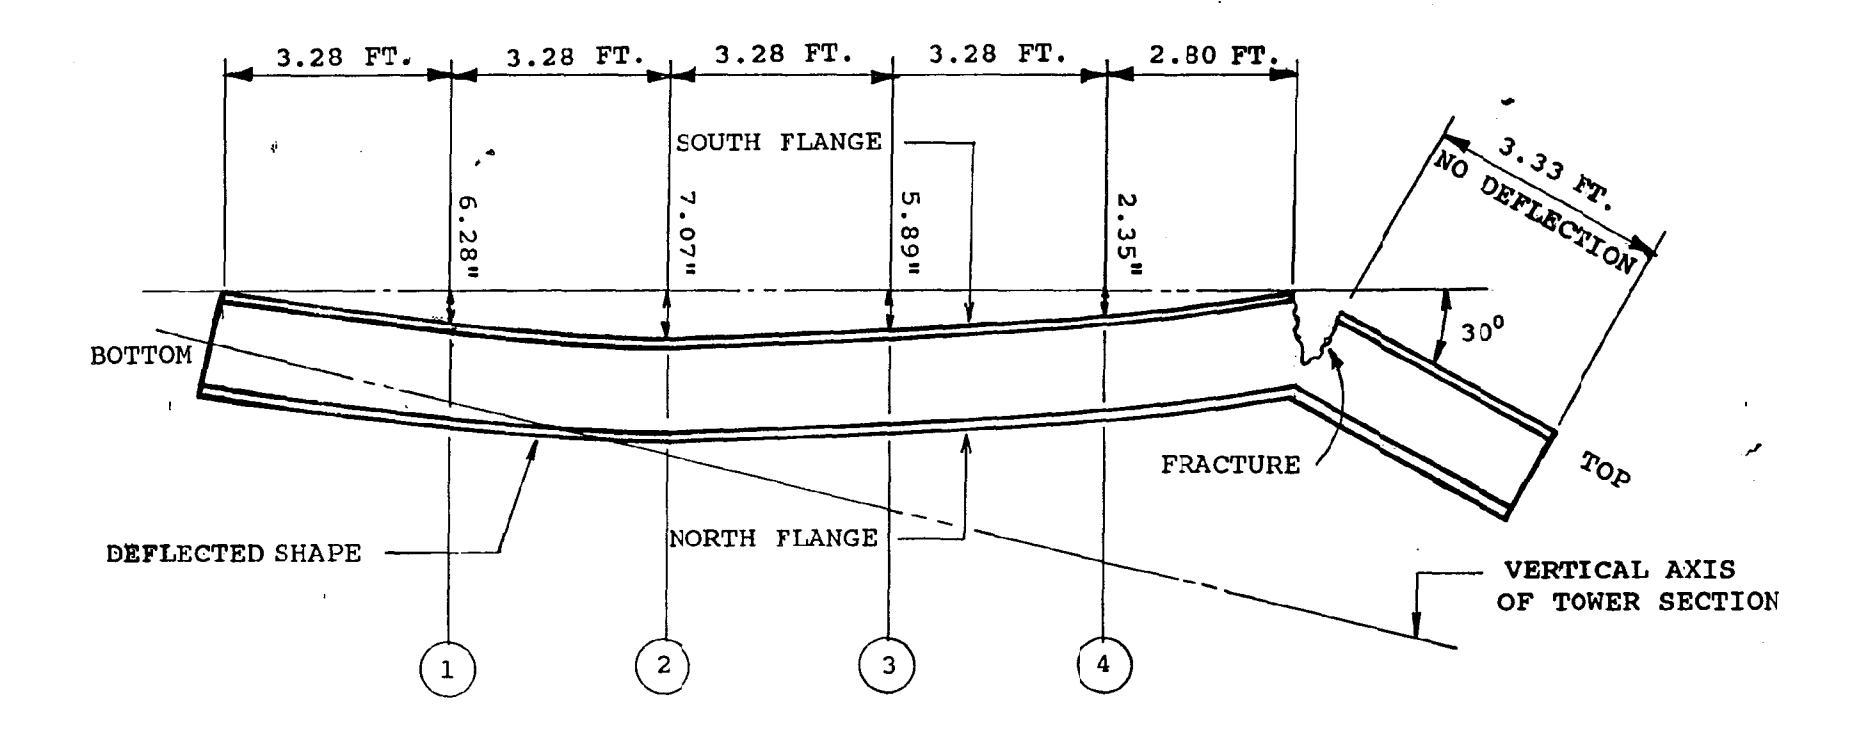
LOOKING WEST. FIGURE 4.3.32

TOWER SECTION NO. 15; NORTHEAST LEG

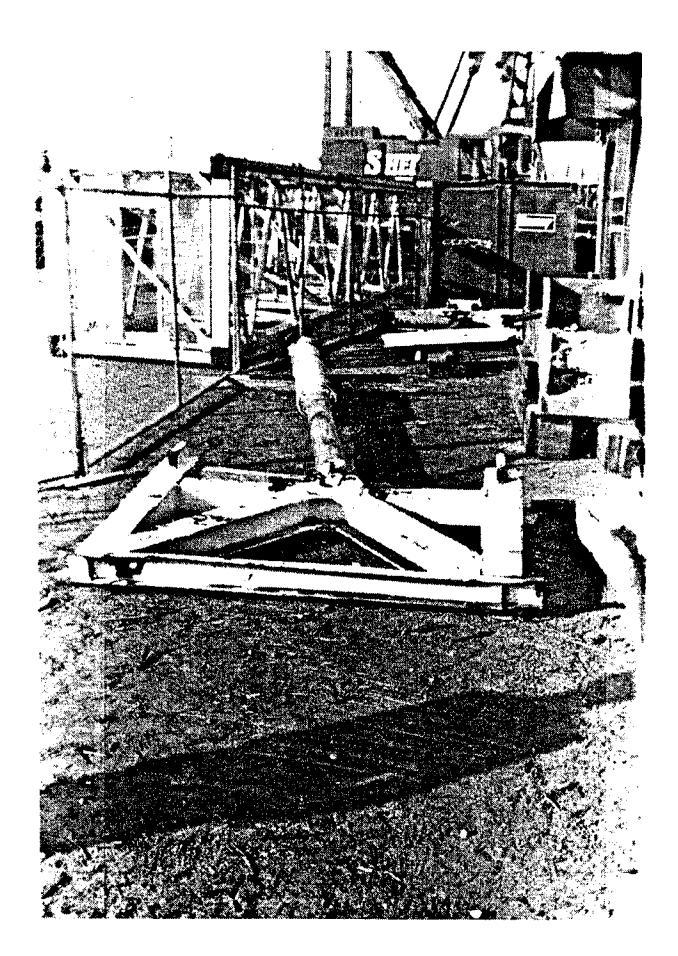
Figure 4.3.39

Hydraulic ram and climbing transverse — looking from bottom.

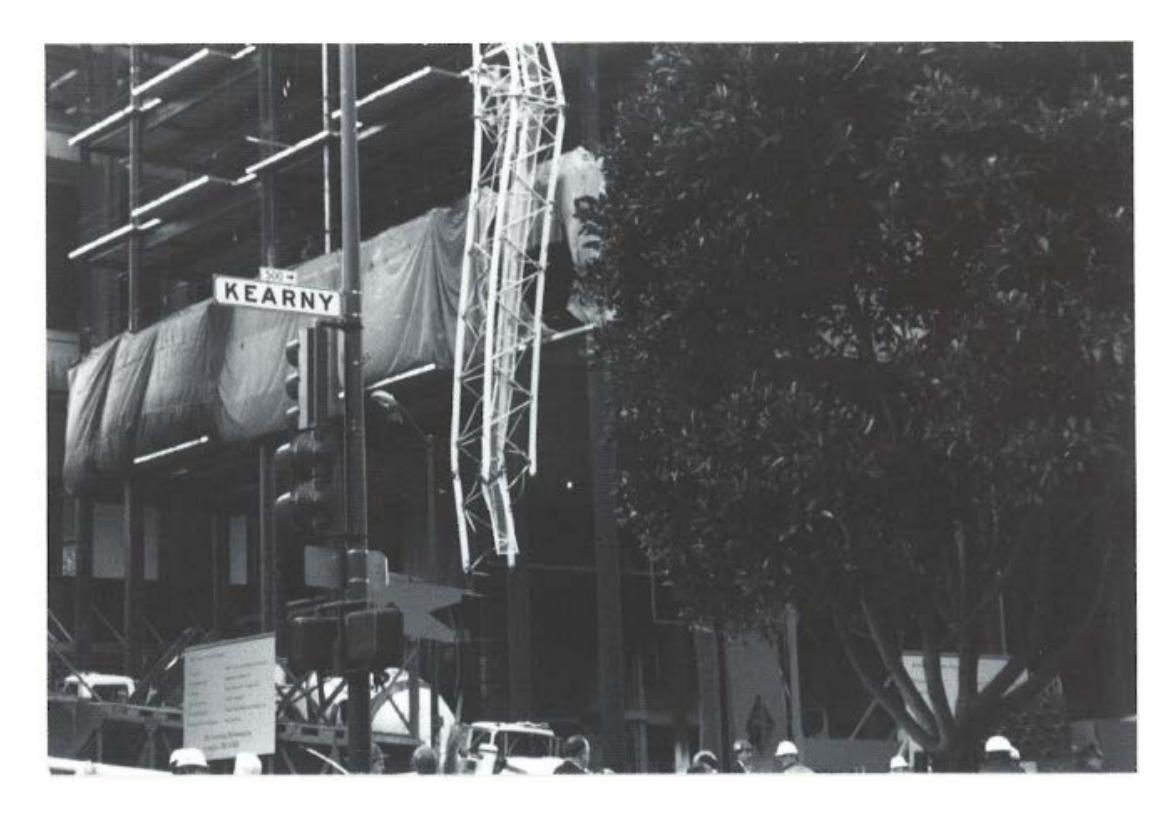
Portion of collapsed boom hanging from the building under construction onto California Street.

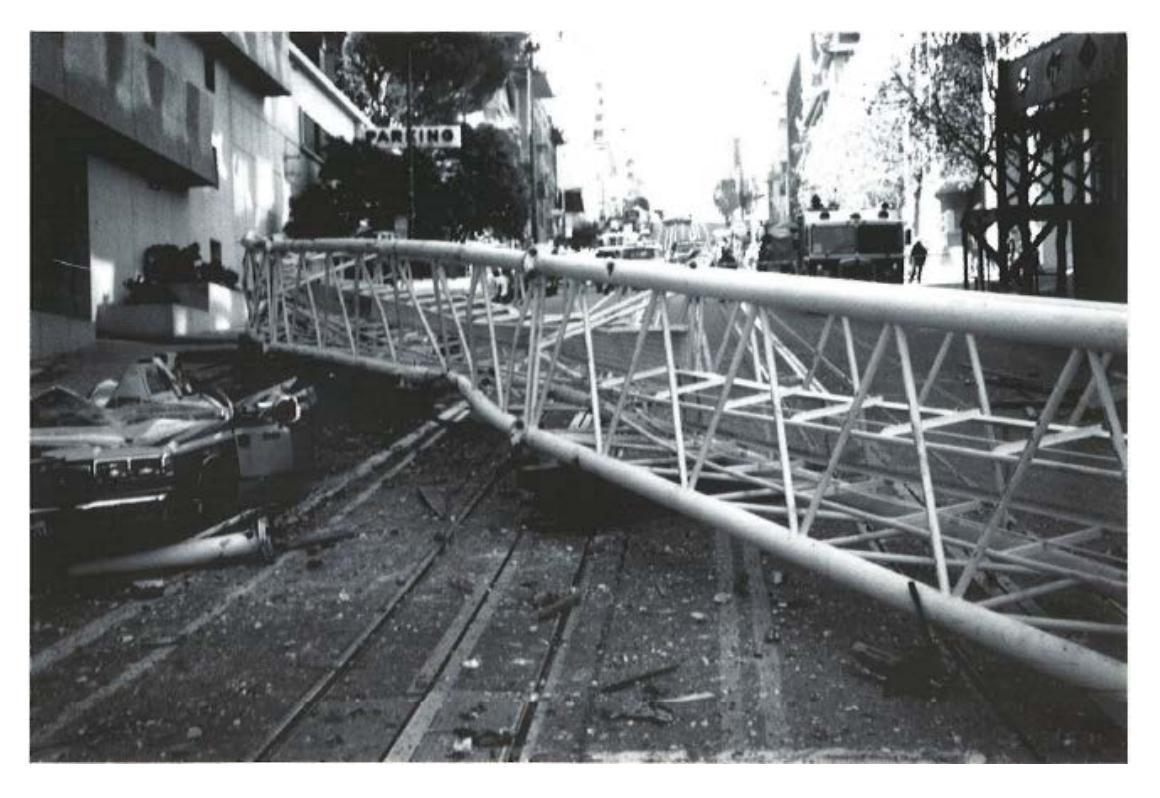
Main part of the collapsed boom - laying on California Street.

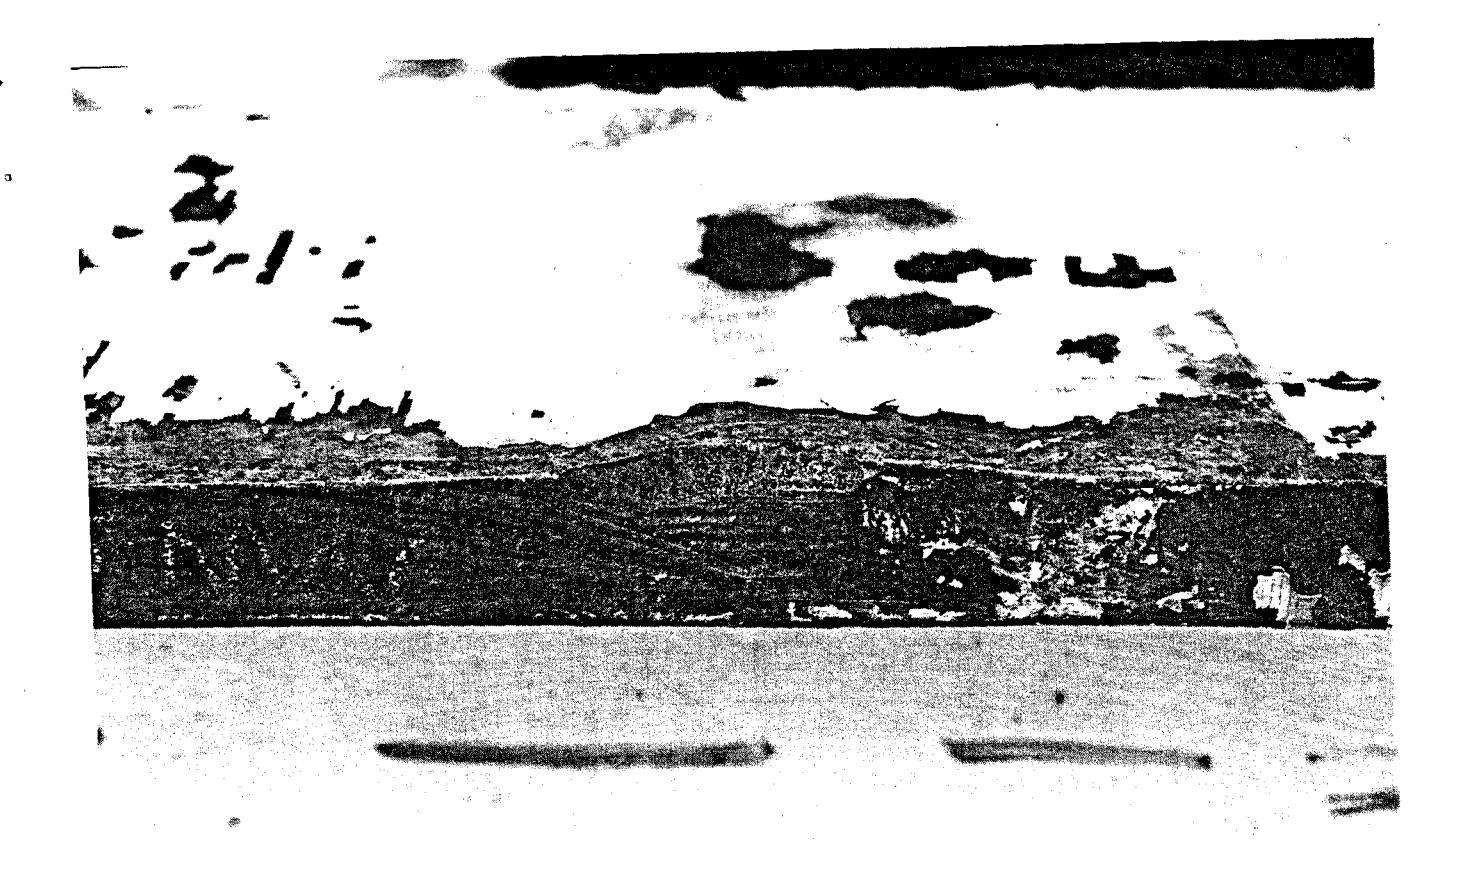
Deformation at 10'-0" from top on the West edge of North flange of tower Section 15 NW leg.

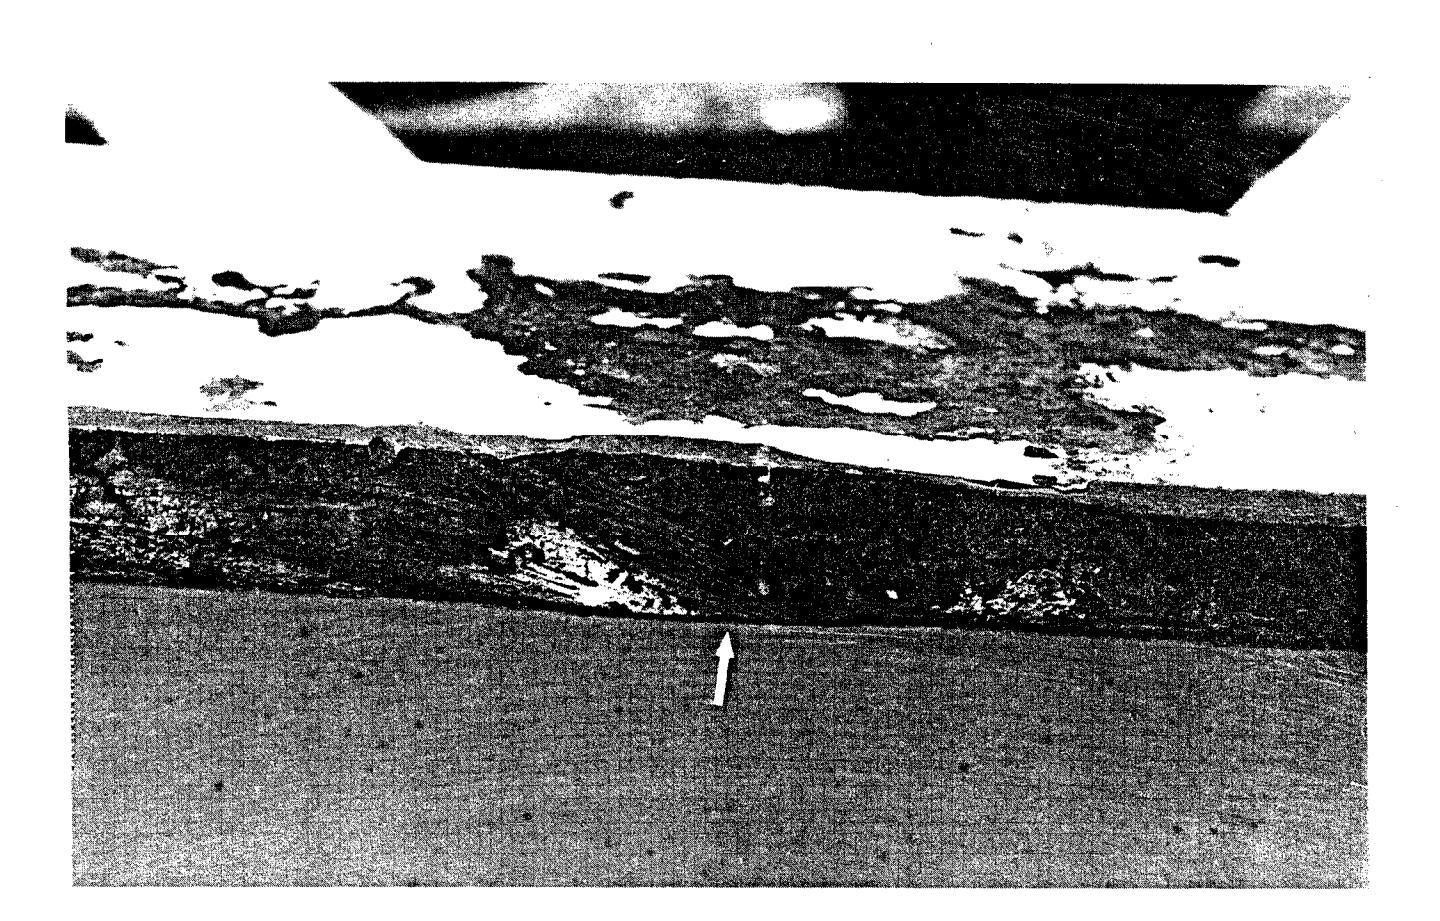
Flange deformation at 3'-2" from top on East edge of South flange of tower Section 15 SE leg.

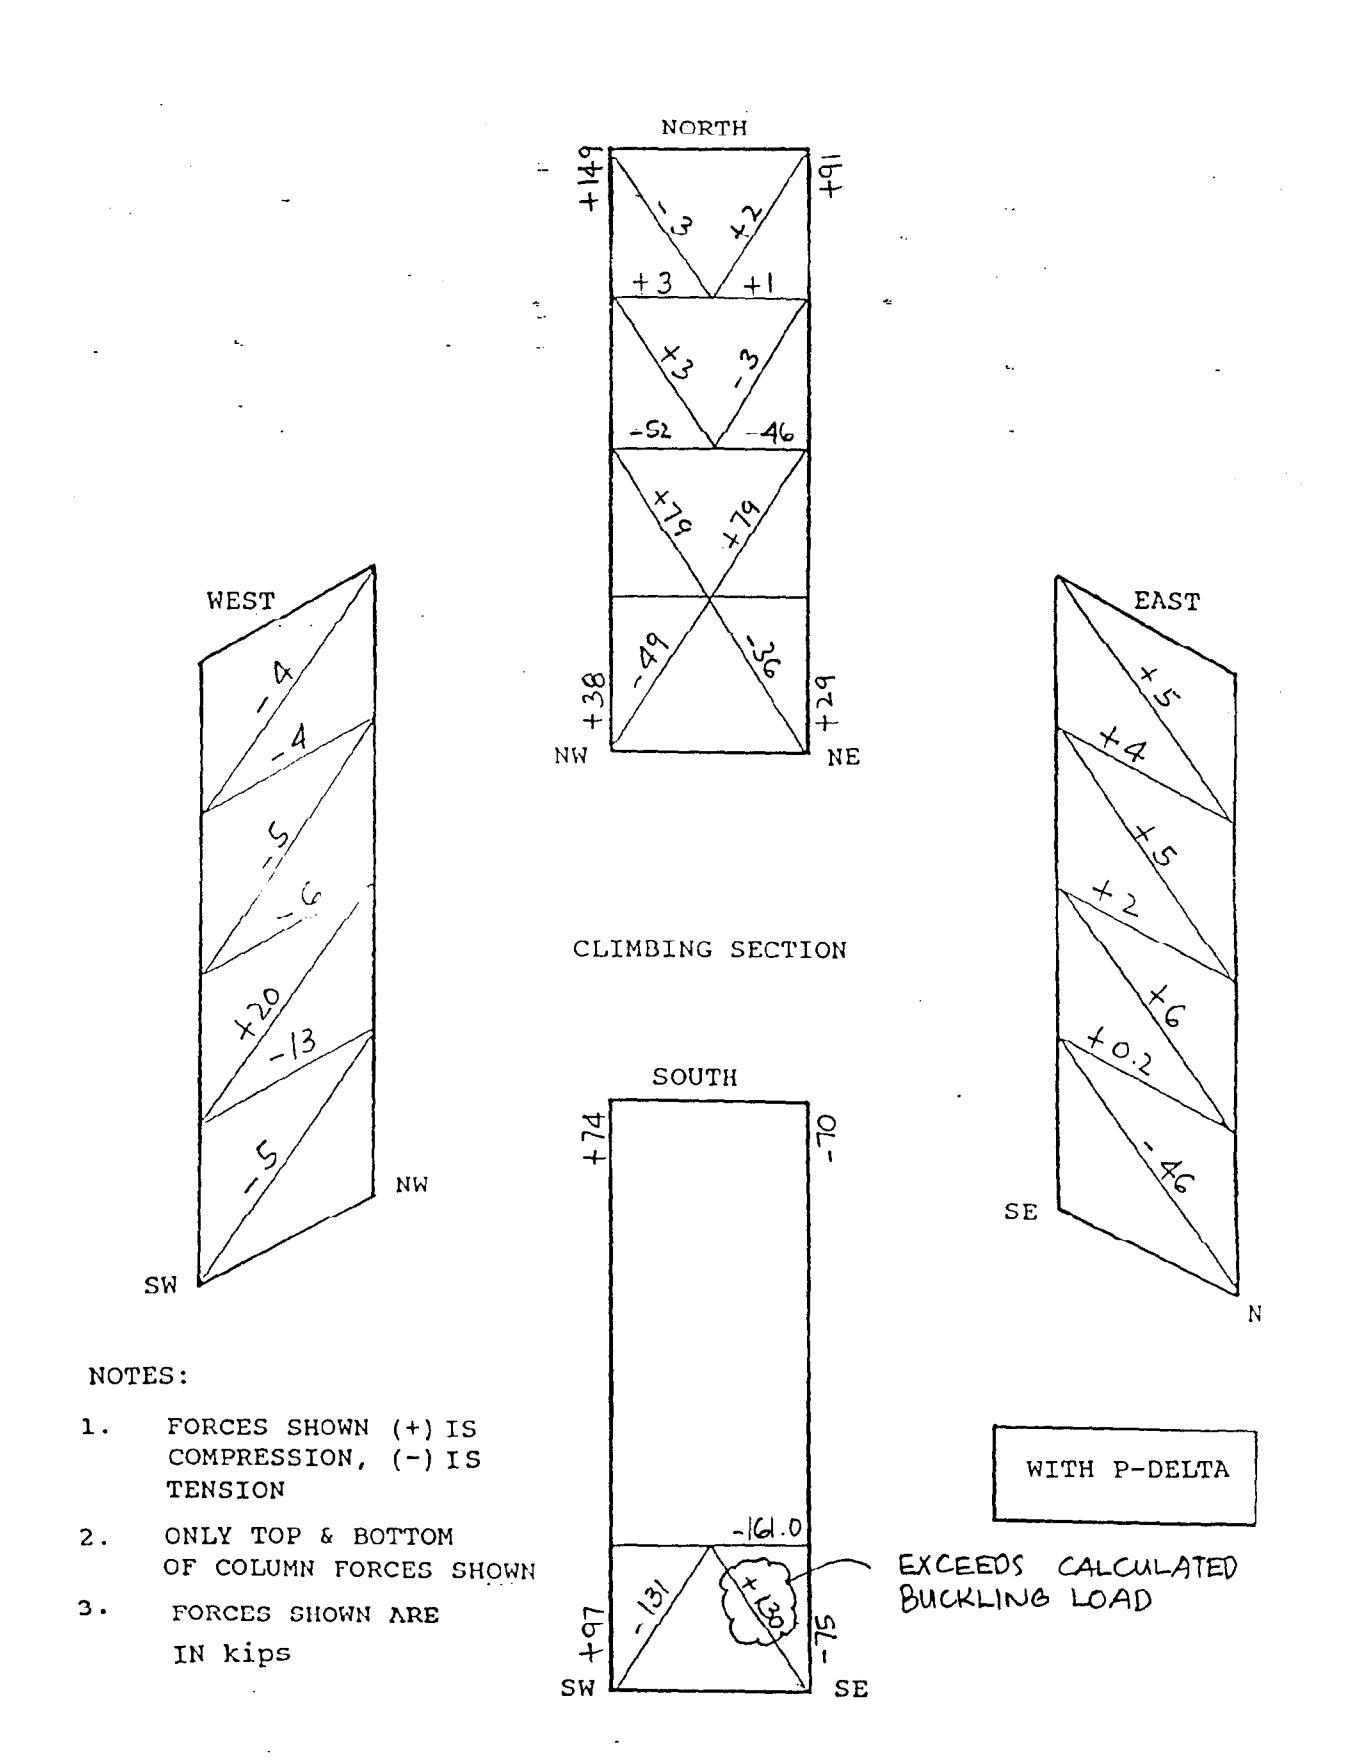
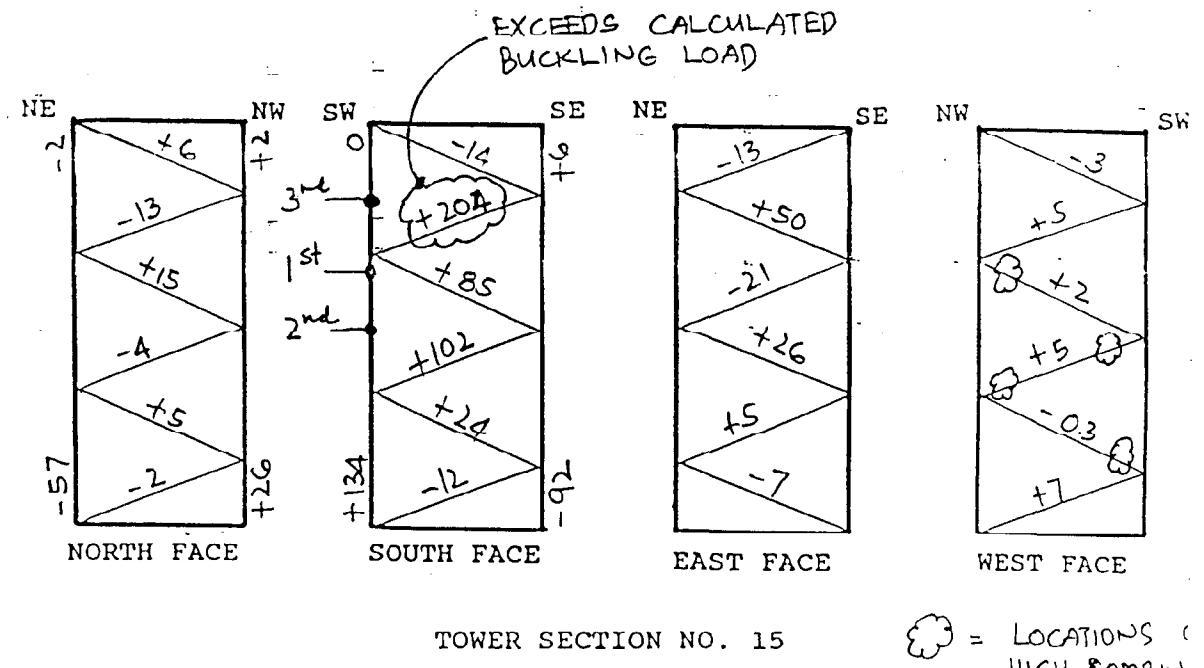
FORCES AND STRESSES IN CLIMBING SECTION AT $\varphi = 45^{\circ}$ FIGURE 6.3.6a

HIGH COMBIN STRESSES

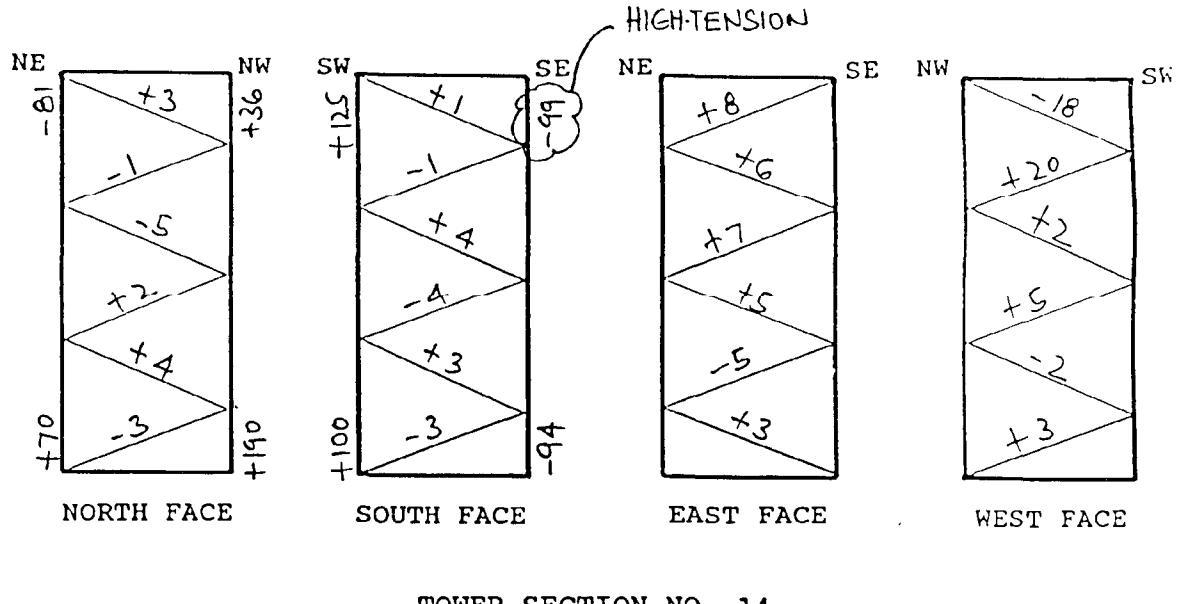
FORCES AND STRESSES IN TOWER SECTIONS $- = 45^{\circ}$ FIGURE 6.3.6b

TOWER SECTION NO. 14

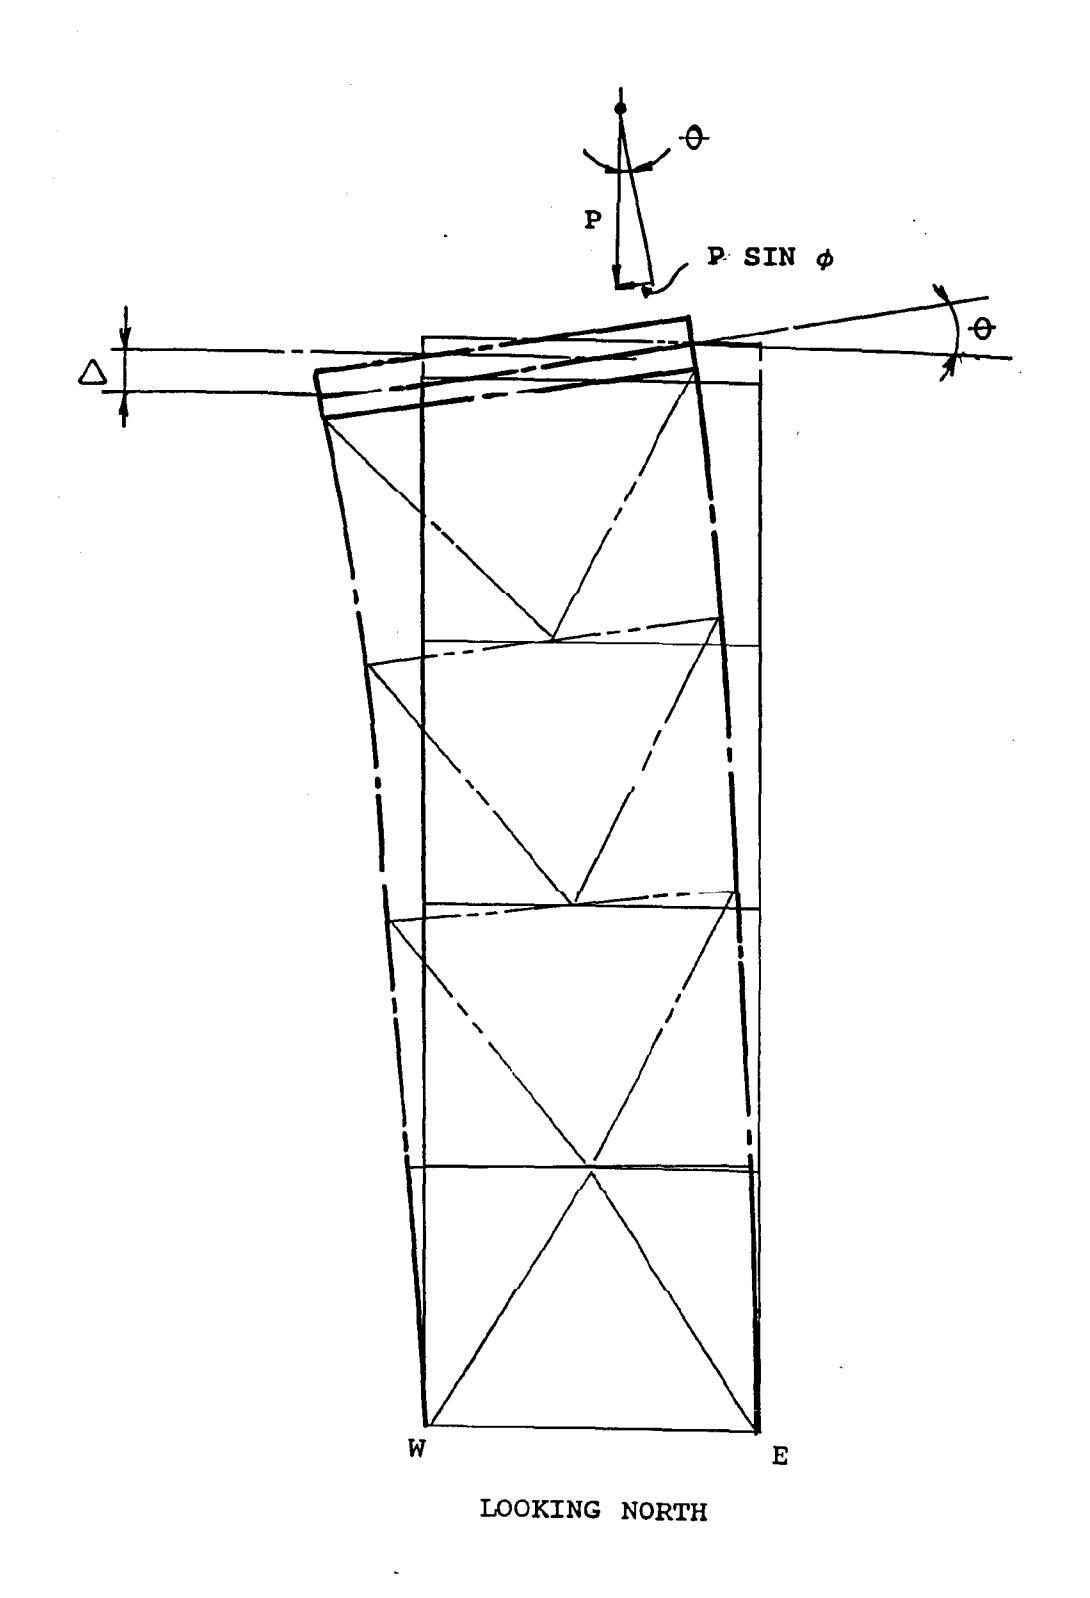
FIGURE 6.3.7
7. ANALYSIS OF COLLAPSE

ROTATION OF CRANE SUPERSTRUCTURE
